NATIONAL TRANSPORTATION SAFETY BOARD

AIRCRAFT ACCIDENT REPORT

NORTH AMERICAN ROCKWELL AERO COMMANDER
MODEL 560E, N3827C
AND CESSNA 182Q, N96402
MIDAIR COLLISION
LIVINGSTON, NEW JERSEY
NOVEMBER 20, 1982

NTSB/AAR-83/03

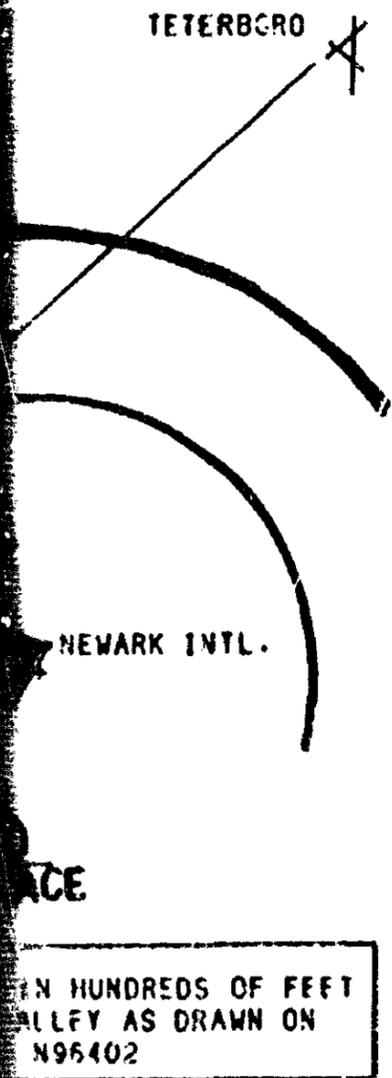
Figure 1.—Collision tracks and excerpts from ATC transcript.

At the time of these transmissions, N96402, a white with red trim Cessna 182Q, was about 7 nautical miles away, at a point that would have been between the 1 to 2 o'clock positions in relation to the pilot's view from the cockpit of N3827C. N96402 had departed Kupper Airport, Manville, New Jersey, about 1600 for a flight to Ramapo Valley Airport near Spring Valley, New York. The airplane was equipped with a 4096-code transponder, which was in use and which caused N96402 to appear as a VFR radar target on air traffic control (ATC) equipment; however, because N96402 did not have mode-C altitude reporting equipment, the airplane's altitude was not shown on the radar. The pilot, who was unaccompanied, apparently intended to fly a direct course, VFR, between the airports. He did not file a flight plan, and there is no evidence that he made radio contact with any Federal Aviation Administration (FAA) facility during his flight. The airplane was equipped with a two-way radio capable of communicating with ATC facilities. When interviewed, the controller handling N3827C said that there were numerous targets in the area at that time, but that he could not recall the movements of the VFR targets, nor did he recall having seen the radar returns of any conflicting traffic. N96402's pilot had flown the direct course several times, and he had marked his intended route on a New York Area chart. His course line passed through the New York Terminal Control Area (TCA) and touched the perimeter boundary where the TCA floor lowers from 3,000 feet mean sea level (m.s.l.) to 1,800 feet m.s.l. (See figure 1.)

Probable Ground Tracks.—The probable ground tracks of the accident airplanes were reconstructed using the recorded radar data from the New York TRACON. (See figure 1.) The radar data were provided from an ARTS III system and contained beacon code radar returns in range and azimuth for all 1200 and 5101 coded targets. ^{2/} The data covered a time period of 19 minutes from 15:55 to 16:14. The range and azimuth values were measured in relation to the antenna site located at Newark International Airport. The geographical area covered by the data was from 210 to 330 degrees (magnetic) in azimuth and 0 to 30 miles in range. Radar returns at this facility are recorded approximately every 4.7 seconds.

The radar ground tracks showed that at 1608:47, when N3827C initially contacted the New York TRACON, the airplane was flying on a southeasterly heading at an altitude of 2,000 feet. About 1 minute later, the mode-C altitude encoder indicated that the airplane was maintaining 1,900 feet. Thereafter, N3827C's recorded altitude varied between 1,900 feet and 2,000 feet until 1611:39, more than 2 minutes before the collision, and no further altitude information was received. At 1612:04, the pilot told the controller that N3827C was "...right now at two point oh [2,000 feet] sir"; the radar data indicated 25 seconds earlier at 1611:37 that the airplane was at 1,900 feet. At the point of collision, N3827C was flying a course of about 180 degrees magnetic.

The radar returns of N96402 showed that the airplane maintained a northeasterly heading from the point of takeoff until the point of collision. The ground track was slightly west of the charted course marked on the pilot's chart until 1612:02, when the ground track crossed the charted track and continued slightly to the east. At the time of collision, the airplane was making good a track of about 62 degrees magnetic.

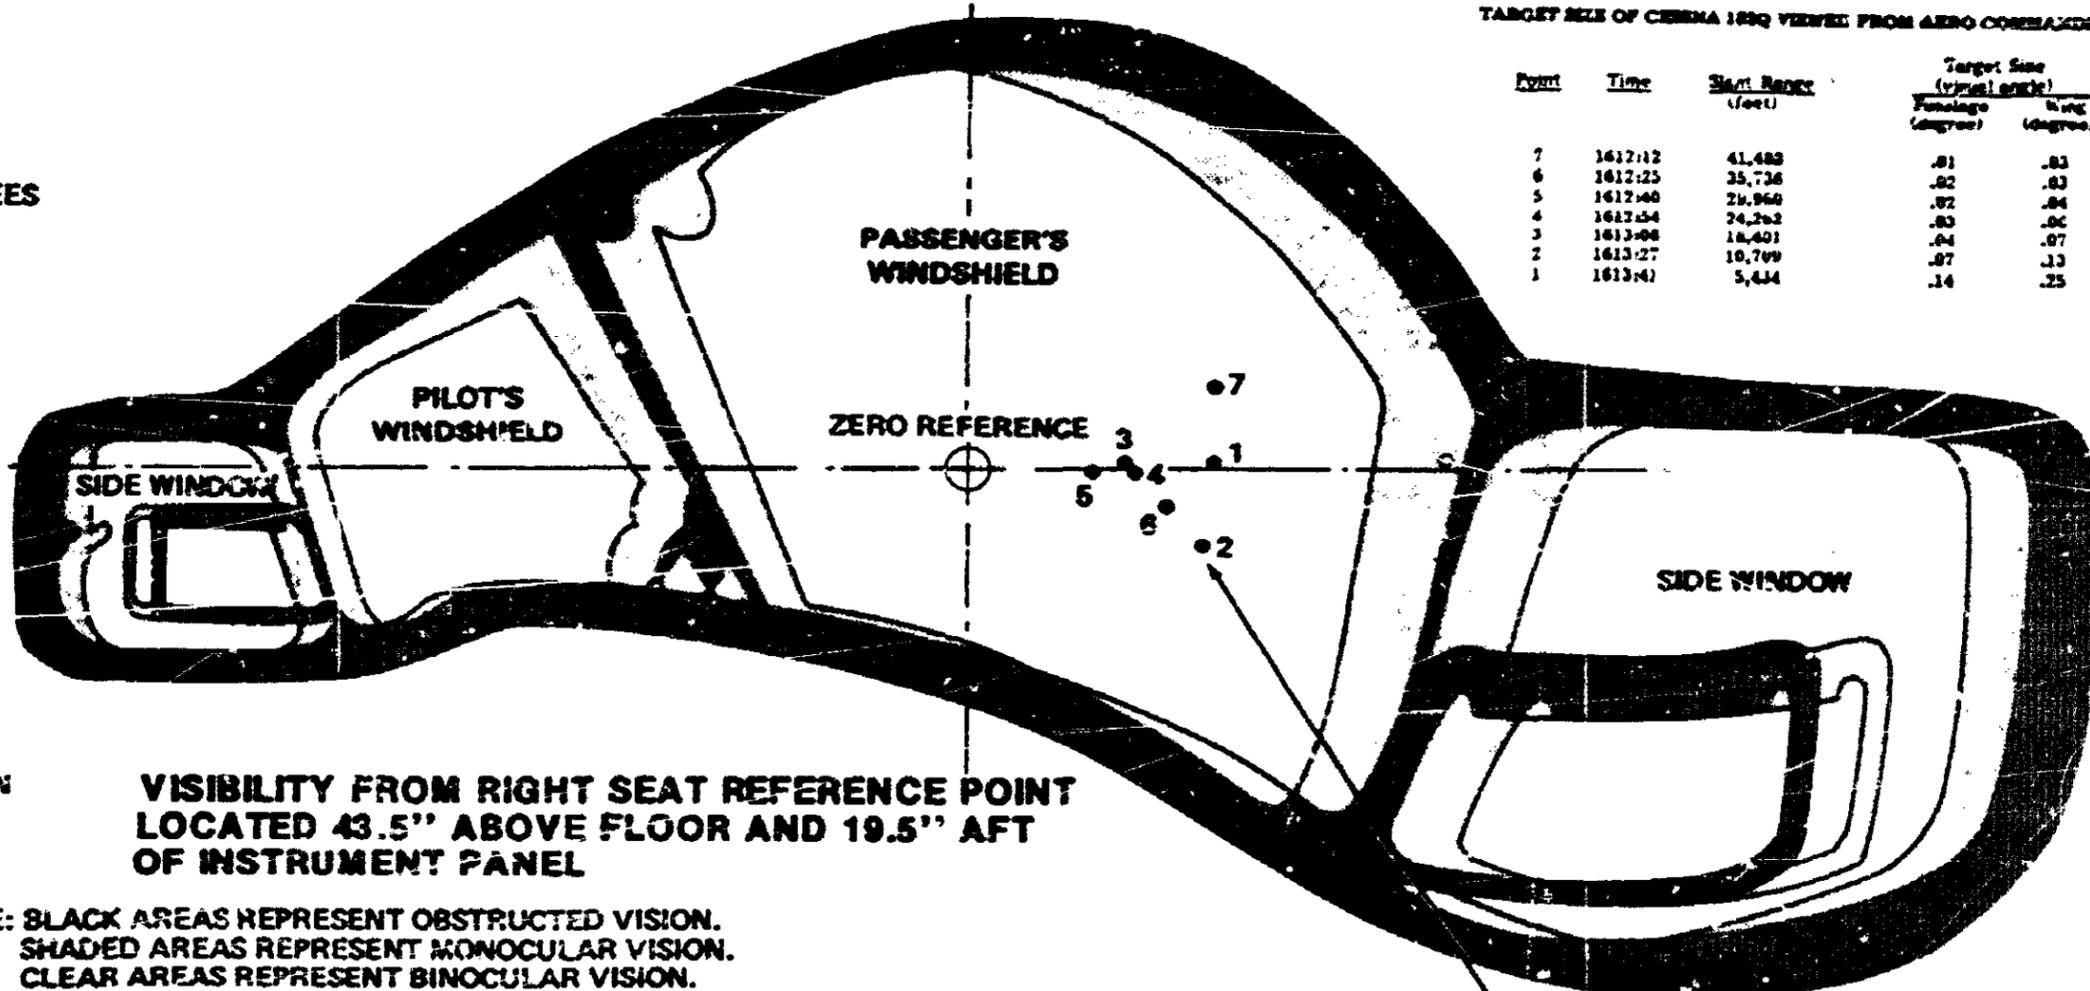
The visual angles of the subject airplanes would have caused the airplanes to be relatively small targets along the collision tracks, and at Point 1 and Point 2 of the binocular photographs (see appendix B), the opposing targets were in the monocular vision of both pilots. The cockpit visibility study indicated that during the 45-second period before the collision, the detection of N96402 was restricted by the windshield centerpost in the vision envelope of N3827C's pilot, and that during the 15-second period before the collision, the image of N3827C was unrestricted in the forward vision envelope of the pilot of N96402; however, in the prior 30-second period, N3827C was in only the monocular vision of N96402's pilot. During the last 30 to 45 seconds before collision, neither pilot had a totally unobstructed view of the other airplane, at least until the target size filled the windshield at some time between 15 seconds and collision. During the 107 seconds before the collision, the passenger in N3827C had the image of N96402 in full view near his zero eye reference.

VISIBILITY FROM RIGHT SEAT REFERENCE POINT
LOCATED 43.5" ABOVE FLOOR AND 19.5" AFT
OF INSTRUMENT PANEL

TARGET SIZE OF CESSNA 180Q VIEWED FROM AERO COMMANDER 560E

Point	Time	Slant Range (feet)	Target Size (visual angle)	
			Fuselage (degree)	Wing (degree)
7	1612:12	41,482	.01	.02
6	1612:25	35,736	.02	.03
5	1612:40	29,990	.02	.04
4	1612:54	24,262	.03	.06
3	1613:08	18,401	.04	.07
2	1613:27	10,709	.07	.13
1	1613:41	5,434	.14	.25

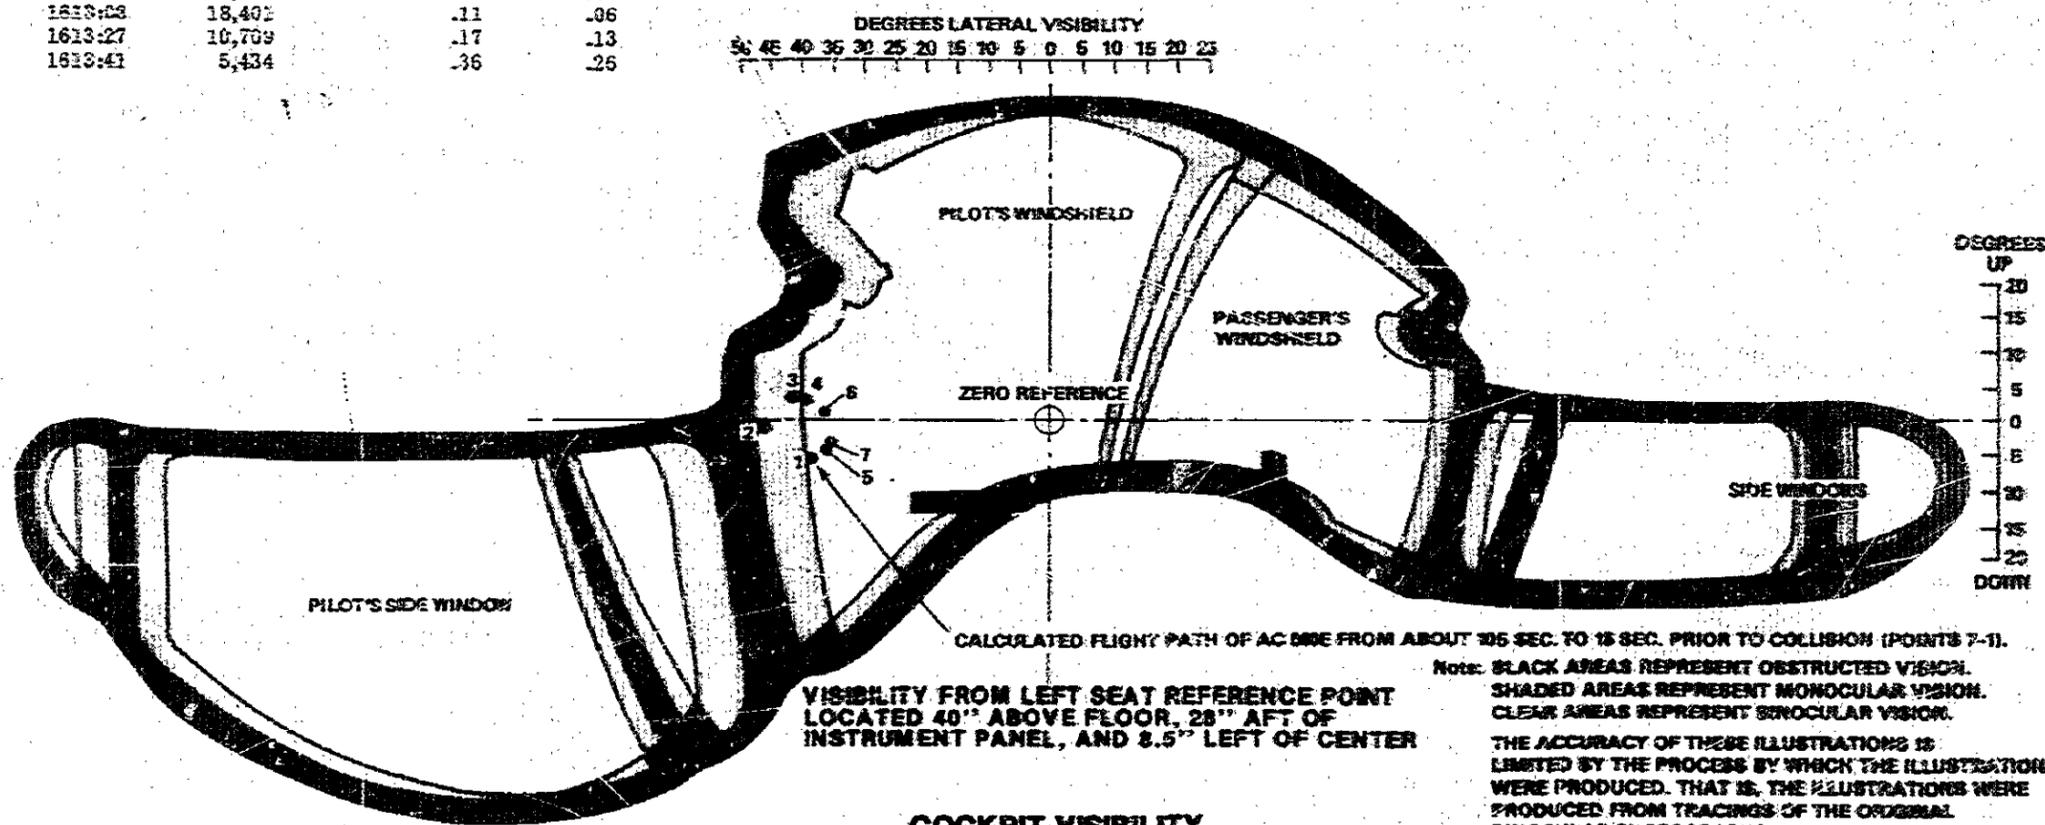
COCKPIT VISIBILITY
CESSNA 180Q
VIEWING AERO COMMANDER 560E

Point	Time	Slant Range (feet)	Target Size (visual angle)	
			Fuselage (degree)	Wing (degree)
7	1612:12	41,433	.05	.03
6	1612:25	35,736	.06	.03
5	1612:40	29,960	.07	.03
4	1612:54	24,262	.08	.04
3	1613:08	18,401	.11	.06
2	1613:27	10,709	.17	.13
1	1613:41	5,434	.36	.26

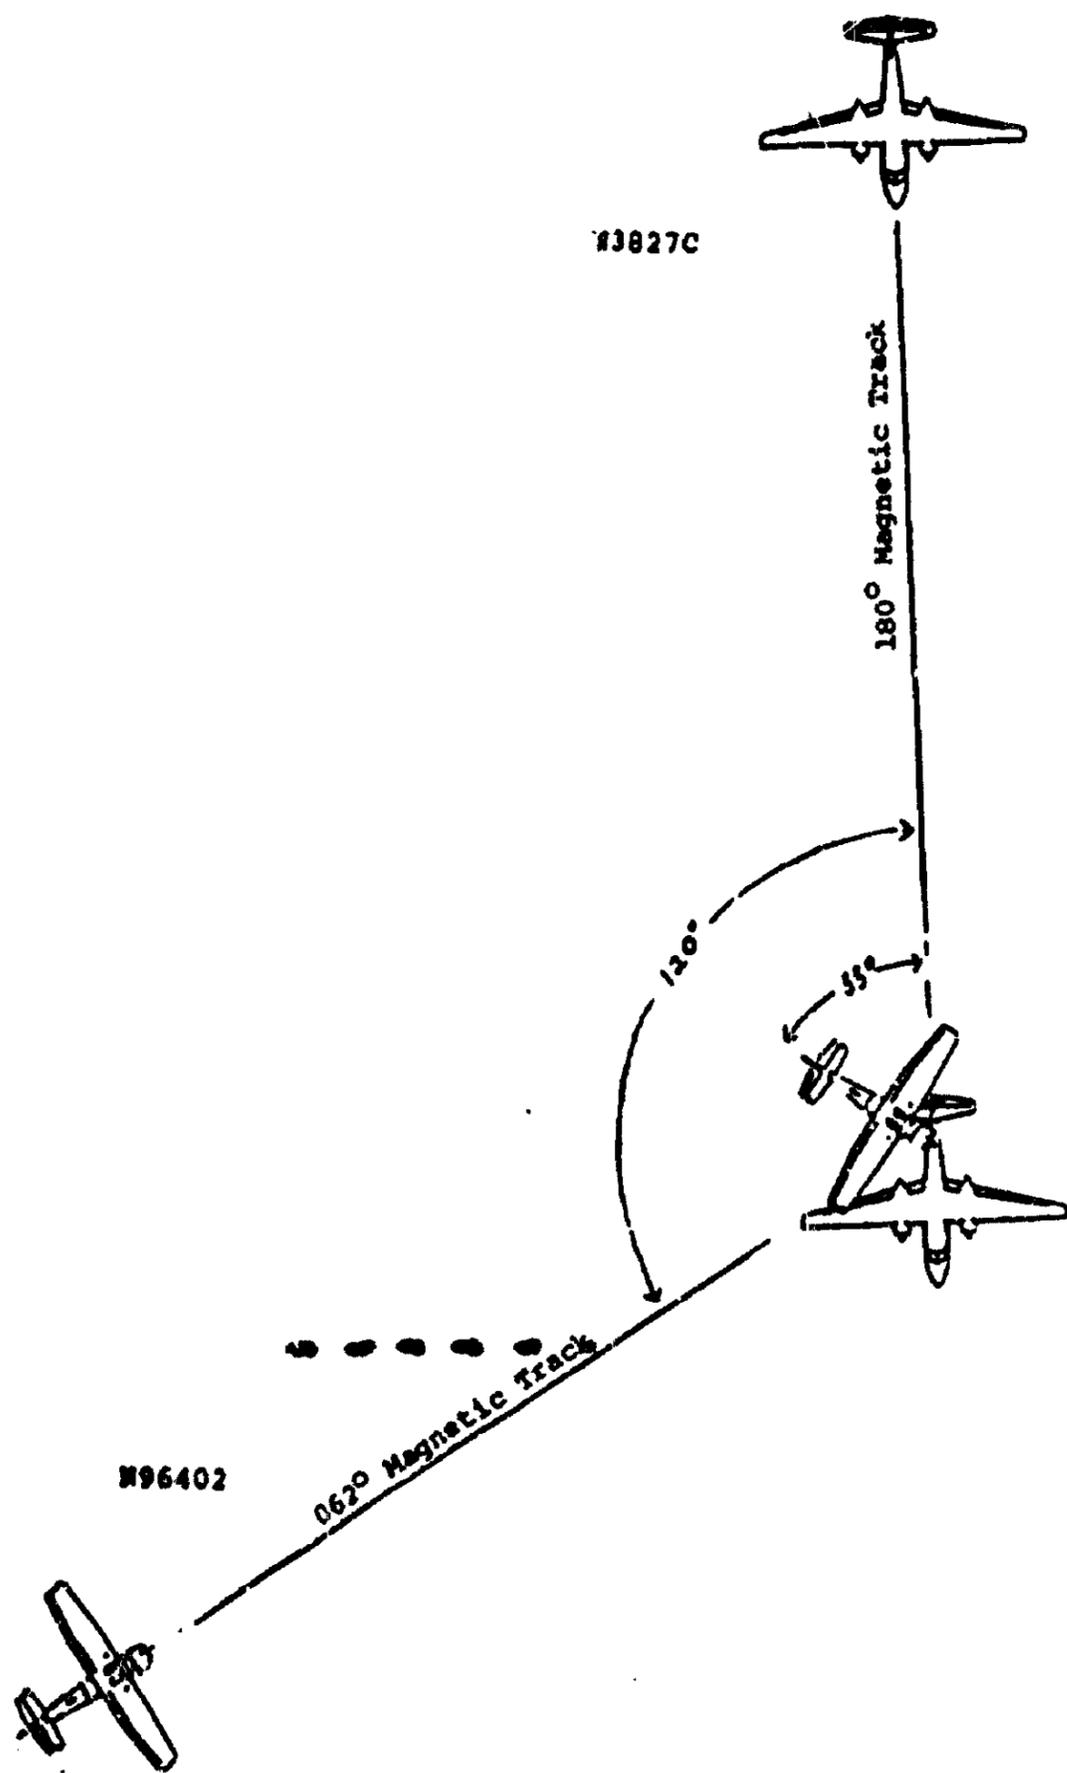
APPENDIX C
RELATIVE AIRPLANE POSITIONS AT IMPACT

The collision damage to N3827C was consistent with witness accounts that the front of N96402 collided with the side of N3827C's rear fuselage and sheared off the latter's empennage. Paint transfer marks and inward crush damage on N3827C indicated that it was hit from the right (see appendix C). Propeller slicing across the rear fuselage and the left stabilizer of N3827C revealed that N96402's engine went across N3827C's tail section at a 55-degree angle. Based upon the ATC radar tracking data, the relative approach angle was 120 degrees, and the 55-degree propeller marks indicate that N96402's heading was turned significantly to the right when it struck N3827C's fuselage. This direction change is believed to have been due to the evasive maneuver by N96402's pilot and the yawing of N96402 after an initial collision between the right wings of the airplanes.
