1. Report No. NTSB/AAR-83/04		2. Government Accession No. PB83-910404		3. Recipient's Catalog No.	
4. Title and Subtitle Aircraft Accident Report--Coin Acceptors, Inc., Cessna Model 551, Citation II, N2CA, Mountain View, Missouri, November 18, 1982.		5. Report Date July 19, 1983		6. Performing Organization Code

**COIN ACCEPTORS, INC.  
CESSNA MODEL 551, CITATION II, N2CA  
MOUNTAIN VIEW, MISSOURI  
NOVEMBER 18, 1982**

NTSB/AAR-83/04

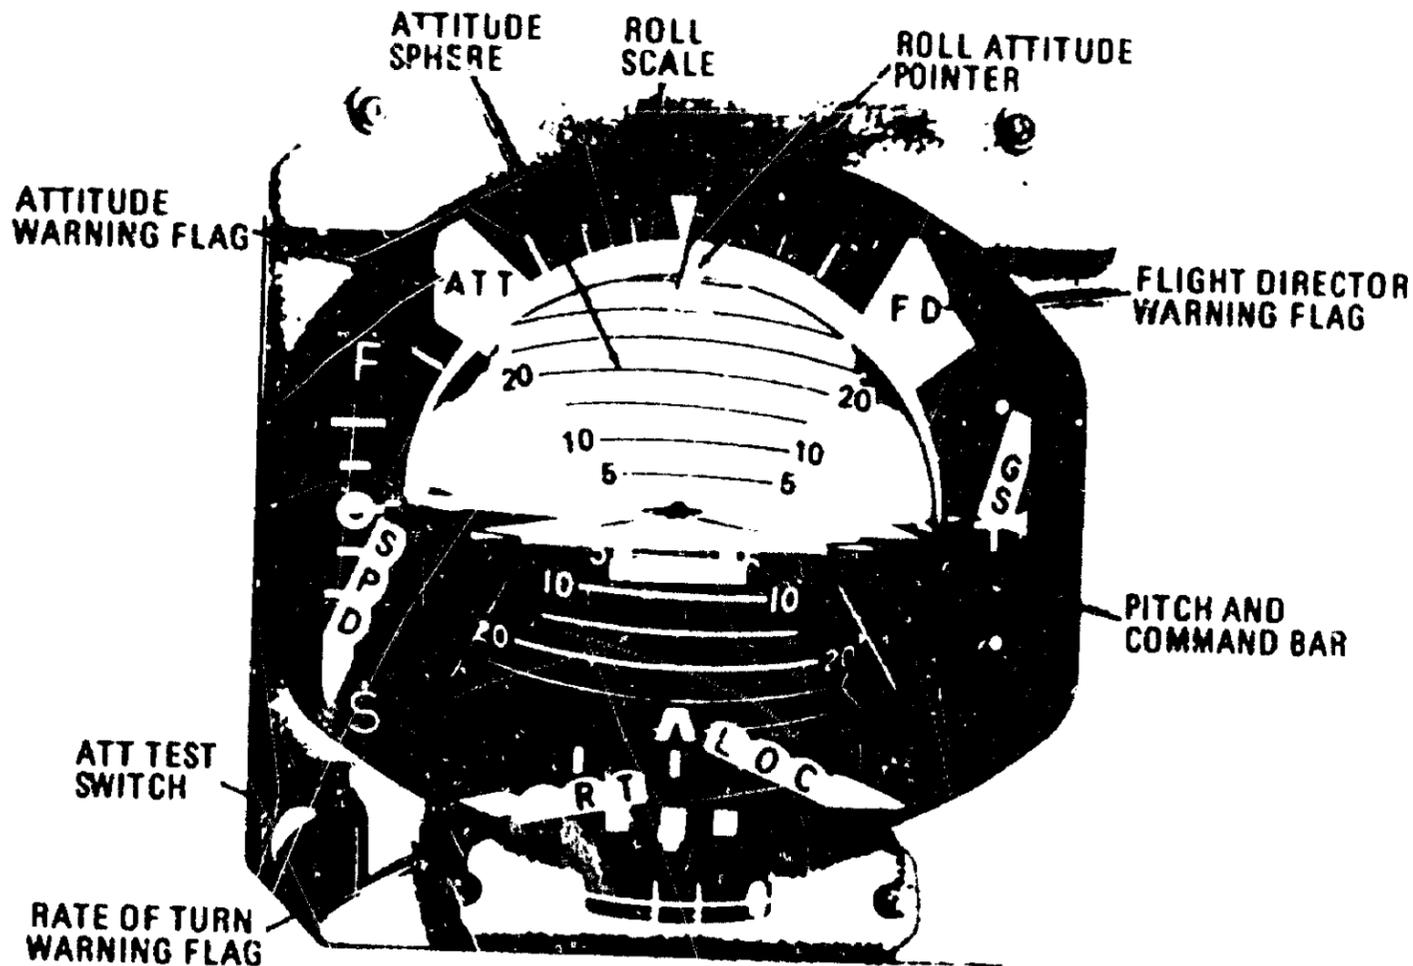
Figure 1.--Pilot's AD-600 Attitude Director Indicator.

The cockpit instruments received severe impact damage. The encoding altimeter was damaged internally and the pointer was detached from the shaft. The barometric dial read 30.11 inHg and 1020 mb. The plastic sphere on the pilot's ADI was broken into many small sections, and the pieces were contained within the unit case. The horizon line was in the vertical position from the zero bank indice on the roll scale to the bottom of the indicator. The blue portion of the attitude sphere was on the right side and the brown portion was on the left side. All pointers, warning flags, and command bars were missing. There were no marks which would indicate pitch or bank attitude at impact. The copilot's ADI was not located.

If no power is applied to the ADI or if power is interrupted during normal operation, the attitude sphere will indicate a left bank. The roll-attitude pointer will be in the horizontal position with the blue portion of the sphere to the right of the pointer.

The tolerance of the ADI in the unpowered state is  $90^\circ$  left bank  $\pm 25^\circ$ . Once power is applied to the system and the vertical gyro reaches operating speed to drive the ADI, the attitude sphere will move to a position where the roll attitude pointer aligns with the zero mark on the roll scale. At that time, the attitude warning flag disappears, and the pitch and roll command bar appears. The flight director warning flag disappears when power is applied to the flight director and will remain concealed unless the command bar information is unreliable. The attitude warning flag will also remain concealed unless the attitude information is unreliable. The autopilot can be engaged only when the gyros, which drive the ADI and the HSI, are operating properly.

The Safety Board believes that the position of the attitude sphere of the pilot's ADI indicated the actual attitude of the airplane at impact -- 90° banked attitude to the left. The Safety Board realizes that the attitude sphere would have gone to the left bank position if there had been a power failure. However, it is unlikely that the attitude sphere would have gone precisely to the 90° point, since the tolerance of the RD-600 was 90° + 25°. Furthermore, the physical evidence near the impact site and the location of portions of the airplane wreckage in the impact site support the conclusion that the pilot's ADI essentially portrayed the bank attitude of the airplane at impact. This finding, and the absence of a history of ADI problems, leads the Safety Board to conclude that the pilot's ADI was functioning properly at the time of the accident.

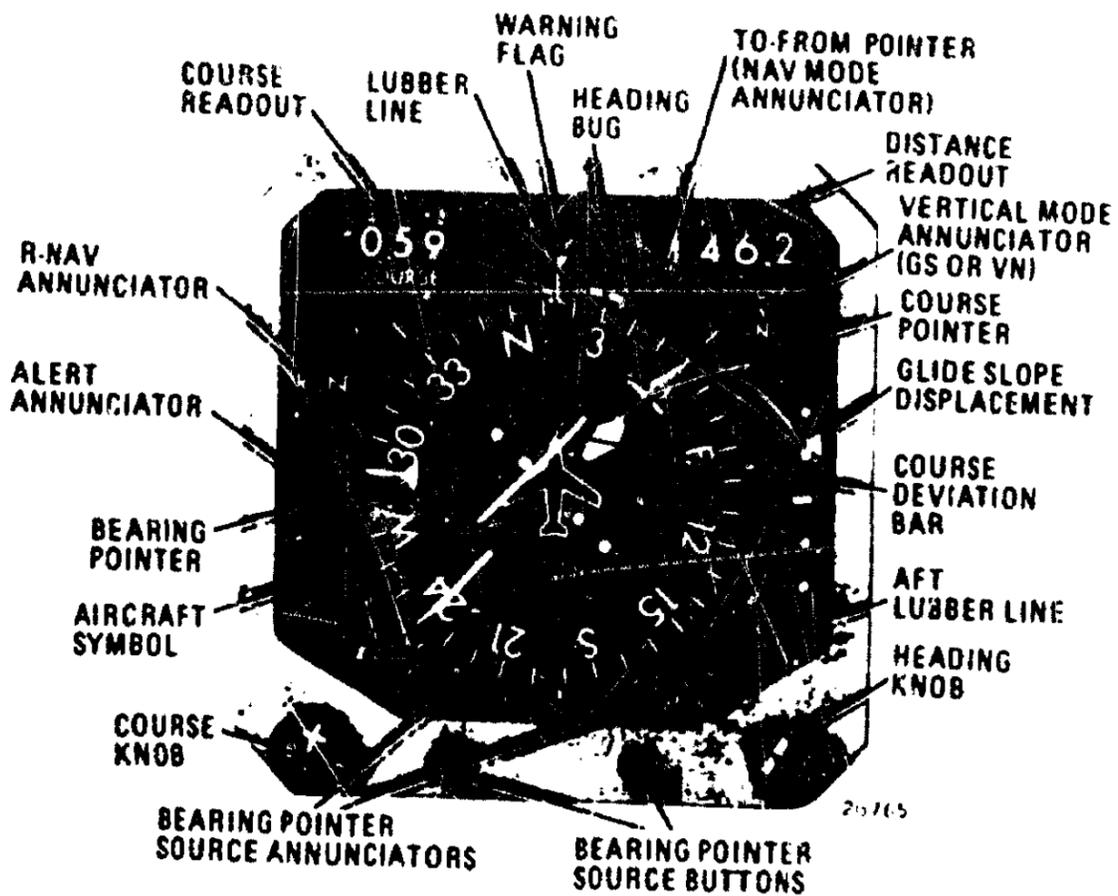
Figure 3.--Pilot's RD-600 Horizontal Situation Indicator.

Both the pilot's and the copilot's horizontal situation indicator (HSI) received extensive impact damage. The pilot's HSI indicated a heading of 20° on the compass card, and had a course pointer reading of 355°. Both NAV mode annunciator flags were in view. There were no pointers or flags remaining on the copilot's HSI. The compass card was in place and indicated a heading between 90° and 120°.

The pilot's HSI was a RD-600 5-inch display. (See figure 3.) The instrument is powered by a C-14 Gyrosyn Compass System (directional gyro), which provides primary

Although both HSI's were damaged severely, the copilot's compass card indicated a heading of 90° to 120°, which was generally coincident with the airplane's heading at impact. The pilot's HSI indicated 20°. If the gyro which drove the pilot's HSI was slow in bringing the HSI up to speed, as had occurred according to the chief pilot in previous flights, the difference between the two compass readings can be explained. It was concluded that the copilot's HSI was operating properly and providing accurate heading information to the pilot, while the pilot's HSI had not become completely operationally usable at impact. A difference in the times required for the HSI's to come up to speed had been noted by the chief pilot, who also said that the pilot had used the copilot's HSI for heading information on the previous day because the pilot's HSI was slow in becoming operationally usable. In summary, the evidence points to a conclusion that the two HSI's on the airplane were not completely functional. However, it appears that the copilot's HSI was providing accurate heading information and that the pilot's ADI probably was providing accurate attitude information at impact.

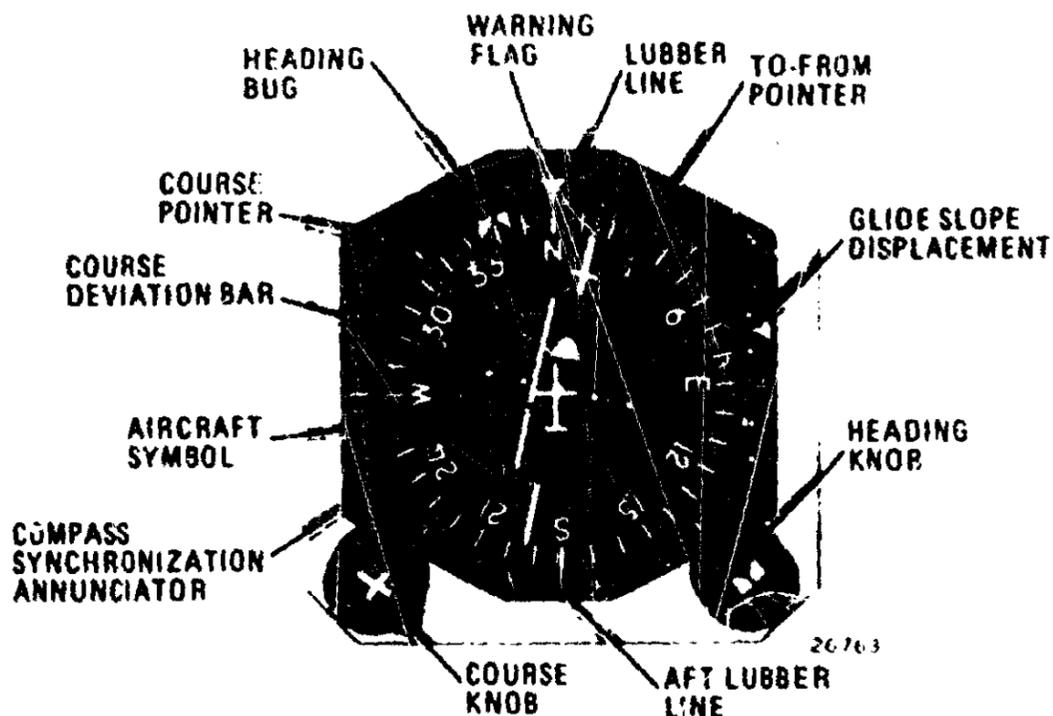
Figure 4.--Copilot's RD-44 Horizontal Situation Indicator.

Both HSI's have warning flags which appear if the heading information is not reliable, or if the gyro is not providing adequate power to the HSI.
