## AIRCRAFT ACCIDENT REPORT

REPUBLIC AIRLINES, INC.  
CONVAIR 580, N844H  
BRainerd, MINNESOTA

JANUARY 9, 1983

NTSB/AAR-83/08

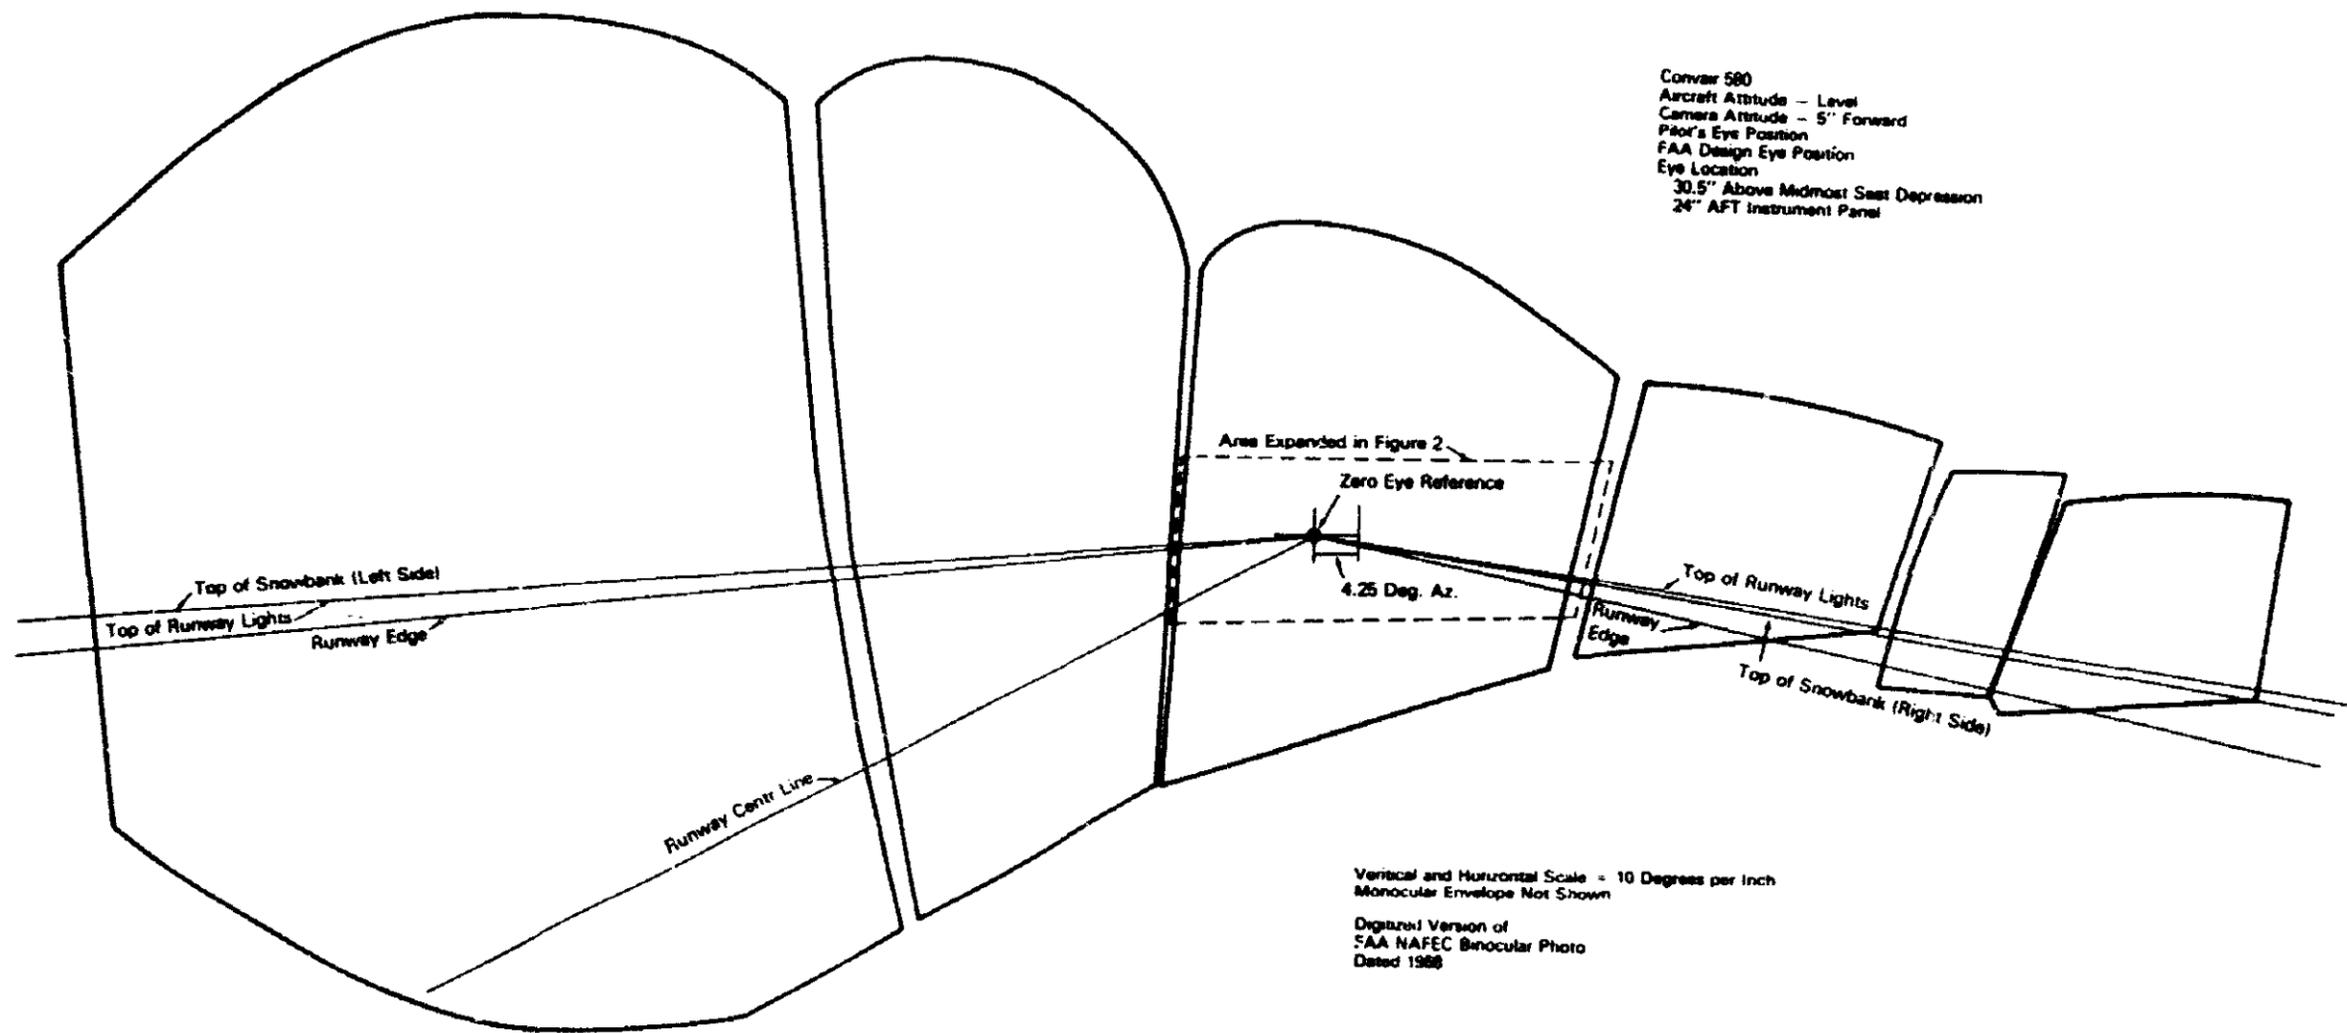
Figure 1.—Full vision envelope at touchdown.

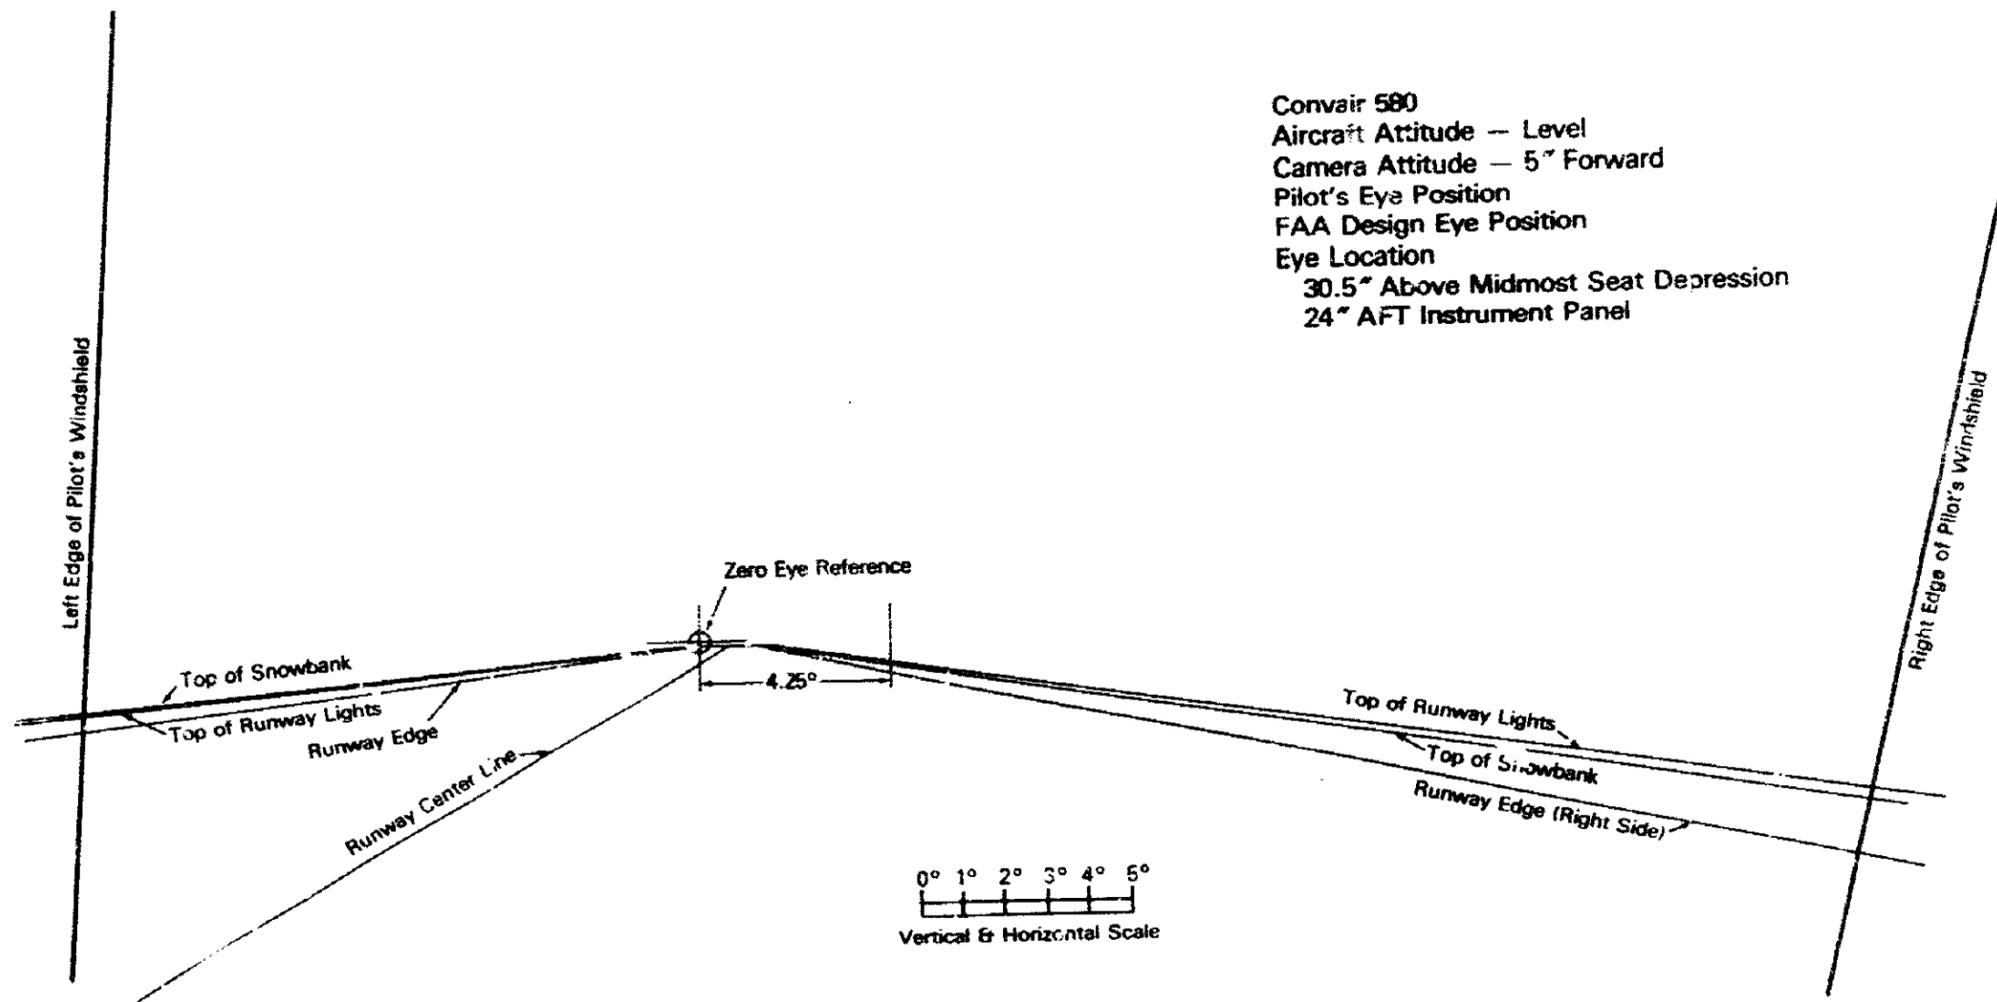
Figure 2.—Expanded view of runway at touchdown.

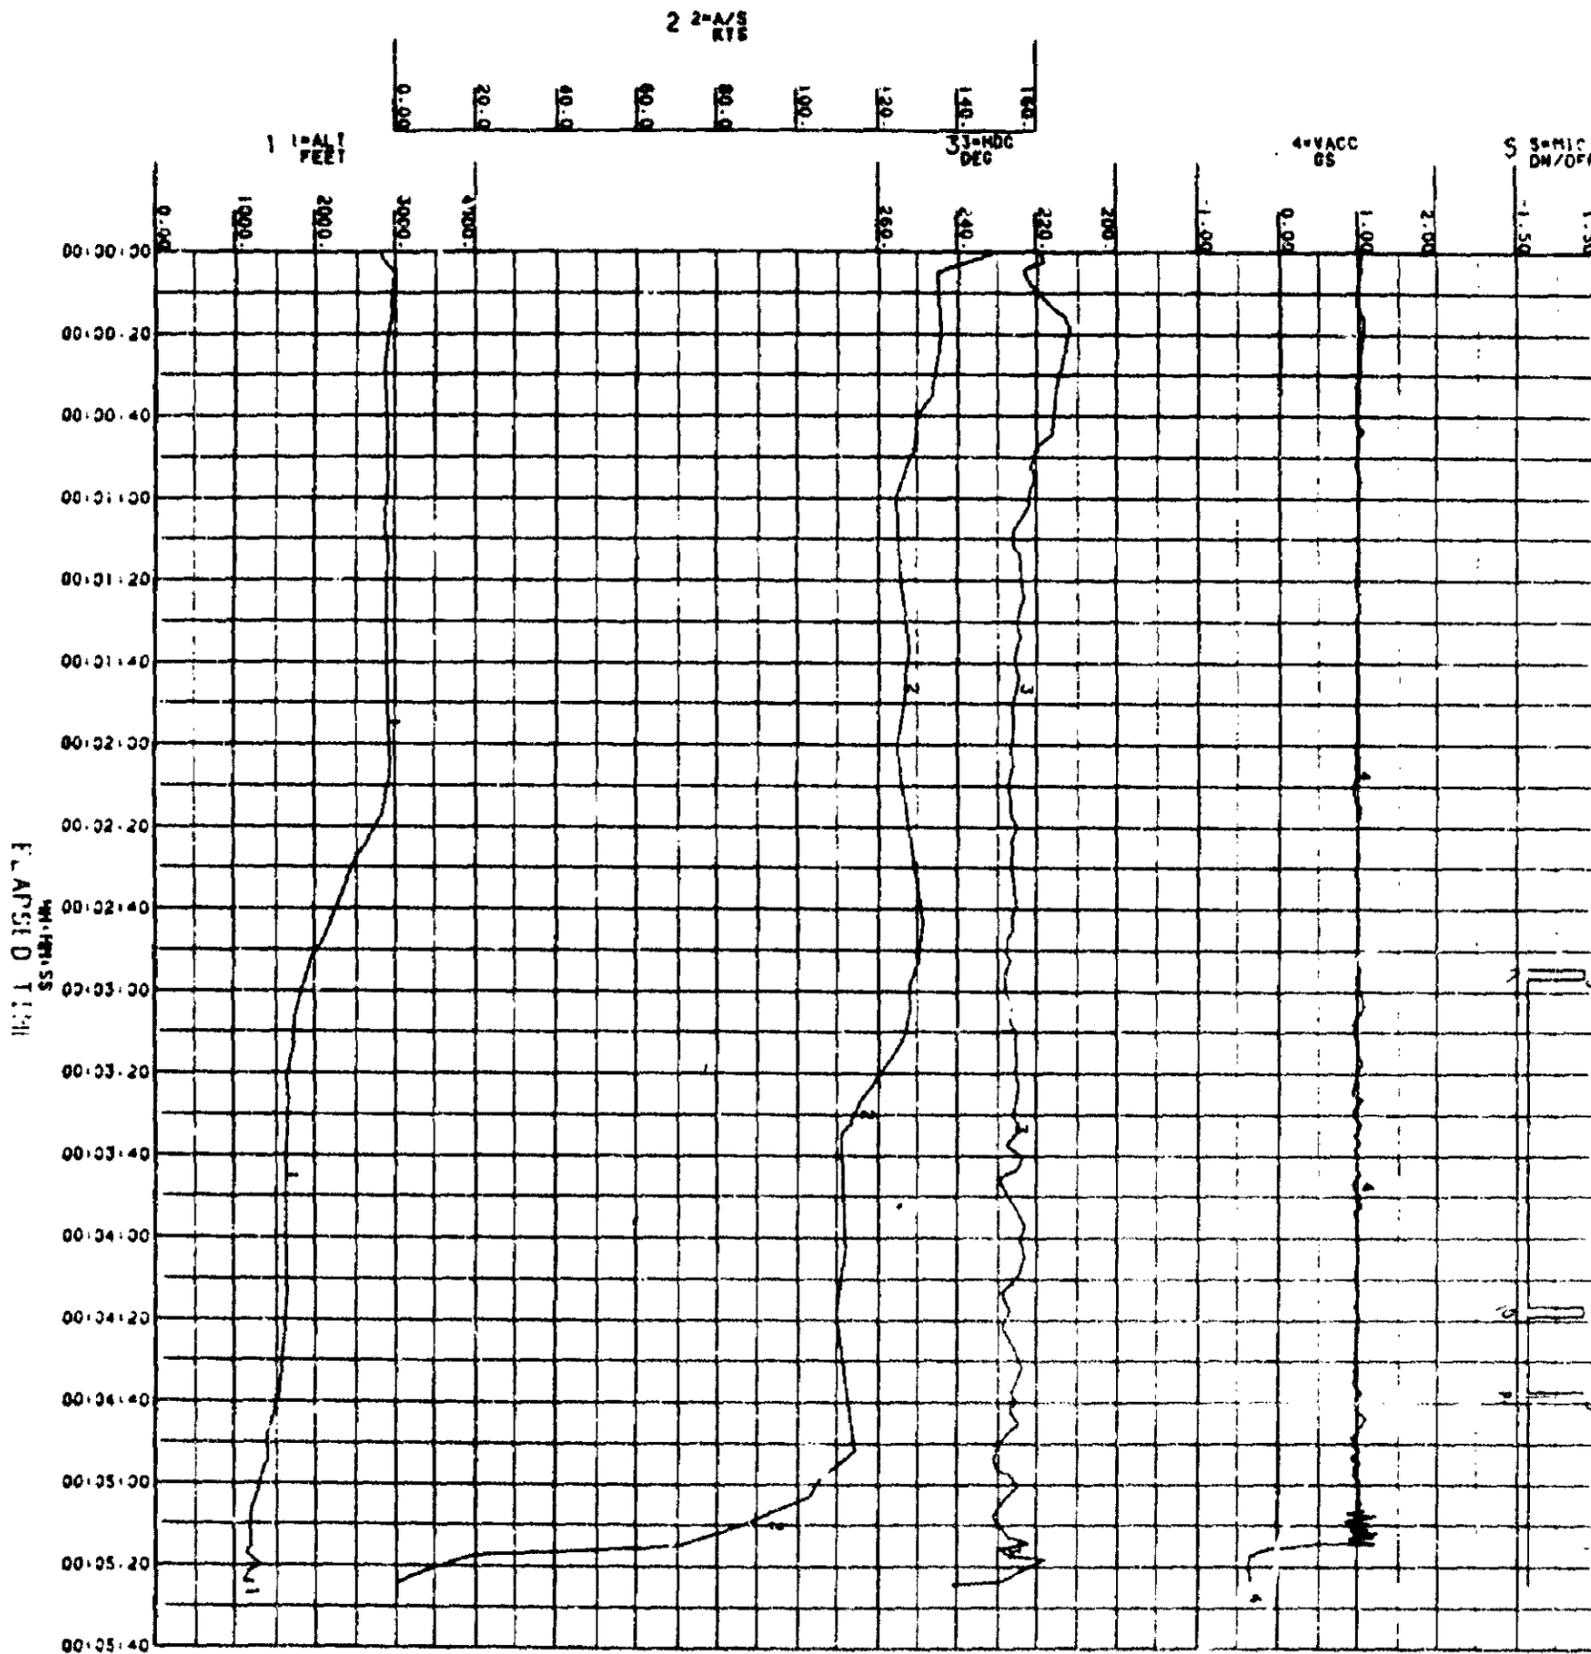
### APPENDIX D FDR TRANSCRIPT

The FDR profile indicated a sharp increase in the rate of descent after the 1940:13 order for 40° of flaps. At 1940:18, the captain stated "Really watch my descent rate because I'm getting fooled here." At 1940:19, the first officer replied, "Okay, you're a hundred feet," which coincides with the indication on the FDR foil that the airplane was about 100 feet above the runway (1,324 feet).

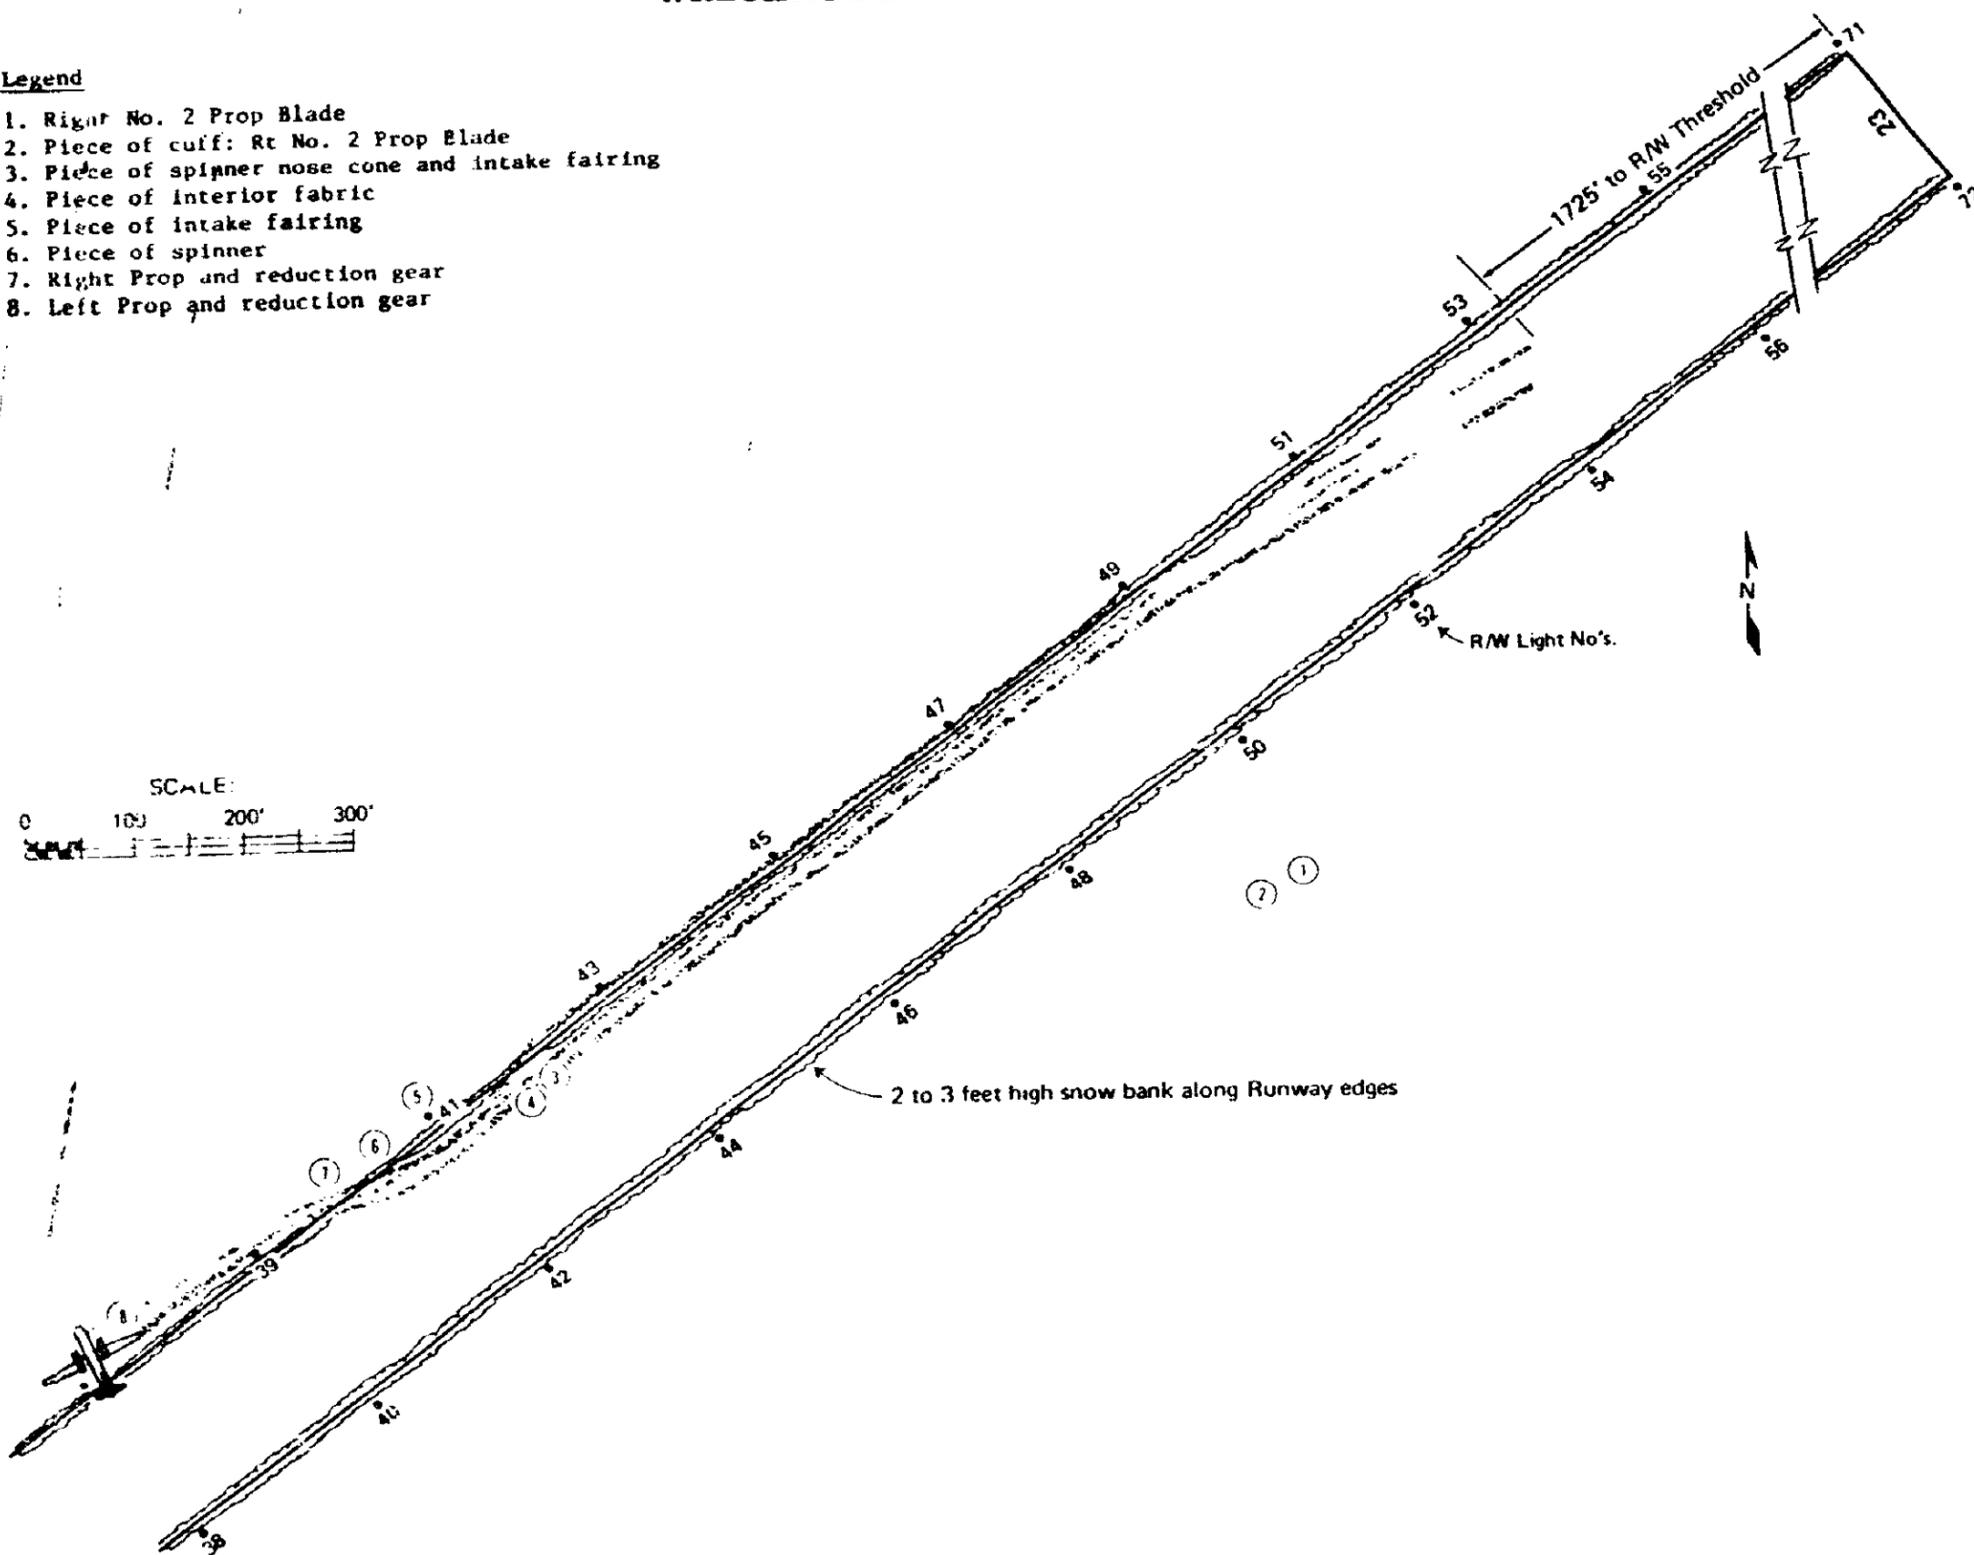
APPENDIX E

The wreckage distribution data showed that the No. 2 blade of the right propeller was found about 540 feet down the runway from the point of initial touchdown. This location was close to the point where the airplane first struck the snowbank, and at the time there were power interruptions to the CVR and FDR. The right propeller struck the snowbank and the No. 1 blade separated and penetrated the airplane cabin on the right side between seat rows 1 and 2, injuring passengers in the cabin. It is likely that the right propeller failed and separated instantaneously after striking the snowbank, creating an imbalance which resulted in the separation of the engine reduction gearbox at the parting flange. It is likely also that the left propeller failed in a similar manner as the airplane veered to the right and again passed through the snowbank.
