NATIONAL TRANSPORTATION SAFETY BOARD

AIRCRAFT ACCIDENT REPORT

**LAS VEGAS AIRLINES FLIGHT 88
PIPER PA-31-350
GRAND CANYON, ARIZONA
AUGUST 17, 1983**

NTSB/AAR-84/05

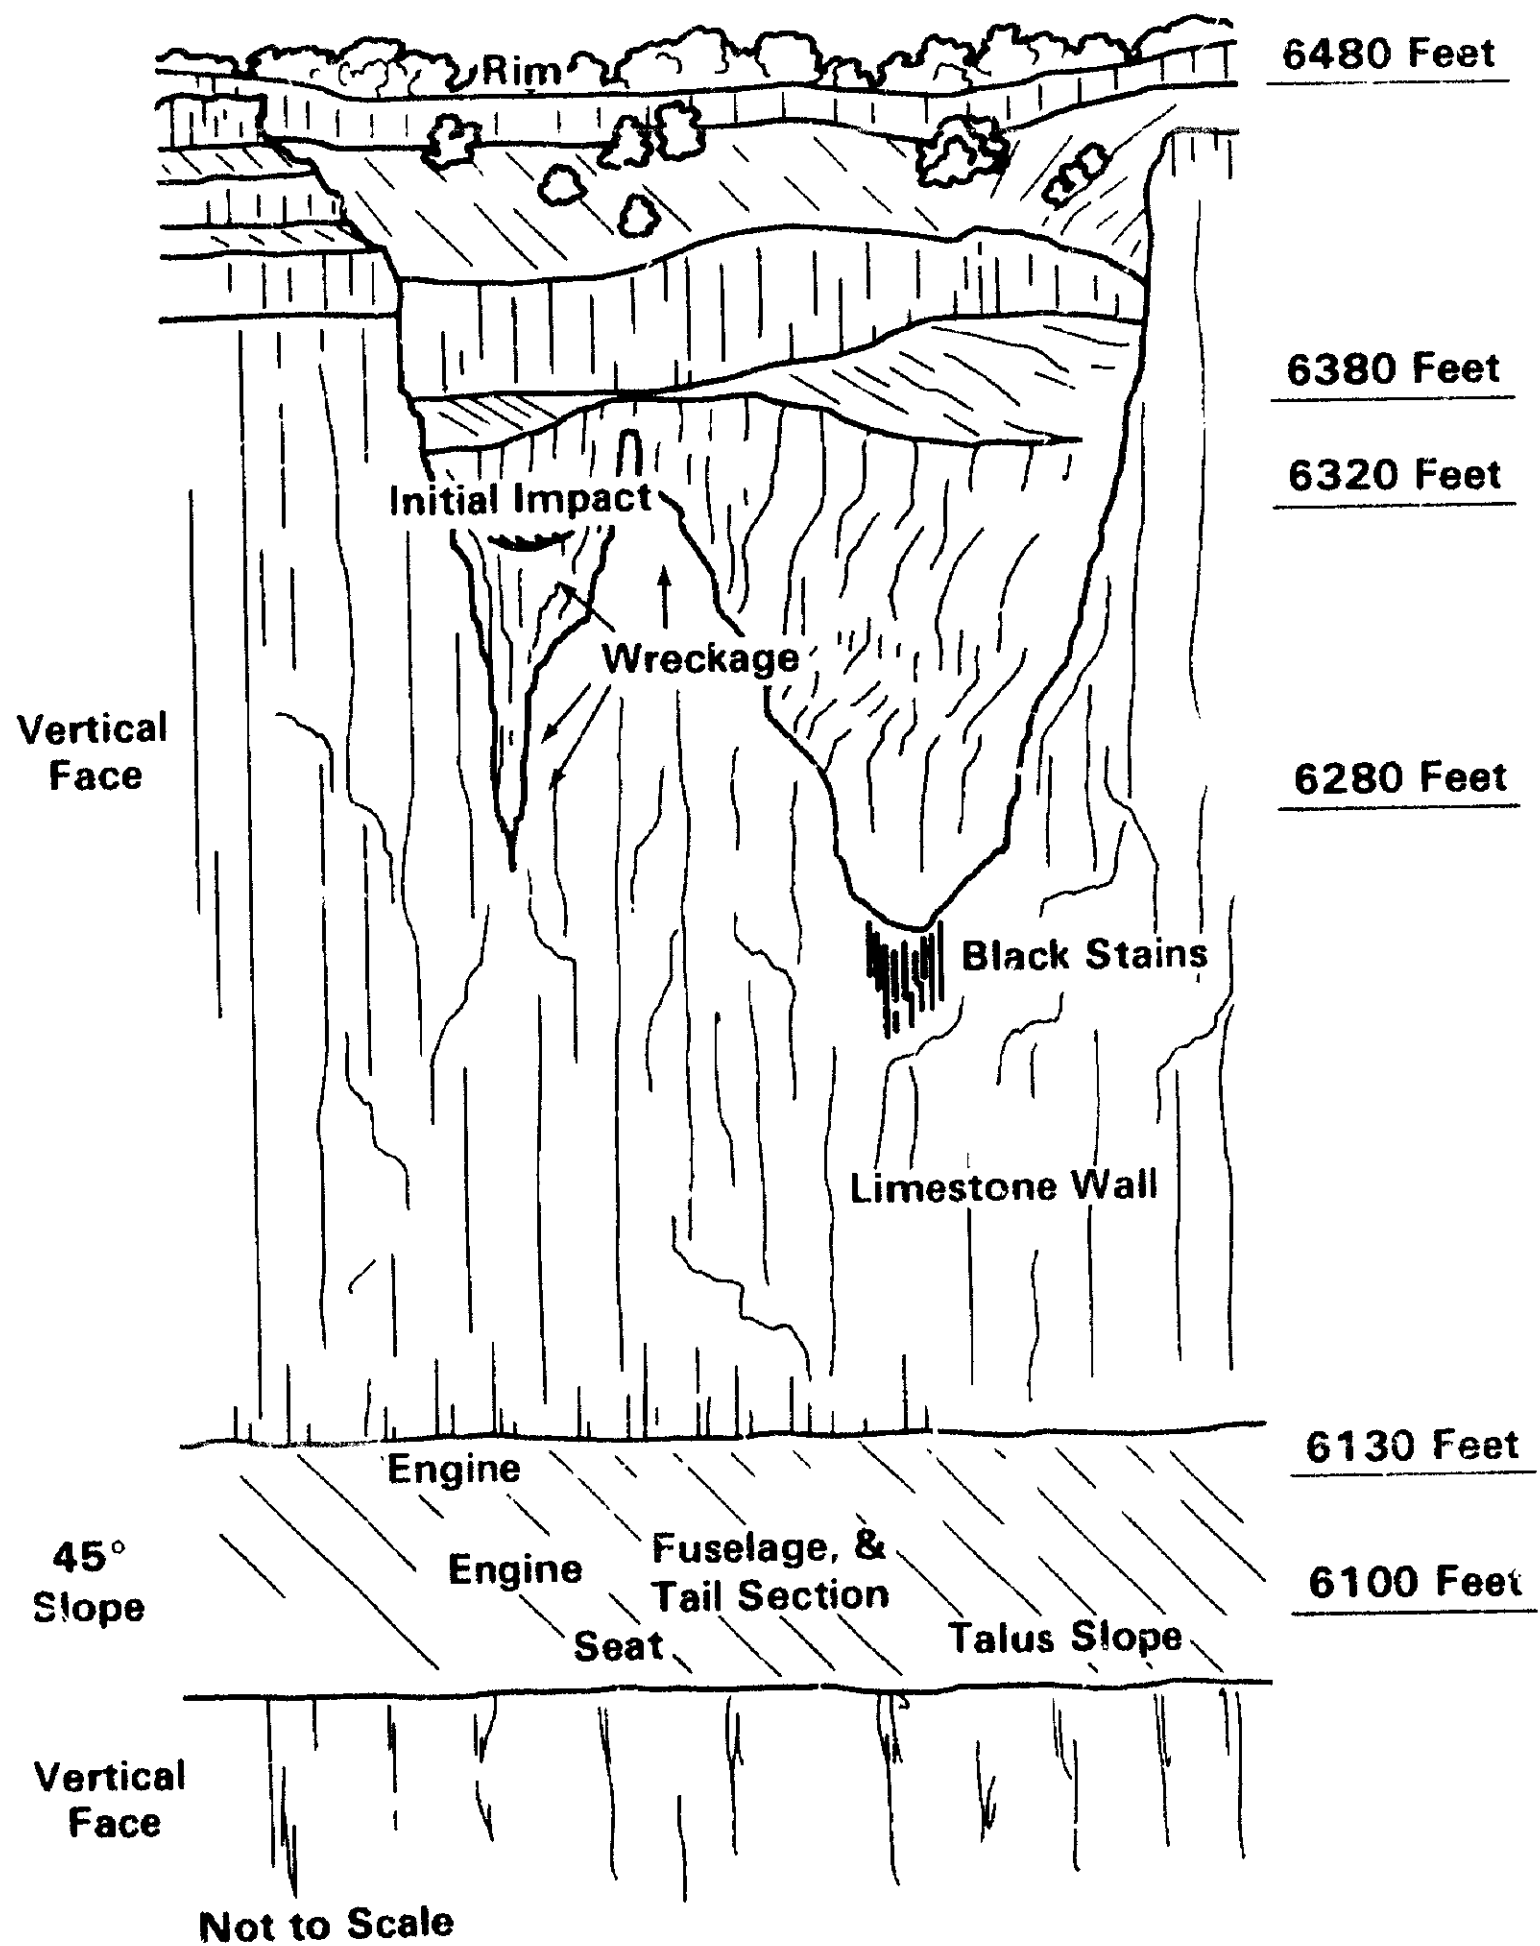
Figure 2.—Wreckage diagram.

Initial impact was in a crevasse in the vertical face of the mesa's wall about 160 feet below the rim. Portions of the forward cockpit/cabin were lodged in the crevasse. Circular marks on the face of the mesa wall corresponded to engine and propeller dimensions, and impact marks indicated that the aircraft struck in a near wings level attitude on a north-northeasterly heading.

Photographs of the area and the wreckage taken on August 20, 1983, from a helicopter chartered by the Safety Board showed that the main wreckage fell onto the talus slope about 200 feet below the initial impact point. Loose rocks and the steep grade precluded a landing by the helicopter on the talus slope, but three Safety Board investigation teammembers were able to observe the wreckage closely. Both wings had separated from the fuselage carry-through structure at or near the wing root area. The right wing was resting upside down on top of a pile of wreckage. The right main landing gear door appeared flush with the lower surface of the wing. The right wing trailing edge flaps were attached to the wing and appeared to be retracted. The left wing lay on a

bearing of about 315° about 75 feet from the large pile of wreckage. The left wing was broken and structurally deflected upward about 30° near the wing midspan. The rudder remained in place on the vertical fin. An airspeed indicator, found on a ledge about 75 feet below the talus slope, indicated about 170 knots indicated airspeed (KIAS). A vertical speed indicator, found near the airspeed indicator, indicated an ascending vertical speed of about 2,000 feet per minute.
