AIRCRAFT ACCIDENT REPORT

**LANDRY AVIATION
LOCKHEED LEARSTAR L-18, N116CA
SILVANA, WASHINGTON
AUGUST 21, 1983**

NTSB/AAR-84/06

LANDRY AVIATION, INC.
LOCKHEED LEARSTAR L-18, N116CA
NEAR SILVANA, WASHINGTON
AUGUST 21, 1983

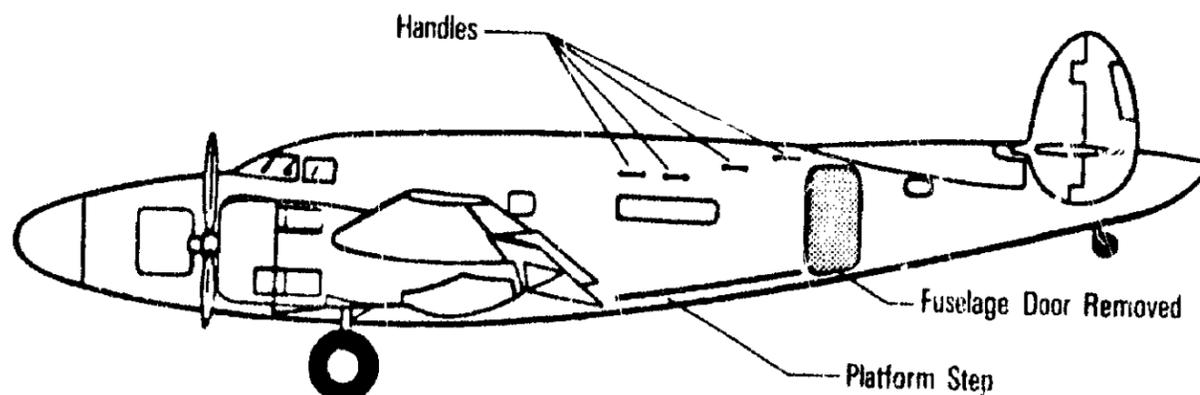
Figure 1.—Modifications to N116CA.

When acquired by Landry Aviation, N116CA was configured as a cargo airplane; it had no passenger seats. There was a jump seat behind the cockpit. In addition to the main cabin entry door, there was one emergency window exit on the left side over the wing. There were three seat track/cargo tiedown rails installed in the floor. In June 1983, the installation of seatbelts for as many as 24 parachute jumpers, using the existing seat tracks, and the removal of the main cabin entry door for purposes of sport parachute jumping were approved in accordance with 14 CFR 43 by a mechanic who held an inspection authorization, and the FAA Flight Standards District Office was notified. An FAA maintenance inspector then issued a standard set of operating limitations to be

After the accident, Landry Aviation contracted for an engineering study and analysis of the installation, and made the results available to the Safety Board. The study indicated that the installation had negligible effects on airplane stability and control. The report of the study and analysis was reviewed by the Safety Board's Aircraft Performance Engineering Staff and found to be correct regarding the effects of the installation.

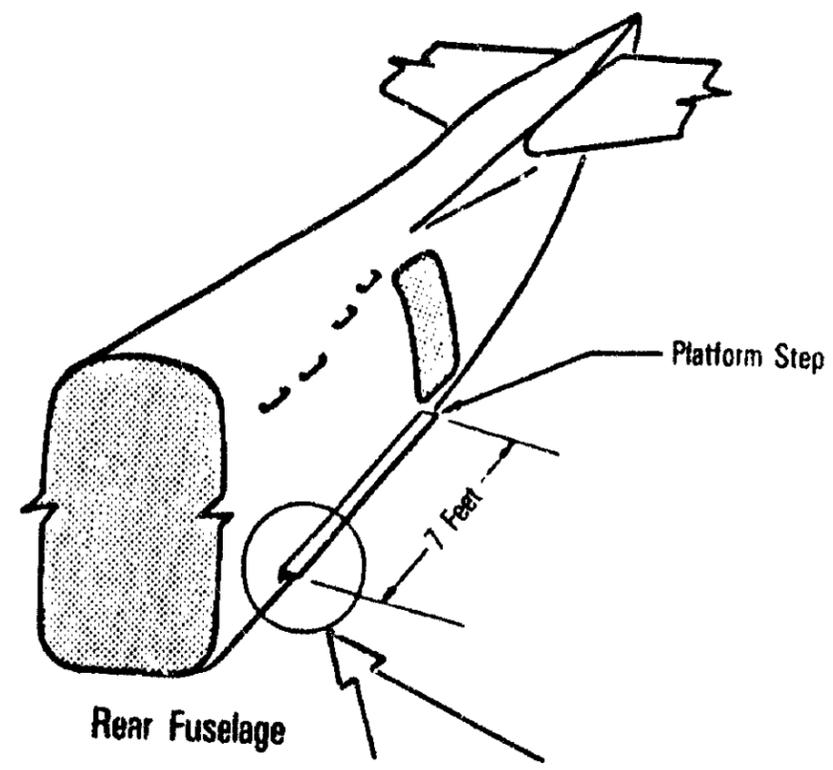
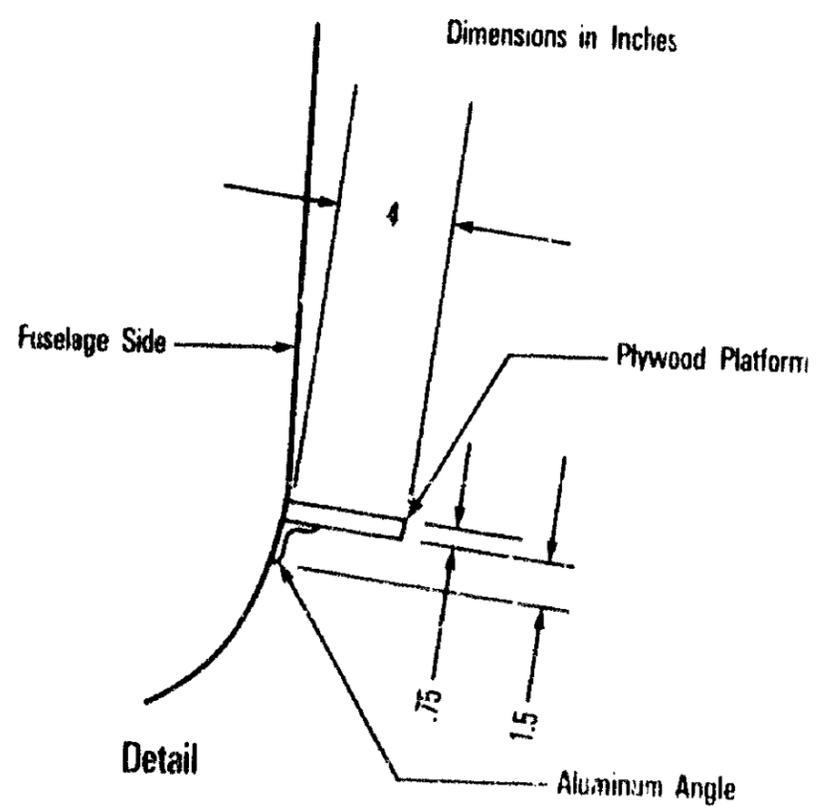
Figure 2.—Detail of step installation.

The owner of Landry Aviation, Inc., testified during deposition proceedings that some parachute jumpers had indicated that mass jump exits could be accomplished more easily if a step were installed adjacent to and forward of the door on the outside of the fuselage. In the week before the accident, four externally mounted handholds and a plywood step were installed on the fuselage forward of the cabin entryway. The step was made of 3/4-inch plywood, was 4 inches wide 7 feet long, and was attached by aluminum angle. (See figures 1 and 2.) He further testified that because similar installations had been made on other Lockheed L-18 airplanes used in jump operations, including a second airplane he had acquired, it was his opinion that the installation either was not a major alteration, and therefore did not require FAA approval, or that it had been approved previously by the FAA for other airplanes. The installation of the step was not inspected and approved by an authorized inspector nor did Landry Aviation request approval from the FAA. No flight testing was conducted to determine the effects on airplane handling and performance. The pilot who flew on the second and third flights on the day of the accident stated that he noticed no different or unusual effects on the airplane characteristics with the step and handles installed or when the jumpers were standing on the steps.

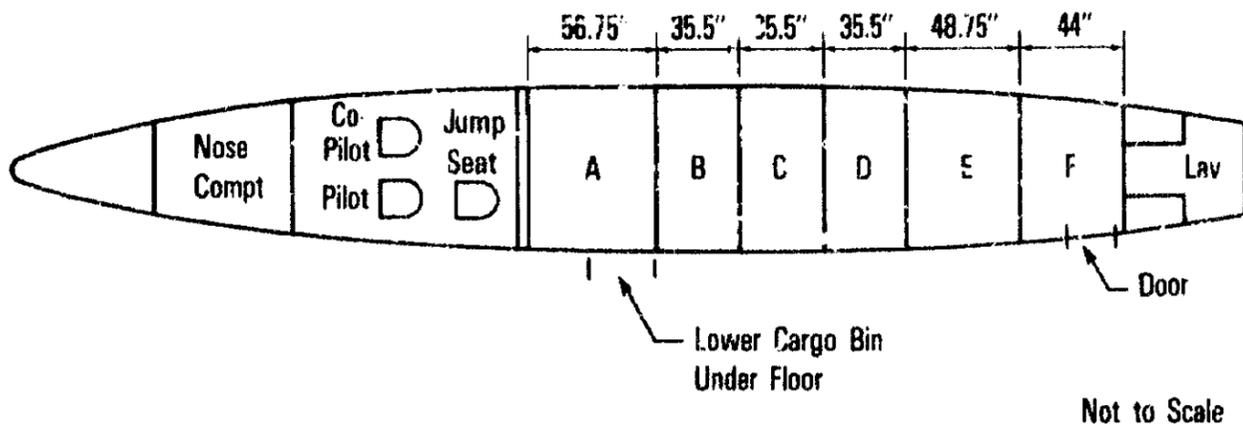
Figure 3.—Airplane configuration for weight and balance determination.

average front-to-back body depth of 10 inches ^{2/} and 10 inches for the thickness of the parachute pack, Safety Board investigators estimated weight and balance for the takeoff with 24 jumpers positioned. The estimate indicated the jumpers would have to occupy space back to compartment D. (See figure 4). That calculation provided an estimated center of gravity location at takeoff of 205.3 inches aft of the datum. The aft limit is 198.8 inches.

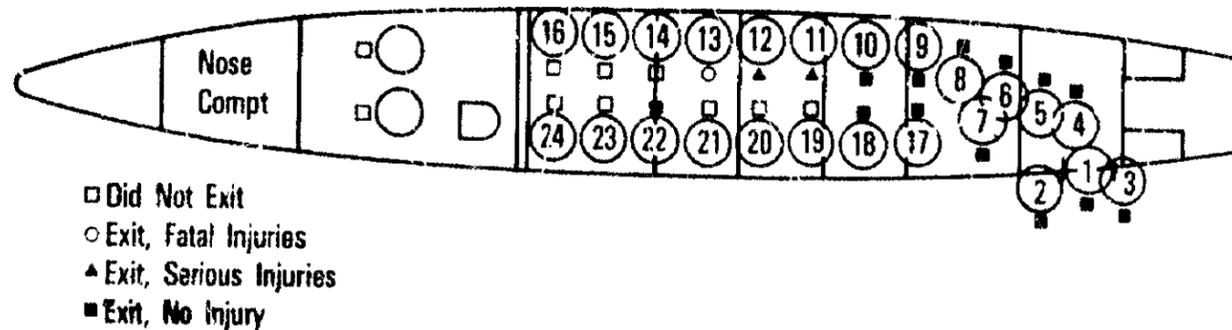
Figure 5.—Jumper positions and center of gravity position at time of upset.

All jumpers participating on the day of the accident had filed "experienced jumper waiver and information" forms on which they also entered their weight. These weights and the typical weights of parachutes and equipment were used by the Safety Board to determine the airplane weight and balance when they were in position for the jump. The position of each jumper as described by the jump coordinator who had assigned each jumper a specific place in the jump sequence and the body dimensions from the cited reference were used to estimate the placement of each jumper in the cabin. The fuel on board was estimated based on the number of flights since last refueling and the typical fuel consumption of previous jump flights. Using this information, the Safety Board calculated a jump configuration center of gravity location of 214.5 inches aft of the datum.

Item	Weight	Arm inches aft of Datum	Moment
Airplane			
Empty Weight	14,499	191.53	2,776,931.40
Door Removed	- 28.25	429.3	- 12,127.00
Ballast in lower cargo bin	200.0	220.0	44,000.00
Step and handholds	+ 12.70	375.0	+ 4,762.00
Pilots	400.0	135.0	54,000.00
Compartment A (6 jumpers)	1055.0	217.0	405,790.00
Compartment B (6 jumpers)	905	262.5	237,562.00
Compartment C (4 jumpers)	815	298.0	242,870.00
Compartment F (6 jumpers)	1,490	422.0	628,780.00
Fuel inboard fwd tanks (80 gals.)	480	167.5	80,400.00
Outer wing tanks 160 gals.	960	175.0	168,000.00
Total weight	<u>20,788</u>	<u>Loaded airplane moment</u>	<u>4,630,968.00</u>

Center gravity = moment divided by weight
