# **NATIONAL TRANSPORTATION SAFETY BOARD**

## **AIRCRAFT ACCIDENT REPORT**

**MIDAIR COLLISION  
MCDONNELL DOUGLAS F-4C/  
BEECH D-55 BARON  
CHERRY POINT, NORTH CAROLINA  
JANUARY 9, 1983**

NTSB/AAR-84/07

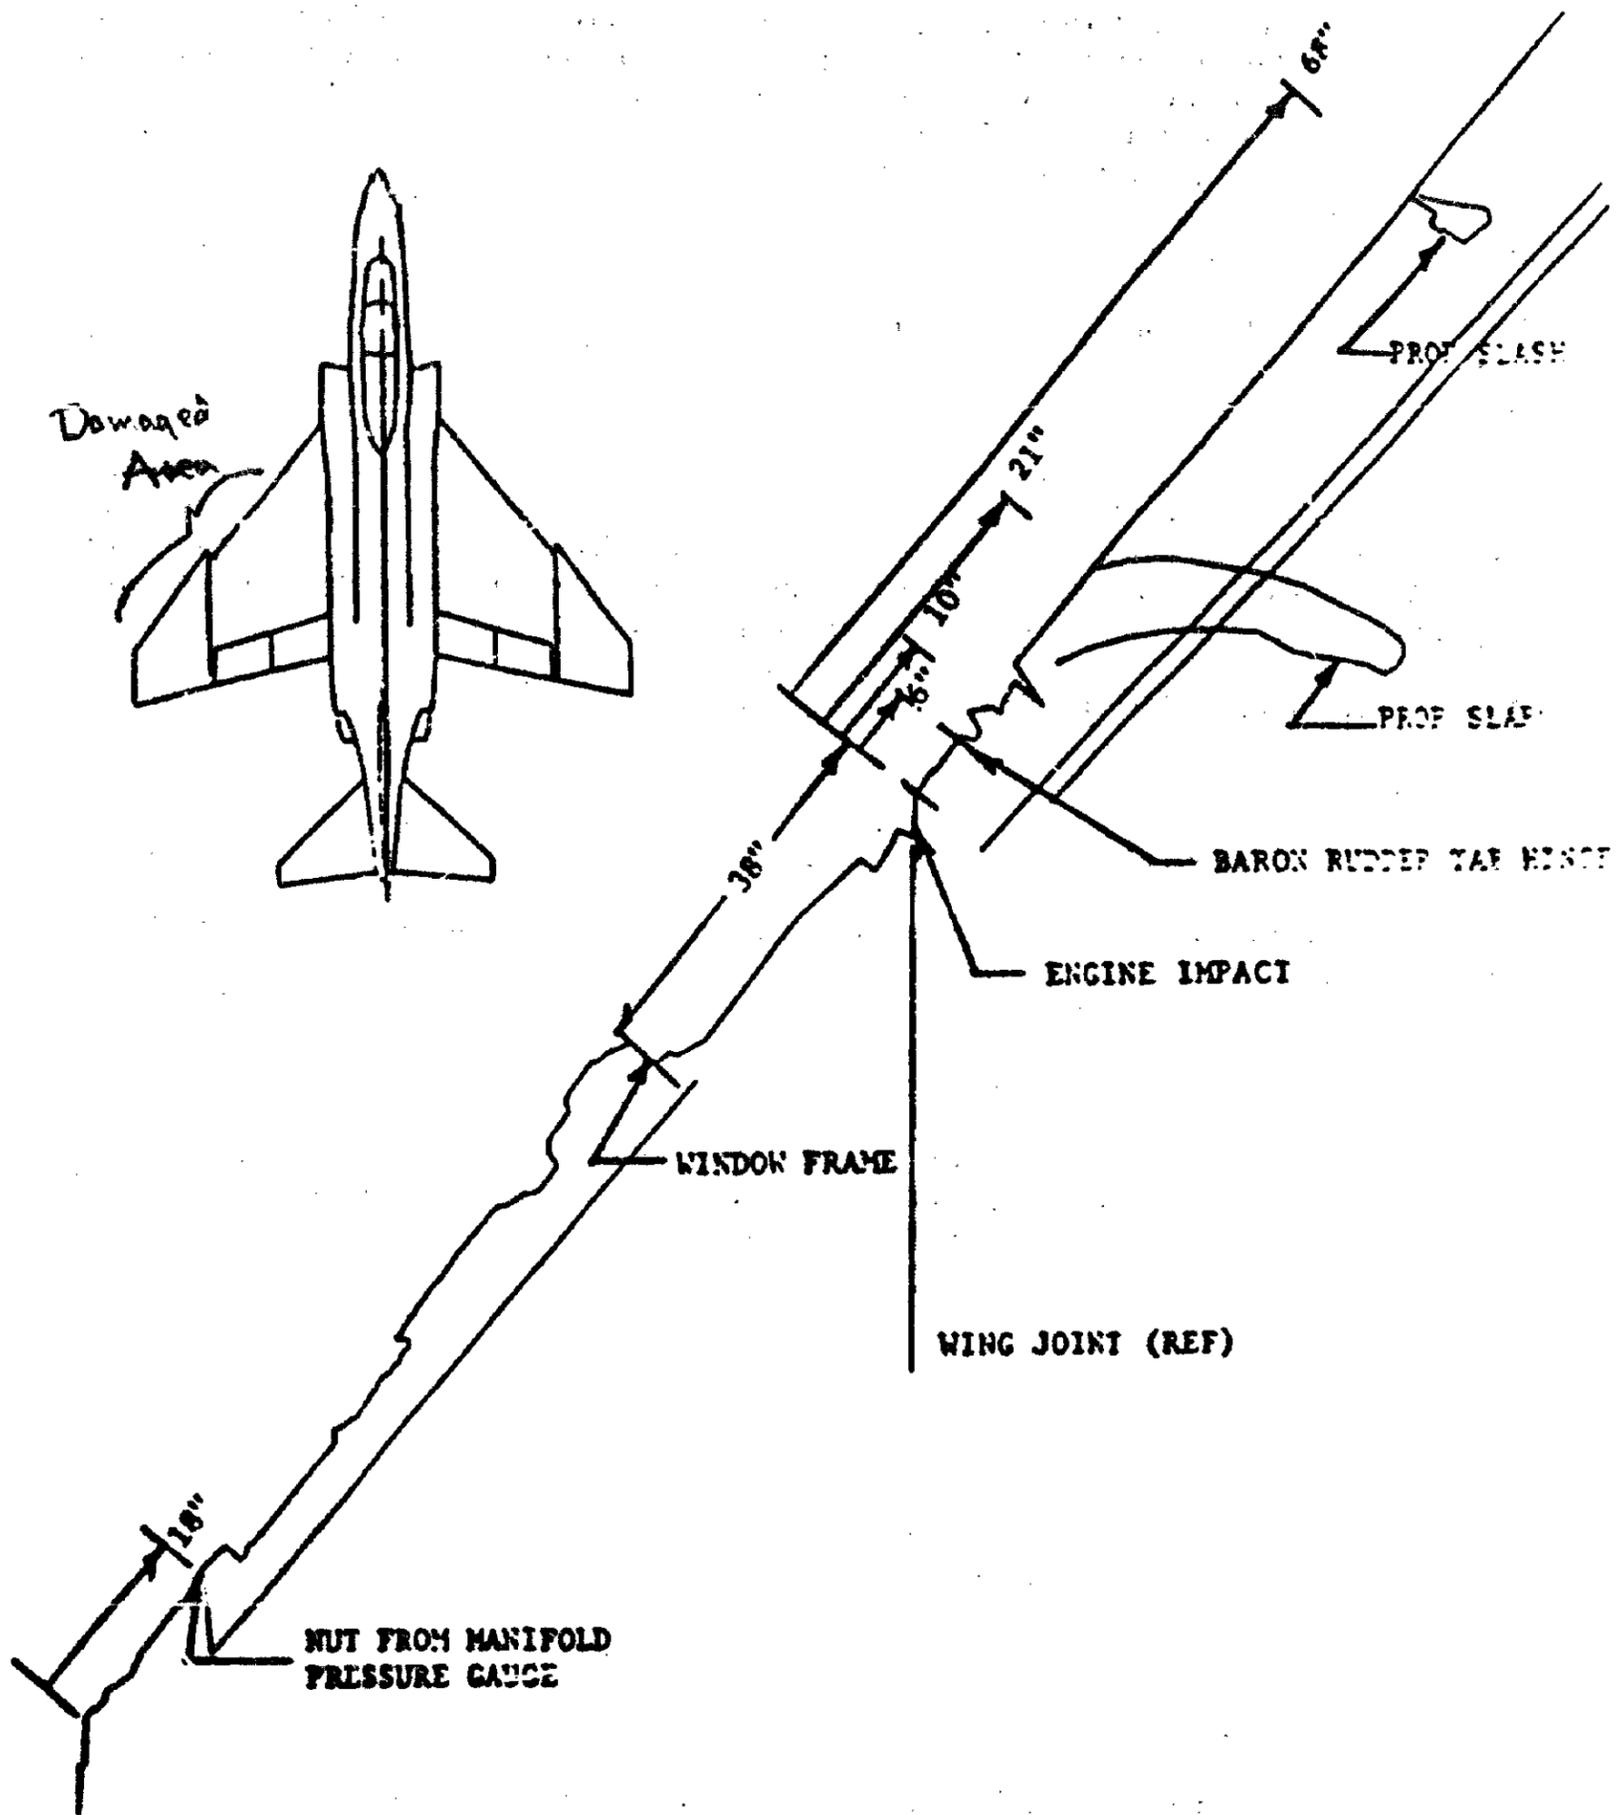
Figure 3.--Damage to McDonnell-Douglas F-4C Left Wing.

The major damage to the F-4C consisted of leading edge damage to the left wing and its fuel tank. Damage to the left wing leading edge consisted of propeller slashes and other impact damage. Parts and debris from the Beech Baron were embedded in the damaged leading edge. Using the wing joint as a reference and measuring parallel to the wing leading edge, the following was noted: (See figure 3.)

1. A propeller slash was found which began 68 inches inboard from the wing joint and progressed into the wing to a distance of 10 inches perpendicular to and aft of the leading edge. The slash ended 72 inches from the wing joint.
2. A V-shaped propeller slap mark was found from 10 inches to 21 inches inboard of the wing joint along the leading edge. The leading edge of the mark was 31 inches long, and its trailing edge was 36 inches long.
3. The wing joint forgings were damaged by impact.
4. A section of a Beech Baron window frame was found embedded in the leading edge of the F-4C's wing, 38 inches outboard from the wing joint.
5. A nut from the Beech Baron manifold pressure gauge was found embedded in the leading edge of the F-4C's wing, 18 inches inboard from the wingtip. The manifold pressure gauge was the top instrument in the center of the instrument panel.

- f. A Beech Baron rudder tab hinge wire was found embedded in the leading edge of the F-4C wing 6 inches inboard from the wing joint. The pin would have been located in the trailing edge of the Baron rudder 8 to 32 inches from the bottom.

The fuel tank on the left wing separated during the collision, and the bottom of the missile launcher for heat seeking missiles on the left wing was also damaged. The bottom of the fuel tank was 37 inches below the bottom of the wing and the tank centerline was 10 feet 6 inches from the junction of the wing leading edge and fuselage. The wing-mounted launcher was 22 inches below the bottom of the wing. The centerline of the launcher was 4 feet from the junction of the wing leading edge and fuselage.

Four areas of the left wing of the F-4C had come in contact with occupants of the Beech Baron. Hair and smeared blood were found on the wingtip and at 27 inches, 54 inches, and 69 inches inboard from the wingtip.

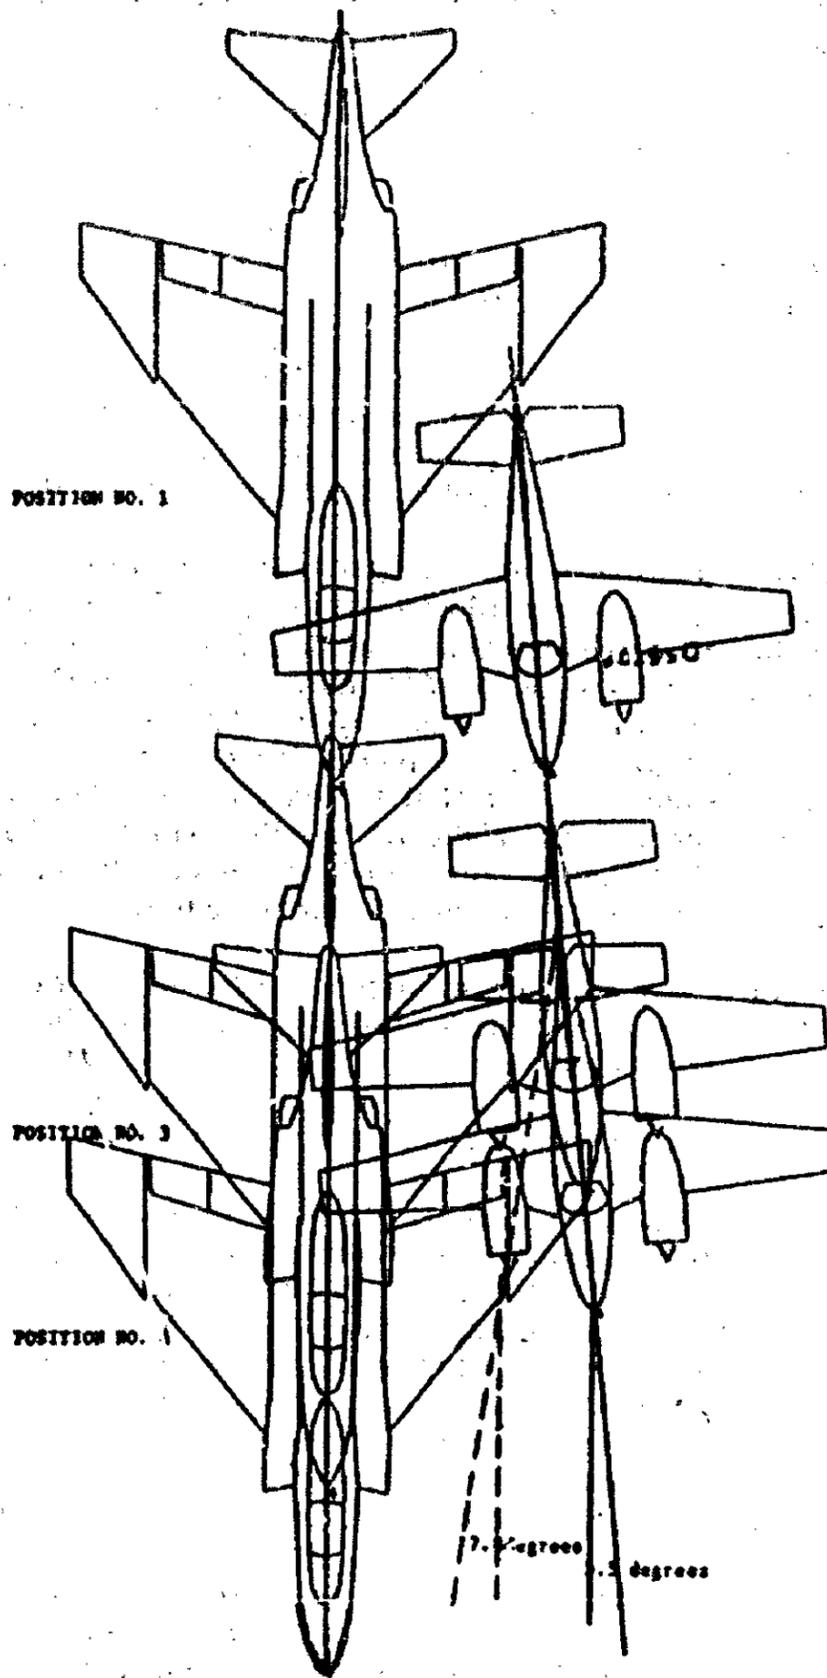
Figure 4.--Reconstructed sequence of positions of each airplane (top view).

A sequence of events was reconstructed by using the 5.5° heading difference and the calculated true airspeed of each airplane. (See figure 4.) This was accomplished by:

- (1) Aligning the rudder tab of the Baron to the position where the rudder tab hinge pin was embedded into the F-4C left wing leading edge.
- (2) Matching the propeller blade tip with the first slash mark in the wing leading edge.
- (3) Matching the original installation location of the manifold gauge in the Baron with the location where the manifold gauge installation nut was found along the F-4C leading edge.

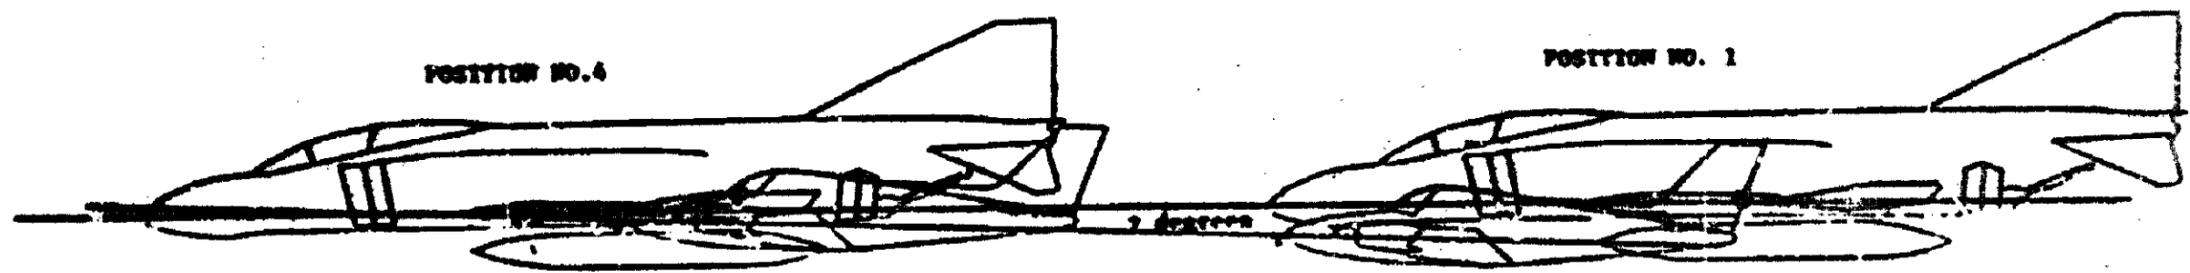
Figure 5.--Reconstructed sequence of positions of each airplane (side view).

Three sources of radar data also were used to reconstruct the flightpaths of the F-4C and the Beech Baron; the radar data were from the Washington ARTCC, Leesburg, Virginia, the Fleet Air Control Surveillance Facility (FACSFAC), Oceana, Virginia, and the terminal ATC radar at Cherry Point Marine Corps Air Station, North Carolina. Obviously erroneous data points were deleted and the coordinates of each data set were rotated to minimize cross range changes. This was done so data from each radar site could be compared. Each set of data had common points with the other sets of data, and each set of data had unique data points not available from the other sets.

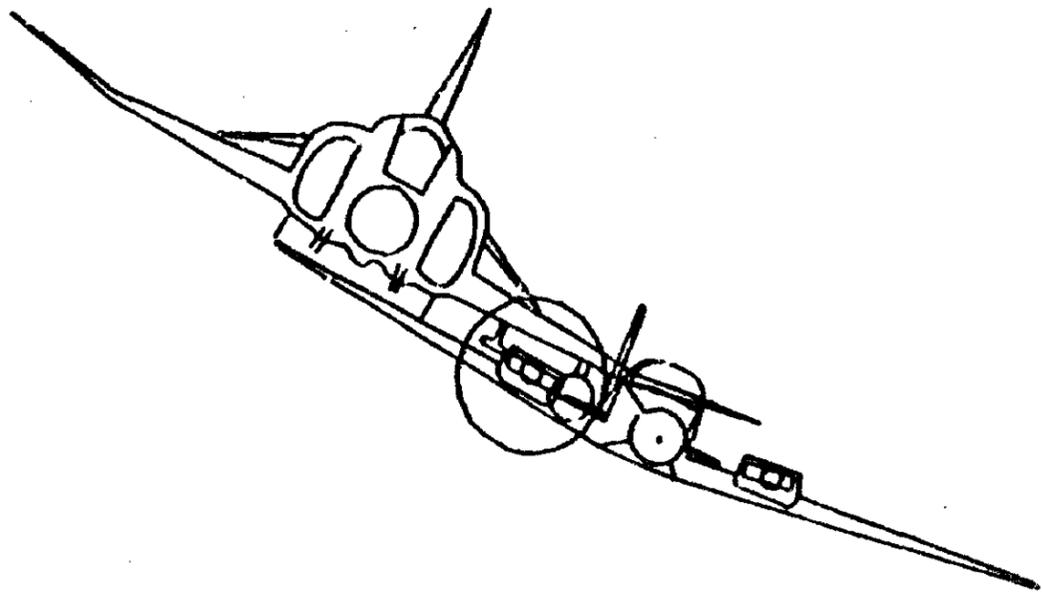
Figure 6.--Probable bank angles at collision.

The pilot of the Baron was instructed to turn left ("direct New Bern") by Washington Center just before impact and collision impact marks confirm that the Baron was in a left turn. A standard rate turn at 180 KTAS would require a bank angle of  $26^\circ$ . The F-4C pilot stated that he rolled  $30^\circ$  left at "break X"; a bank angle of  $4^\circ$  more than that of the Baron. Since the radius of turn of the Beech Baron would have been smaller than that of the F-4C, the relative closure angle was such that the F-4C would have been closing onto the Baron. Based on the point of impact of the Baron tail, the impact on the bottom of the heat-seeking missile launcher, and the strikes on the Sparrow missile fins, the roll angle of the Baron relative to the F-4C was established at  $3.5^\circ$  left wing down.
