**NATIONAL
TRANSPORTATION
SAFETY
BOARD**

AIRCRAFT ACCIDENT REPORT

**FLYING TIGERS, INC., FLIGHT 2468
McDONNELL DOUGLAS DC8-63, N797FT
CHAMBERS FIELD, NAVAL AIR STATION
NORFOLK, VIRGINIA
OCTOBER 25, 1983**

NTSB/AAR-84/08

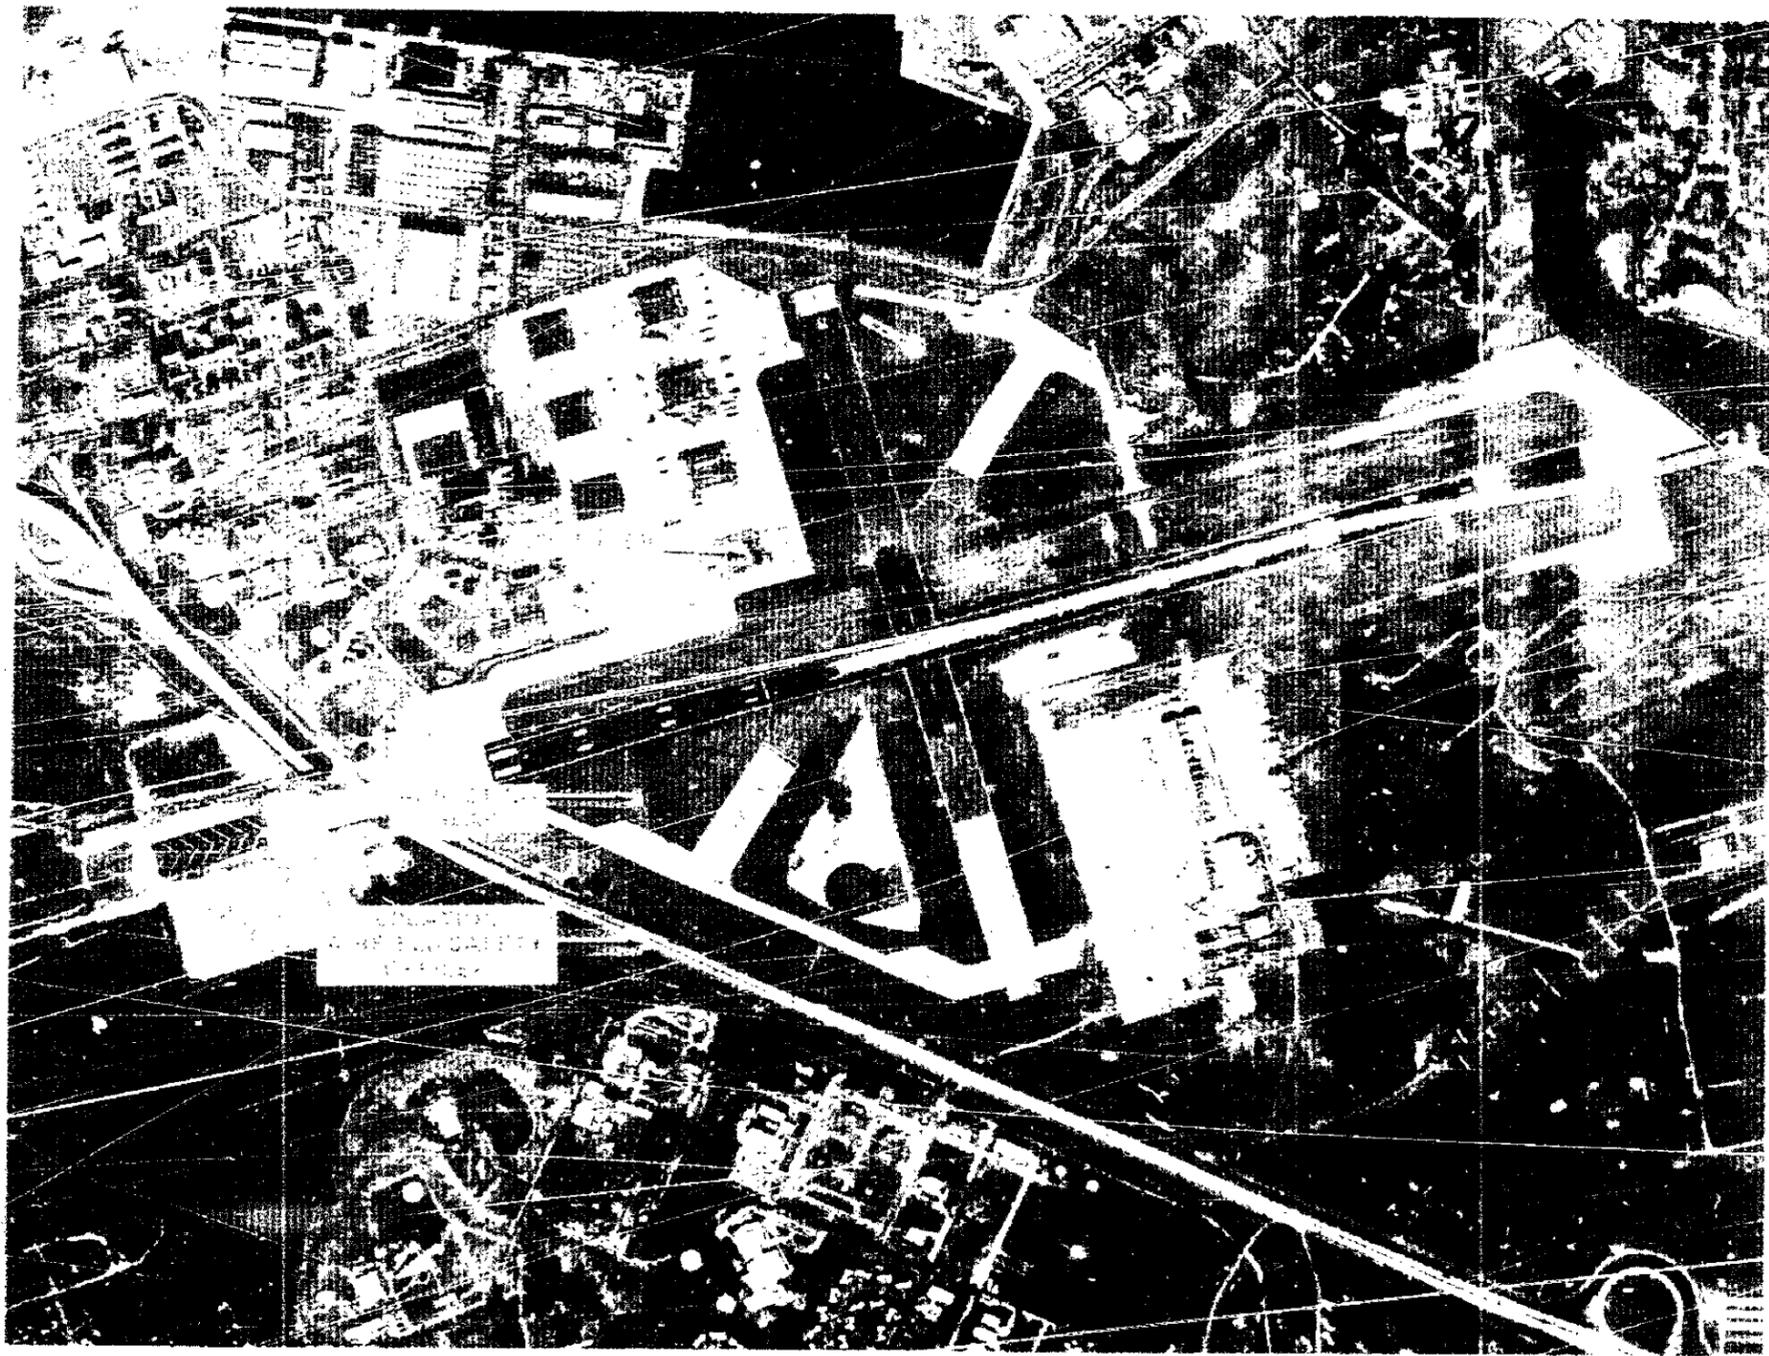
Figure 1.—Airfield diagram and ground track of airplane.

The local controller, who was located in the tower cab (see figure 1), stated that the airplane touched down at the No. 1 arresting gear and bounced 50 to 100 feet into the air and finally touched down a second time abeam of the tower, or just before reaching the tower. An off-duty ground control trainee saw the airplane touch down by the No. 1 arresting gear, bounce about 50 feet, and touch down a second time abeam of the tower just before midfield. Neither the local controller or any other controllers was aware about a tendency for the runway to flood under certain meteorological conditions.

A flight data controller who first saw the airplane at midfield said the airplane was "going very fast." Both the flight data controller and the local controller said that they did not hear the sound of reverse thrust. The flight data controller recalled seeing water spray emanating from the airplane as it went down the runway. The airfield aviation safety officer, a Naval aviator, was driving to work and saw a DC8 touch down on runway 10 "just east of the southwest taxiway centerline" which was between the intersection of the two runways and a point abeam of the tower.
