# **NATIONAL TRANSPORTATION SAFETY BOARD**

## **AIRCRAFT ACCIDENT REPORT**

**US AIR, INC., FLIGHT 183**

**NTSB/AAR-85/01**

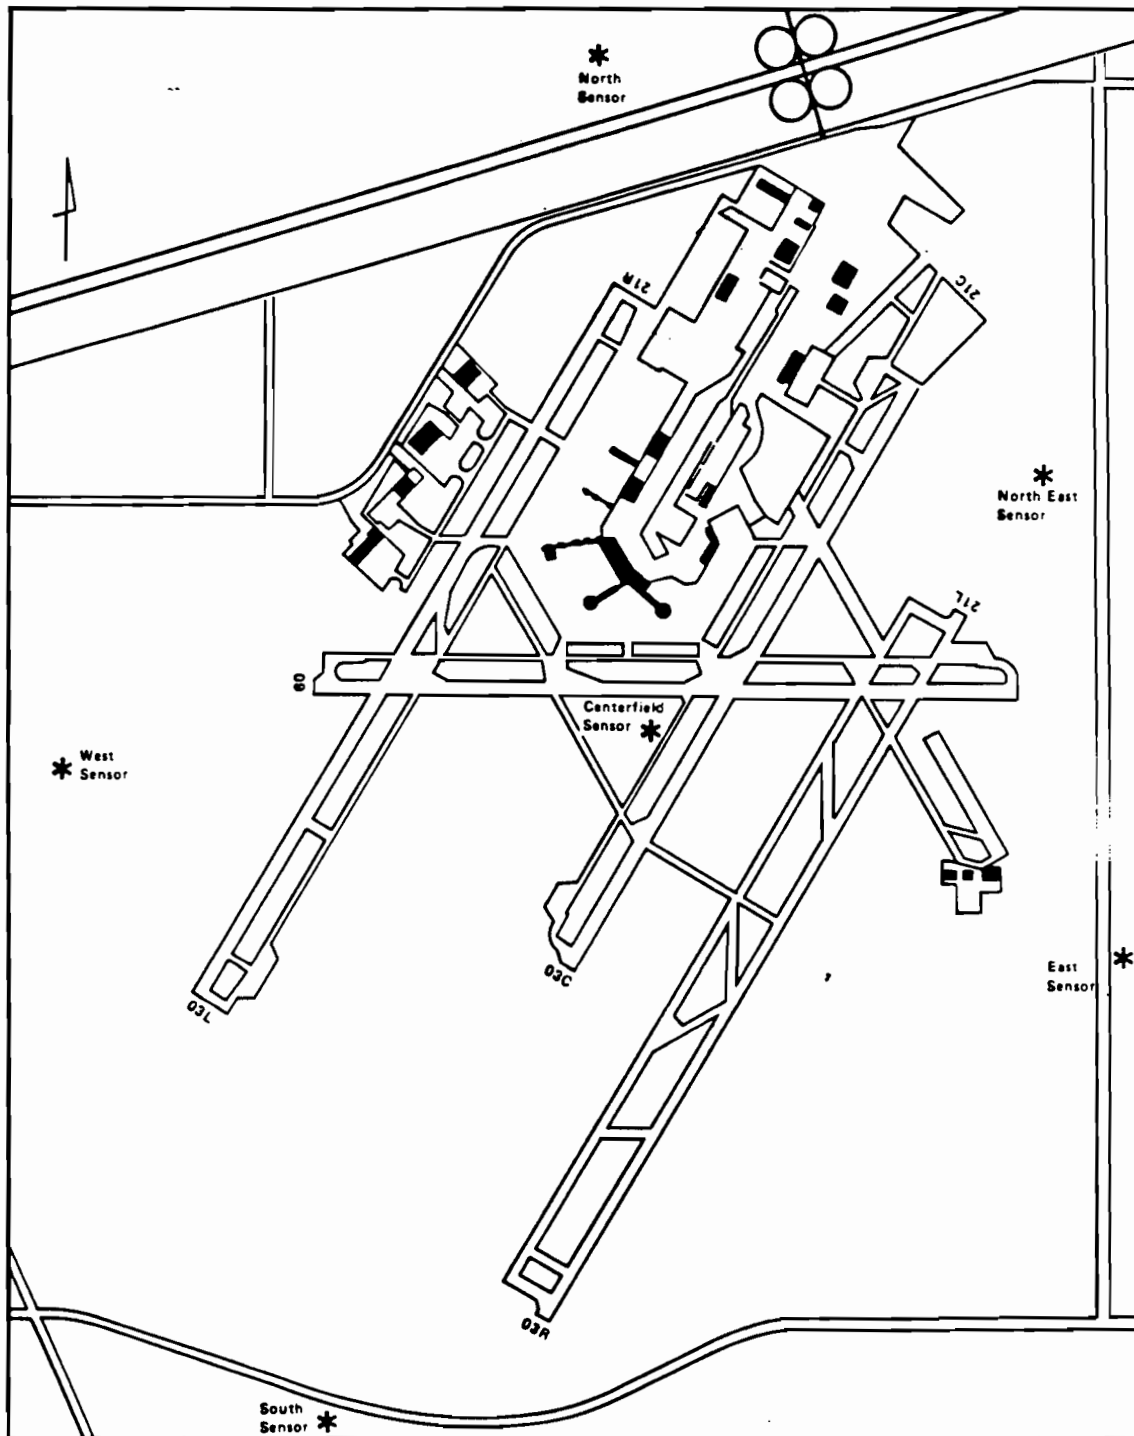
Figure 1.-- Airport diagram/low level wind shear alert system.

The landing area consists of four runways: 3L/21R, 3C/21C, 3R/21L, and 9/27. (See figure 1.) Runway 21R is 10,500 feet long and 200 feet wide, with a grooved concrete surface. Runway 21R has high-intensity runway edge lights, runway centerline lights, and a high-intensity approach light system with sequenced flashing lights.

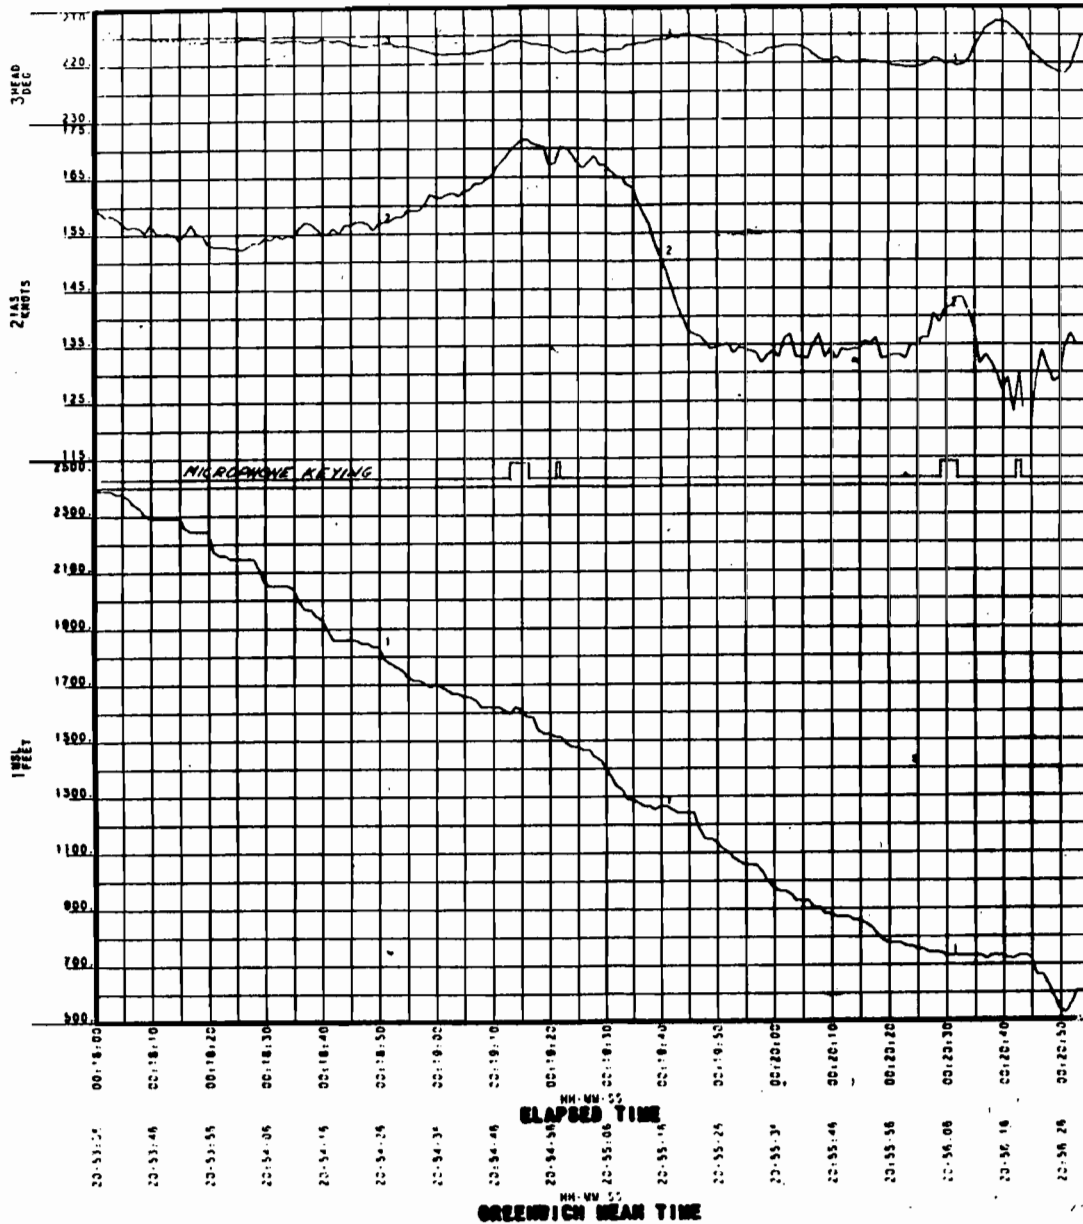
# APPENDIX E READOUT OF FLIGHT DATA RECORDER

The flight recorder was undamaged and in working order. The data recovered from the recorder indicated that it operated normally during the flight of Flight 183, and that it stopped at 1656:31. However, the vertical acceleration values were invalid since the vertical acceleration sensor had failed before the start of Flight 183. (As a result of the accident investigation, USAir revised the DFDR test procedure for the accelerometer on August 2, 1984. The accelerometer is now checked at values of 1 "g", 0 "g", and -1 "g".)
