# **NATIONAL TRANSPORTATION SAFETY BOARD**

## **AIRCRAFT ACCIDENT REPORT**

**AIR CONTINENTAL GATES LEARJET 23  
BRADLEY INTERNATIONAL AIRPORT  
WINDSOR LOCKS, CONNECTICUT  
JUNE 4, 1984**

NTSB/AAR-85/02

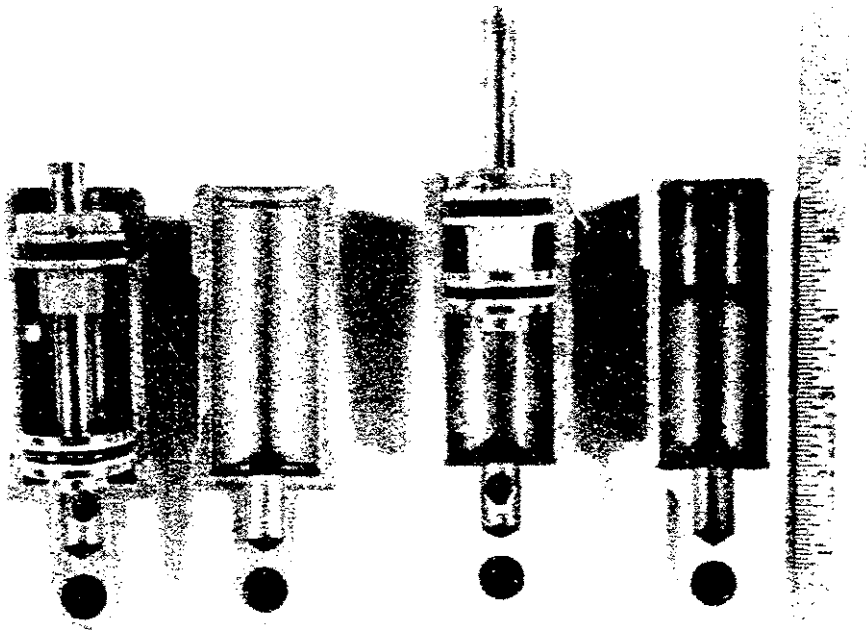
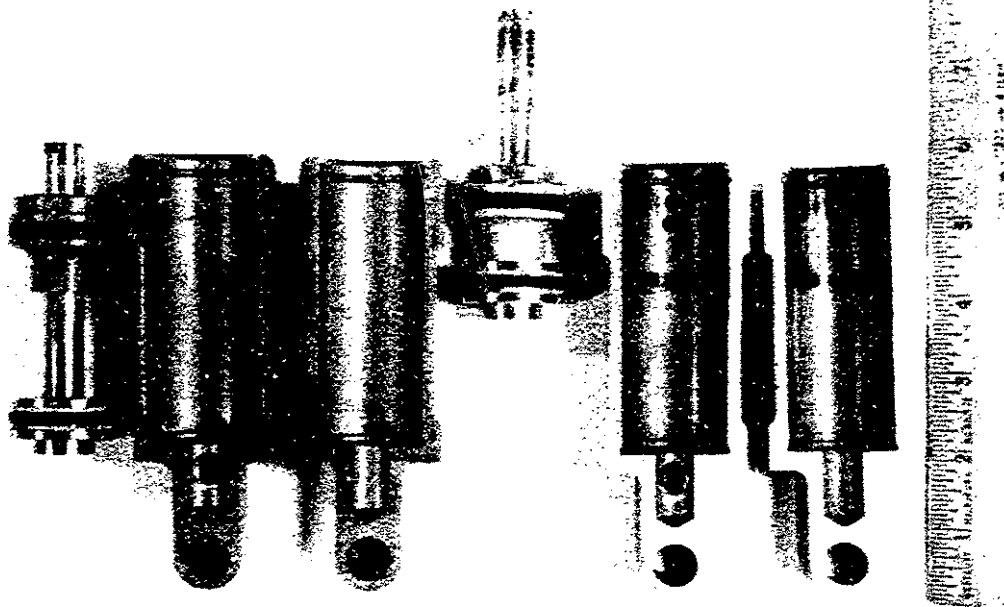
Pistons out of barrel.  
Figure 1

The left and right spoiler actuators were split in half lengthwise and examined by an engineering firm to determine if a materials trace pattern could be identified to indicate the position of the spoilers at impact or during the ground fire. (See figure 1.) The left spoiler actuator was not damaged by the ground fire; however, traces of rubber specks were found on the inside walls of the actuator, and a faint Sand was found on the actuator walls, corresponding to the piston O-ring in the extended and the retracted positions. The retract end of the left spoiler actuator barrel assembly was faintly scored; the circular scoring was aligned with the end of the piston rod. (See figure 2.) The right spoiler actuator was damaged by ground fire; heat decomposed rubber specks were found on the actuator walls and a heavy band of dark color was found on the actuator wall corresponding to the piston being in the extended position. The retract end of the barrel assembly was scored; the circular scoring was aligned with the end of the piston rod.

Pistons in barrel

A laboratory inspection of the right spoiler actuator revealed a heavy band of discolored metal on the interior wall that corresponded to the piston being in the extended position, indicating that the spoiler was in the extended position while exposed to the postaccident ground fire. Although circular scoring marks were found on the retract end of the spoiler actuator barrel assembly, examination of the marks was not conclusive in determining whether the scoring was caused by inservice use or by impact damage. The left spoiler actuator barrel assembly had faint scoring marks. Based upon the weight of the physical evidence and the reactions of the airplane during the last part of the flight, the Safety Board concludes that the spoilers were asymmetrical at impact. The aileron trim actuator was recovered in a position toward full travel for left wing down which points to the possibility of a lateral control problem and indicates that the pilot attempted to counteract an uncommanded airplane roll to the right by using aileron trim.
