NATIONAL TRANSPORTATION SAFETY BOARD

AIRCRAFT ACCIDENT REPORT

**HENSON AIRLINES FLIGHT 1517
BEECH B99, N339HA
GROTTOES, VIRGINIA
SEPTEMBER 23, 1985**

NTSB/AAR-86/07

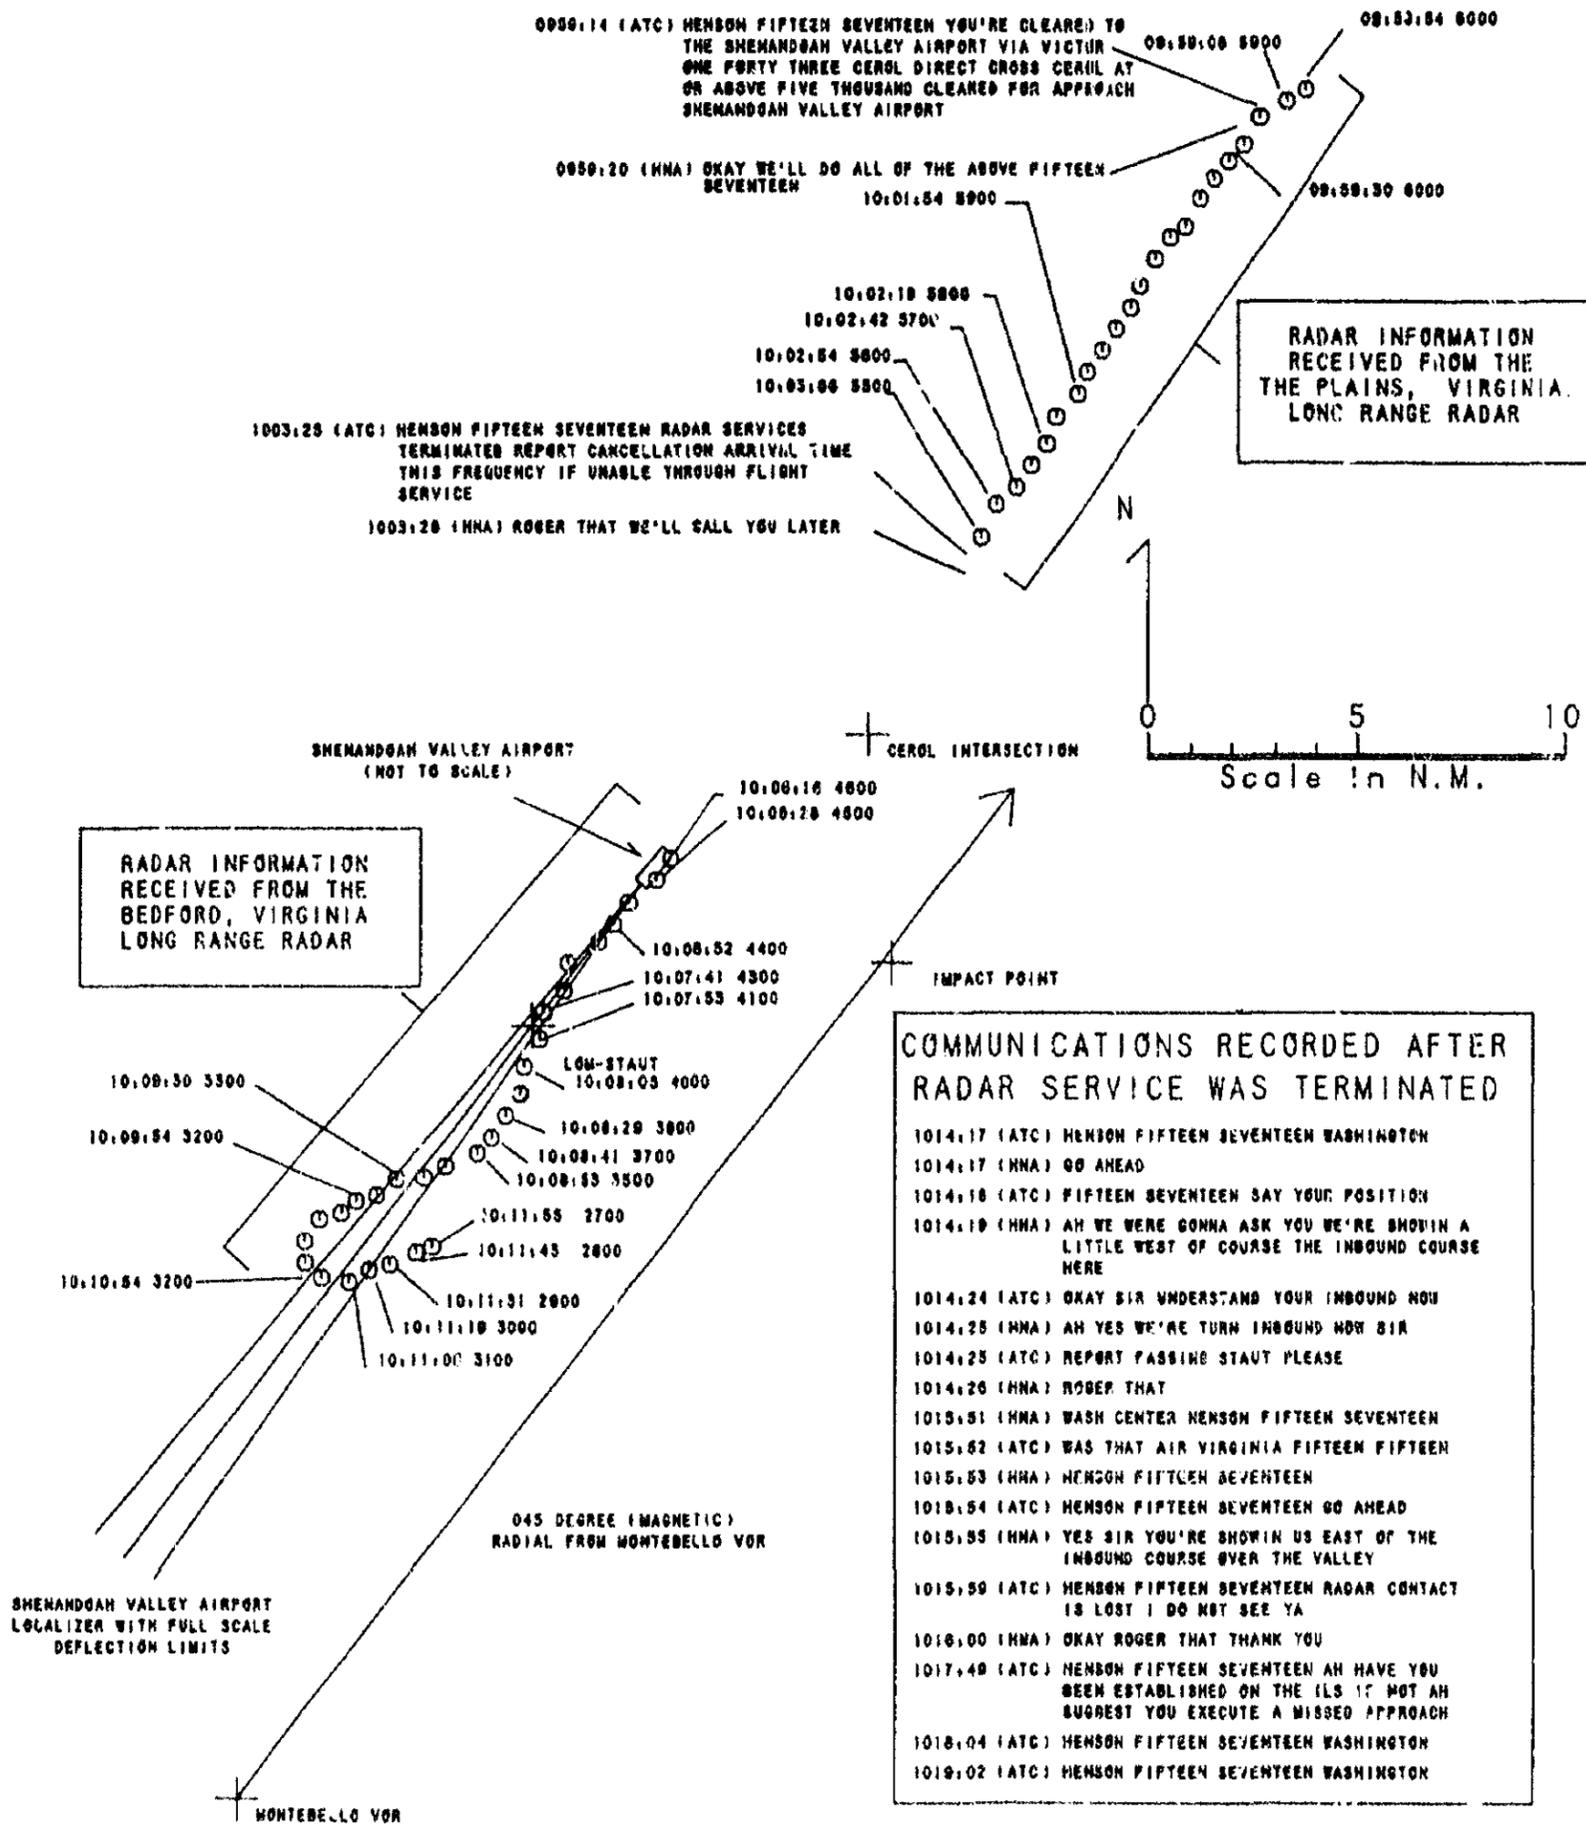
Figure 3.—Recorded radar flightpath reconstruction.

HENSON FLIGHT 1517
 RECORDED RADAR FLIGHT PATH RECONSTRUCTION
 (Note : Axes are aligned with true north)

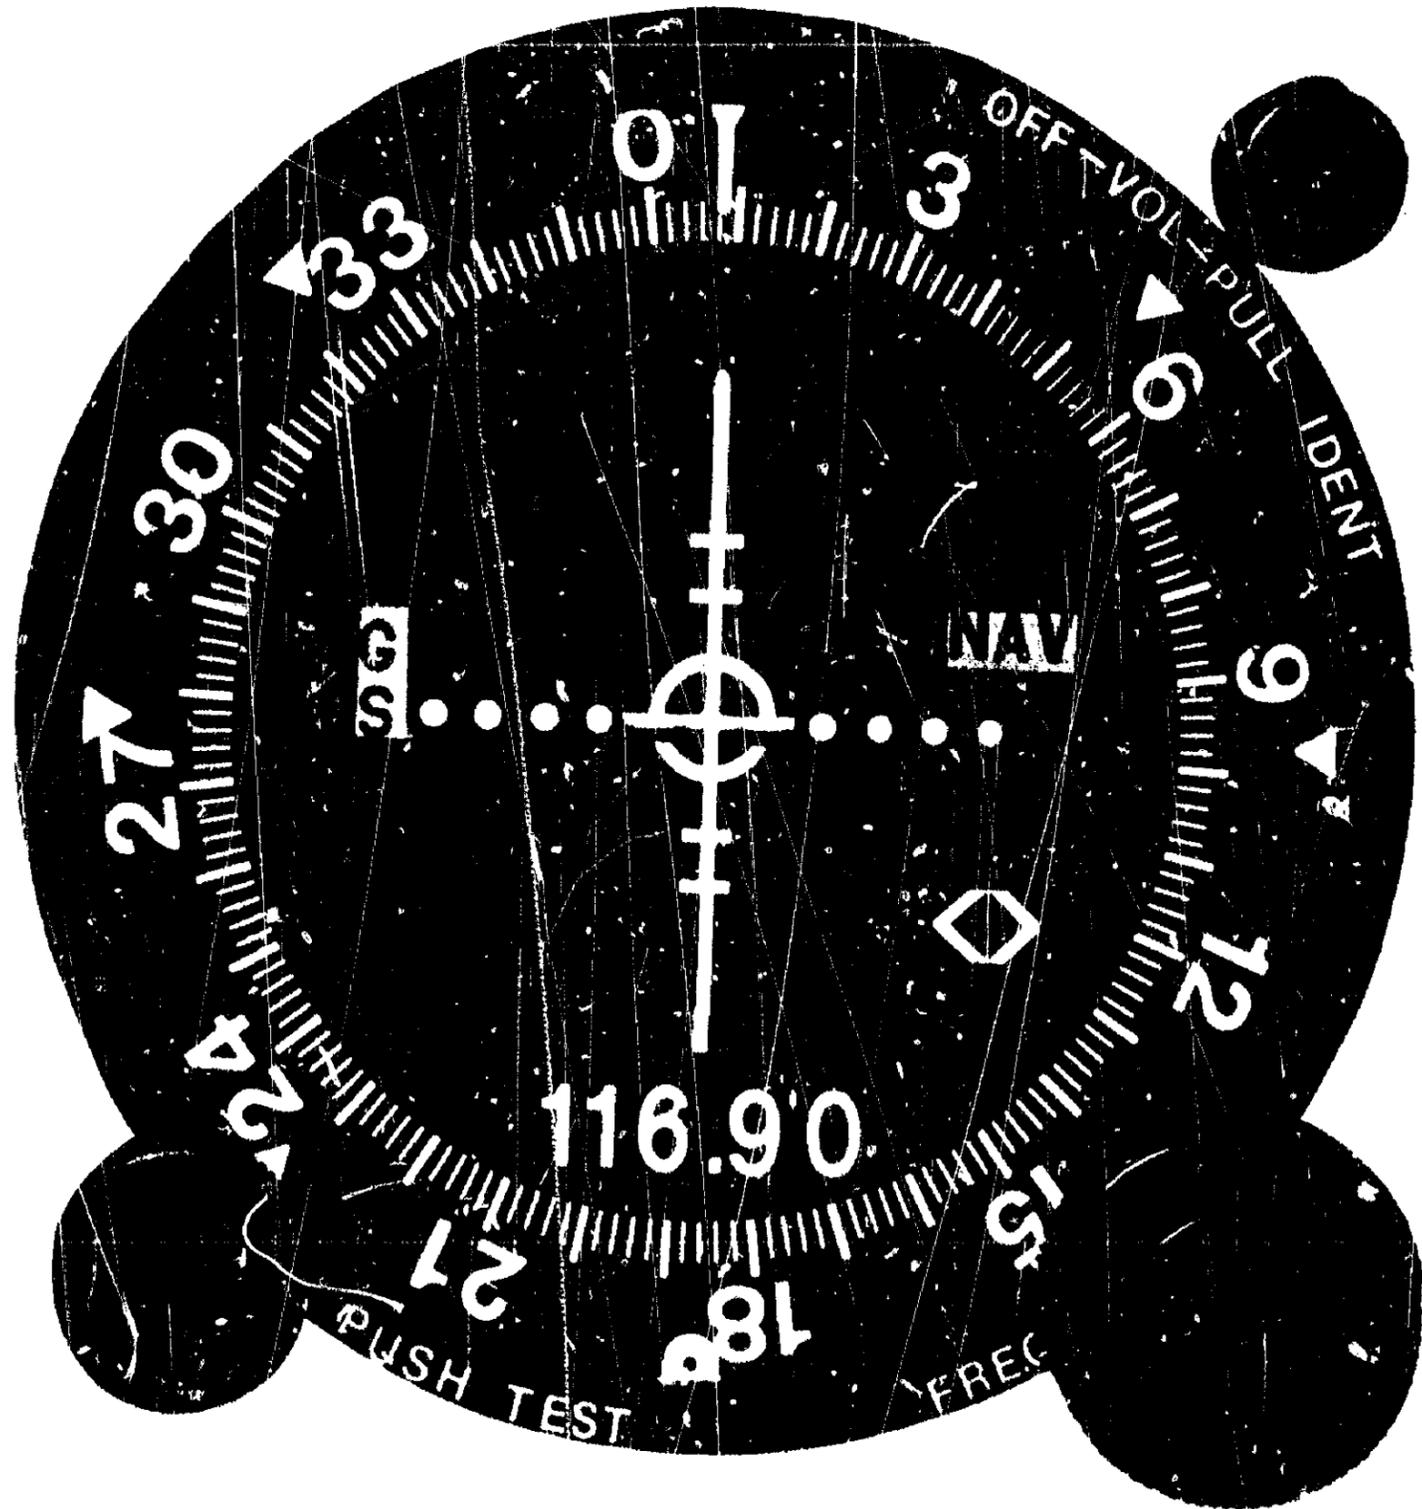
Figure 5.—Enlarged front view NAV 122 and NAV 122A.
(Courtesy of NARCO Avionics, Inc.)

9/ Navigational displays consist of omnibearing selector (OBS), course deviation indicator (CDI), glideslope (GS), TO/FROM indicators, On/Off flags, and a scale to indicate the degrees of deflection from the centerline of the selected VOR radial or the localizer and the glideslope. (See figure 5.)

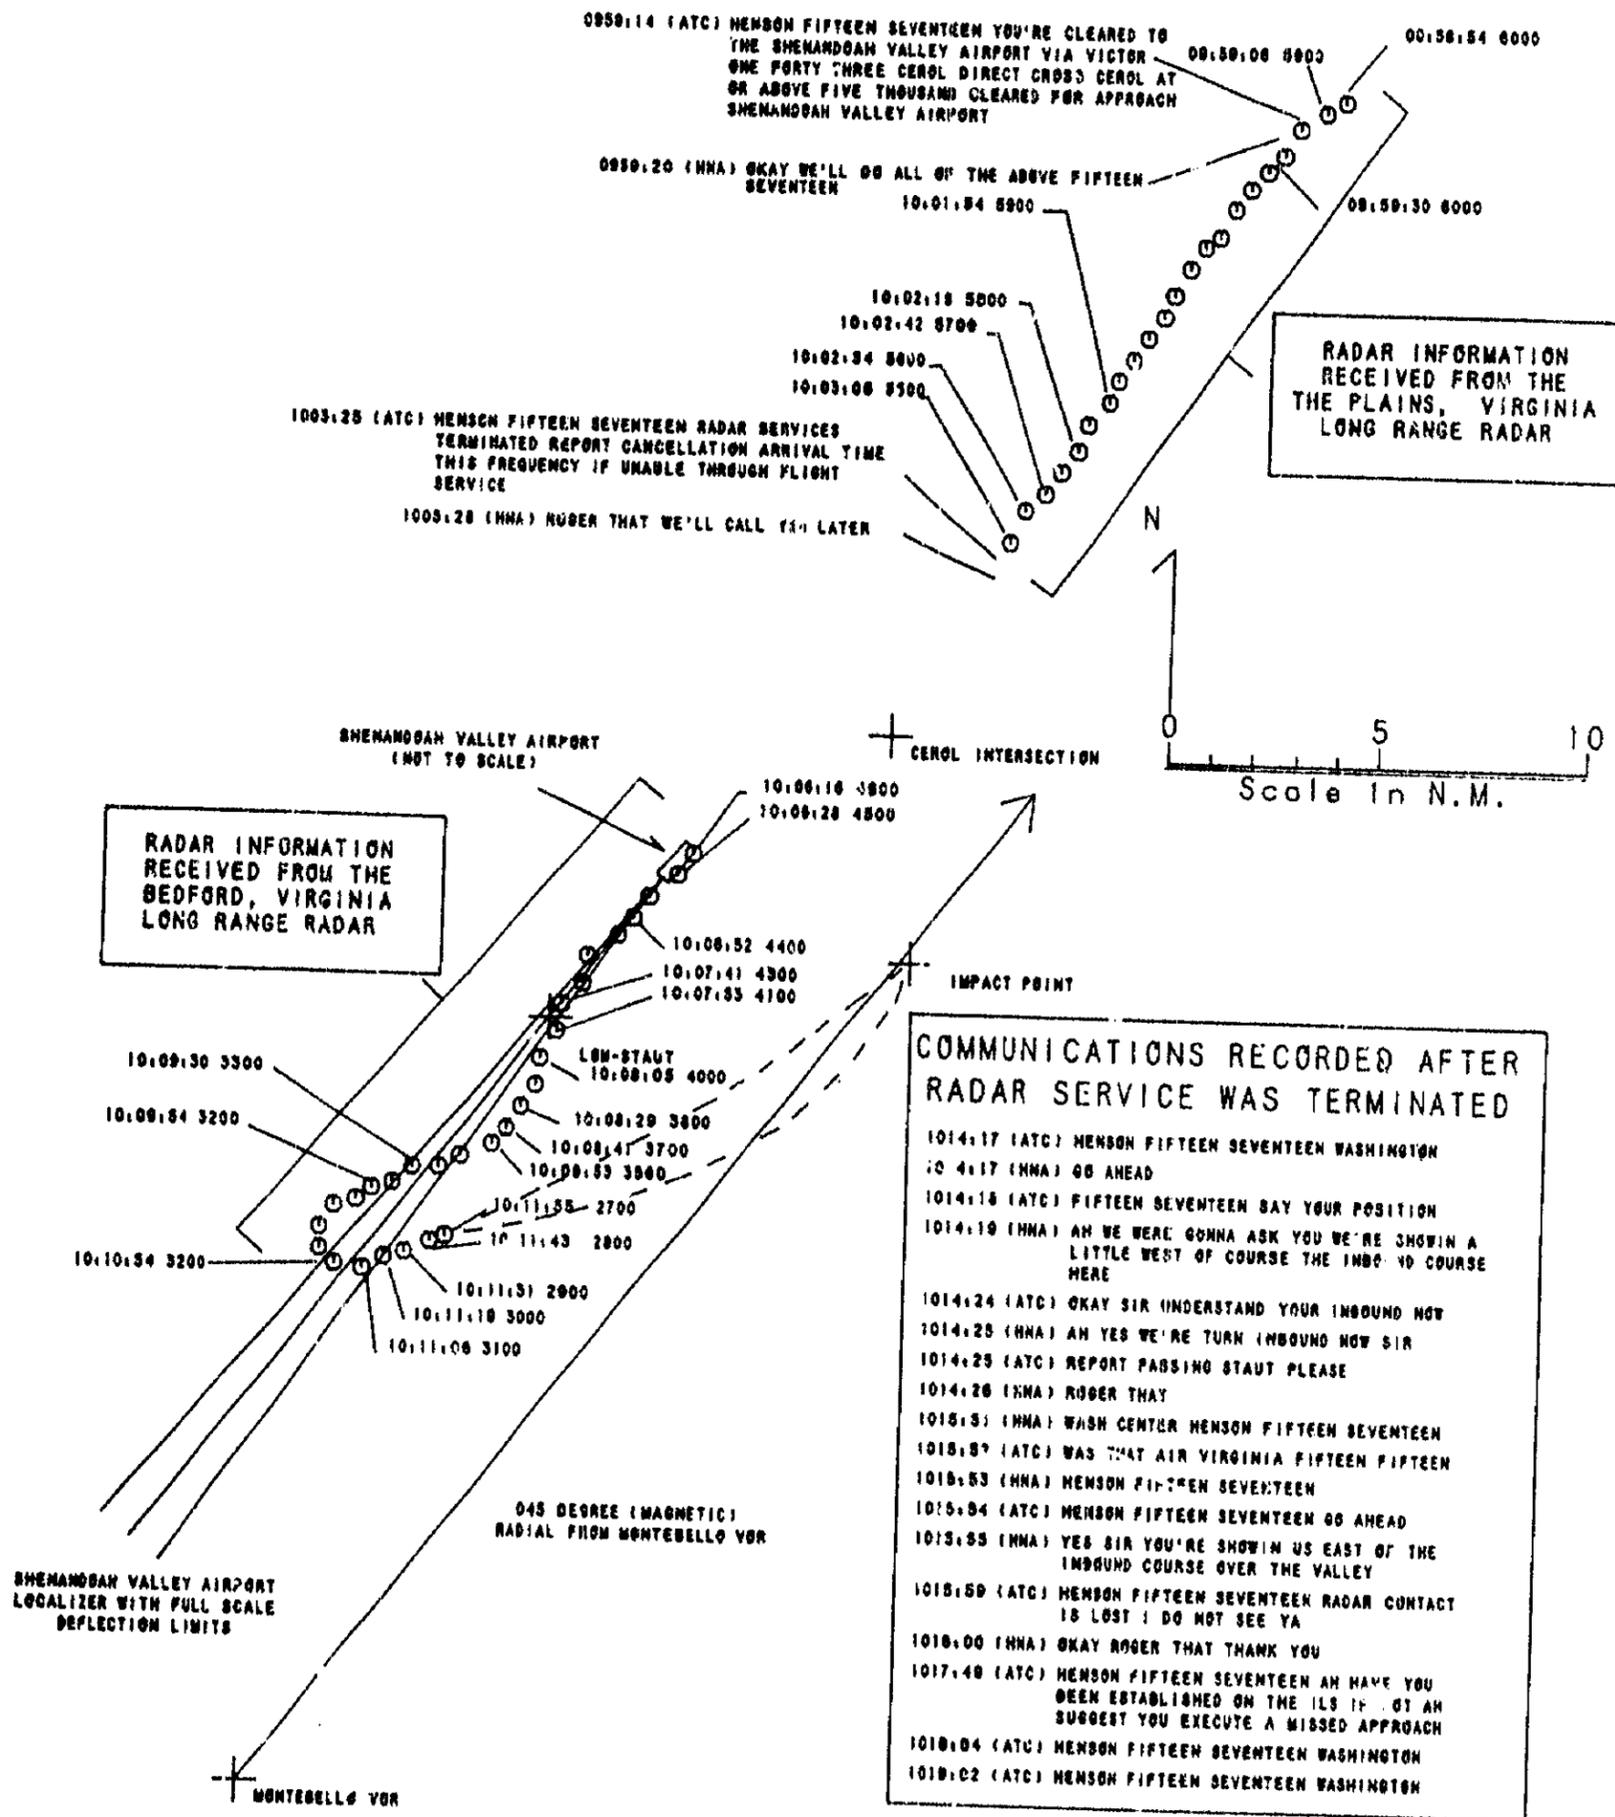
Figure 6.--Projected flightpath of flight 1517.

After the flightcrew intercepted what they thought was the localizer course and turned inbound, they must have descended below the glideslope intercept altitude of 2,700 feet since they struck the mountain at 2,400 feet, about 371 feet below its peak altitude and about 200 feet below a ridge in the flightpath of flight 1517. There are two possible explanations for the airplane crashing at 2,400 feet along the 045° radial of the MOL VOR.

One explanation for the final phase of the flight is that the flightcrew flew along the 045° radial of MOL and allowed the airplane to drift down to 2,400 feet as they waited for passage of STAUT. Eventually, they became uncertain as to their location after noting a slow swing of the ADF needle, no marker beacon indication, and no glideslope indication. The captain's contact with ATC at 10:15:55 about being east of course supports such an explanation. Further, there would be a time delay after turning inbound on the localizer before the crew would have expected to receive the marker beacon or an ADF needle swing indicating passage of STAUT. Thus, once the crew intercepted the 045° radial of MOL, thinking it was the localizer, the crew would not have expected to receive an immediate indication that they had passed STAUT. Once the crew realized that sufficient time had passed for outer marker passage, either the captain or the first officer may have noted the ADF needle pointing toward the left wing. This would indicate that the airplane was east of course and could account for the captain's inquiry to ATC. The flightcrew may have finally realized that they were not on the localizer course or, in response to the controller's suggestion that they execute a missed approach, they may have initiated a climb to a minimum safe altitude. However, the airplane collided with the ground before it could begin a left turn to STAUT according to the missed approach instructions, since the airplane struck the trees in a wing's level fuselage attitude.

HENSON FLIGHT 1517
RECORDED RADAR FLIGHT PATH RECONSTRUCTION
(Note : Axes are aligned with true north)
DASHED LINES REPRESENT PROBABLE GROUND TRACK

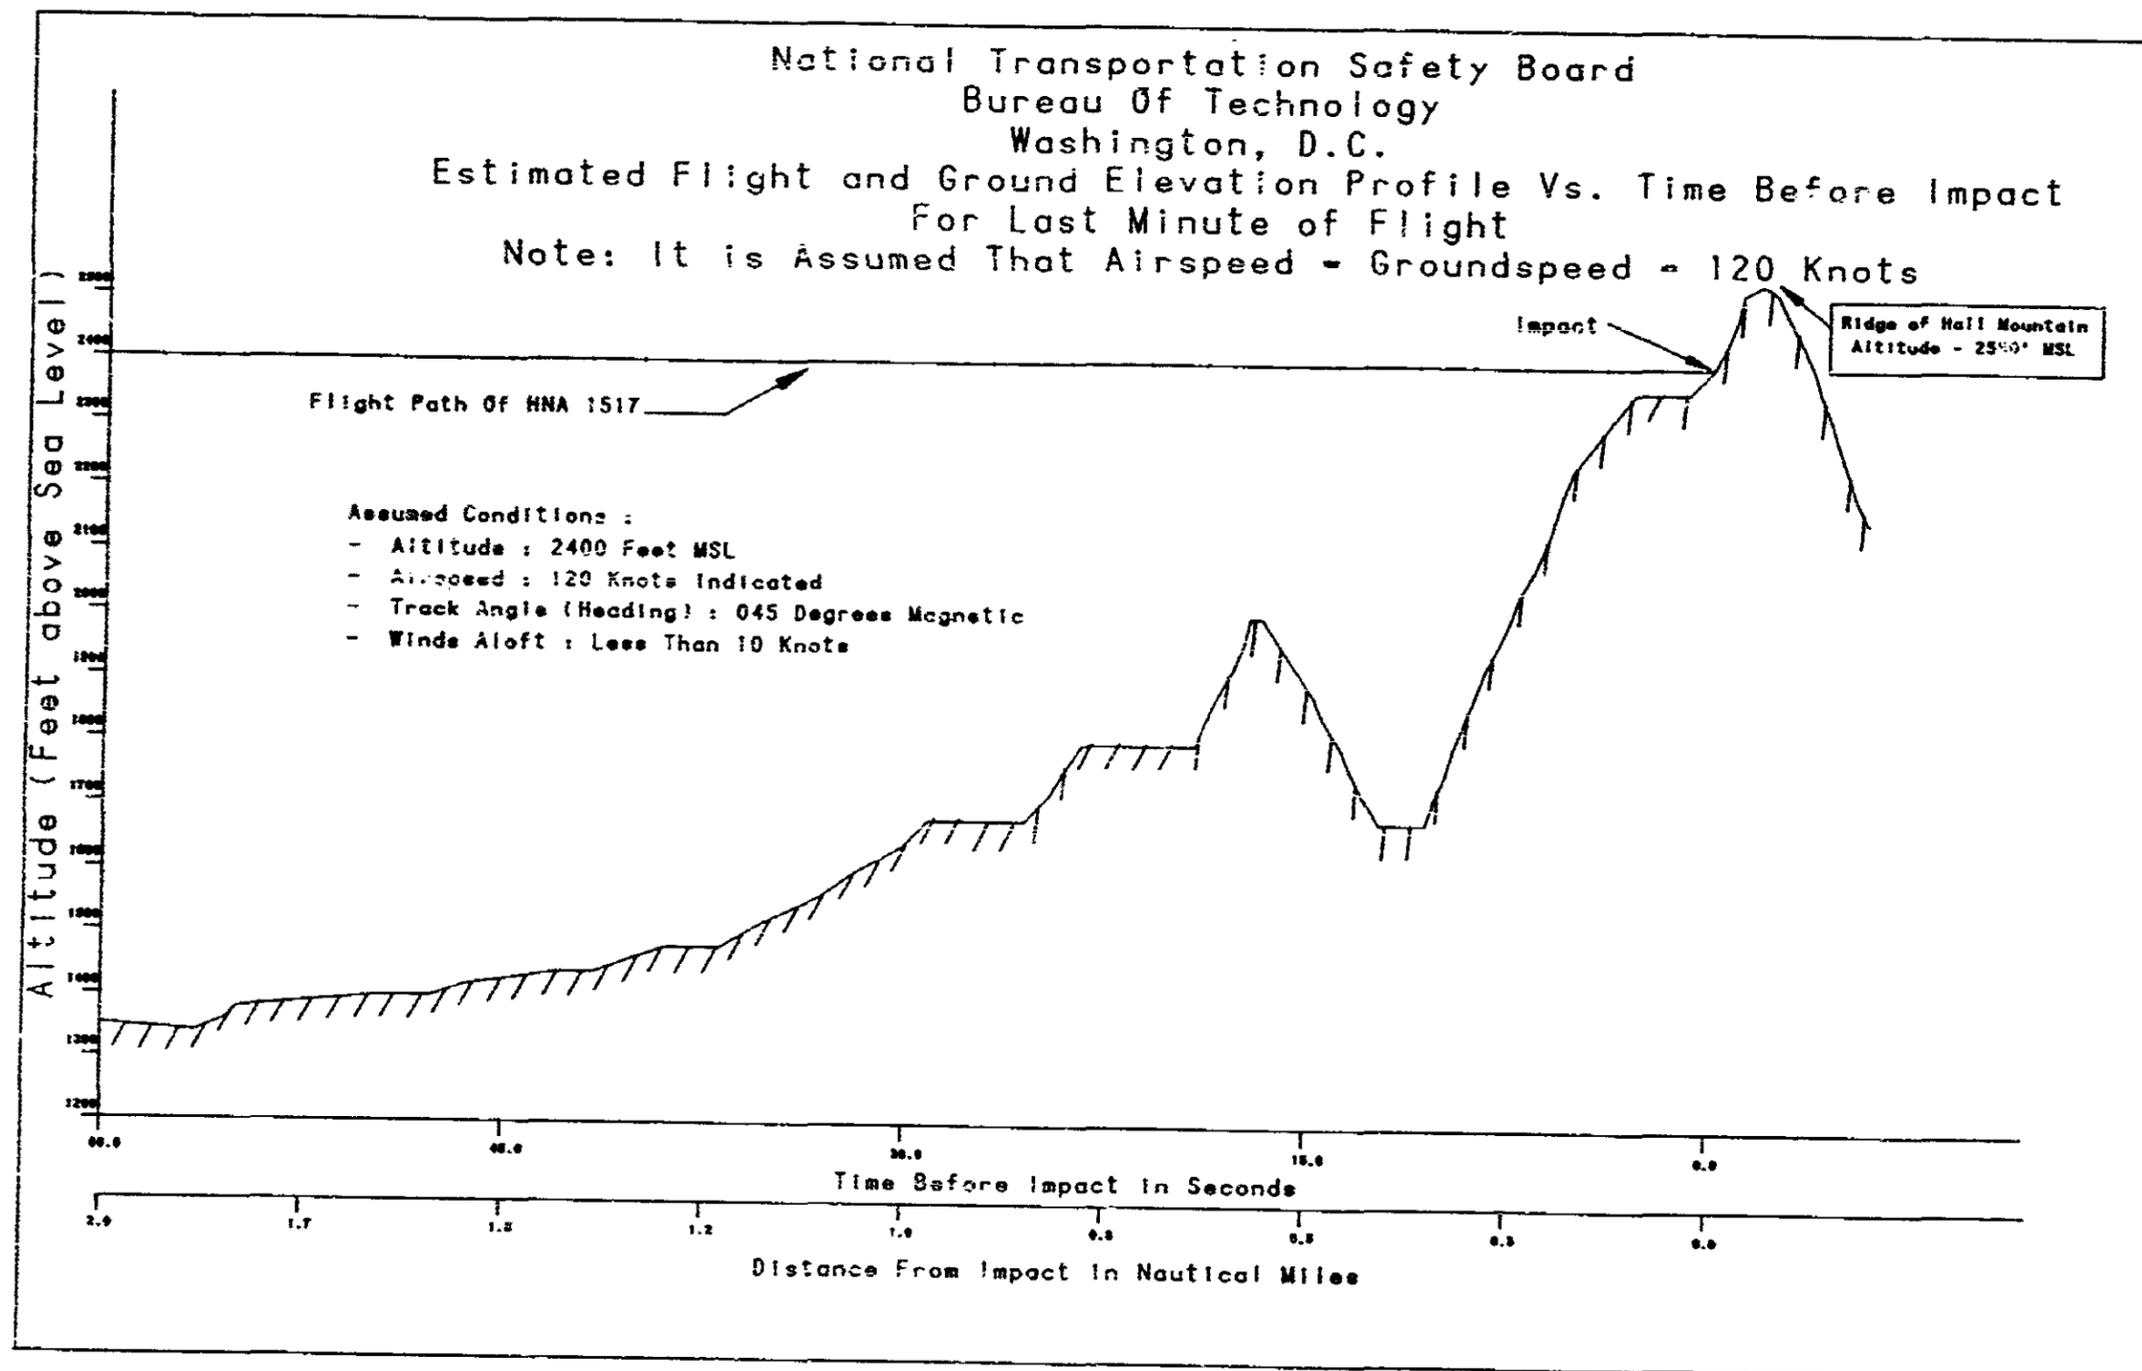
Figure 8.--Estimated flight/ground profile vs. time before impact.

Assumed Conditions :

- Altitude : 2400 Feet MSL
- Airspeed : 120 Knots Indicated
- Track Angle (Heading) : 045 Degree Magnetic
- Winds Aloft : Less Than 10 Knots

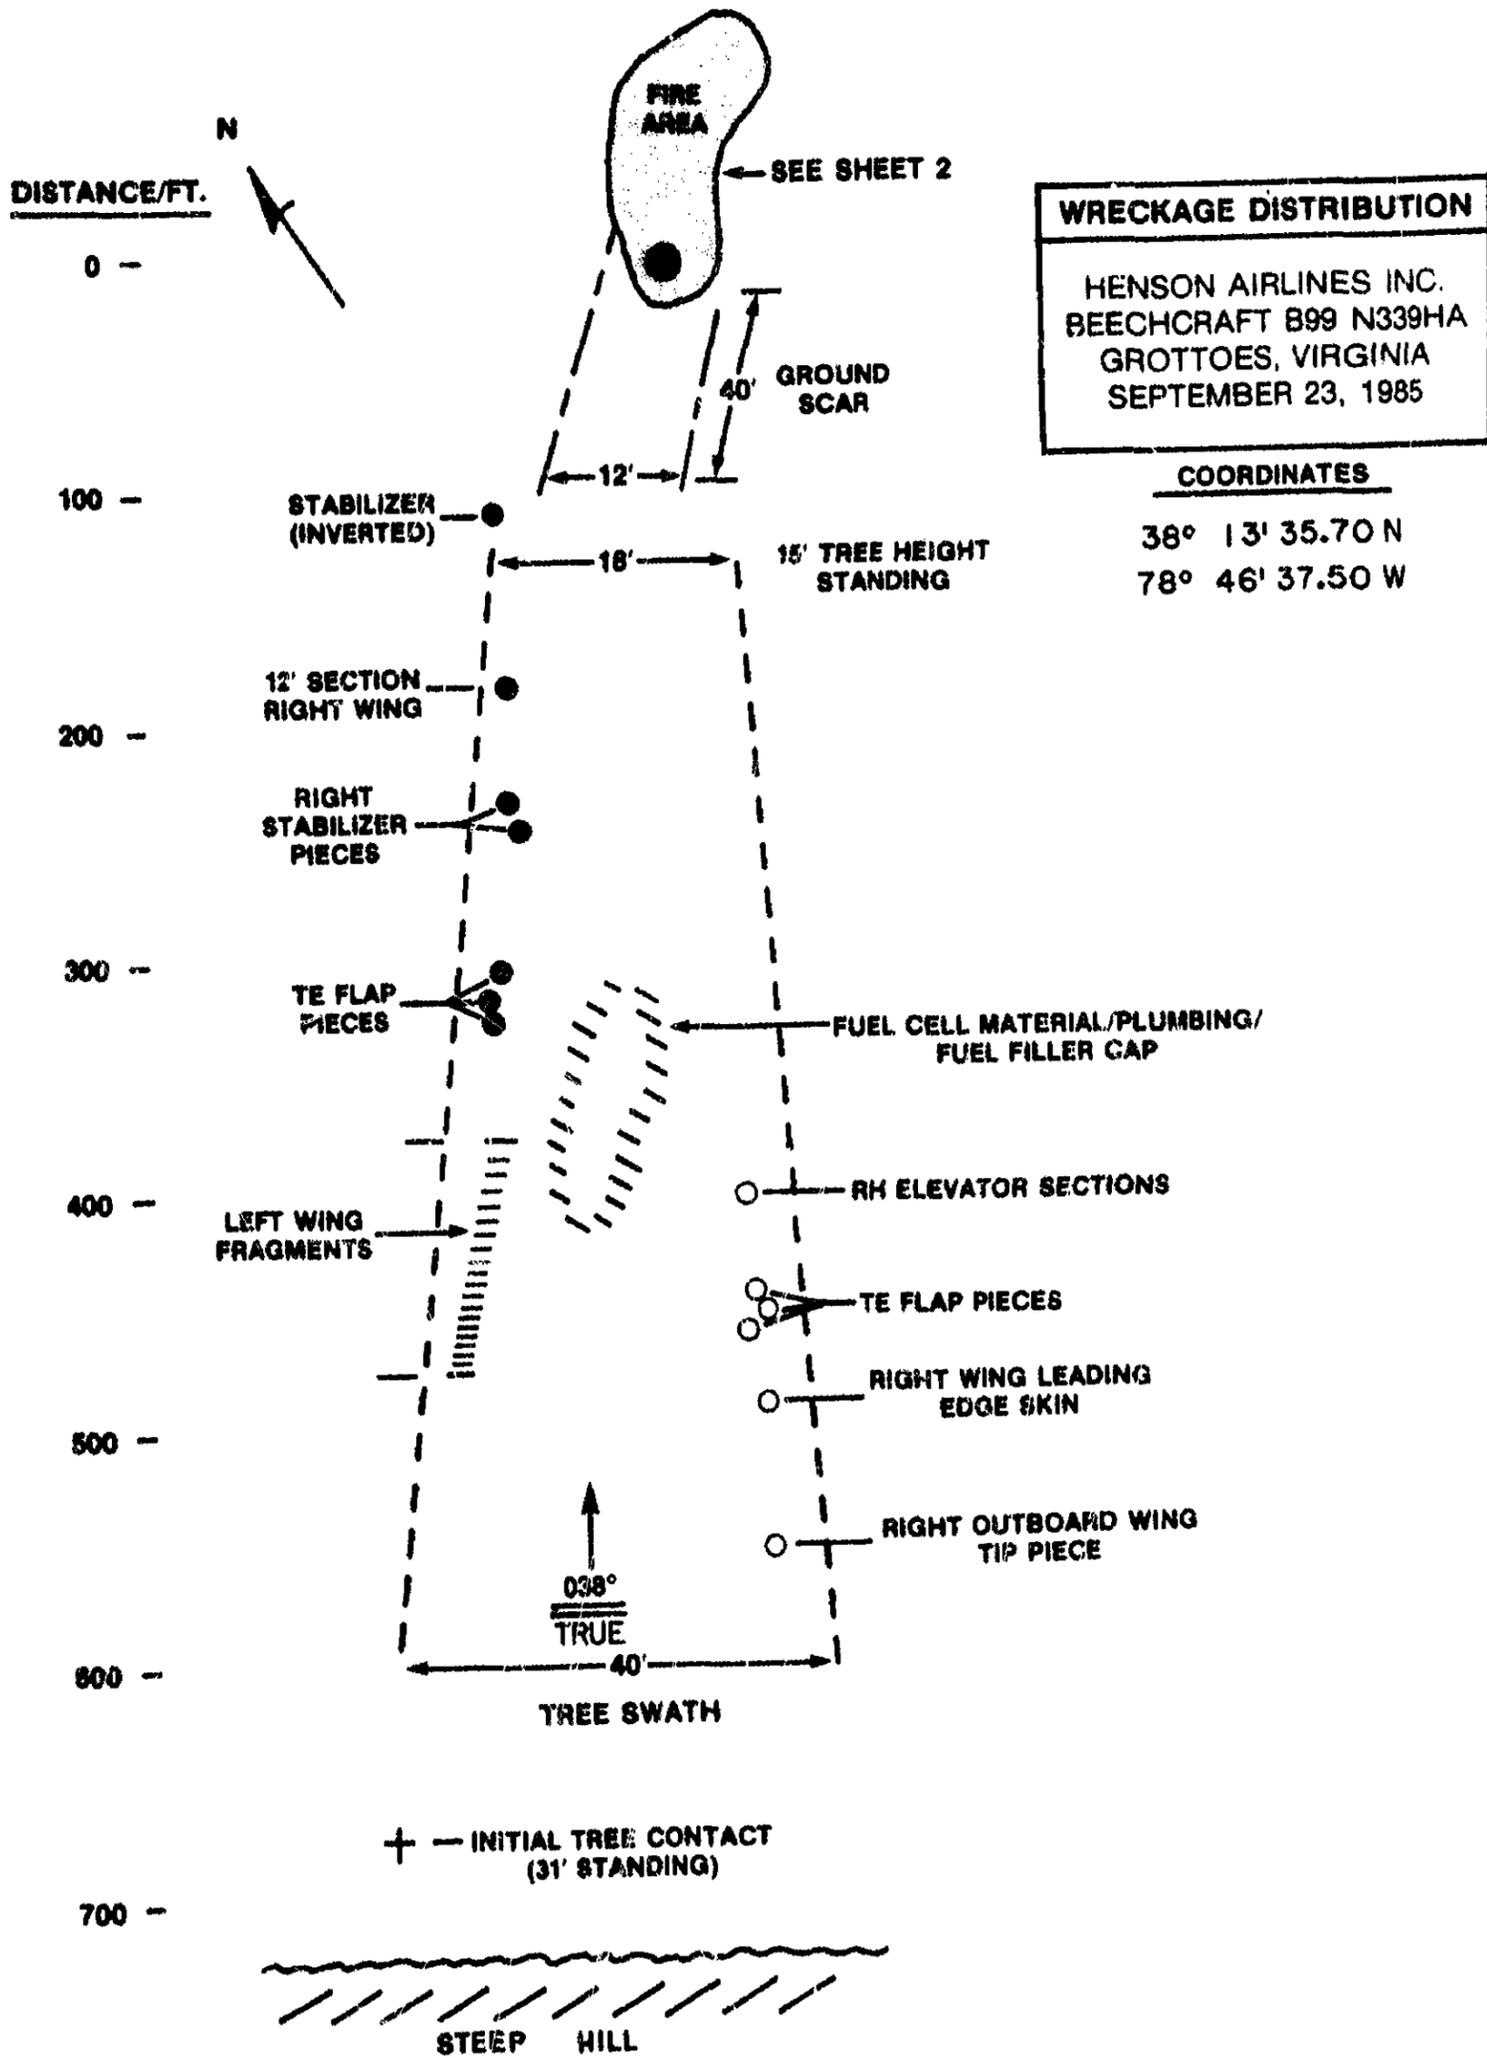
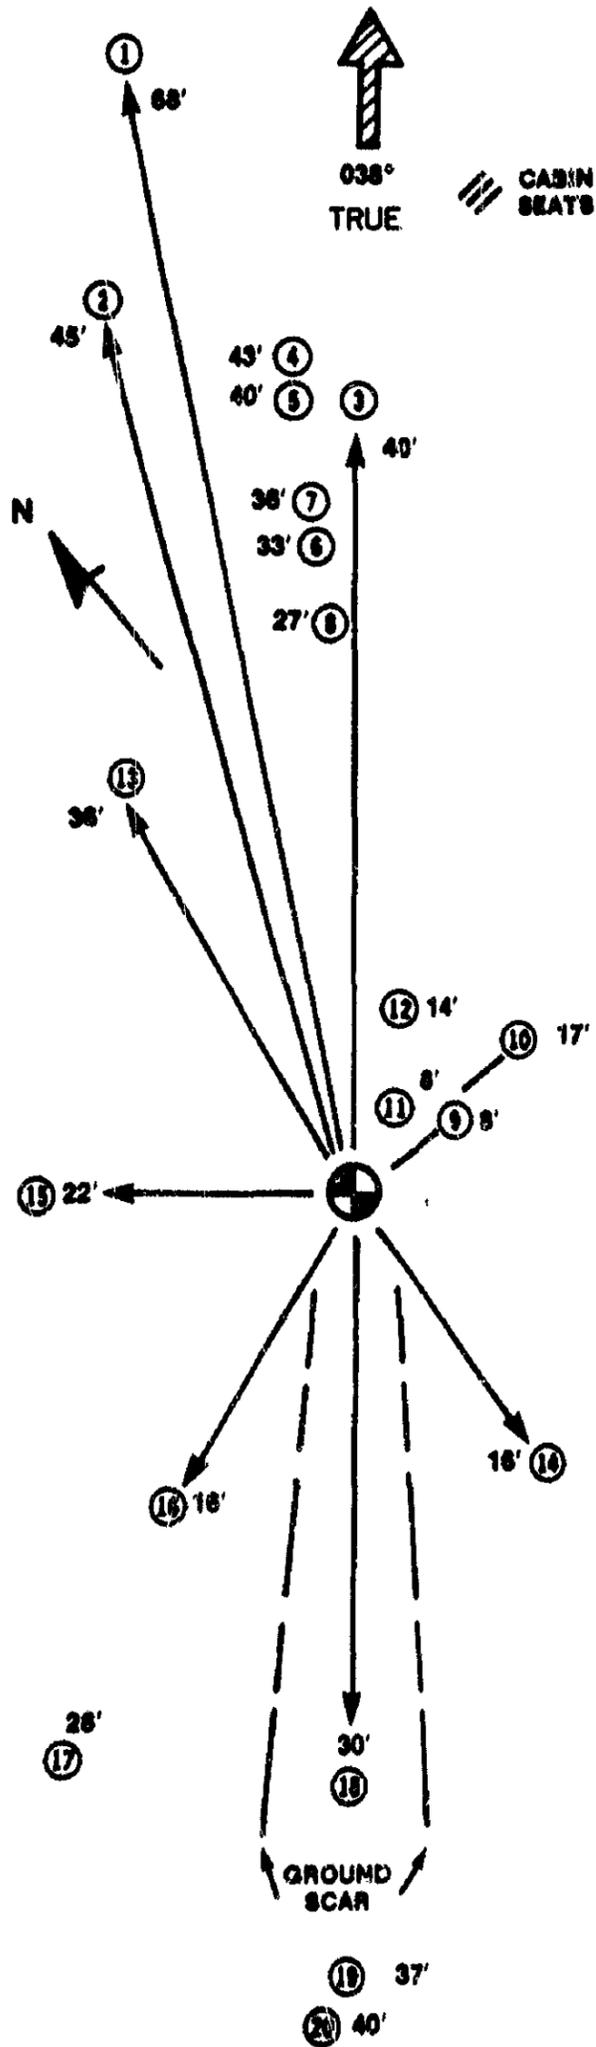
WRECKAGE DISTRIBUTION
 HENSON AIRLINES INC.
 BEECHCRAFT B99 N339HA
 GROTTOS, VIRGINIA
 SEPTEMBER 23, 1985

The airplane struck the first tree at 31 feet a.g.l. This tree was located about 100 feet northeast of a very steep drop in the terrain. The airplane continued to travel in a northeasterly direction (045° magnetic). Damage to fallen tree tops, limbs, and branches indicated that the airplane was in a wings level, fuselage level attitude. Propeller slash marks on the fallen tree limbs were identified on both sides of the tree swath centerline. The tree swath was initially 40 feet wide and narrowed down to about 18 feet just before ground impact. There was no appreciable descent angle until just before ground impact. A 40-foot ground scar was noted with two deeper impressions located 12 feet apart. The ground scar terminated at the foot of an uprooted oak tree which was estimated to be about 50 feet high and about 2 feet in diameter. The cockpit/cabin area of the airplane came to rest northeast of the base of the uprooted tree. Both engines and propellers were located northeast of the tree base with the No. 1 (left) powerplant on the left side and the No. 2 (right) powerplant on the right side. There was no fire damage to any of the structures which separated before the ground scar. (See appendix E.)

A section of the aft tail cone and the right horizontal stabilizer, with elevator attached, was found near the beginning of the ground scar. The left horizontal stabilizer, complete with a section of the elevator attached, was located to the left and northeast of the initial ground strike. The complete rudder, with trim tab attached, had separated from the vertical stabilizer and was located southwest and to the right of the uprooted tree.

The left wing section, outboard of the engine nacelle, had been fragmented as the airplane cut through the trees. Pieces of the leading edge skin, spar structure, wing tip, aileron, and trim tab were distributed along the wreckage path to the left of the tree swath centerline and before the beginning of the ground scar. The inboard and outboard flap sections were found near the uprooted tree. The No. 1 engine had separated from the nacelle and came to rest to the left and northeast of the uprooted tree, about 15 feet forward of the left propeller.

The right wing section outboard of the engine nacelle separated as a unit and was located about 100 feet southwest of the beginning of the ground scar and near the left edge of the tree swath. No fire damage was evident. About 5 feet of leading edge skin and spar were missing. Several pieces of leading edge skin were located along the wreckage path to the right of the tree swath, as were trailing edge flap pieces. A portion of the right inboard flap was found northeast of the uprooted tree. The No. 2 engine had separated from the nacelle and was located in two sections to the right of and adjacent to the base of the uprooted tree, about 6 feet forward of the right propeller.

The wing center section and the left and right inboard wing sections were located about 25 feet northeast of the uprooted oak tree; all had been badly damaged by fire. The inboard sections were attached by the spar strap, with bolts in place. This area also contained the main landing gear wheel wells. Examination of the landing gear actuators, the positions of several trailing edge flap tracks, and two separated flap actuators indicated that the main landing gear and flaps were retracted at the time of impact.
