AIRCRAFT ACCIDENT/INCIDENT SUMMARY REPORT

REF AVIA, ICELAND - JANUARY 29, 1986

NTSB/AAR-87/01/SUM

AIRCRAFT ACCIDENT/INCIDENT SUMMARY

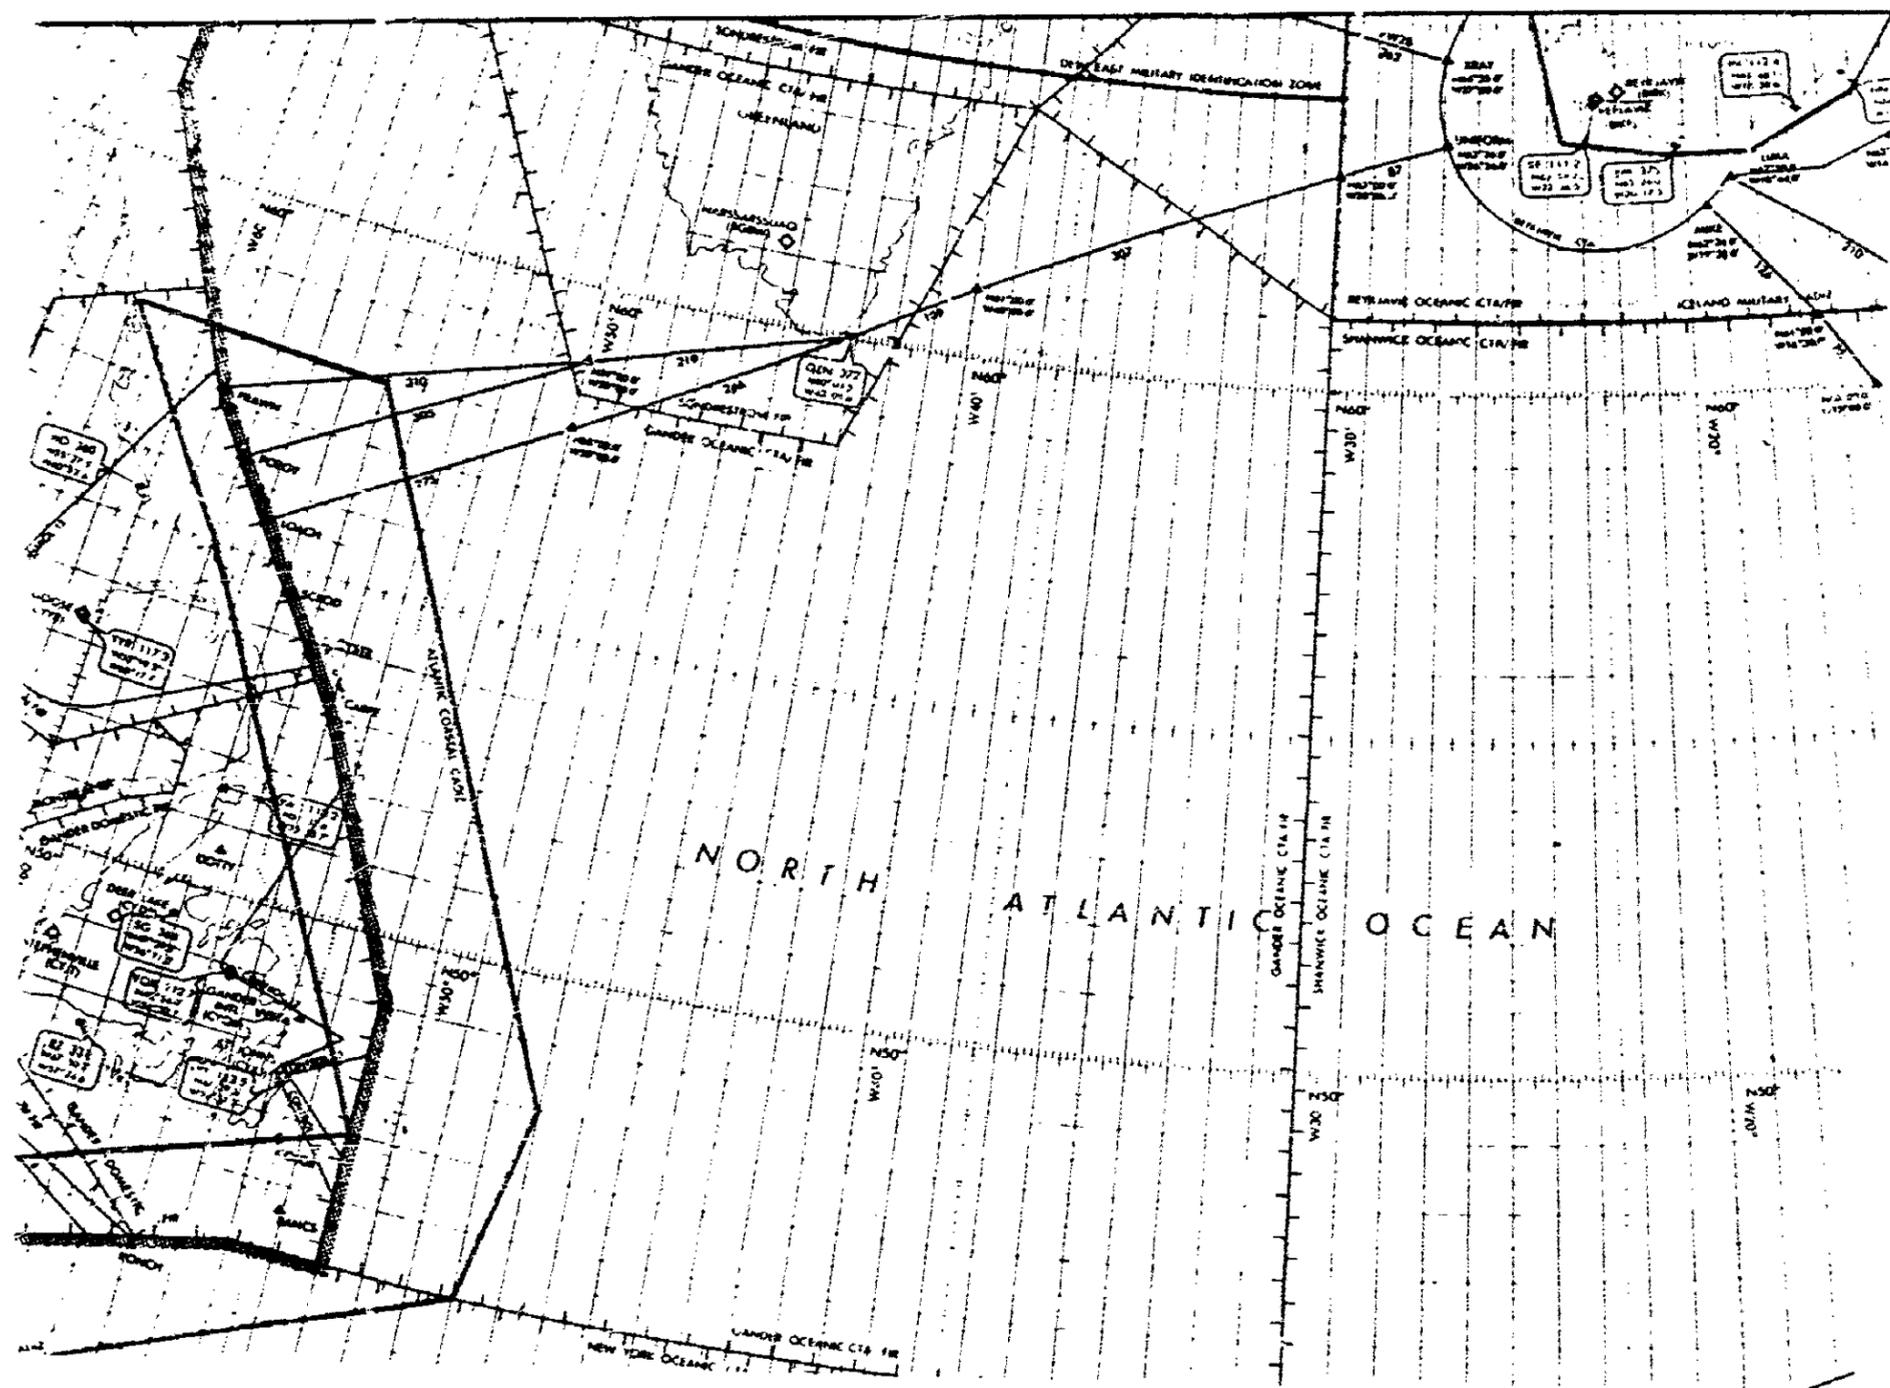
Figure 1.—North Atlantic route chart

On January 29, 1986, N4906K, a Cessna P210N, operated by Brune Air Service, France, departed Goose Bay, Labrador, Canada, at 1146 Greenwich mean time (G.m.t.) 1/ on a transoceanic ferry flight to the airport at Narssarssuaq, Greenland. (See figure 1.) Before departing Goose Bay, the pilot of N4906K had obtained a weather briefing from the Goose weather office. He was supplied with forecasts for his destination airport and an alternate airport at Nuuk, Greenland, the wind/temperature forecast, and the significant weather chart 2/ for the north Atlantic. The forecast for Narssarssuaq for the airplane's estimated time of arrival (ETA) was: 1,000 feet scattered, 3,500 feet overcast, visibility—greater than 10 kilometers, and wind—220° at 15 knots, gusting to 25 knots. Temporary conditions (Tempo) 3/ which were forecast for the destination for the time of arrival were for an indefinite ceiling of 800 feet, sky obscured, visibility—1,500 meters, and rain and snow. The forecast for Nuuk/Godthab was: 600 feet overcast, freezing rain, visibility—5,000 meters, and winds—variable at 10 knots. Tempo conditions forecast for Nuuk for the time of arrival were: 400 feet overcast, visibility—800 meters, rain and snow, and wind—160° at 20 knots. Forecast winds at 5,000 feet were 230° at 46 knots for Goose Bay and 150° at 54 knots for Narssarssuaq. The significant weather chart forecast layers of clouds between 2,000 and 20,000 feet along the route of flight between Goose Bay and Narssarssuaq with light to moderate icing between 5,000 and 12,000 feet in the vicinity of Goose Bay and between 10,000 and 20,000 feet in the vicinity of Narssarssuaq. According to the weather briefer at the Goose weather office, the pilot saw a copy of the significant weather chart which had been prepared for another flight, but did not ask for a copy. The weather briefer stated that the pilot was "anxious to go."
