AIRCRAFT ACCIDENT REPORT

SIMMONS AIRLINES, FLIGHT 1746
EMBRAER BANDEIRANTE
EMB-110P1, N1356P
NEAR ALPENA, MICHIGAN
MARCH 13, 1986

NTSB/AAR-87/02

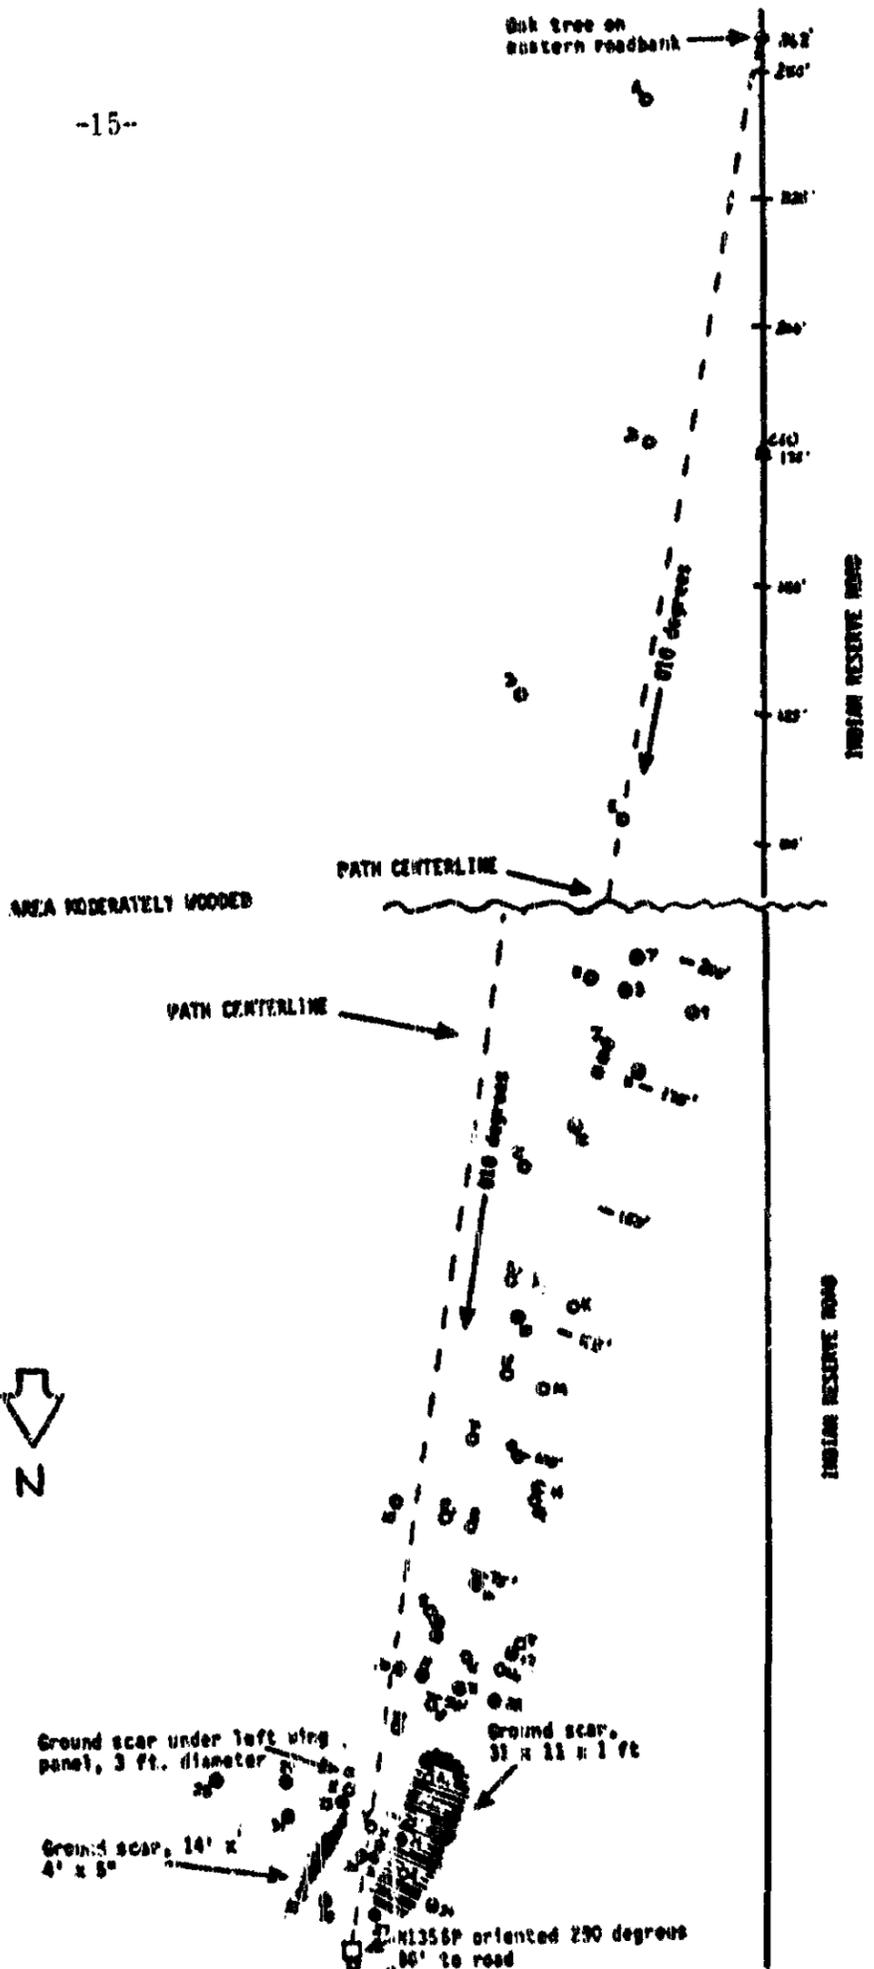
Figure 3.--Wreckage distribution of Simmons 1746.

The airplane came to rest in a wooded area 1 1/2 miles south of the runway 1 threshold. The wreckage path was confined to an area about 500 feet long, and about 80 to 90 feet to the east of Indian Reserve Road, which was parallel to the extended centerline of the runway. (See figure 3.) The initial flightpath of the airplane through the trees was 3.2° down, an angle which then steepened to 10.4° at the principal impact point. The first tree struck was located on the east side of the road, about 500 feet south of where the airplane came to rest. Damage was found at the treetop level, about 35 feet above ground level (AGL). A second tree, about 35 feet north of the initially damaged tree, also was damaged at 35 feet AGL. An 8-inch tip section from a right propeller blade was embedded in another tree located 84 feet north of the first damaged tree at about 17 feet AGL. The elevation of the tree tops at the initial impact point was about 40 feet (AGL), and the elevation of the terrain at the main wreckage was about 680 feet.

The right wing structure from the area outboard of the engine nacelle was fragmented and found distributed along the wreckage path. The remainder of the wing was attached to the fuselage. The left wing was found separated about 2 feet outboard of the engine nacelle and 18 inches outboard of the main wing spar attachment.

The ventral fin was bent by impact 90° to the right, and the left horizontal stabilizer by about 50° upward. The right stabilizer was found intact but had been crushed about mid-span.

- F. Pair of pine trees broken 23' agl
- G. Line of broken pine trees, 20' agl
- H. Pine trees topped 20' agl
- I. Several trees in line broken 20' agl
- J. Two foot dia. pine trees topped 20' agl

- K. Two inch dia. tree broken 10' agl
- L. Pine tree broken 20' agl
- L1. Pine tree broken 20' agl
- M. Five tree splintered 12' agl
- N. Small pine tree broken 12' agl

- O. Ten inch dia. pine tree broken 16' agl
- P. Tree broken 29' agl
- Q. Pine trees broken 23' agl
- R. Four inch dia. pine broken 10' agl
- R1. Ten inch dia. pine tree broken 26' agl

- S. Six inch dia. tree broken 15' agl
- T. Large pines scuffed on south side, 26' agl
- U. Six inch dia. pine tree broken 7' agl
- U1. Eight inch dia. tree scuffed 12' agl

- Y. Eight inch dia. tree broken 10' agl
- W. Four inch dia. tree broken 8' agl
- X. Ten inch dia. tree broken 15' agl
- Y. Eight inch dia. tree on ground

- Z. Eight inch dia. pine uprooted on ground
- Z1. Eighteen inch dia. oak tree penetrating right side of cabin
- A1. Tree base
