**NATIONAL
TRANSPORTATION
SAFETY
BOARD**

AIRCRAFT ACCIDENT REPORT

**SOUTHERN AIR TRANSPORT
LOGAIR FLIGHT 51, LOCKHEED L-382G
KELLY AIR FORCE BASE, TEXAS
OCTOBER 4, 1986**

NTSB/AAR-87/04

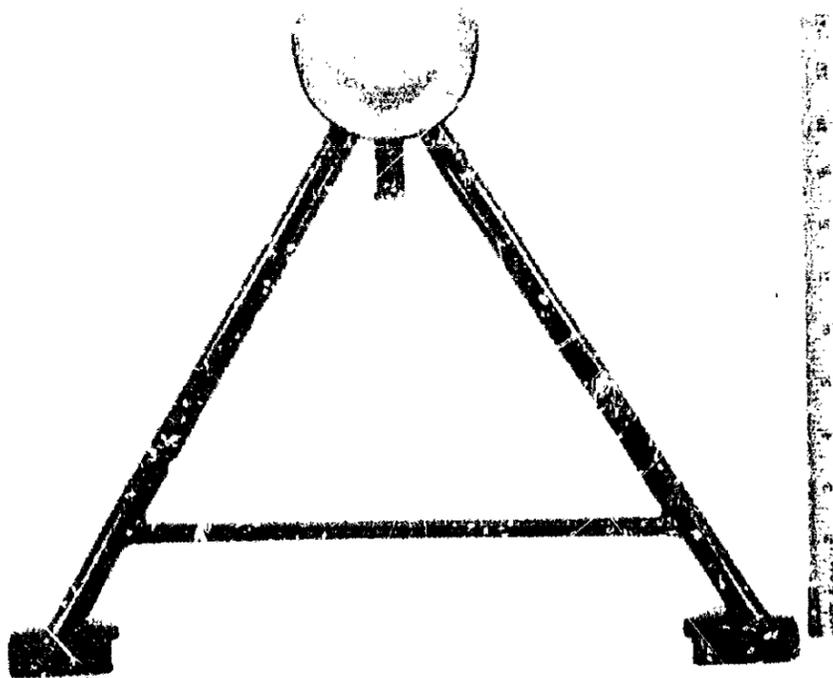
SAT had also designed and fabricated an elevator control block, which was no longer in use, for use in their airplanes. The SAT design was different in size and shape from TIA's device. (See figure 3.) At the time of the accident, there was only one in existence. According to SAT, only four were ever constructed. SAT's elevator control block was constructed in a wishbone shape and displaced the control column so far aft of neutral that it would not be possible for the flightcrew to occupy their seats with it installed.

Figure 3.--SAT-type elevator control block.

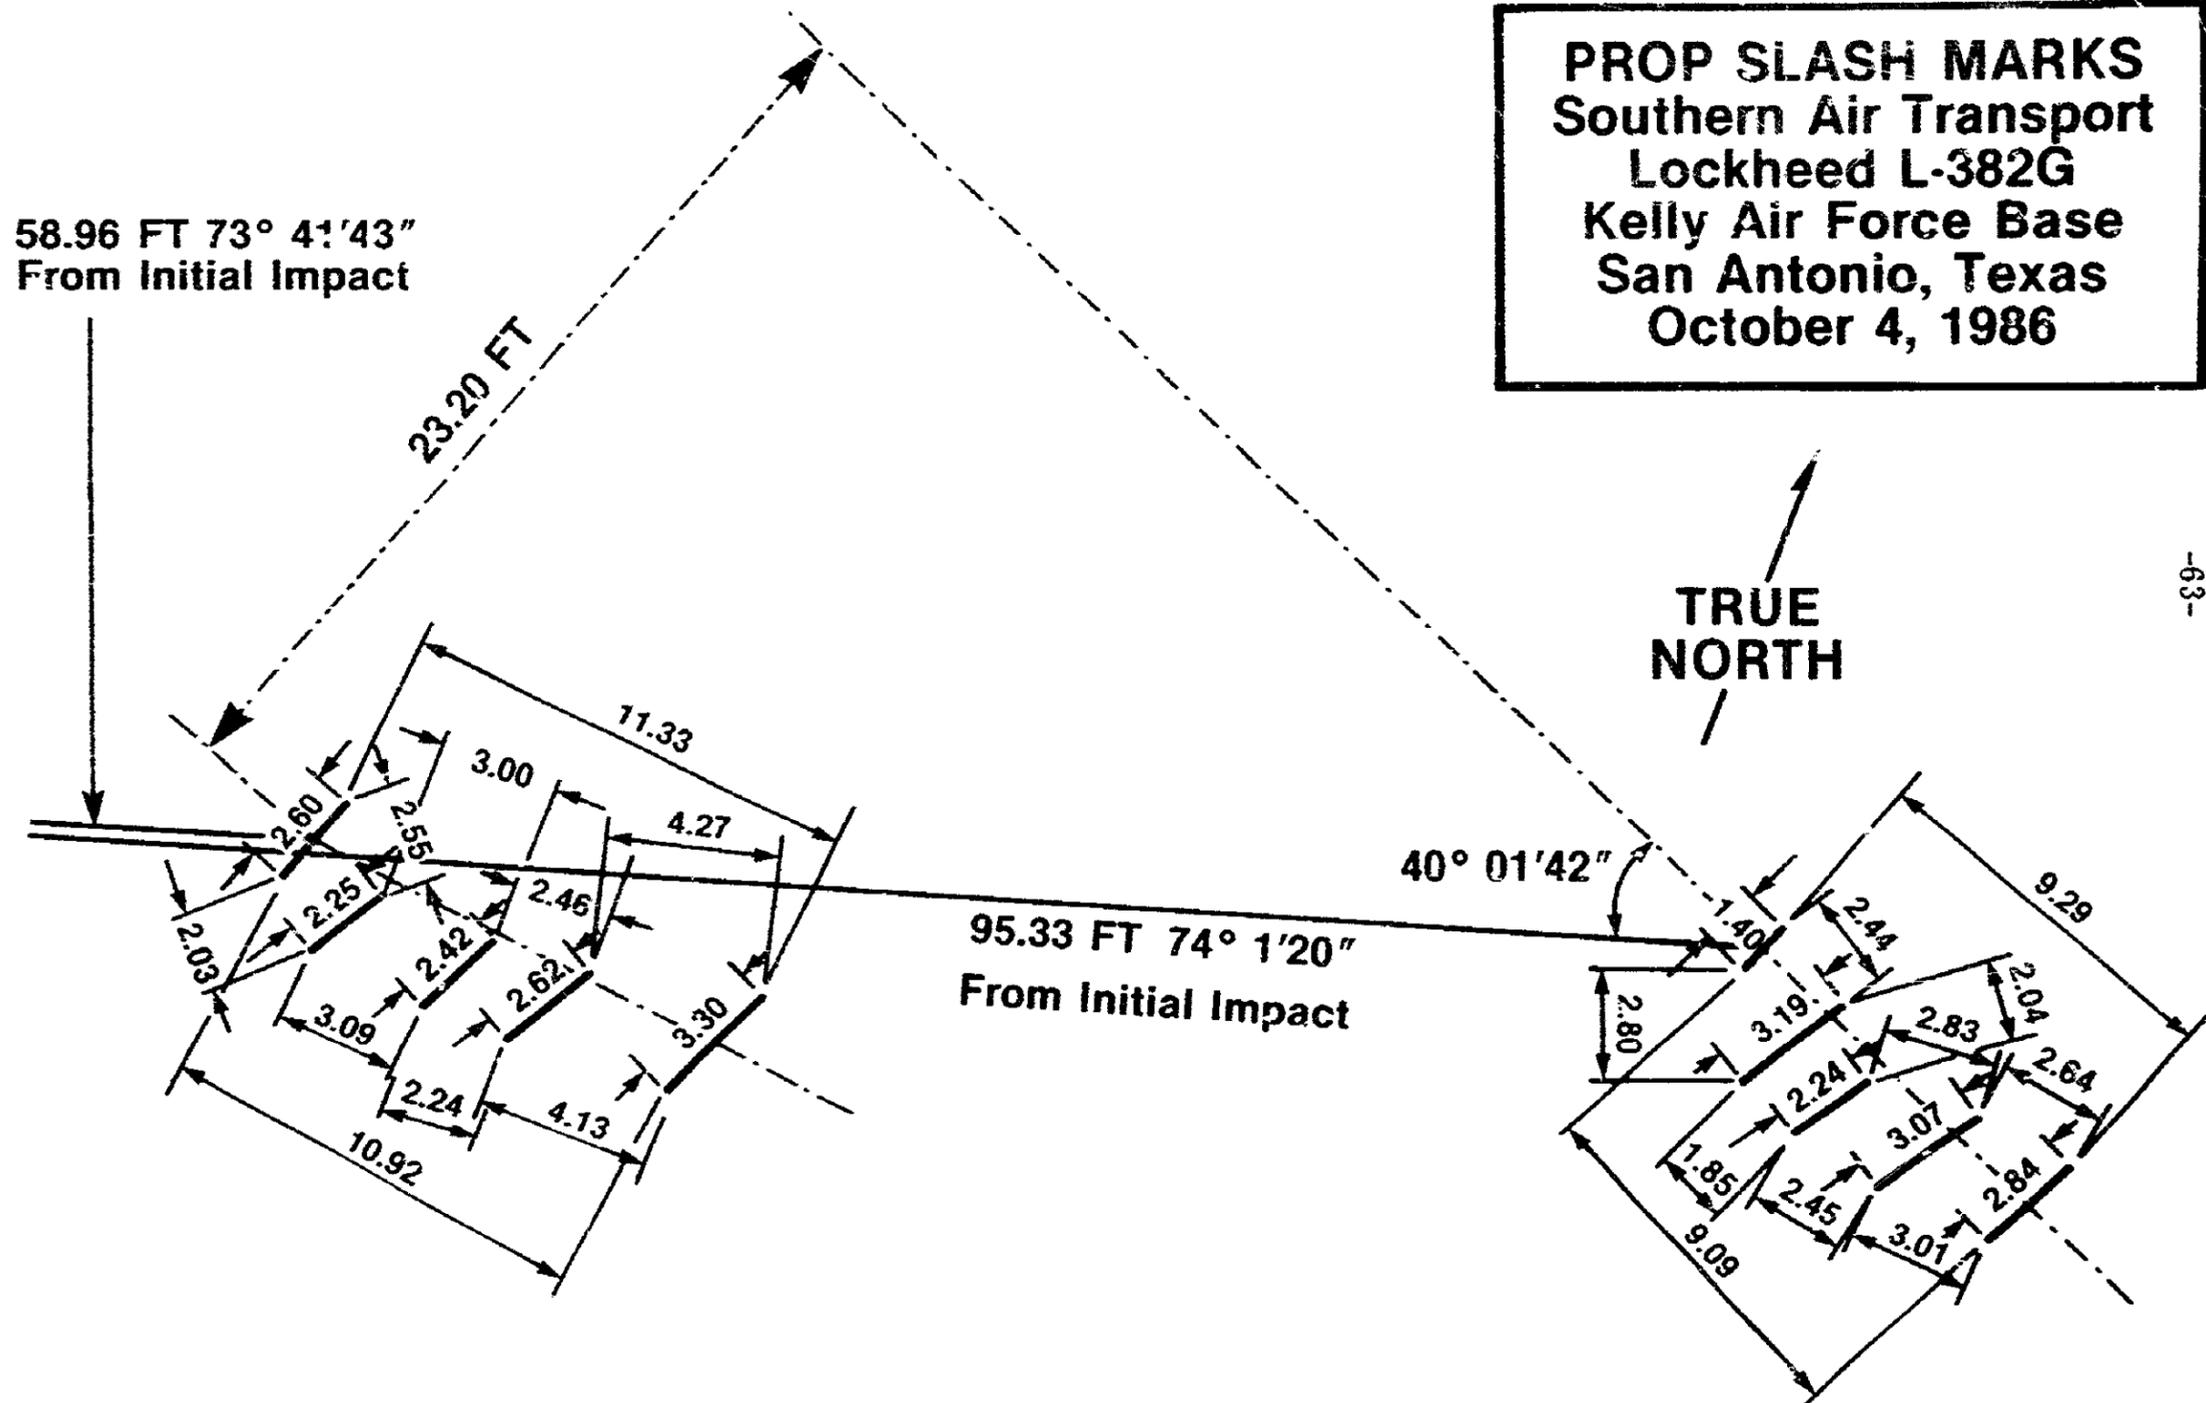
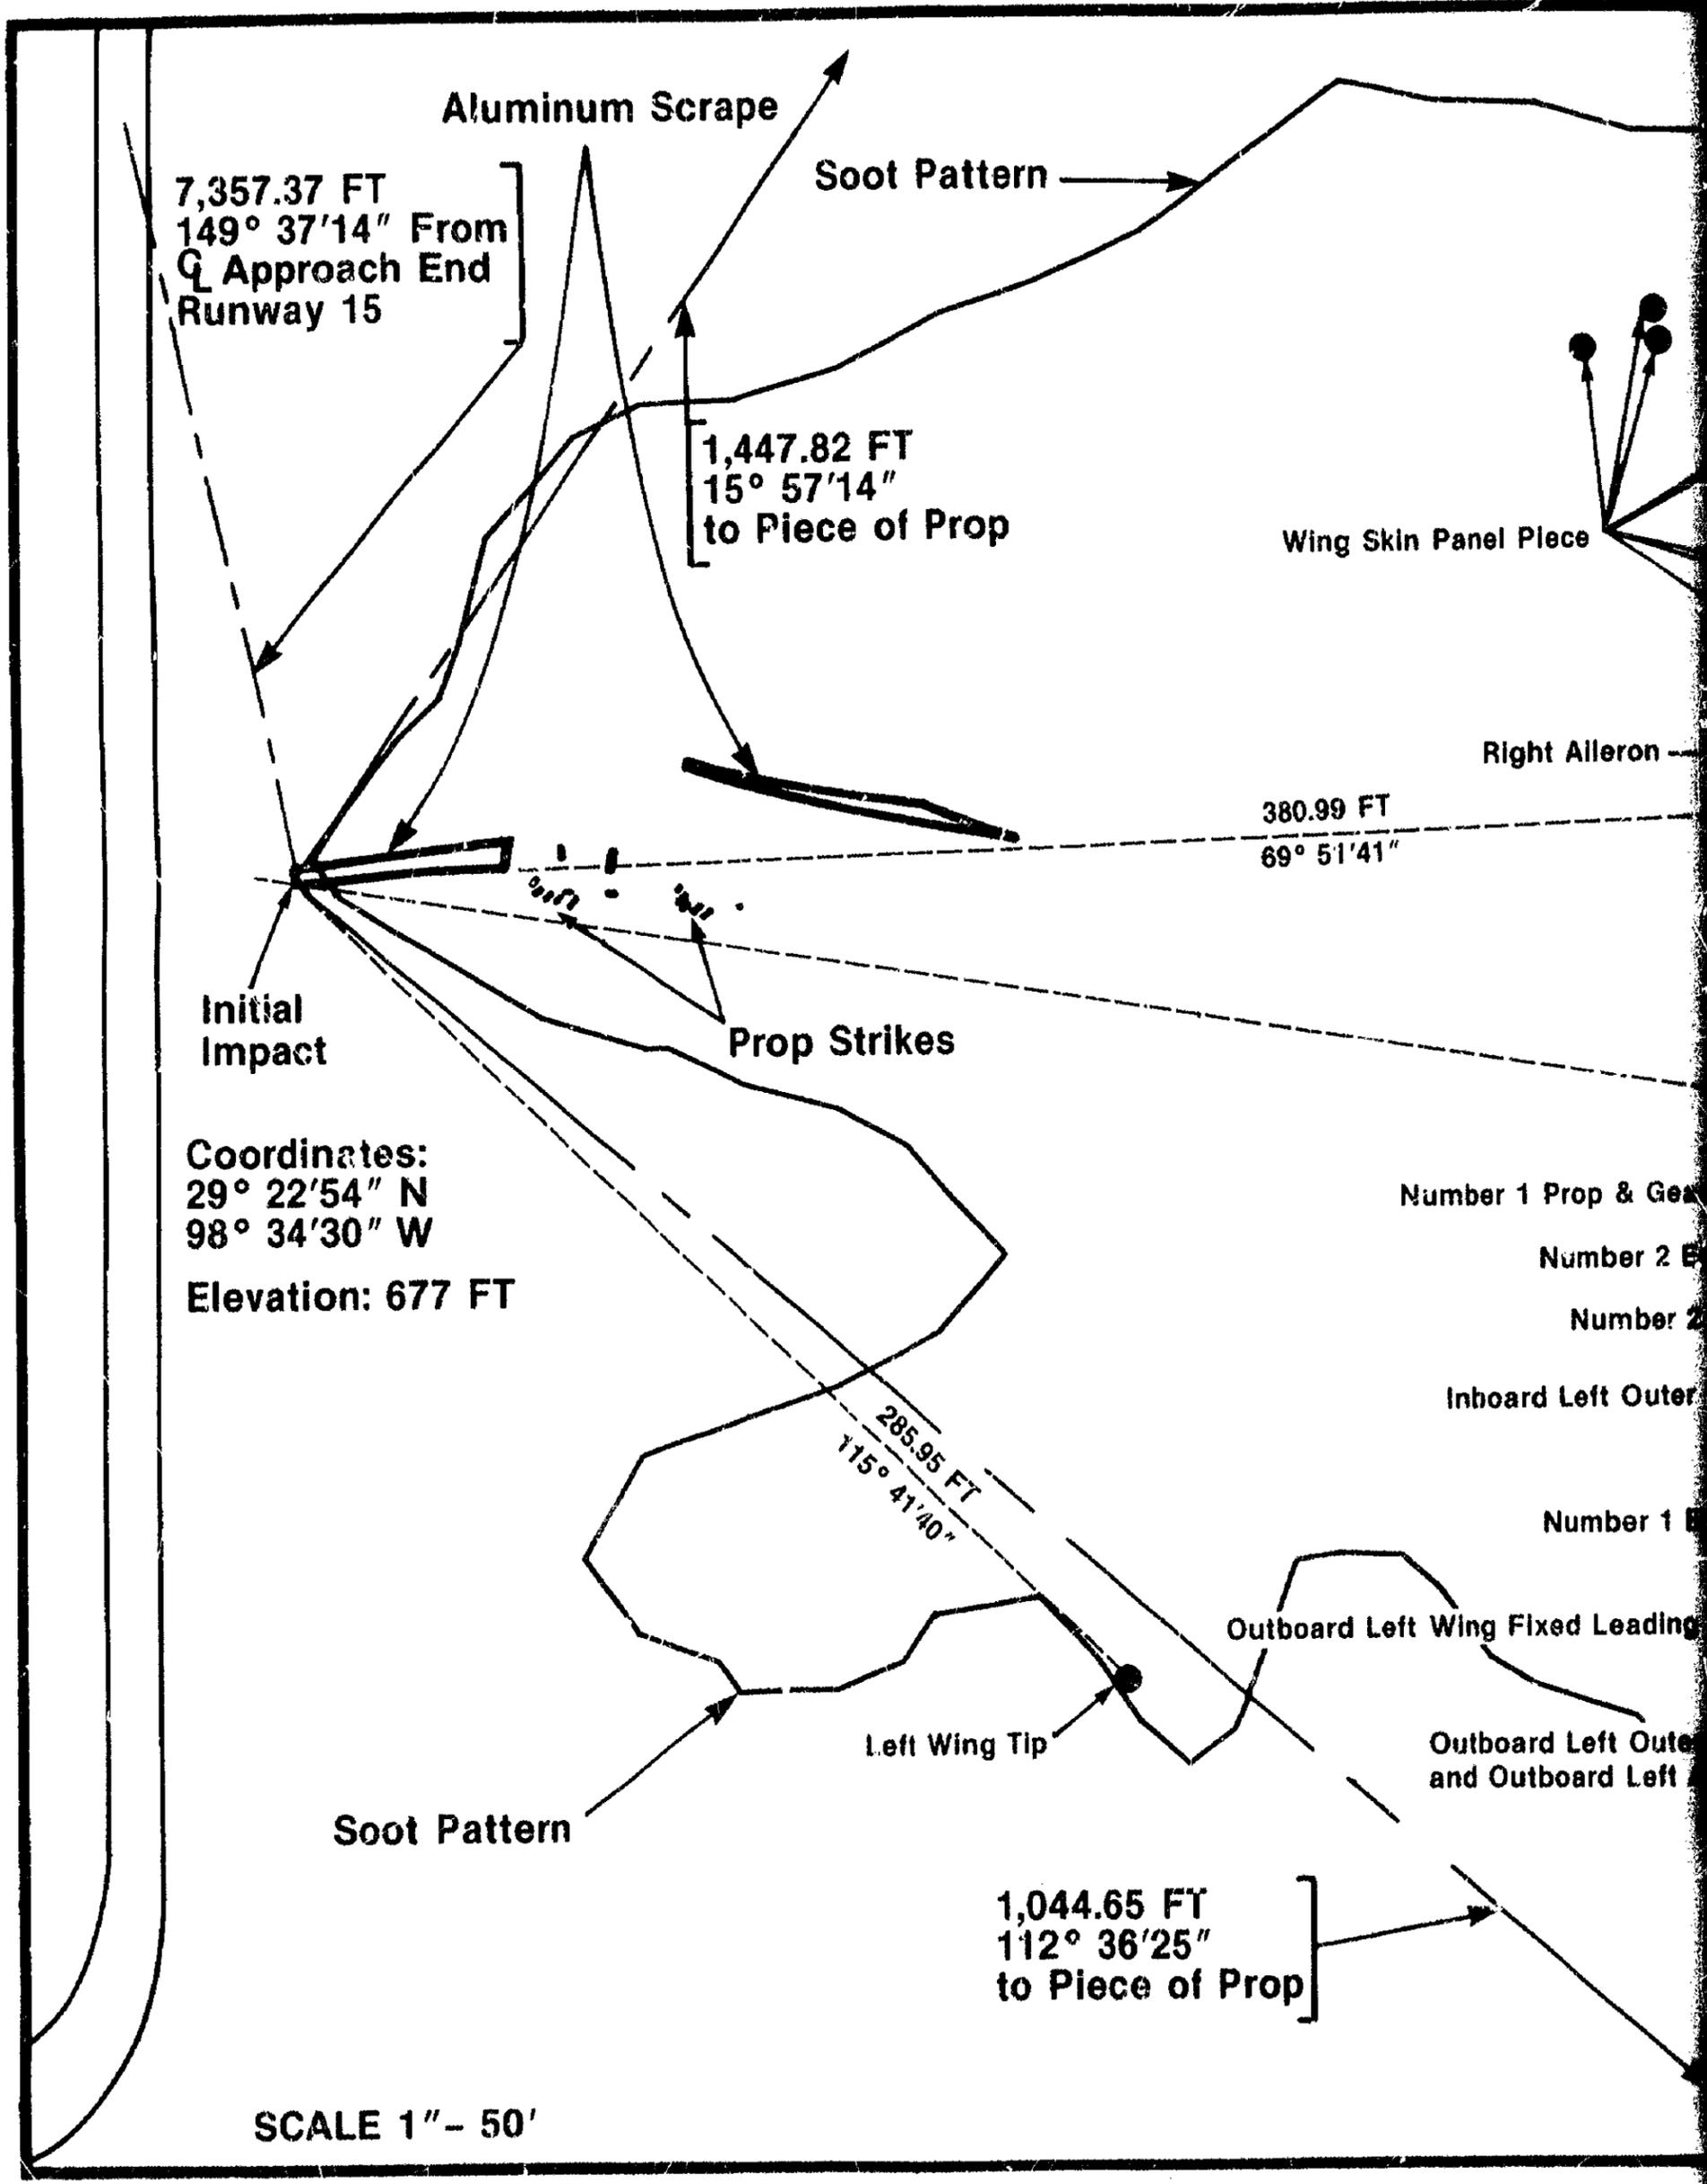
APPENDIX E
WRECKAGE DIAGRAMS

PROP SLASH MARKS
Southern Air Transport
Lockheed L-382G
Kelly Air Force Base
San Antonio, Texas
October 4, 1986
