NATIONAL TRANSPORTATION SAFETY BOARD

AIRCRAFT ACCIDENT/INCIDENT SUMMARY REPORT

NEWARK, NEW JERSEY - - NOVEMBER 13, 1986

NTSB/AAR-87/04/SUM

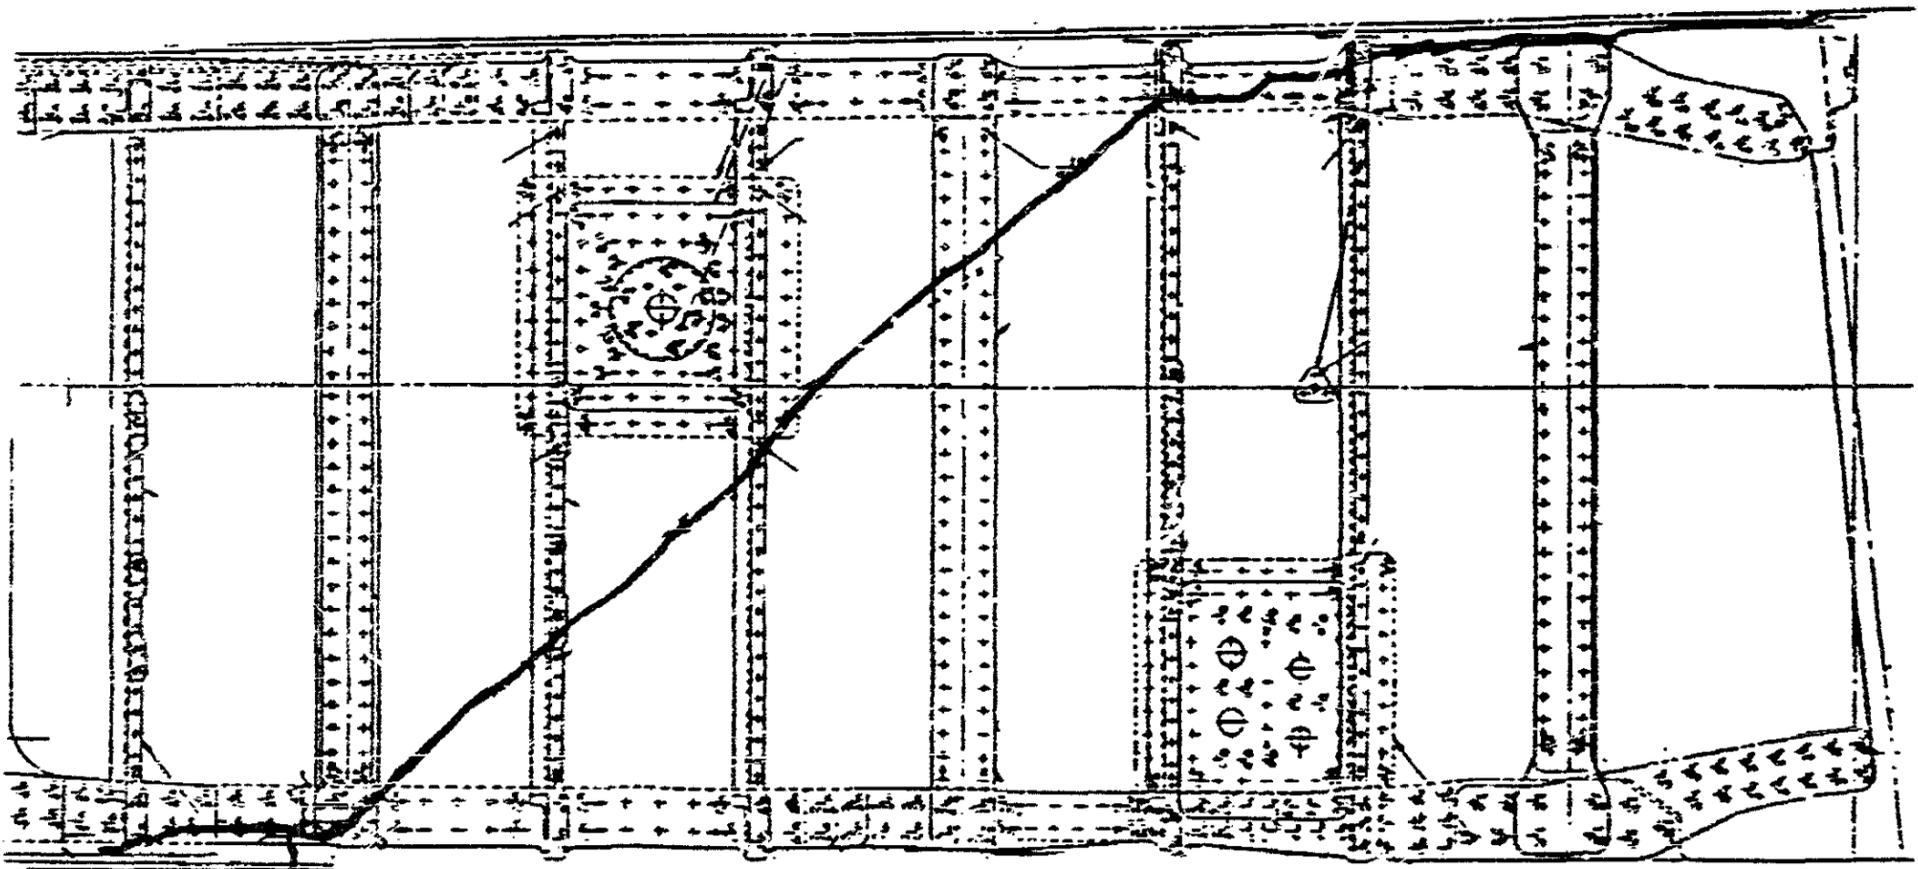
The airplane sustained substantial damage, which was confined to the right wing and included upper and lower skin panel deformation and the separation of the rear wing spar. The rear spar was separated outboard and diagonally downward, between inboard wing station 241.0 (IWS 241.0) and IWS 293.5 (See figure 1.)

Figure 1.--Inboard rear spar fracture line.
