# **NATIONAL TRANSPORTATION SAFETY BOARD**

## **AIRCRAFT ACCIDENT/INCIDENT SUMMARY REPORT**

NEWARK, NEW JERSEY - - NOVEMBER 13, 1986

NTSB/AAR-87/04/SUM

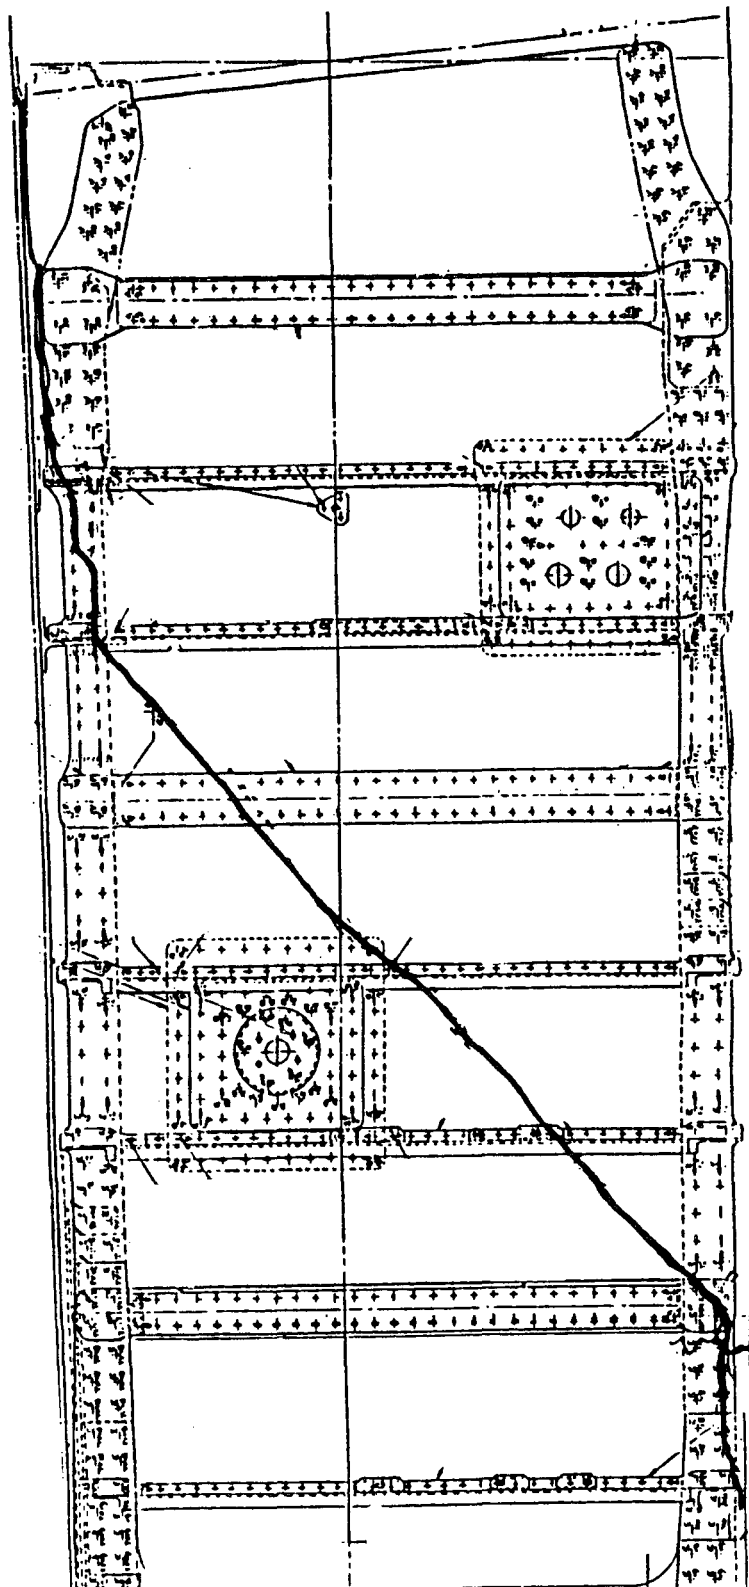
Figure 1.--Inboard rear spar fracture line.

The airplane sustained substantial damage, which was confined to the right wing and included upper and lower skin panel deformation and the separation of the rear wing spar. The rear spar was separated outboard and diagonally downward, between inboard wing station 241.0 (IWS 241.0) and IWS 293.5. (See figure 1.)

Inboard Rear Spar Fracture Line--Looking Aft (Left Spar Shown)

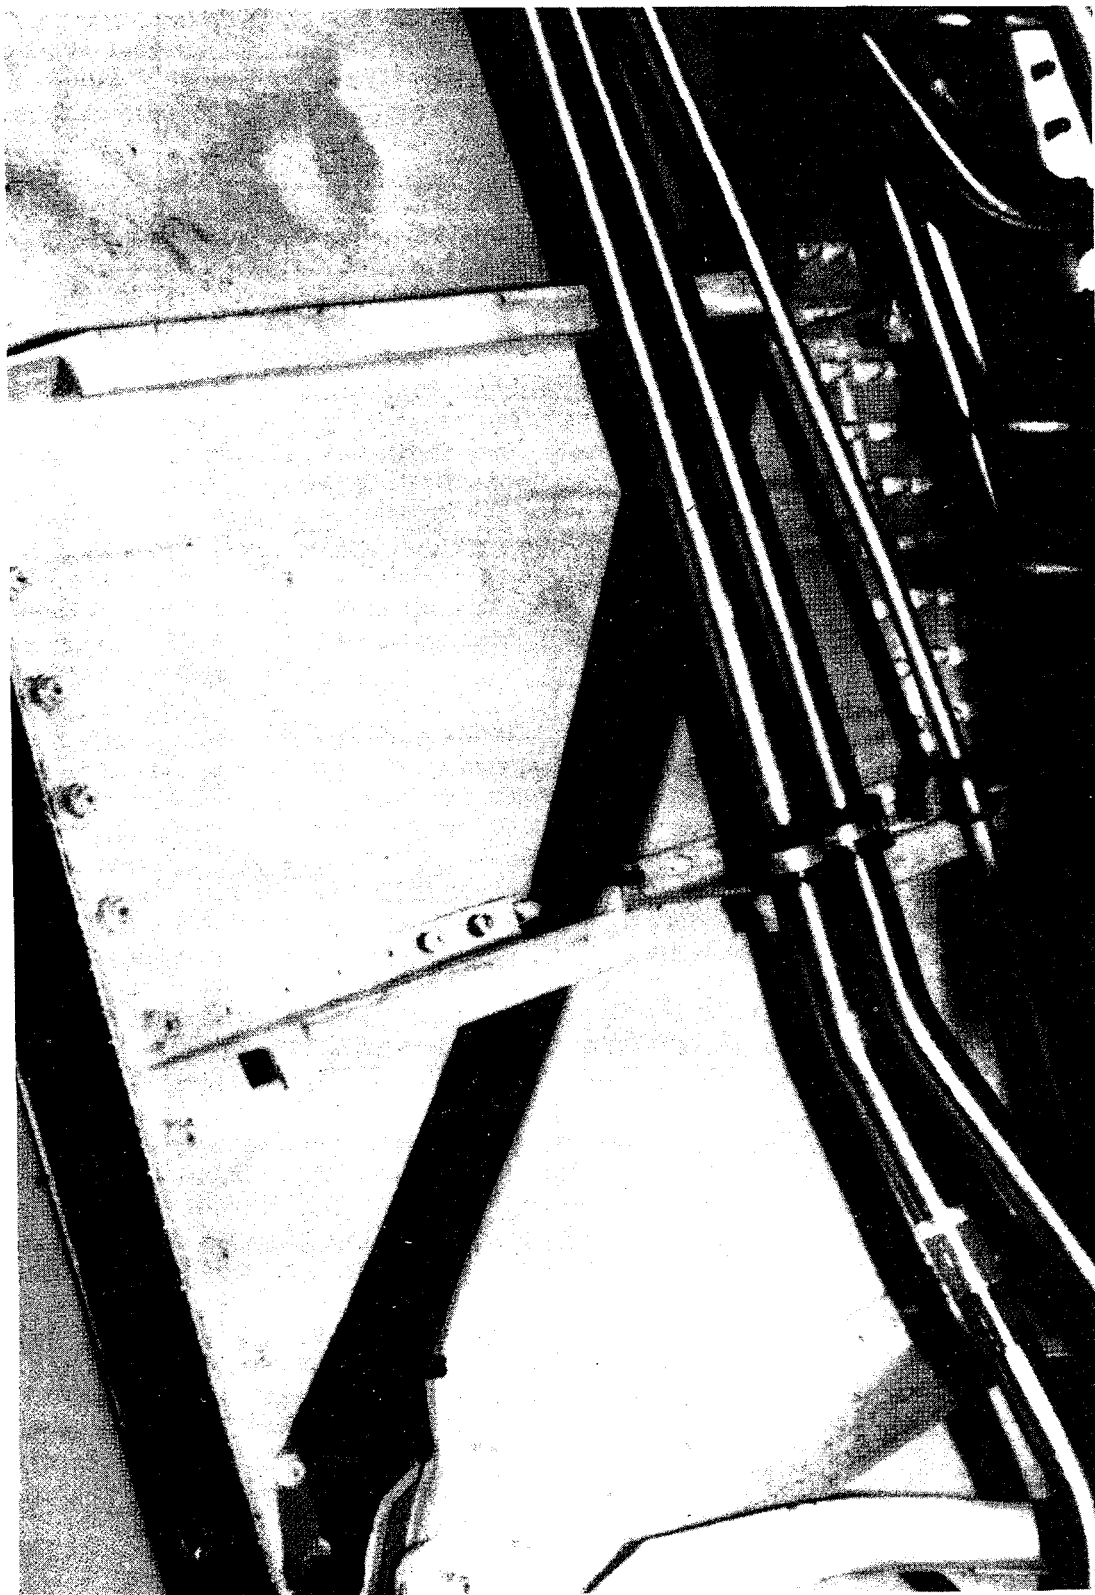
The National Transportation Safety Board, Delta, and Lockheed personnel examined the fractured surface of the spar and found an approximately 6 3/4-inch-long aggregate fatigue crack in the spar web that separated from a "HI-LOK" fastener hole used to attach a doubler to the side of the spar web. (See figures 2 and 3.) On the inboard side of the doubler, two vertical Z-shaped stiffeners were attached to the aft side of the web to provide reinforcement around the fuel fill valve hole in the spar. Another doubler was attached to the back side of the web between the stiffeners. The fatigue crack was on the forward surface of the spar web adjacent to, and on each side of, the lower inboard 5/16-inch "HI-LOK" fastener hole that attaches the forward (inner) doubler. The fatigue began in an area that was not visible from the forward side of the spar because it was masked by the doubler.

Figure 2.--Damage to the wing and rear spar of the right wing, looking up and forward at spar web crack.

Require an immediate inspection using methods adequate to detect fatigue cracking of the wing rear spar with emphasis on the spar web at the lower inboard fastener hole for the forward side doubler reinforcing the fuel filler valve hole of all Lockheed L-1011 airplanes having more than a conservatively established threshold of both flight hours and flight cycles; the threshold should be predicated upon the time and cycles on the accident airplane. (Class I, Urgent Action) (A-86-128)

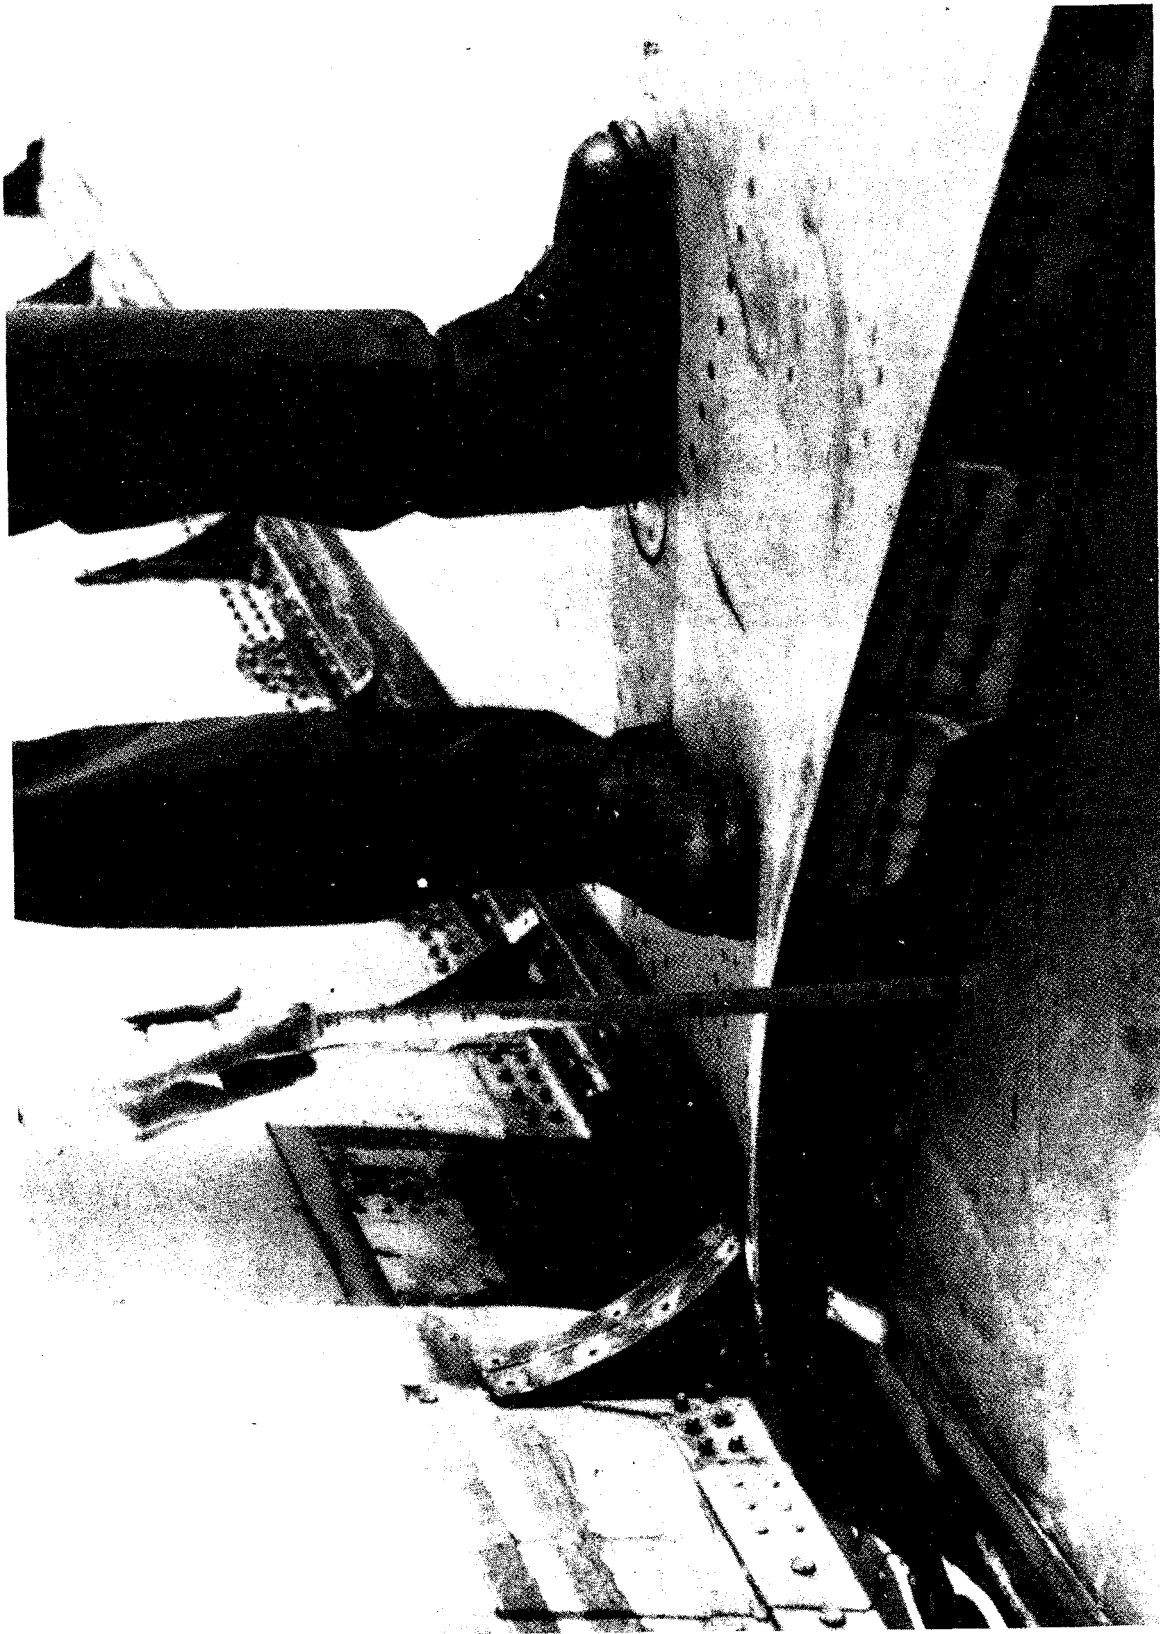
The other damage to the upper wing skin panels at the wing root is shown in figure 3. The wing spar forms the aft section of the wing integral fuel tank; therefore, when the spar separated, fuel leaked from the tank.

Figure 3.--Distortion of rear spar and upper skin of the right wing.

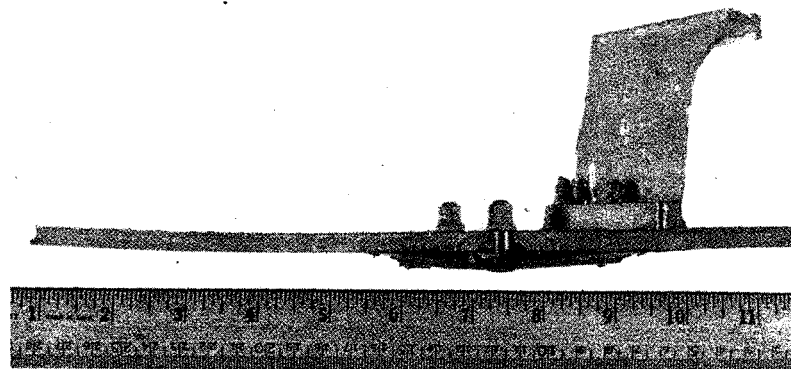
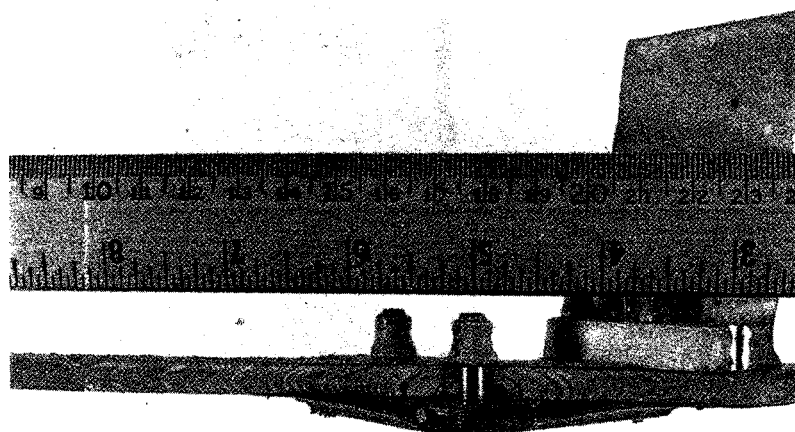
The fatigue cracks initially propagated aft through the web thickness and away from the fastener hole. The fatigue cracks propagated approximately 4 1/4 inches inboard and up, and about 2 3/8 inches outboard and down from the fastener hole. (See figures 4 and 5.) The fatigue crack in the latter stages appeared to be growing rapidly, which is typical of a crack reaching critical crack length. As a result, the total fracture of the rear spar could have resulted from the fatigue region under normal loading conditions. The weakening of the wing structure by the complete fracture of the rear spar was considered critical to the operation of the airplane within the design flight envelope.

Figure 4.--Fatigue crack in rear spar web of the right wing.

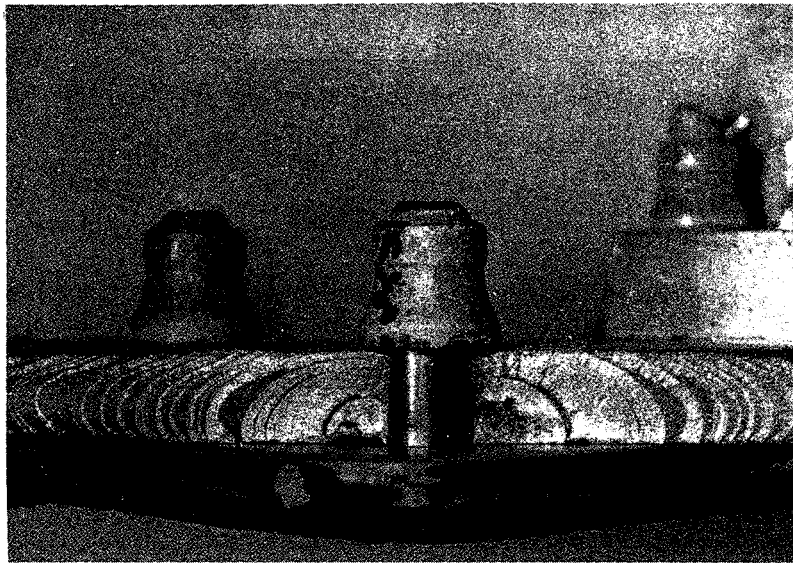
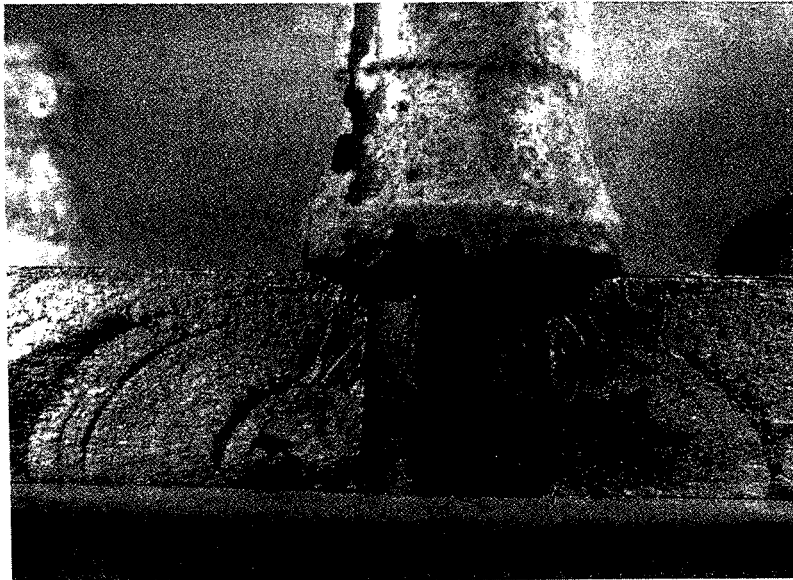
Figure 5.--Fatigue crack in rear  
spar web of the right wing.
