# **NATIONAL TRANSPORTATION SAFETY BOARD**

## **AIRCRAFT ACCIDENT REPORT**

**PIPER PA-23-150, N2185P  
AND PAN AMERICAN WORLD AIRWAYS  
BOEING 727-235, N4743  
TAMPA, FLORIDA  
NOVEMBER 6, 1986**

**NTSB/AAR-87/06**

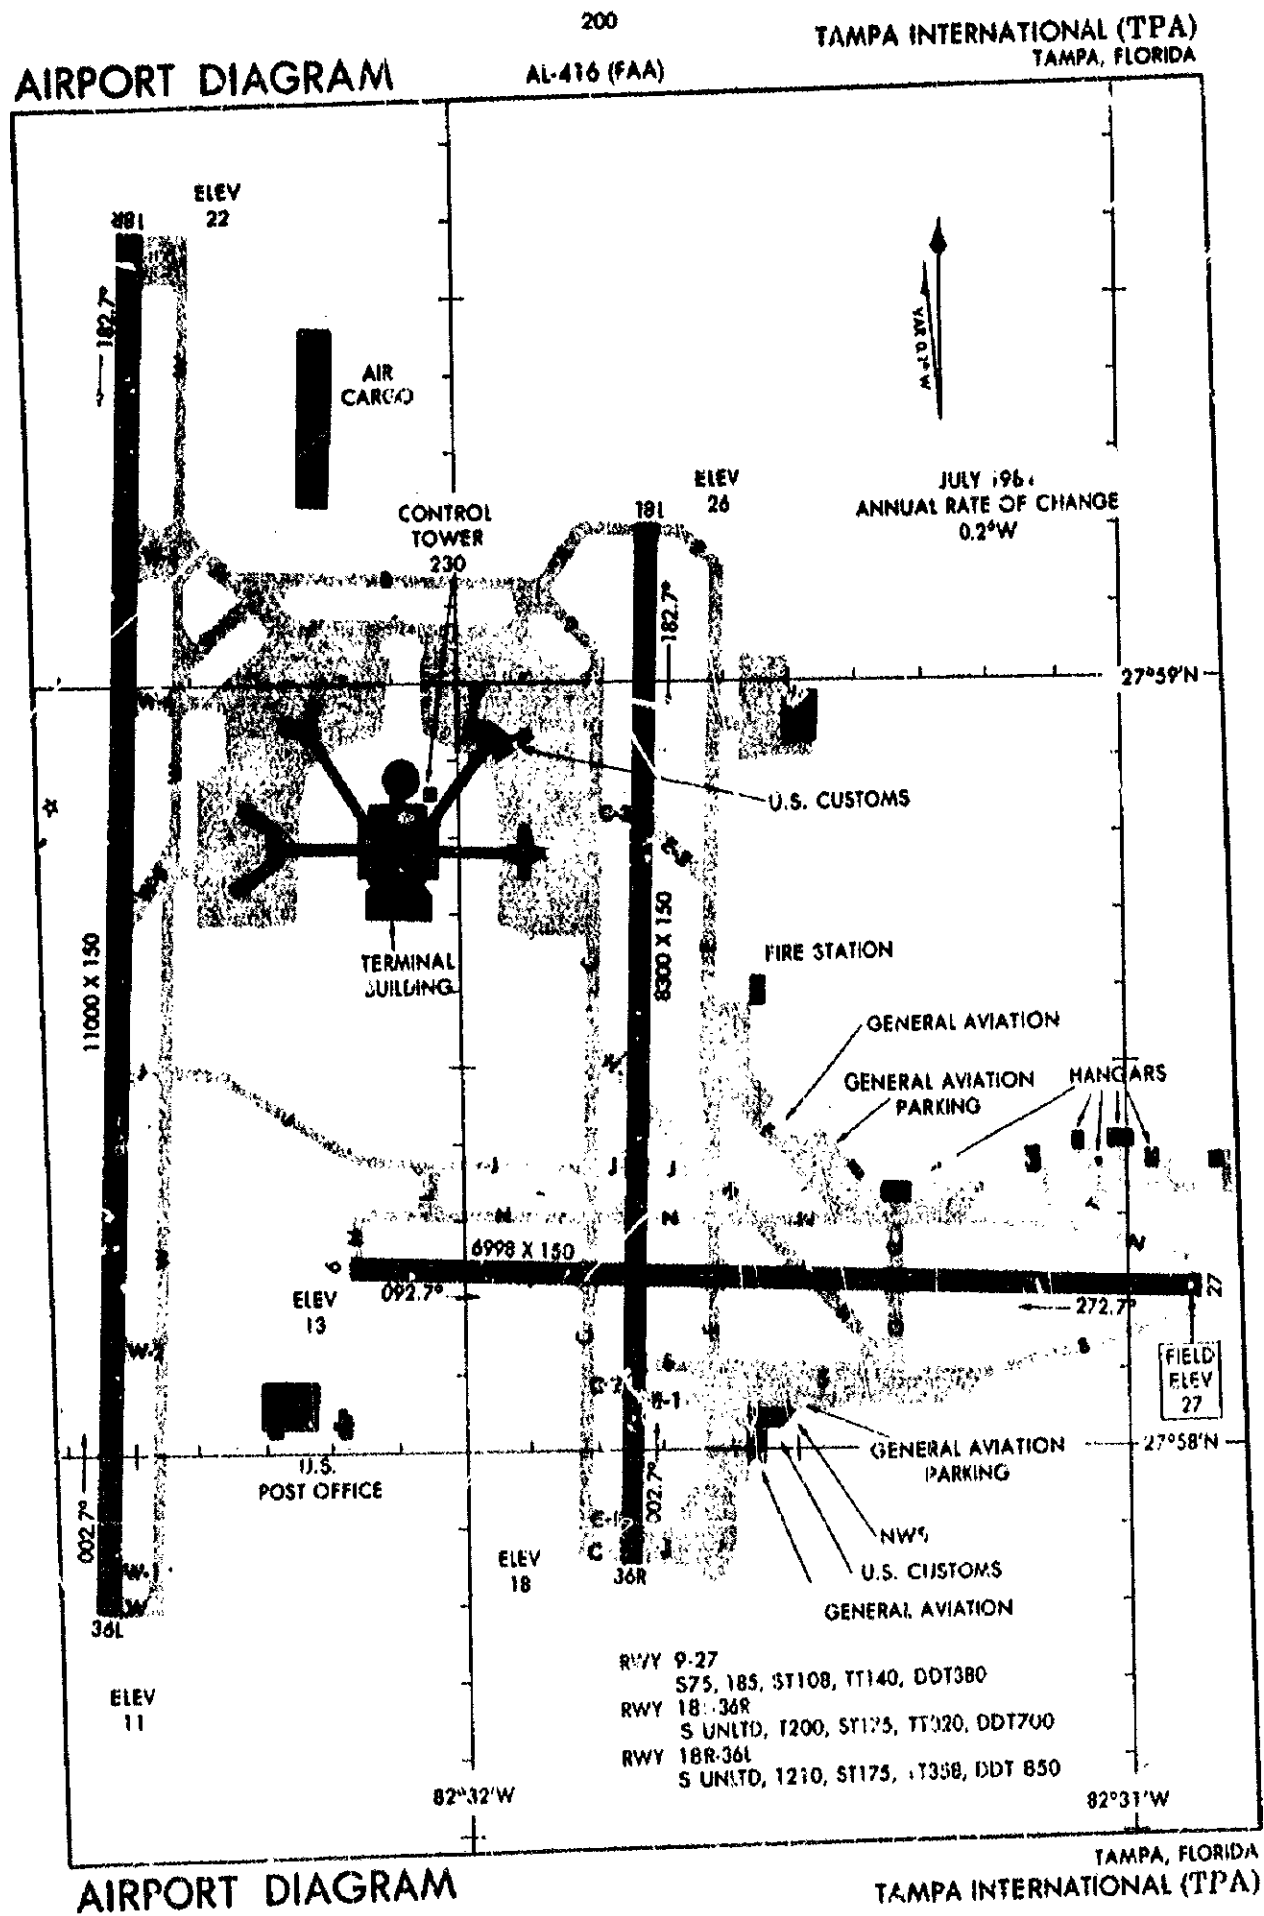
Figure 2.—Diagram of Tampa International Airport.

About 2 seconds later, the left engine of the Apache struck the B-727 in the lower nose area, separated from the Apache, and remained embedded just behind the radome. Fuel from the Apache's ruptured tanks ignited as it passed under the wing of the

B-727. The B-727 captain attempted to stop; however, his hydraulic brakes were ineffective. As he applied the emergency air brakes, the first officer applied his hydraulic brakes, and the B-727 rolled onto the grass between the taxiway and runway. The Apache came to rest and continued to burn on the taxiway about 100 feet behind the 727. The pilot of the Apache sustained fatal injuries.

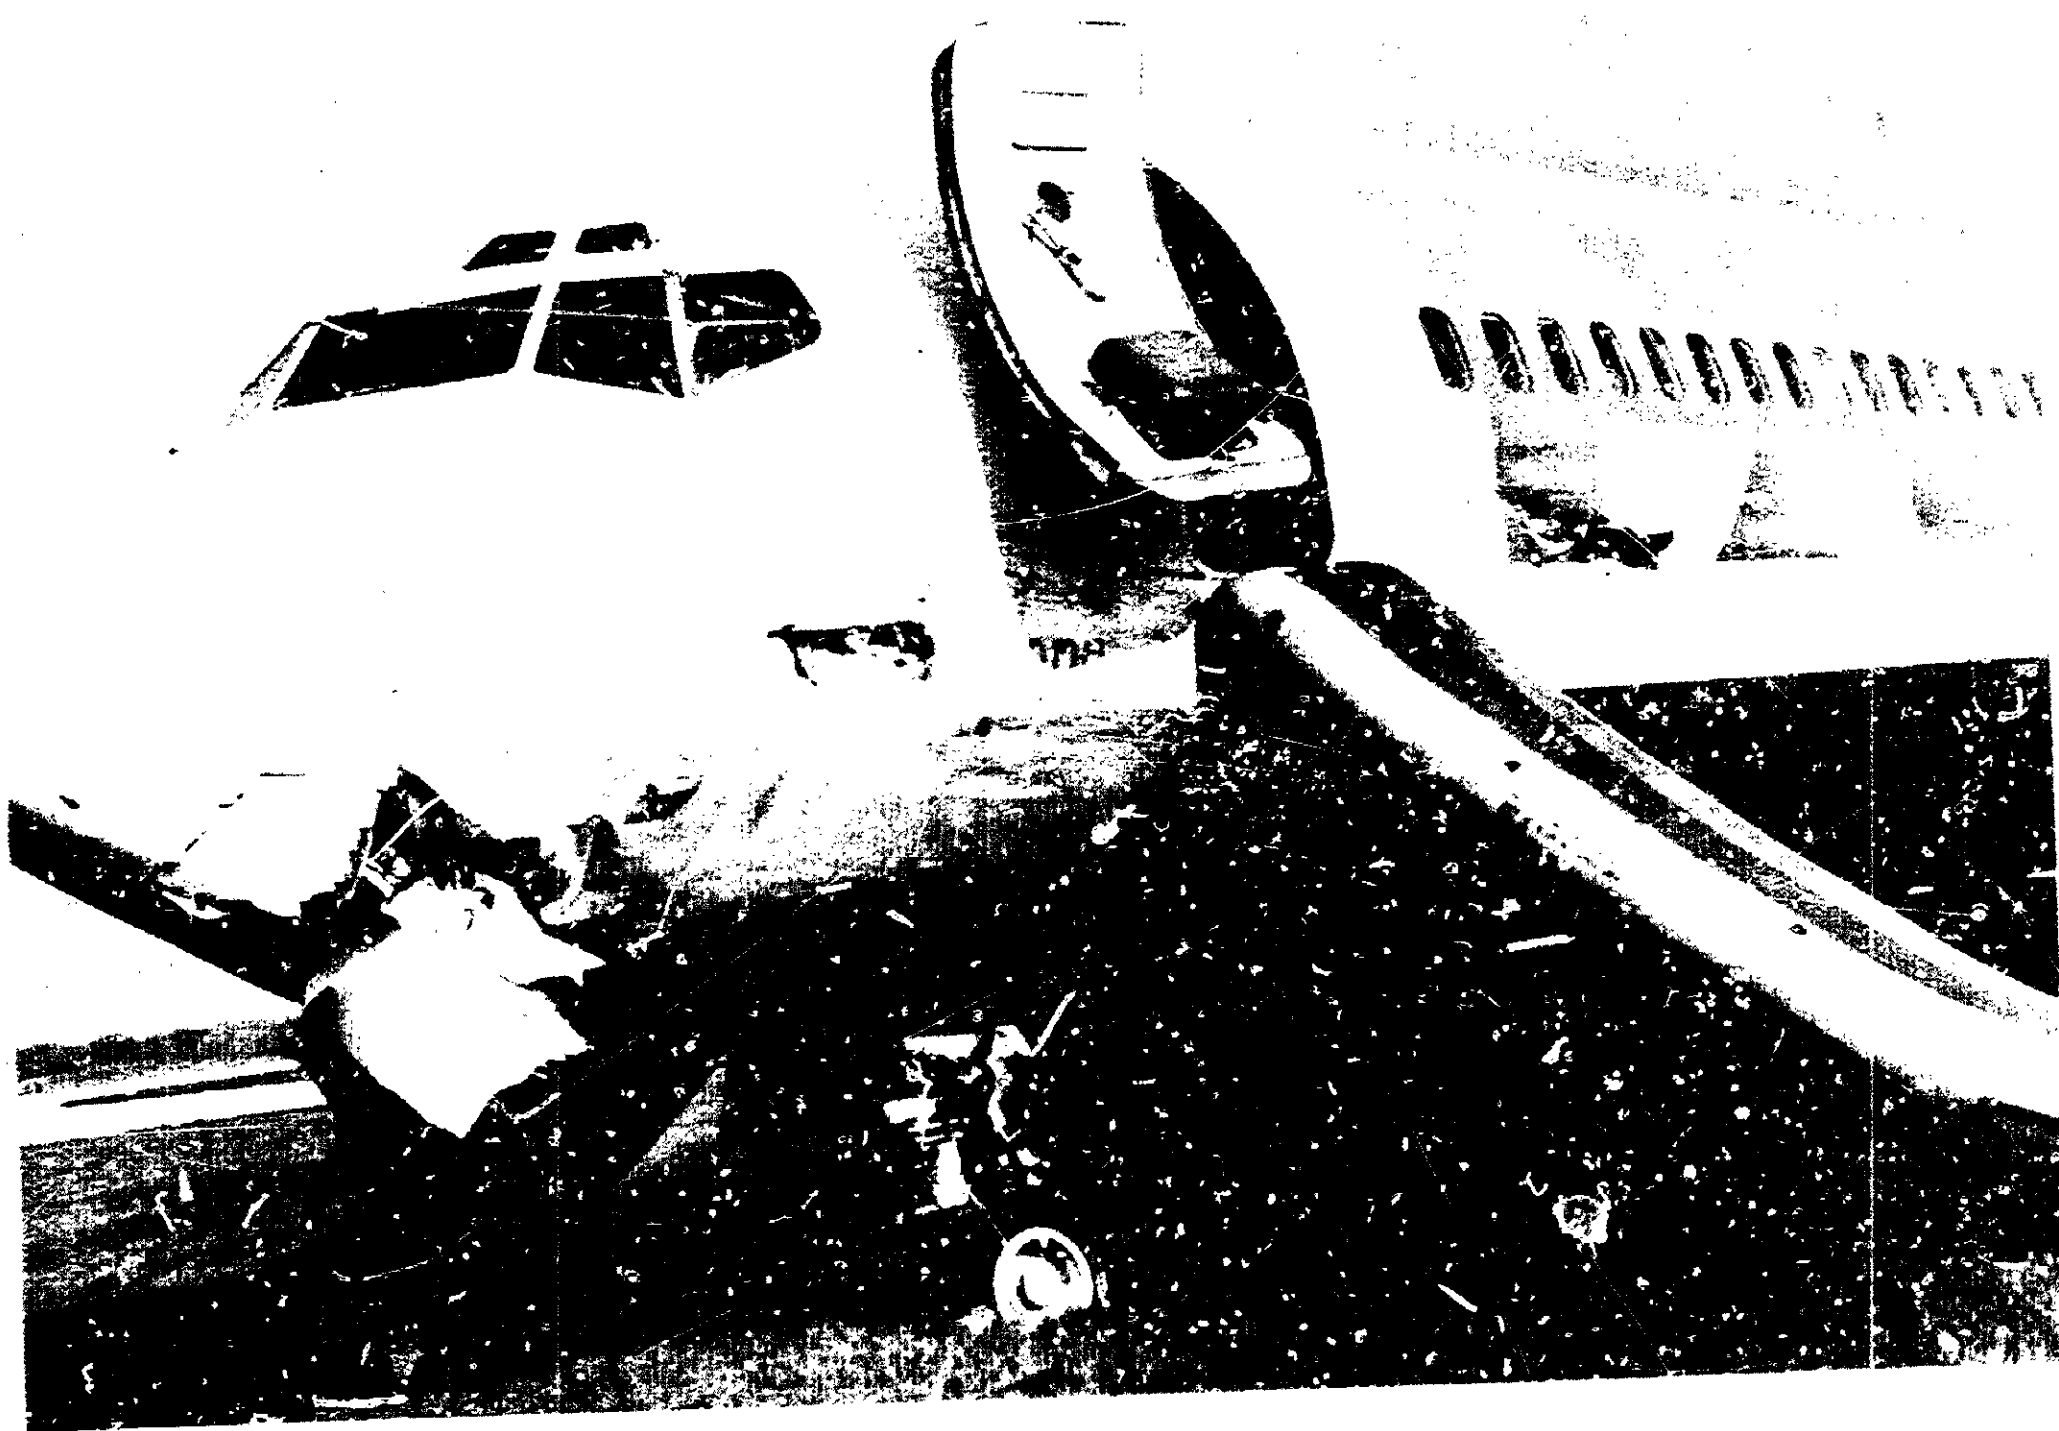
Figure 3.--N4743, a Boeing 727.

The Boeing 727, N4743, sustained substantial damage in the area of the radome and forward electronic compartment. The left side fuselage skin was scratched, dented, and torn. Fire damage was confined to the surface of the left lower wing and adjacent fuselage area.

The left engine and propeller of the Apache separated at impact and remained imbedded in the B-727 in the radome area. The radome and radar antenna were destroyed. The forward half of the B-727 nose gear left wheel well door was torn away. The electrical cable for the left main landing gear anti-skid system was severed. The horizontal stabilizer control drum mechanism and all mechanical systems located in the forward electronic compartment were damaged by the impact. The left side of the B-727 fuselage sustained scratches; dents and tears, including a deep dent; and scratches on the lower surface of the left forward entry door. Heat and fire damage were evident on the underside of the left wing between the fuselage and the midwing area. The left fuselage area and air conditioning bay access panels also were damaged by heat and fire.

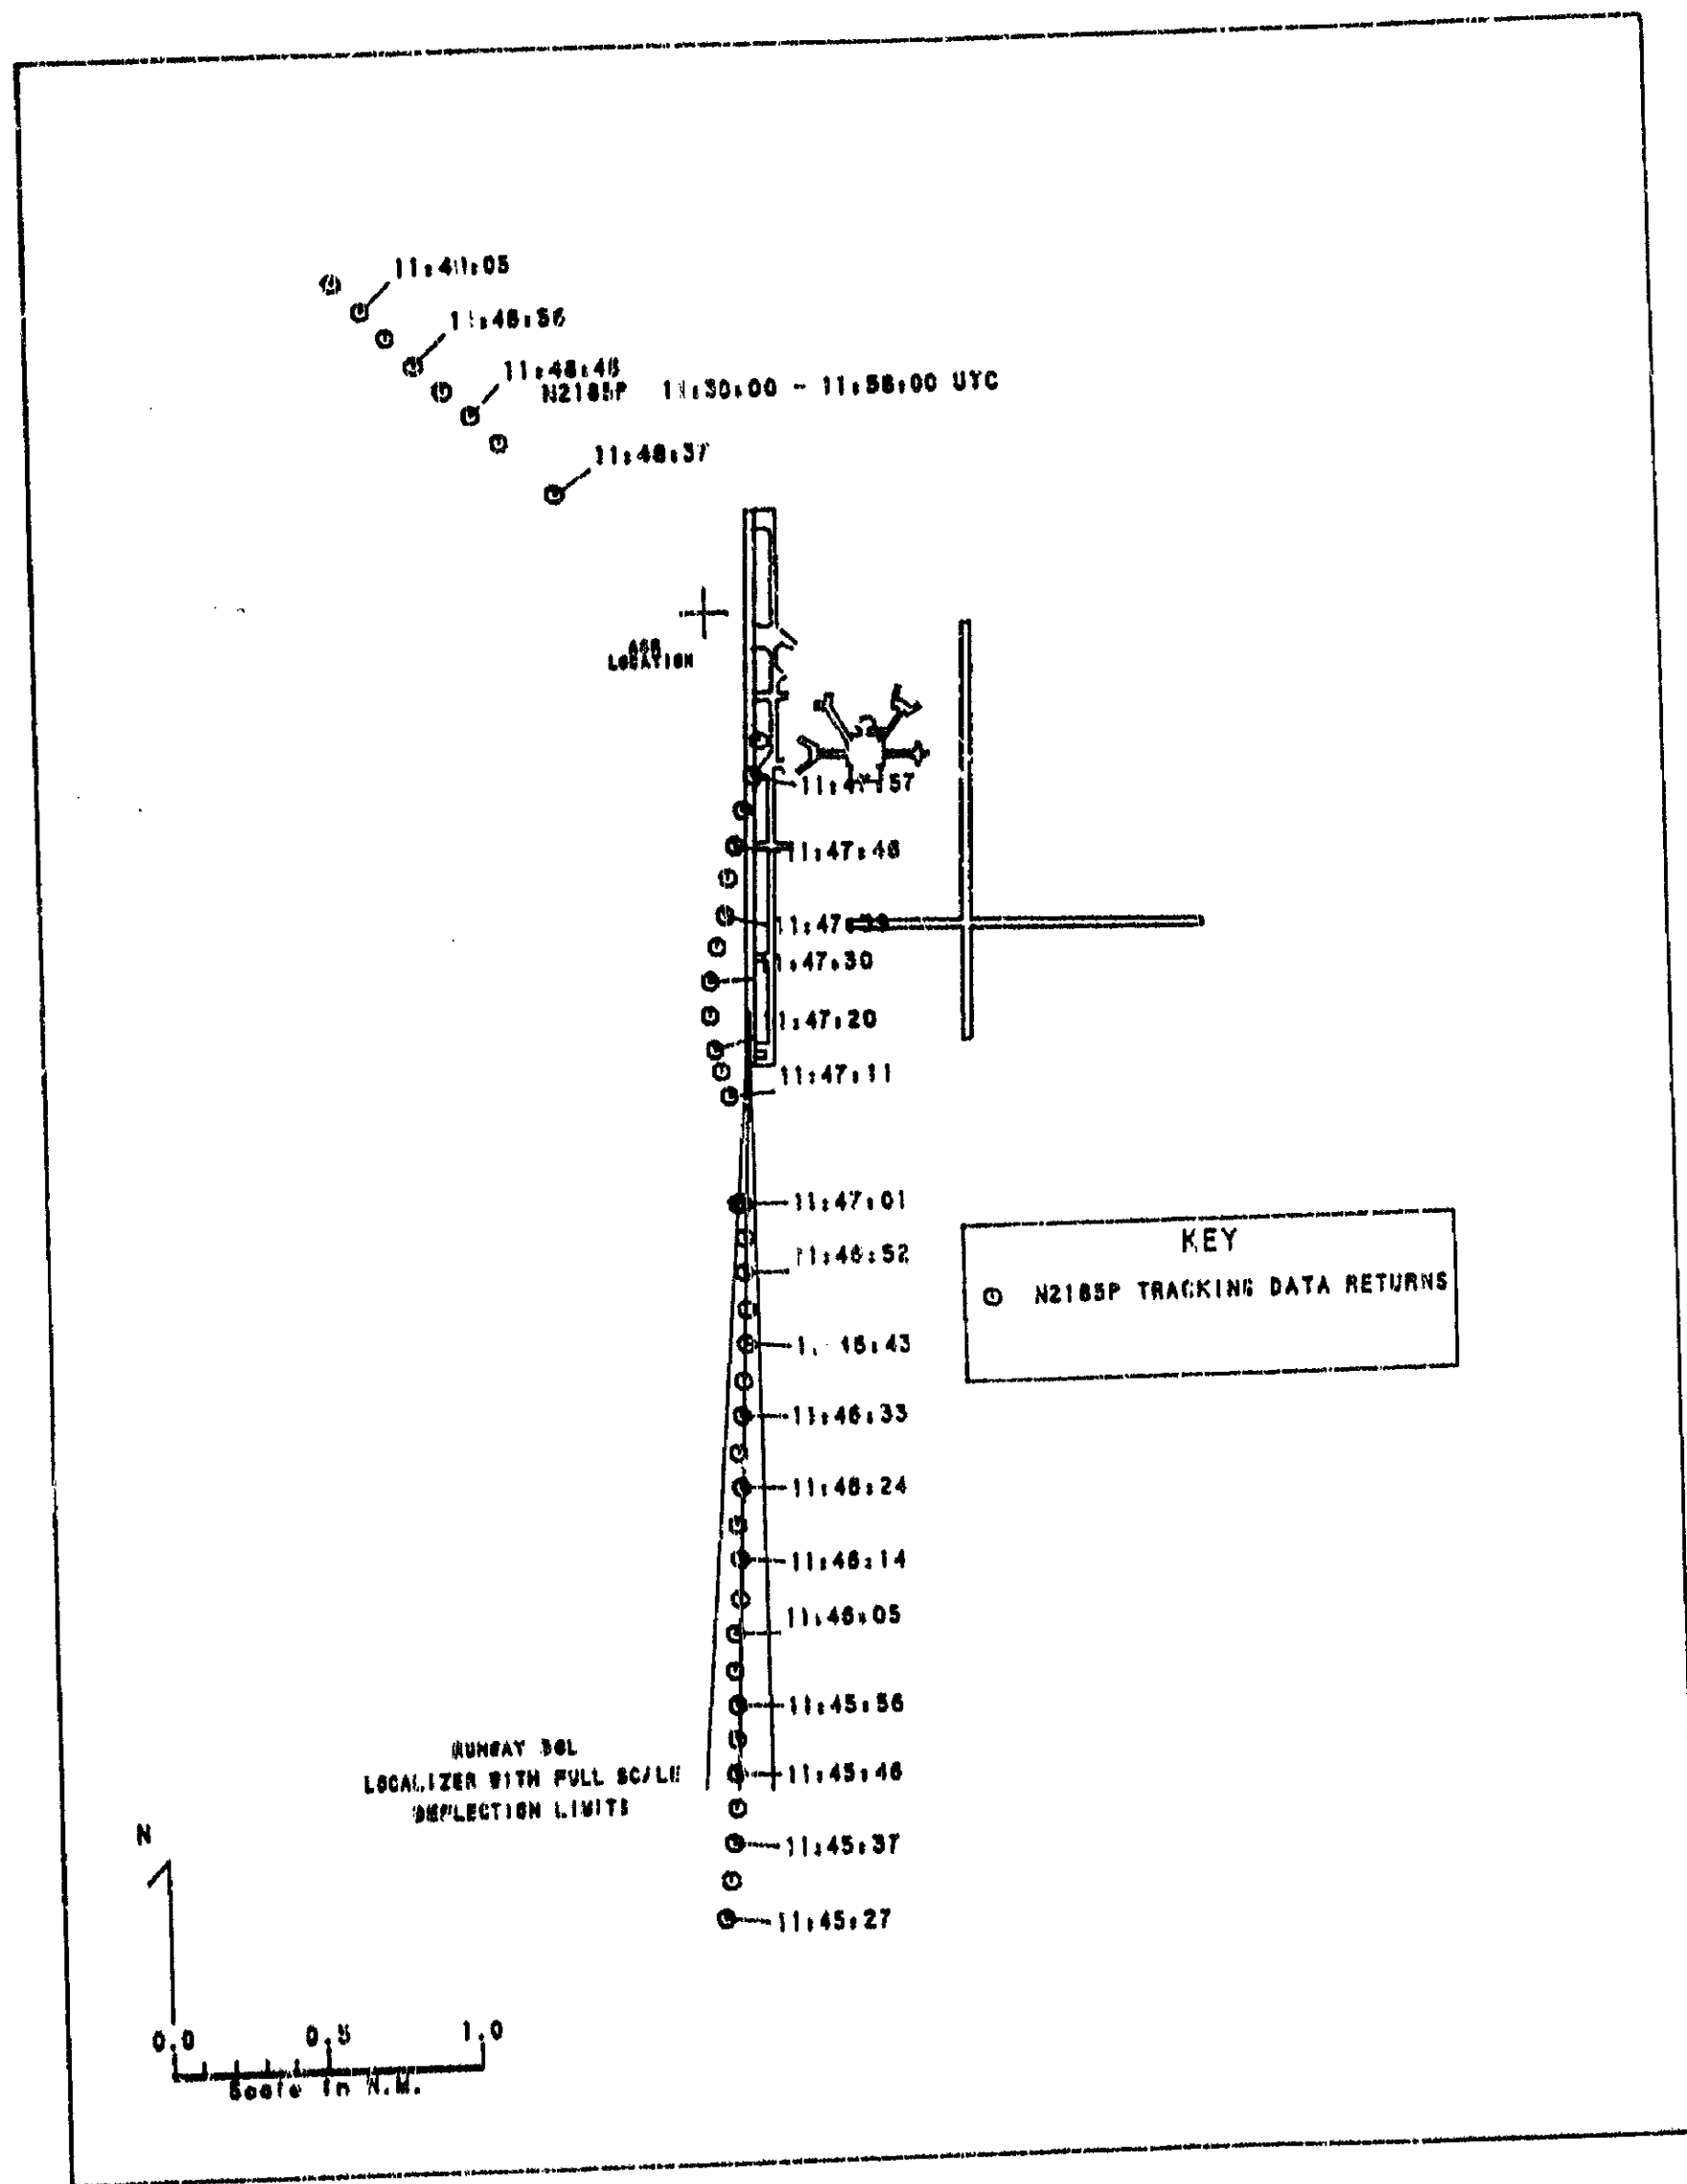
Figure 4.--First approach of the Piper Apache.

The only information available concerning the Apache pilot's execution of the two ILS approaches is found in the radar data recorded by Tampa Approach Control. Although the airplane was equipped with a transponder, it did not have an altitude reporting capability or an encoding altimeter. Therefore, there is no data available to determine the altitudes flown during those approaches. The course data indicate that both approaches were flown with a high degree of precision. There was normal bracketing of the localizer centerline, but no significant deviations were evident. As the two approaches progressed toward the middle marker, located 0.5 nautical mile from the end of the runway, the slight deviations decreased. Just inside the middle marker, however, at a point where the airplane should have been arriving at DH, slight excursions from the localizer were noted. On the first approach, this deviation was to the left (west) of course, and on the second approach, the airplane moved to the right (east) and lined up with taxiway W. At this point, the pilot would probably have been looking for the visual
