## **AIRCRAFT ACCIDENT REPORT**

**NORTH STAR AVIATION, INC.  
PA-32 RT-300, N39614  
AND ALAMEDA AERO CLUB  
CESSNA 172, N75584  
OAKLAND, CALIFORNIA  
MARCH 31, 1987**

NTSB / AAR-87/09

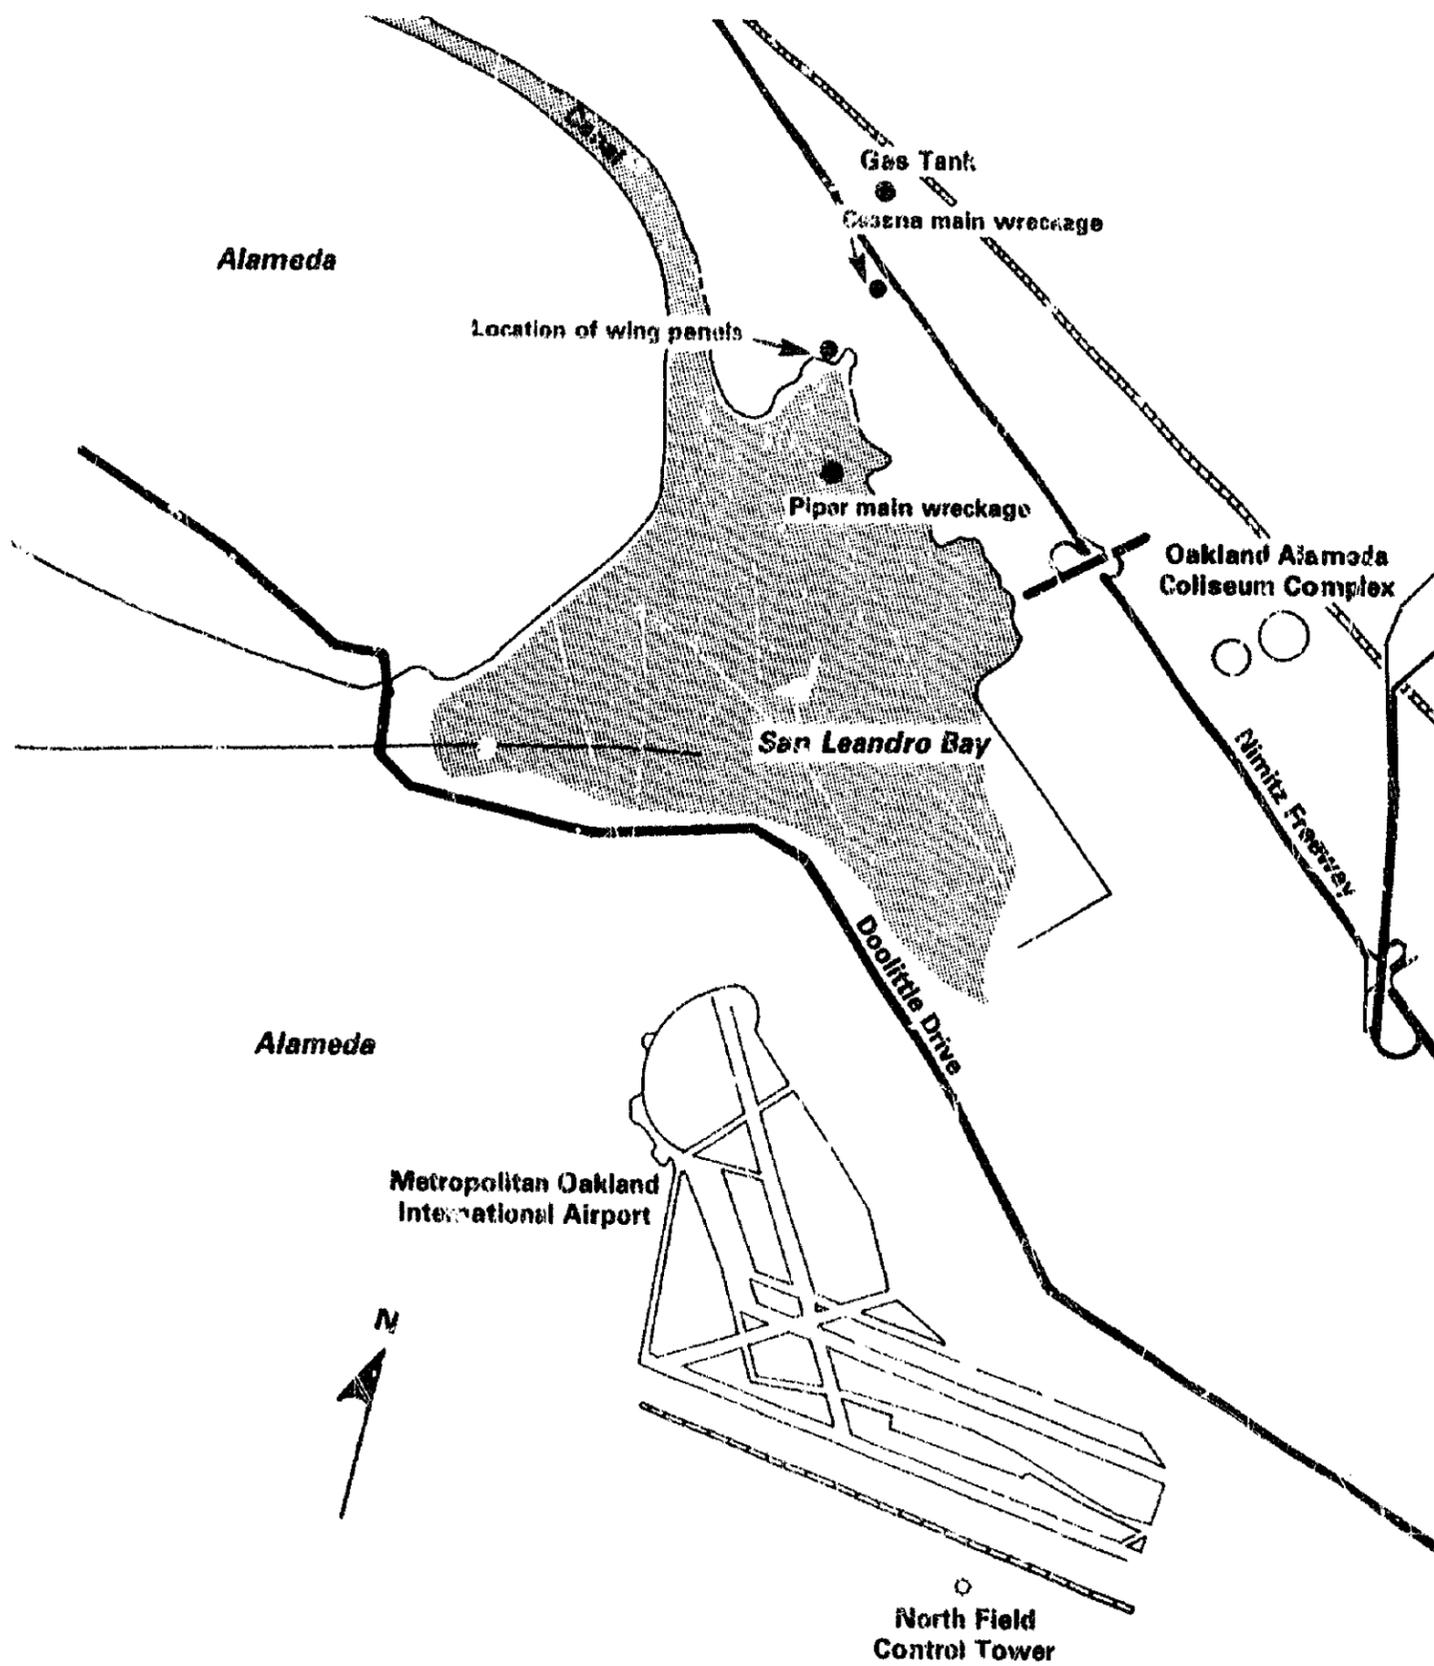
The main wreckage of both airplanes was found within a 2,500-foot diameter circle centered about 7,900 feet north of the departure end of runway 33. (See figure 5.) The center of the circle was aligned on a magnetic heading of 357° from the departure end of runway 33.

Figure 5.--Wreckage distribution.

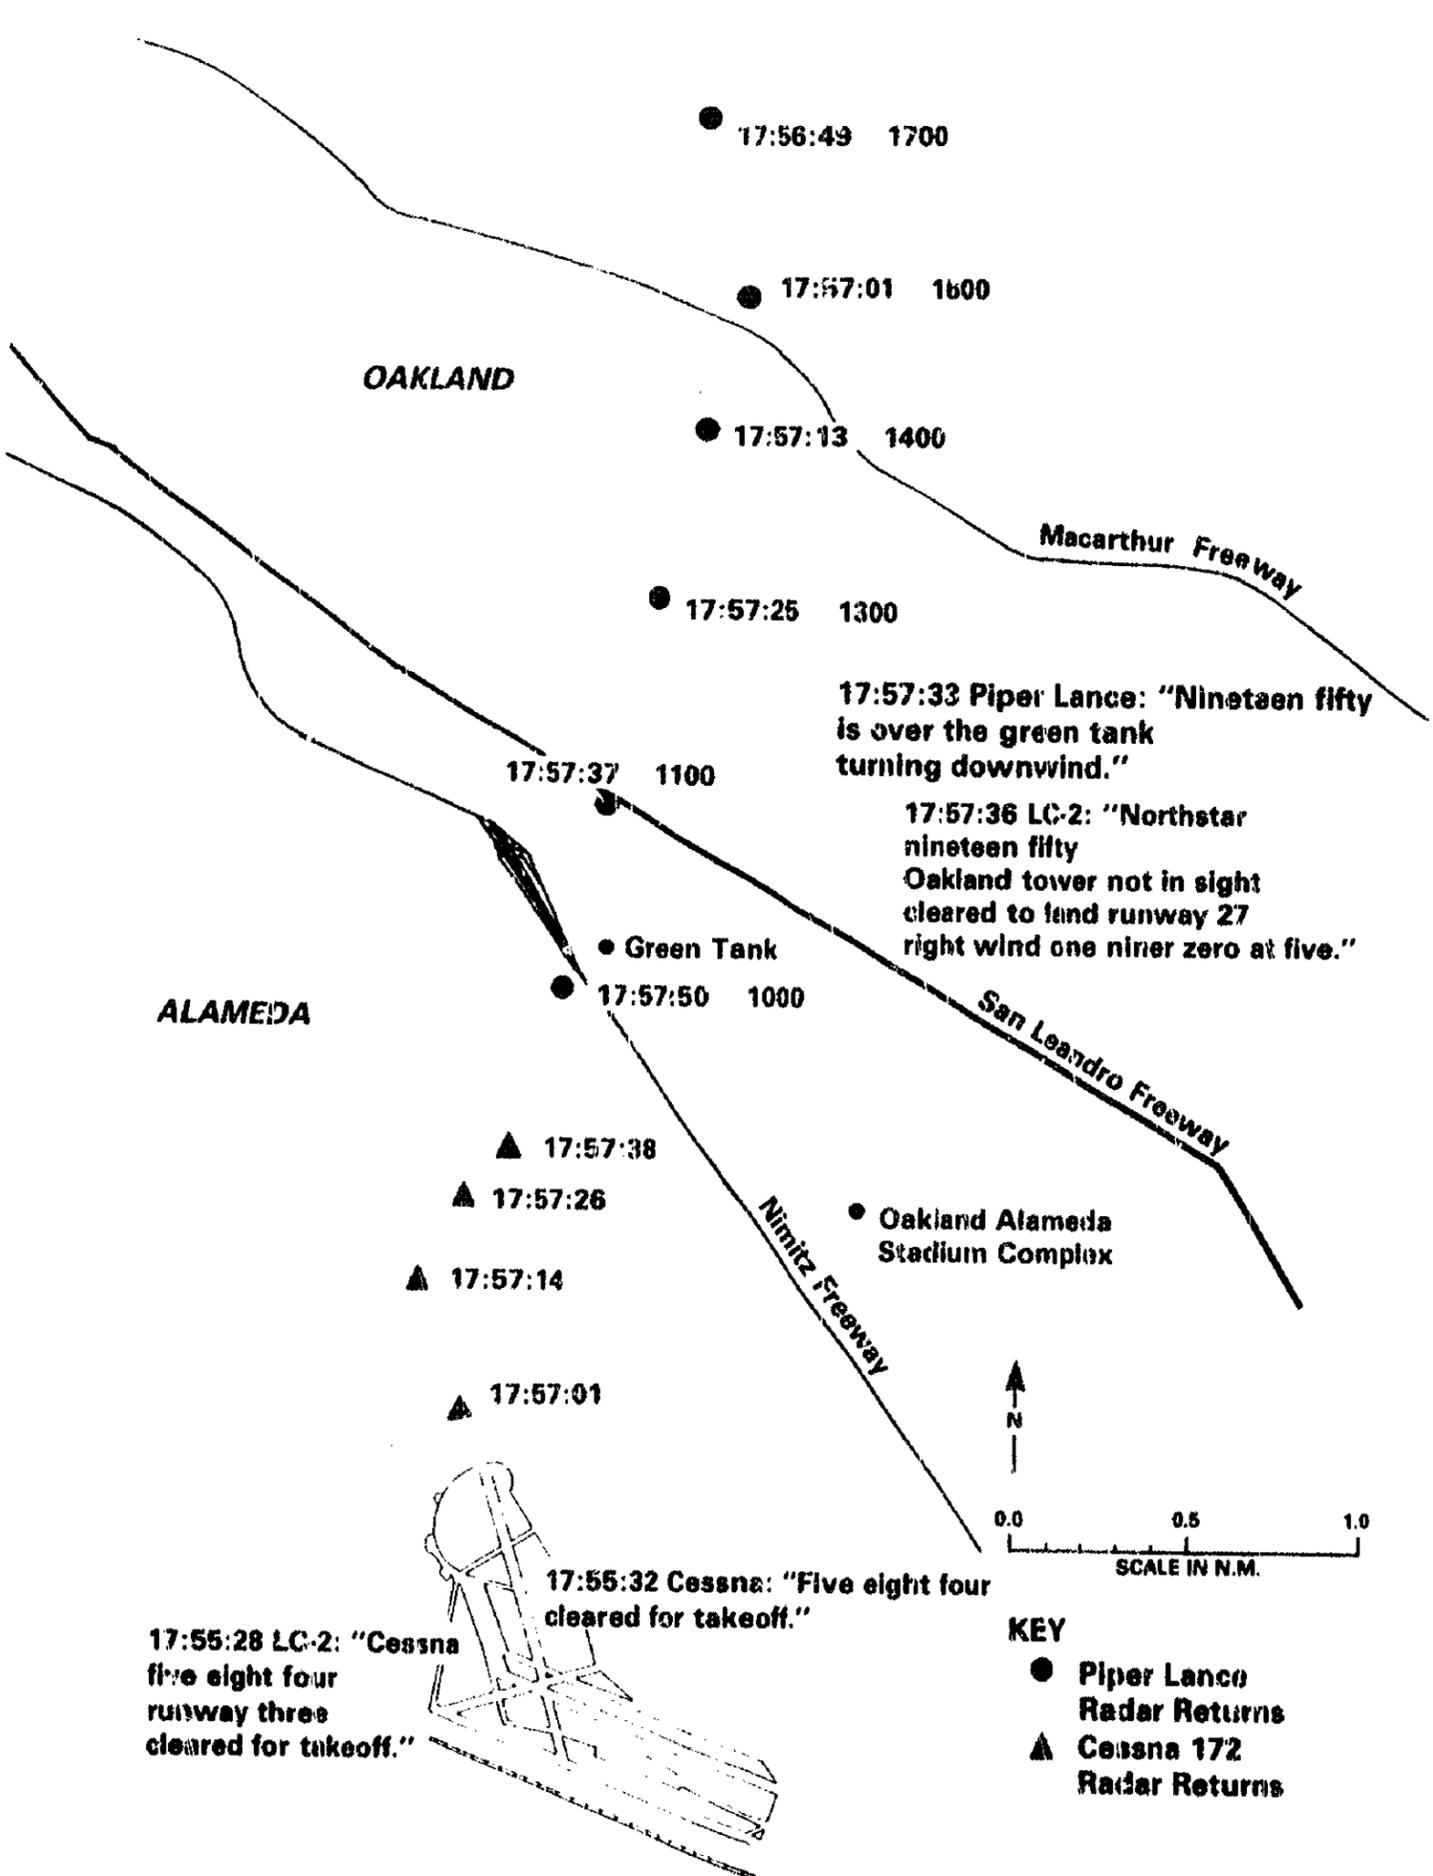
The evidence from the scratch marks, paint transfer, propeller slash marks and impact angles indicate that the angle of the relative headings of the two airplanes to each other was approximately  $45^{\circ}$  at impact. Since, according to the radar data, the Cessna was in an approximate due north heading before impact, this indicates that the heading of the Piper would have been about  $135^{\circ}$ . The relative pitch angle of the two airplanes to each other was about  $10^{\circ}$ . Because the radar data indicate that the Piper was at the pattern altitude of 1,000 feet at the time of impact and the Cessna was in a climb, therefore, the physical data indicate that the Cessna was in a  $10^{\circ}$  nose up attitude at that time.

Figure 8.--Flightpaths of the Piper and the Cessna.
