# **NATIONAL TRANSPORTATION SAFETY BOARD**

## **AIRCRAFT ACCIDENT REPORT**

**MIDAIR COLLISION OF  
U.S. ARMY U-21A, ARMY 18061,  
AND SACHS ELECTRIC COMPANY  
PIPER PA-31-350, N60SE  
INDEPENDENCE, MISSOURI  
JANUARY 20, 1987**

NTSB/AAR-88/01

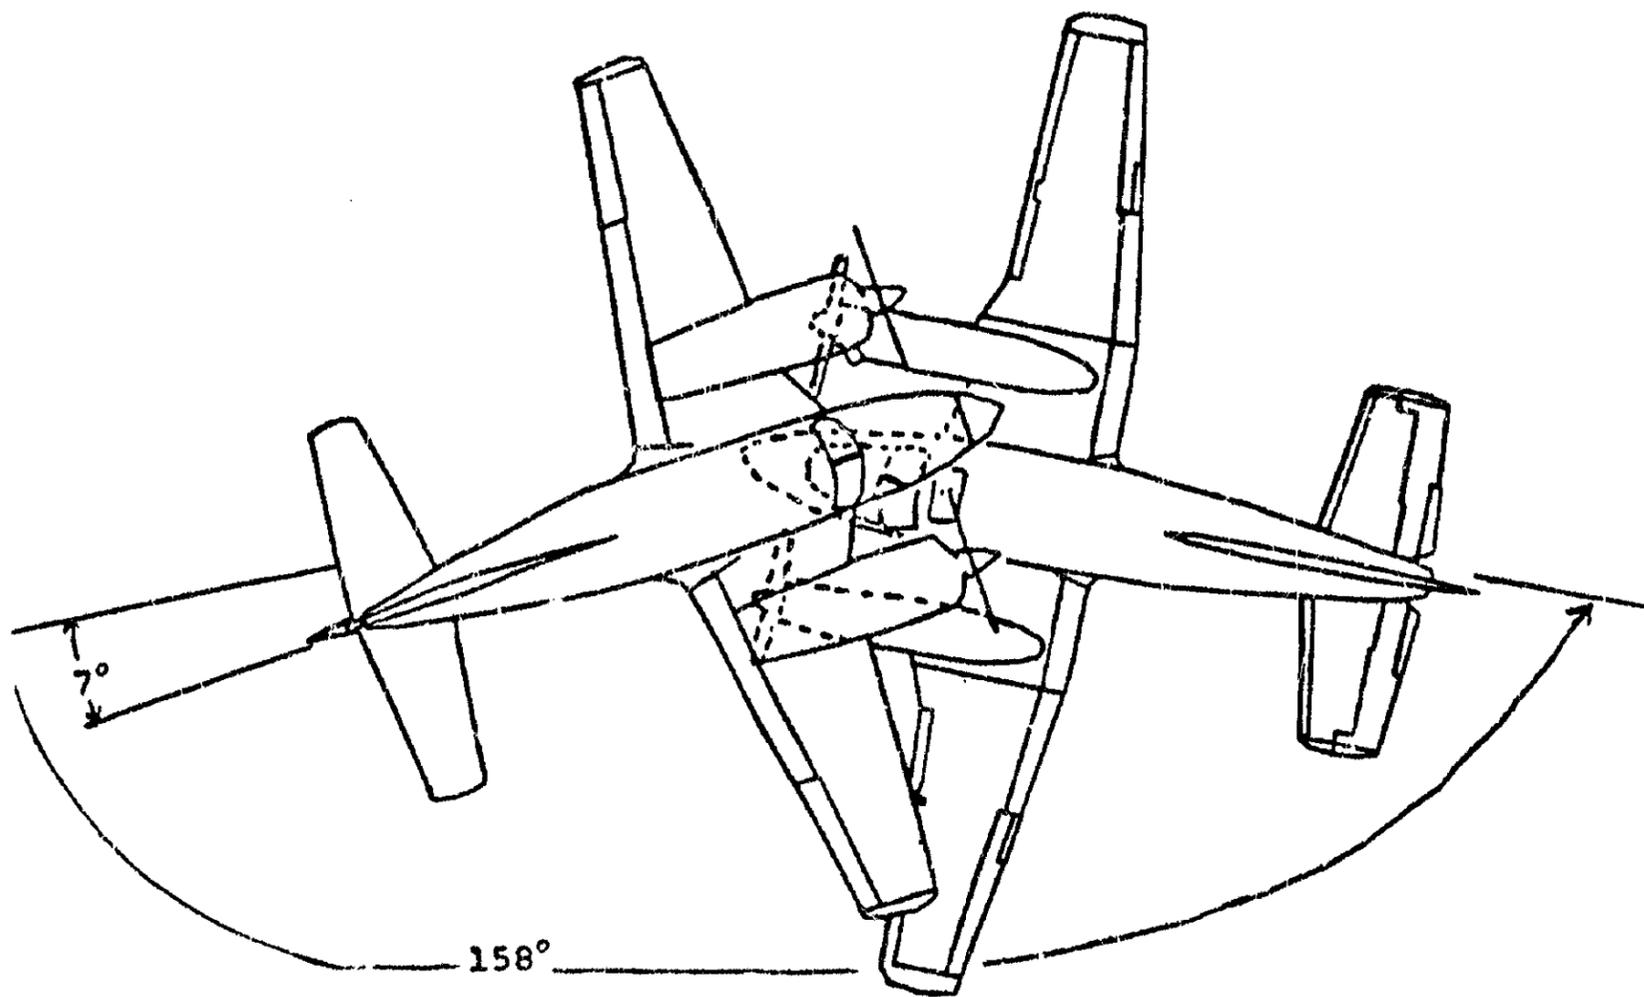
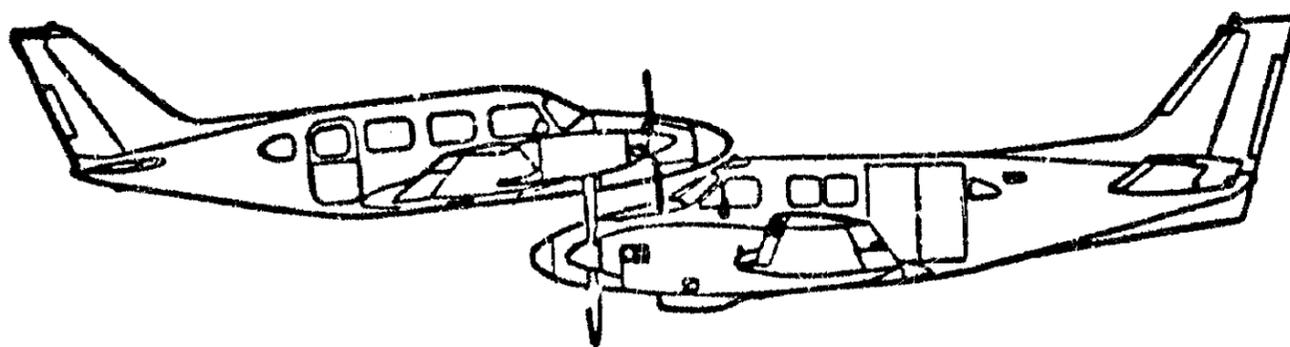
Figure 3.--Horizontal and vertical relationship of the airplanes at impact.

Although the U-21 was extensively damaged by ground impact forces and postcrash fire, its wreckage still revealed useful information from which to evaluate the collision geometry. The shearing of the cabin roof at the top of the pilot's windshield in a level plane revealed that the PA-31 had contacted the top of the U-21 windshield with a

In addition to the cabin roof, the entire aft fuselage and empennage of the U-21 was separated from the forward cabin area in the collision. This was evidenced by the disintegration of the empennage and the scatter of the aft fuselage and empennage debris. Contact between the PA-31 cabin or right wing, as the PA-31 rode over the top of the U-21, would have caused such damage. The recovery of a piece of the vertical stabilizer from the U-21 in the PA-31 cabin showed that the vertical stabilizer had contacted or passed through the PA-31 cabin. (See figure 3.)

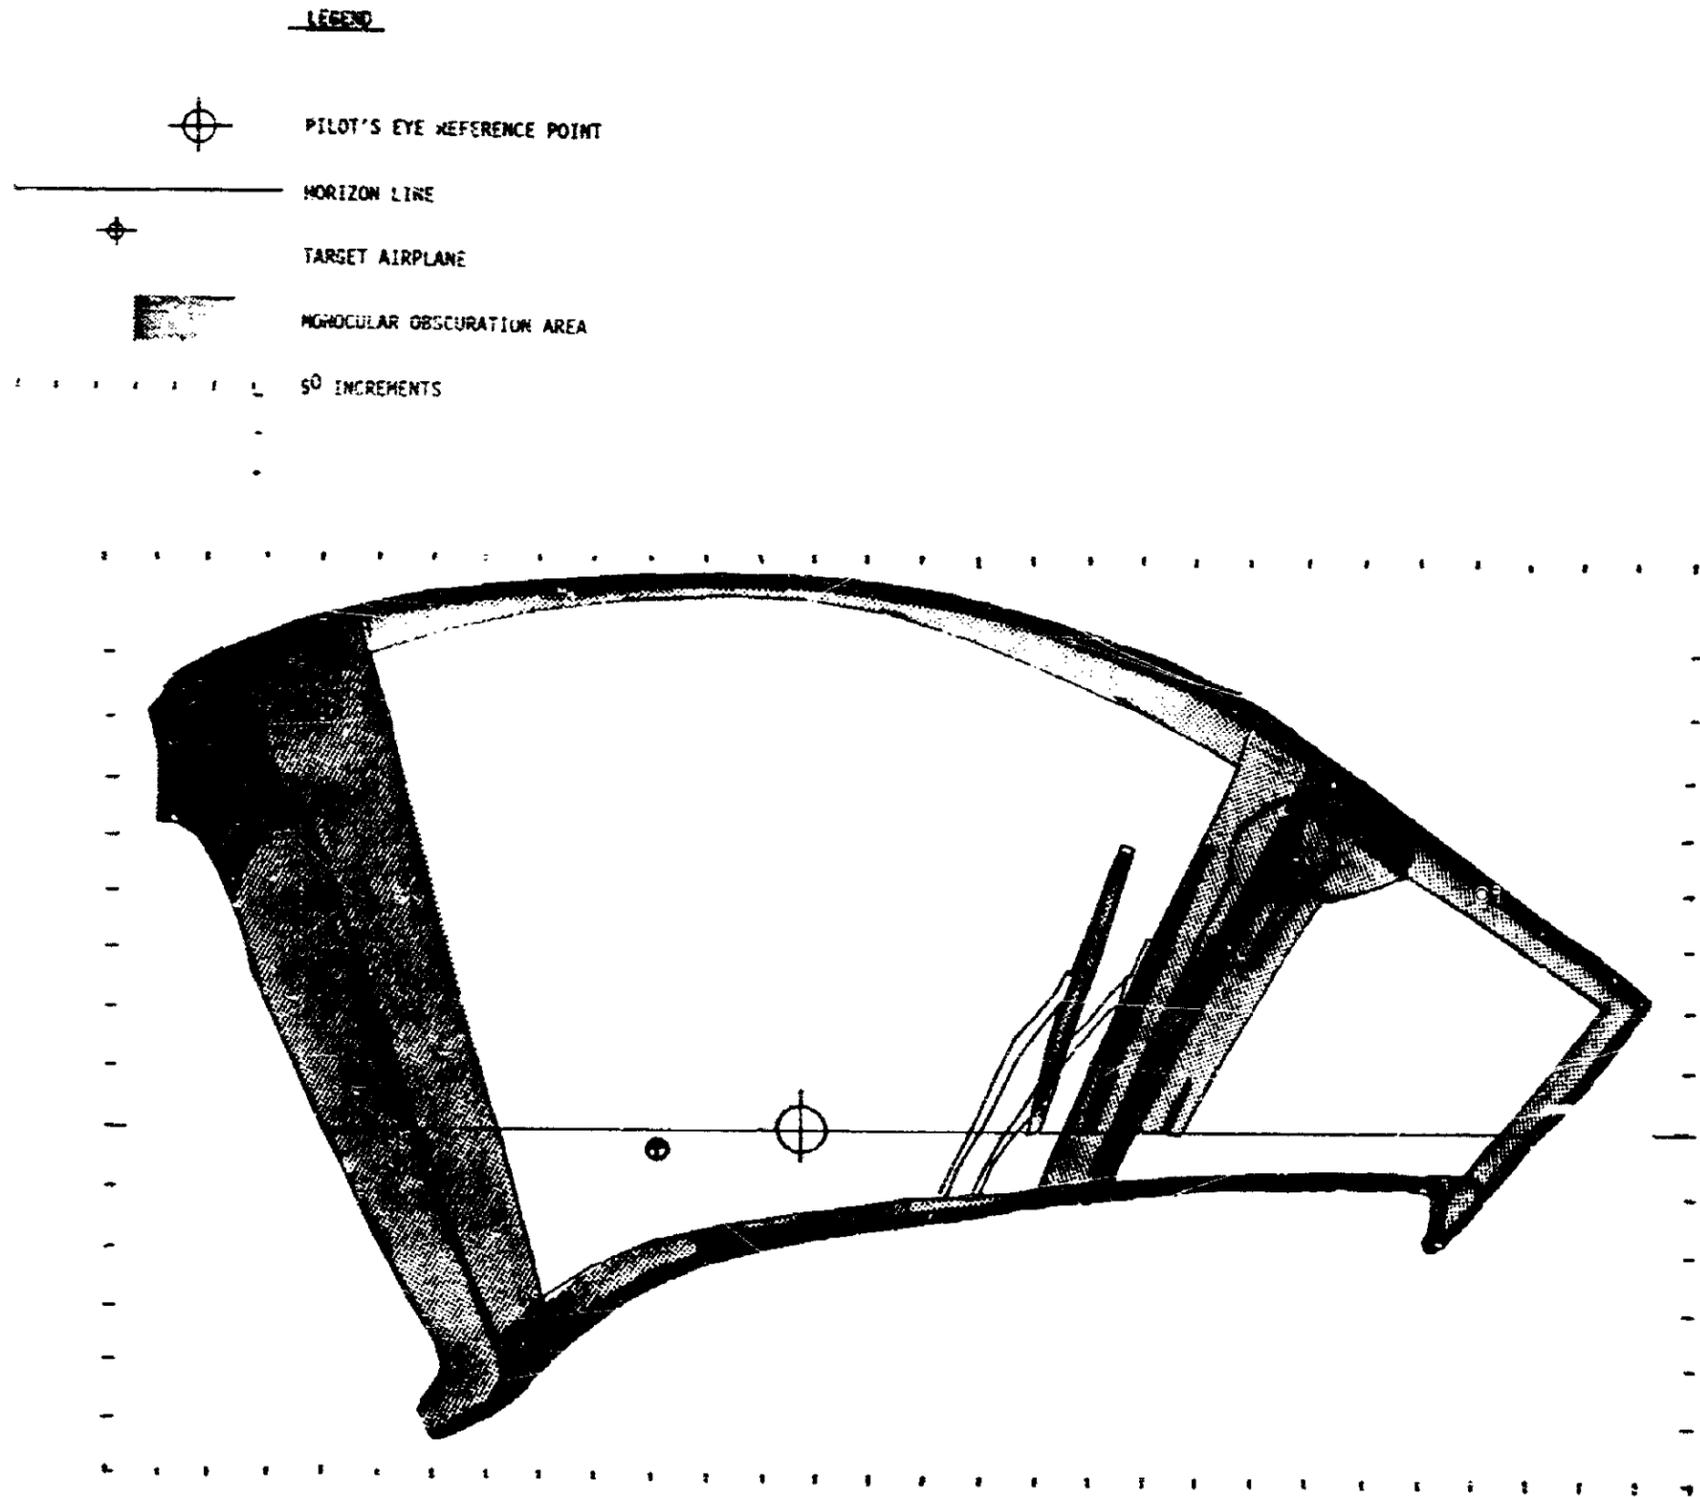
Figure 1. U21A, R18061, Pilot's Design Eye Reference Position at 41.5 in. Above the Floor and 5 in. Aft of the Rear Most Column Movement.

The cockpit visibility study showed that the PA-31 was visible through the windshields of both U-21 pilots. Neither pilot's view would have been obstructed by windshield or door posts, windshield wipers, or other airplane equipment. There was no need to attempt to view the PA-31 by looking outside the viewing area associated with normal outside scanning. The sun should not have produced any abnormal glare on the windshield.

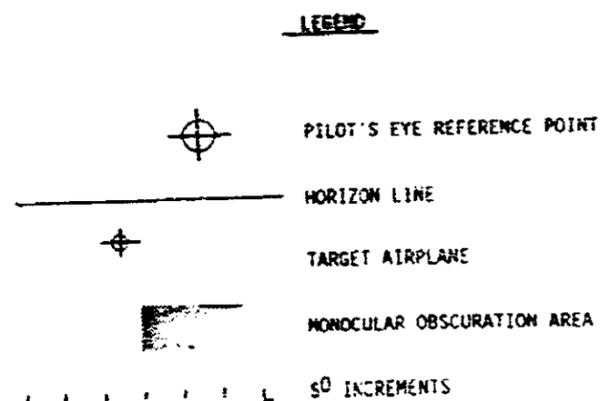
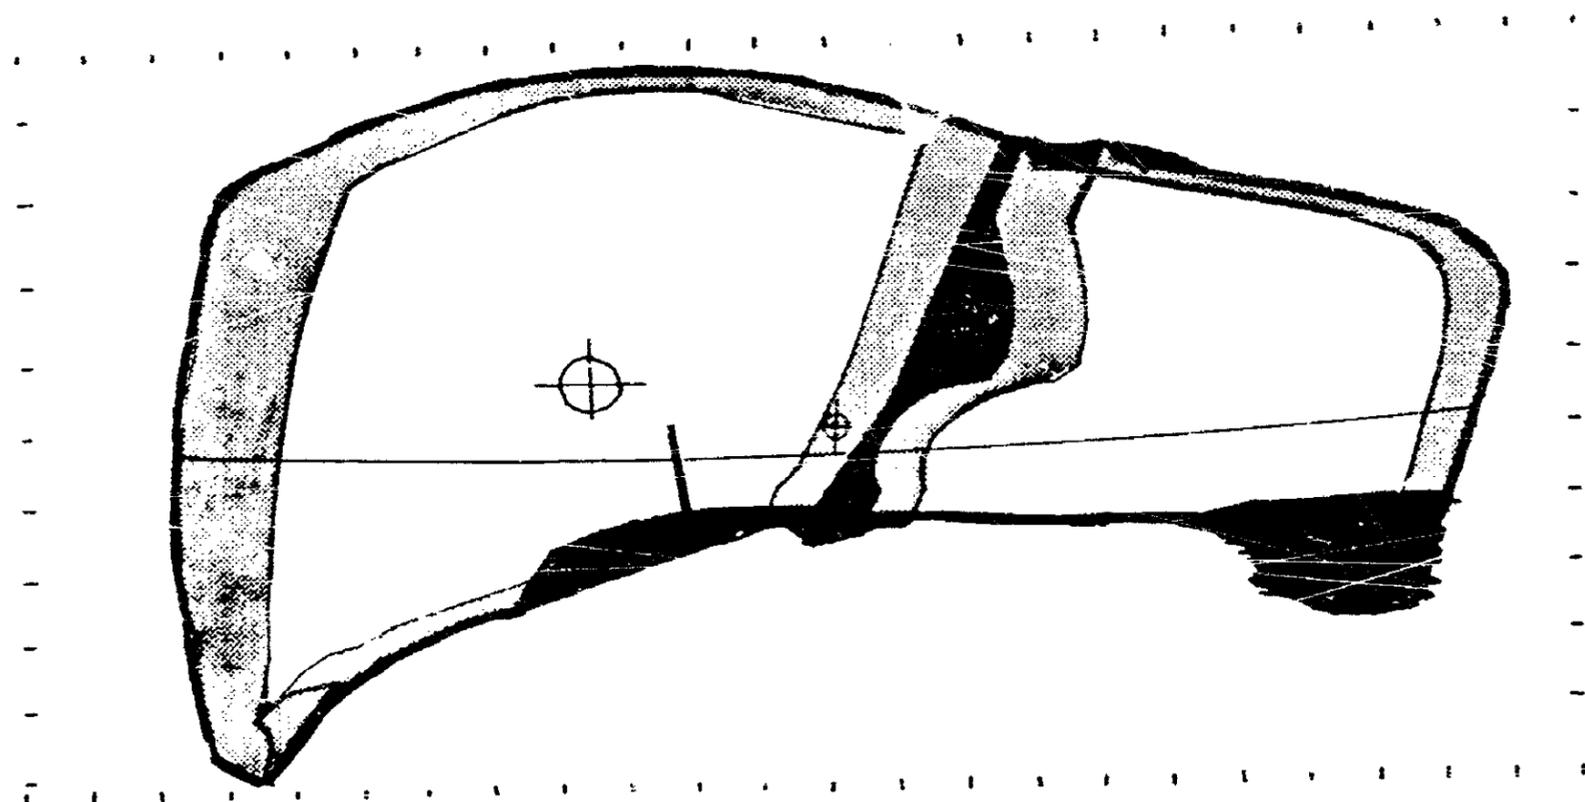
Figure 3. PA31-350, N60SE, Pilot's Design Eye Reference Position at 43.5 in. Above the Floor and 5 in. Aft of the Rear Most Column Movement.

The study showed that the U-21 would have been positioned near the center windshield post of the PA-31 pilot's windshield. If the pilot kept his head motionless, the U-21 would have been sufficiently obscured by the windshield post that the pilot would
