# **NATIONAL TRANSPORTATION SAFETY BOARD**

## **AIRCRAFT ACCIDENT REPORT**

**AIR NEW ORLEANS,  
DBA CONTINENTAL EXPRESS FLIGHT 962,  
BRITISH AEROSPACE 3101  
(JETSTREAM 31) N331CY,  
NEW ORLEANS INTERNATIONAL AIRPORT  
KENNER, LOUISIANA  
MAY 26, 1987**

NTSB/AAR-88/06

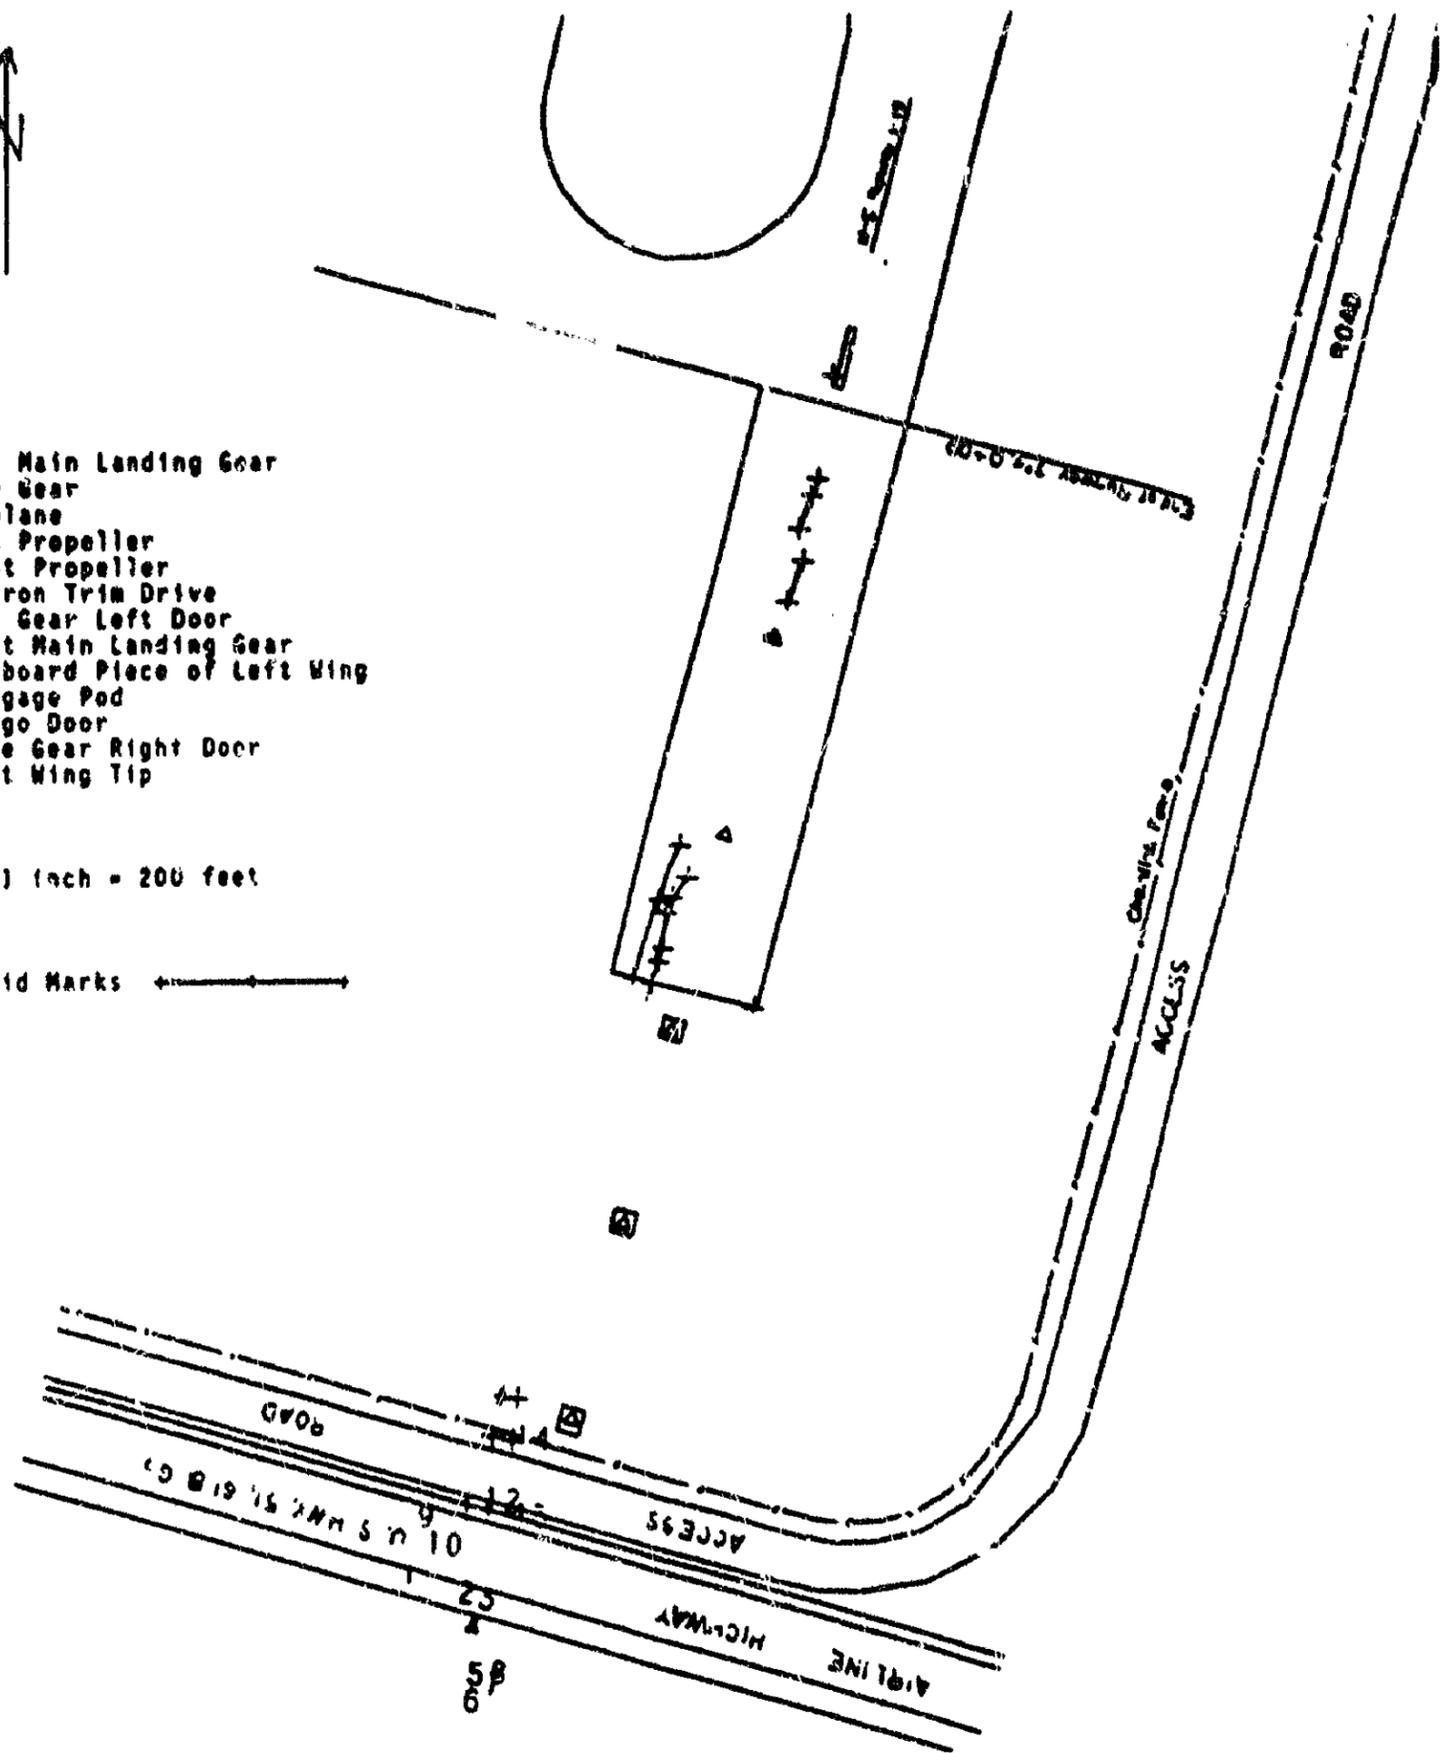
NATIONAL TRANSPORTATION SAFETY BOARD Washington, D.C.
<b>WRECKAGE DISTRIBUTION CHART</b>
Aircraft: BAC, Jetstream 31, N331CV Operator: Air New Orleans, FLT 962 Location: New Orleans Int. Airport, La Date: May 26, 1987

The wreckage scatter pattern began with tire skidmarks in the overrun of runway 19. The distance between the first tire skidmark and the final resting point of the main wreckage was about 1,100 feet. The initial skidmarks stopped after about 100 feet. A damaged runway centerline strobe light was located about 35 feet beyond the end of the first left gear skidmark. The tire skidmarks began again about 400 feet beyond the initial touchdown point and continued to the end of the paved overrun for runway 19.

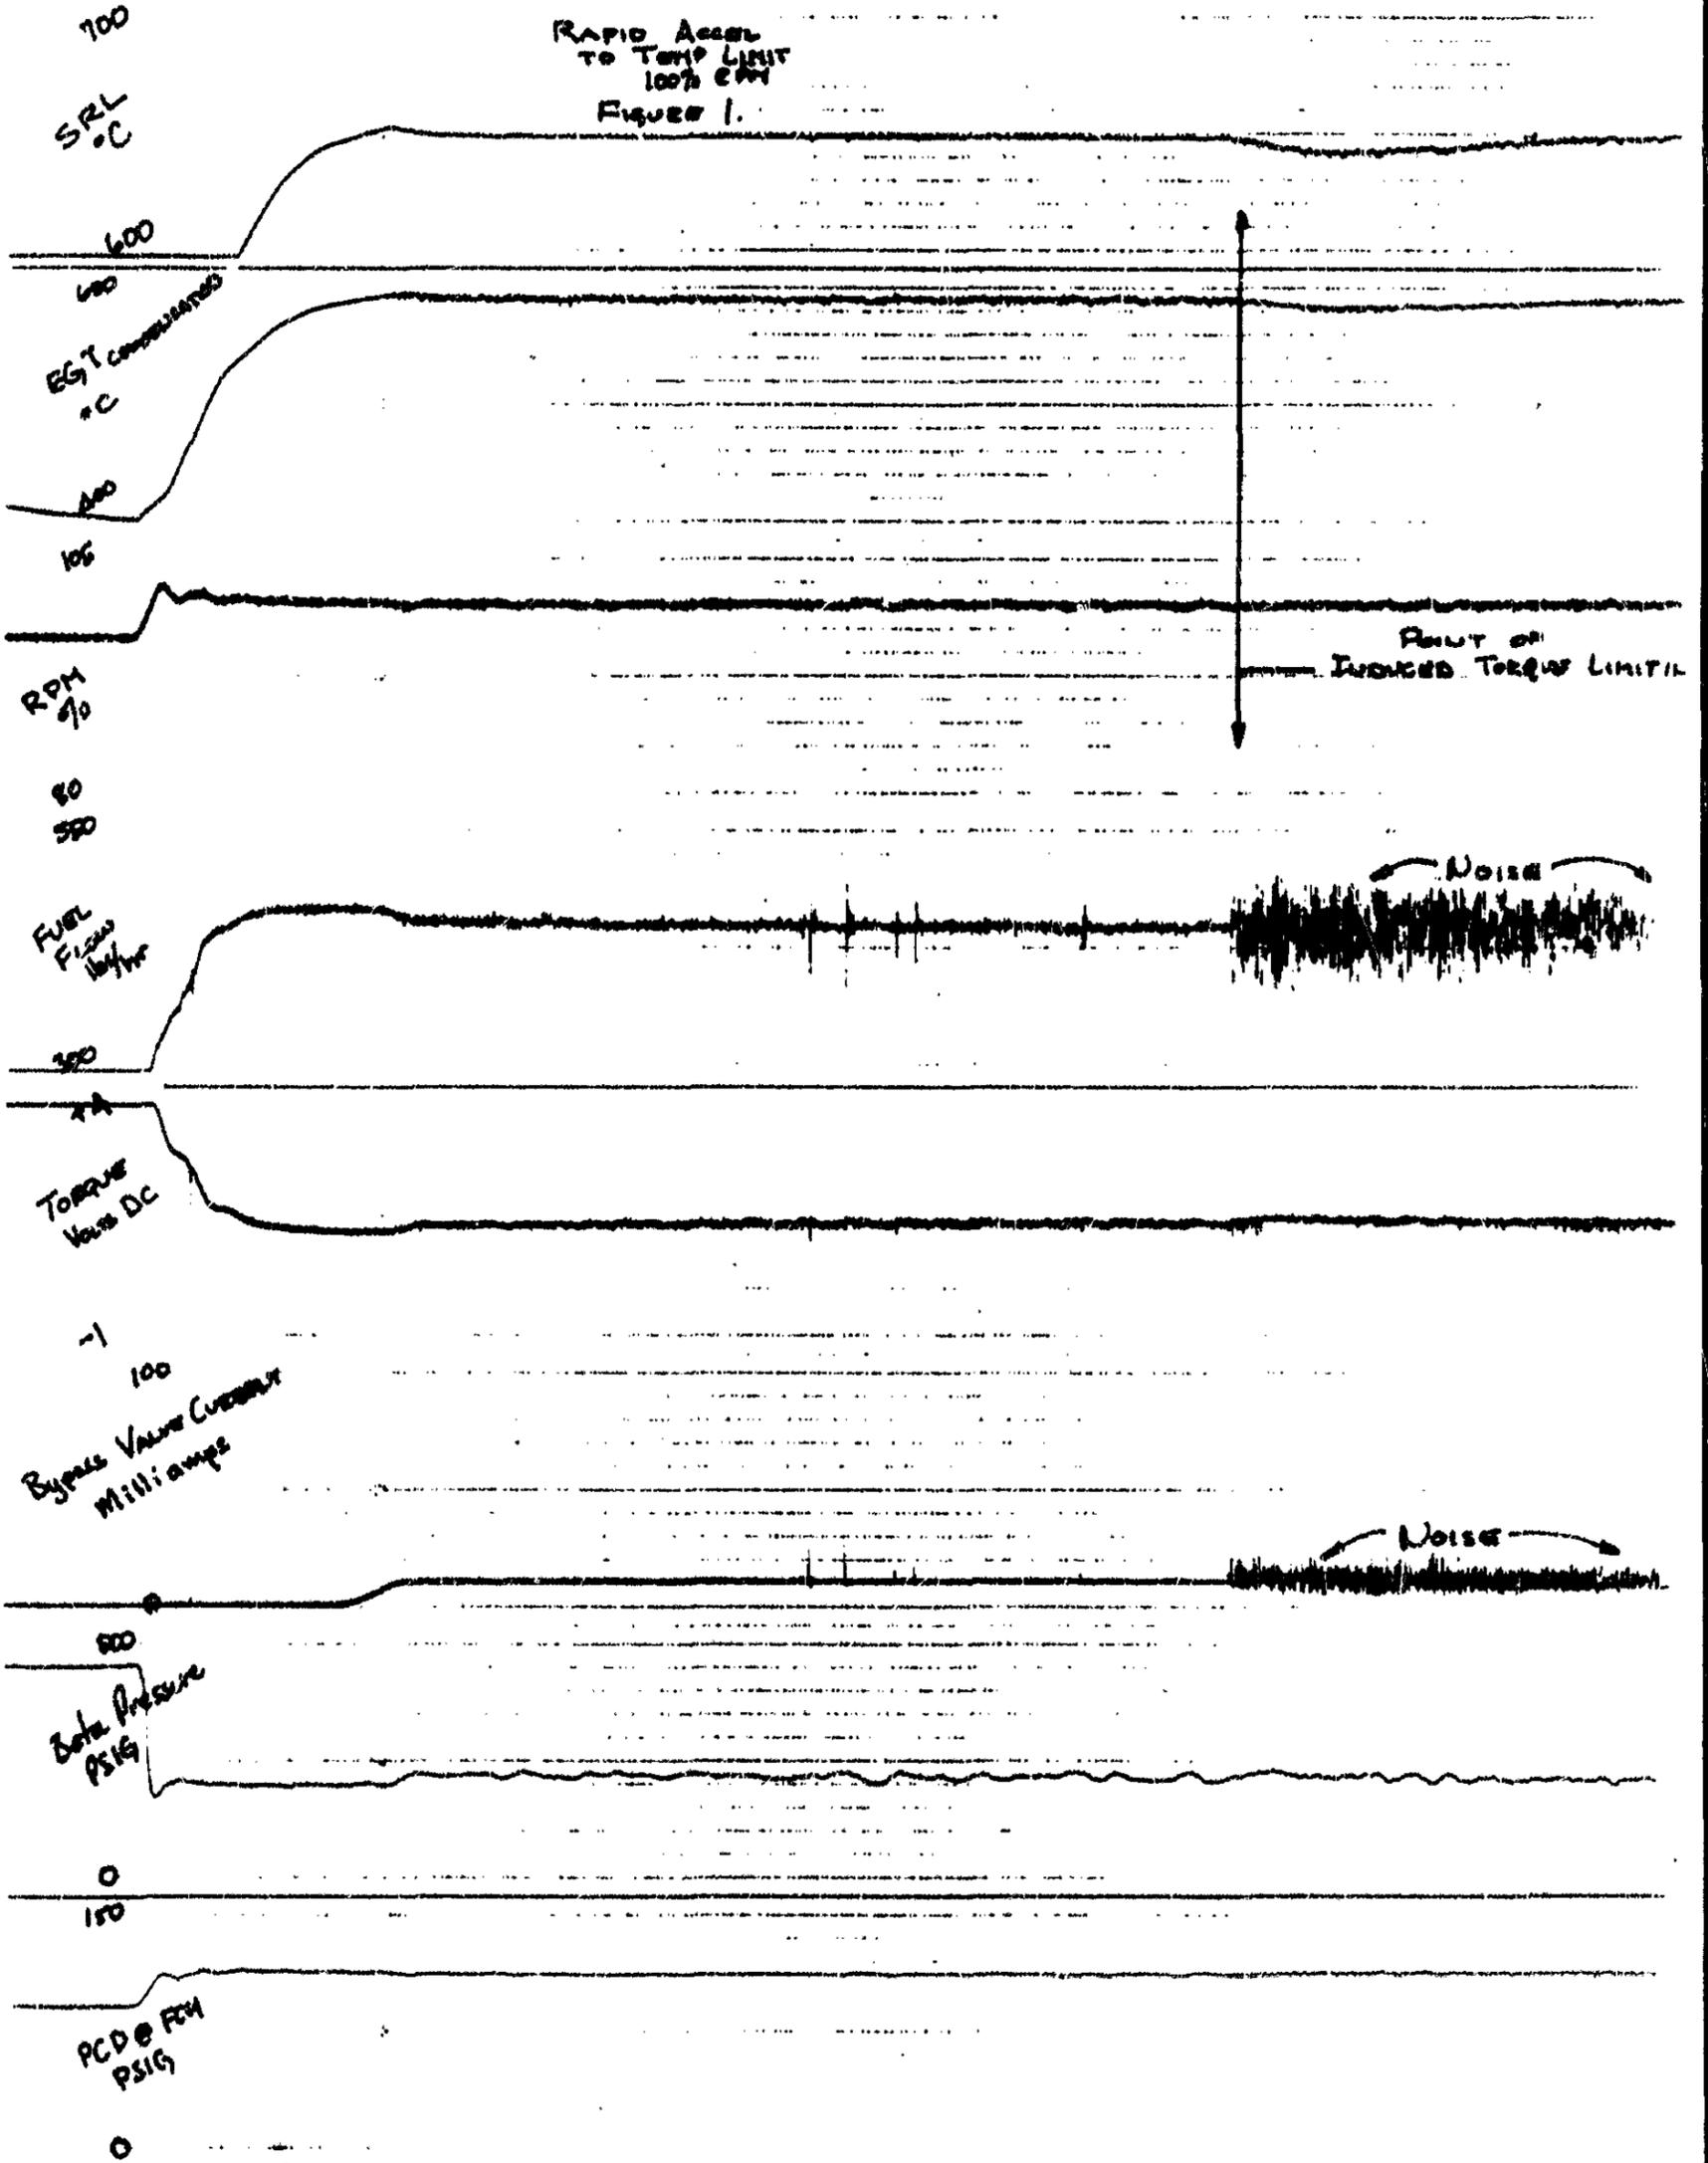
RAPID ASSEMBLY  
TO TEMP LIMIT  
100% RPM  
FIGURE 1.

The first engine condition set was engine RPM, 100%, and a temp. limit of 650°C. At this point, all engine parameters were stable. Next, the P/L was advanced from the minimum position to the maximum position, ensuring that temperature limiting was achieved. Figure 1 shows that the SRL temperature stabilized at 650°C 4 seconds after the initiation of the temp. limiting function (shown on the trace as a rise in bypass valve current). All parameters at this point were stable.

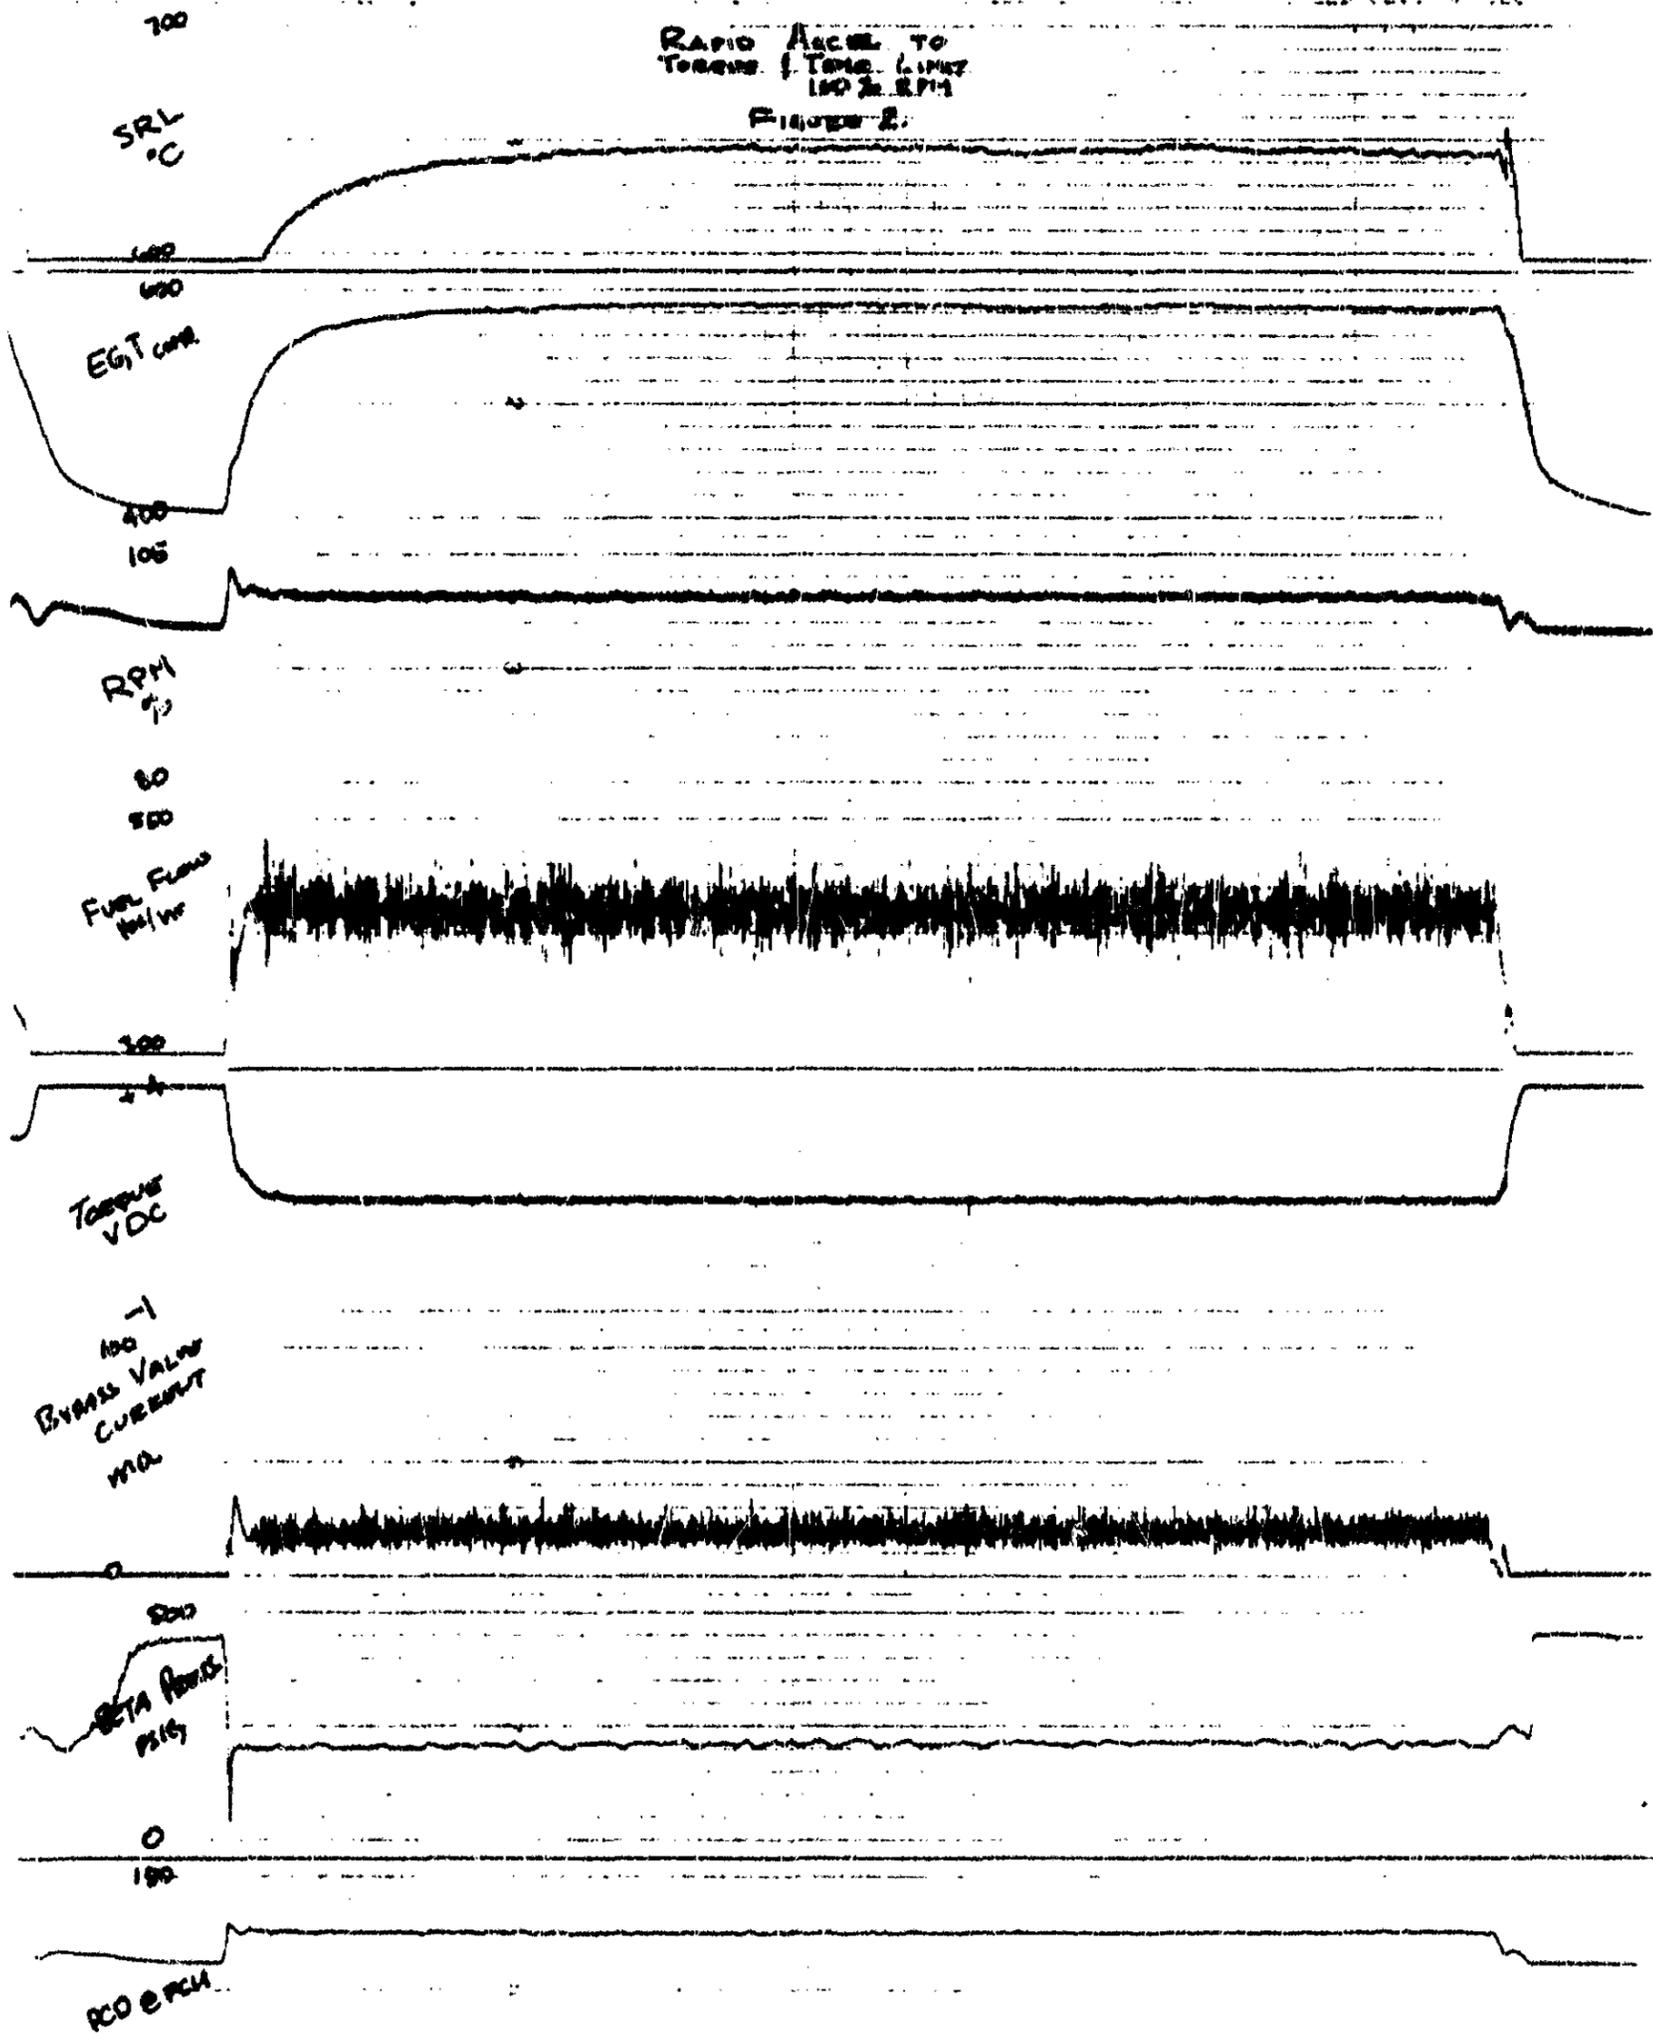
FIGURE 2

Next, at 100% RPM, both torque and temp. limiting conditions were established. When the torque limit signal was induced, the signal from the limiter to the bypass valve became noisy as did all the other parameters, most notably the fuel flow. Engine operation, however, remained stable during slow accelerations and rapid accelerations (Figure 2).
