# **NATIONAL TRANSPORTATION SAFETY BOARD**

## **AIRCRAFT ACCIDENT REPORT**

**TRANS-COLORADO AIRLINES, INC., FLIGHT 2286  
FAIRCHILD METRO III, SA227 AC, N68TC  
BAYFIELD, COLORADO  
JANUARY 19, 1988**

NTSB/AAR-89/01

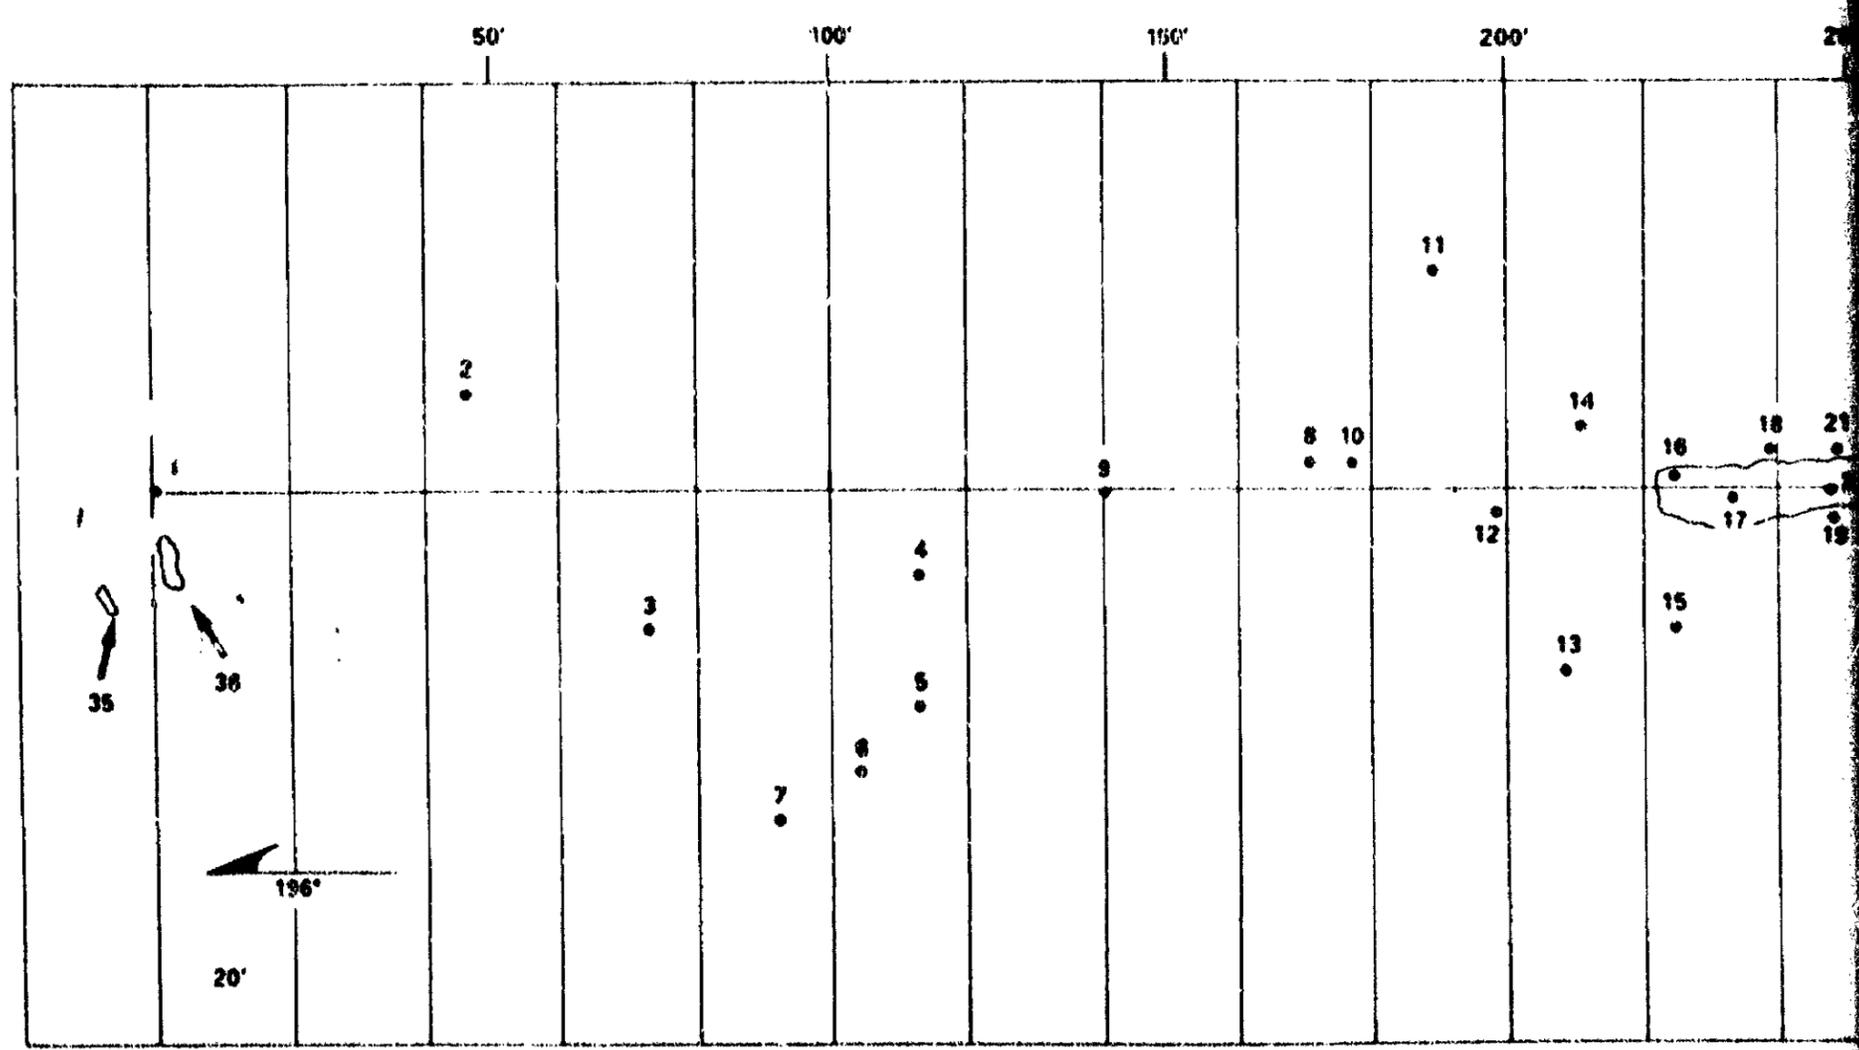
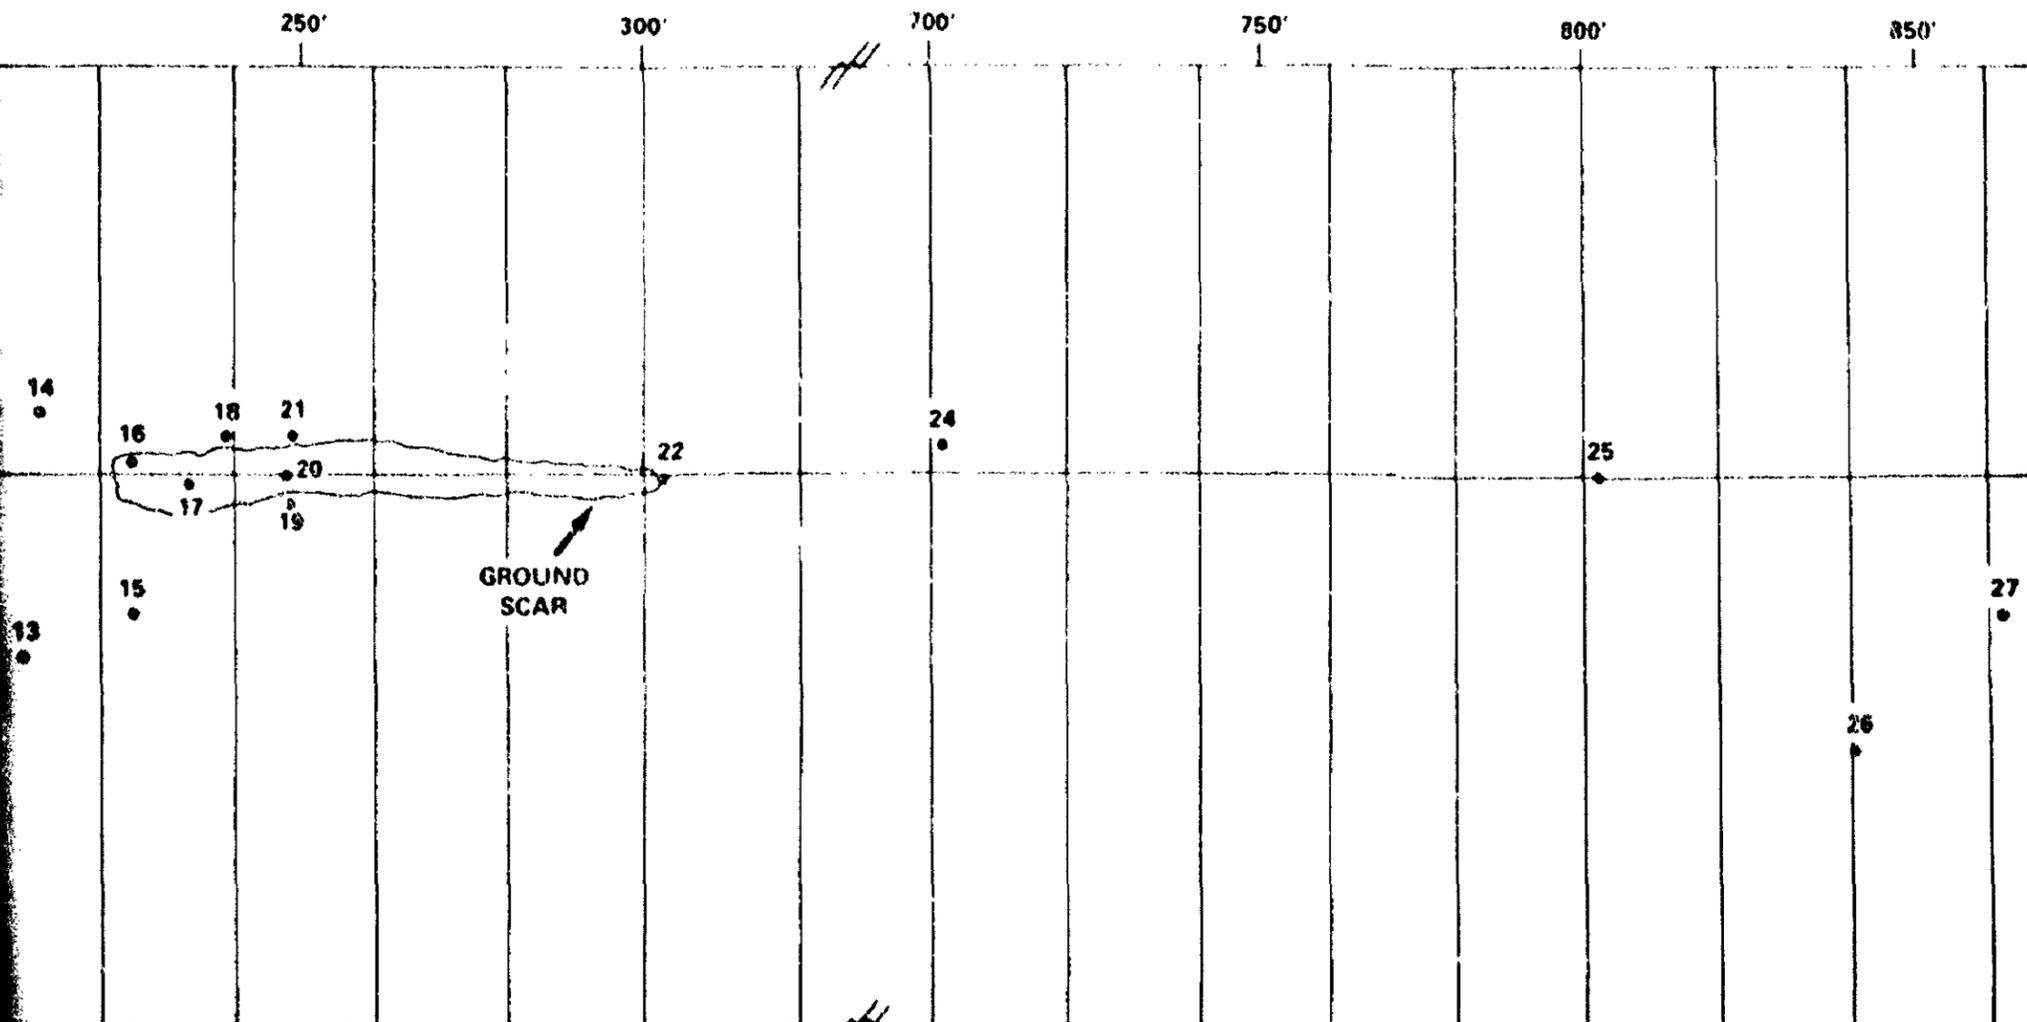
Figure 2.--Wreckage diagram

The main wreckage was found on a heading of 104°. The fuselage was essentially upright, although lying nose down on a hill. (See figure 3.) The wing had separated from the fuselage at the attachment fittings and was lying inverted above the fuselage. (The Metro III is constructed of a single wing that is mated to the fuselage.) The right engine and its nacelle were hanging nose down from the wing, restrained primarily by control cables, tubing, and torn sheet metal. The left engine had been torn from its mounting and was found buried in the snow, adjacent to the right forward fuselage.

About 2/3 of the left part of the wing was fragmented from the tip inward. The left wing tip was found away from the main wreckage near the site of the initial impact with the trees. About 1/4 of the right part of the wing from the tip inward had separated from the remainder of the wing and came to rest about 250 feet from the fuselage within the wreckage path. The left flap actuator was found extended 5 inches, corresponding to a fully extended position.

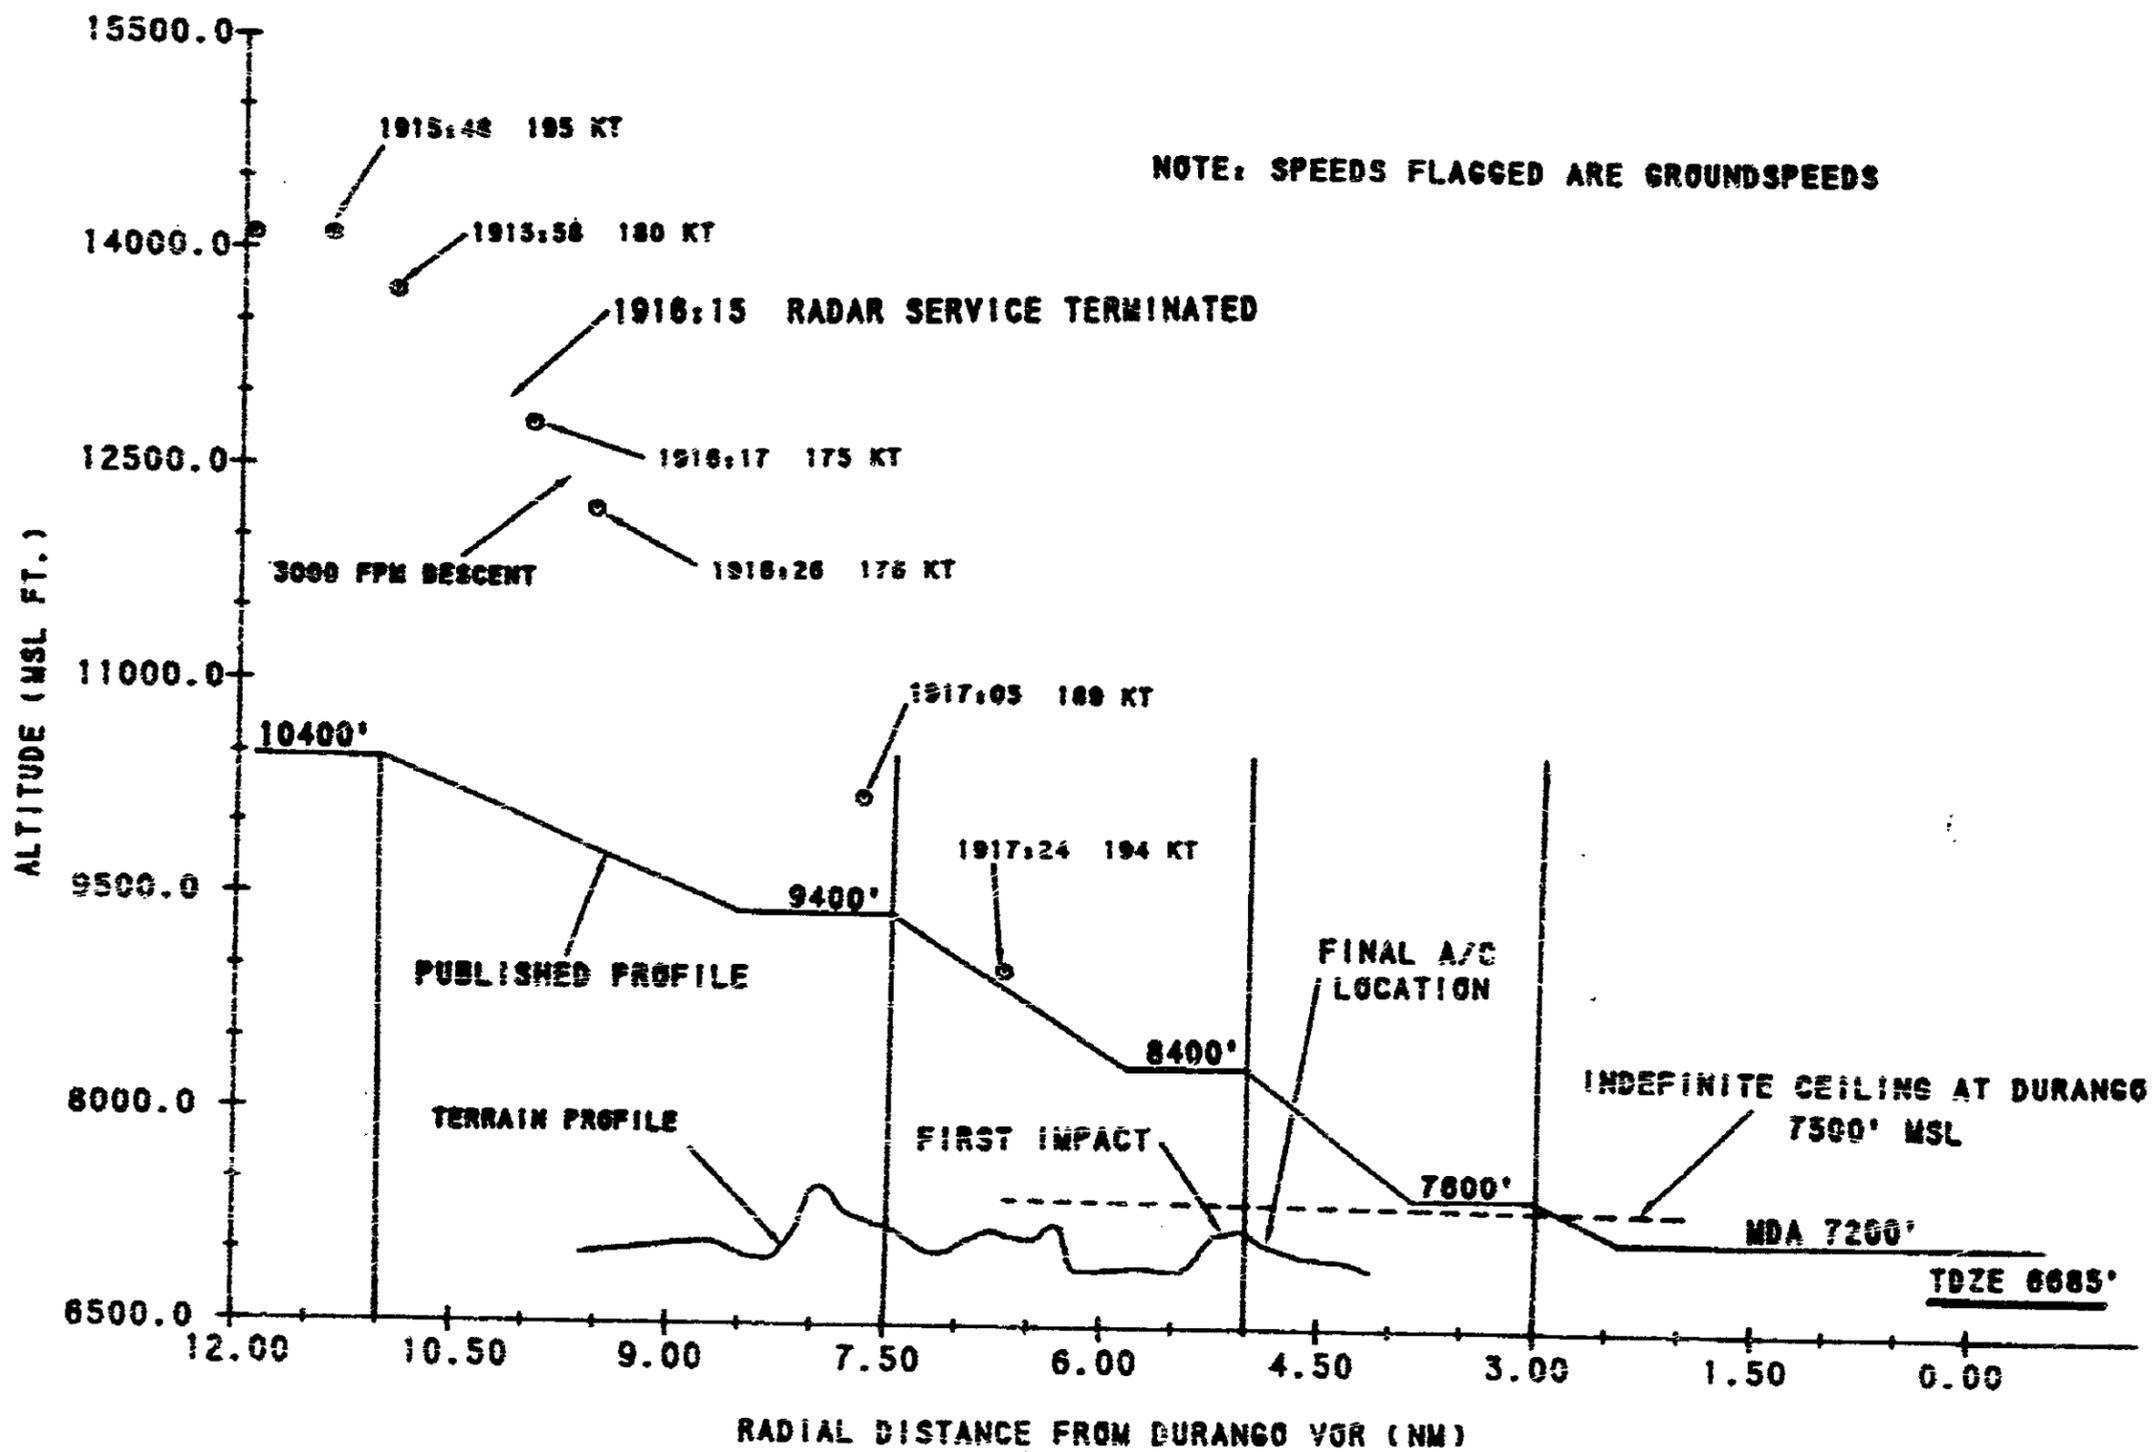
Figure 4.--Profile of the approach of Trans-Colorado 2286 with ground speeds, altitudes, and local times.

The evidence indicates that the first officer, perhaps recognizing the potential influence of the tailwinds and the high altitude, allowed the airplane to reach an over 3,000-fpm descent and an indicated airspeed over 165 knots. Given the documented, repeated instances of deficiencies in his instrument flying abilities, the evidence suggests that he maintained a poor instrument scan and diverted his attention from his altimeter, his DME, or both and allowed the airplane to descend prematurely below the published descent profile.
