# NATIONAL TRANSPORTATION SAFETY BOARD

## AIRCRAFT ACCIDENT REPORT

HORIZON AIR, INC.  
DEHAVILLAND DHC-8  
SEATTLE-TACOMA INTERNATIONAL AIRPORT  
SEATTLE, WASHINGTON  
APRIL 15, 1988

NTSB/AAR-89/02

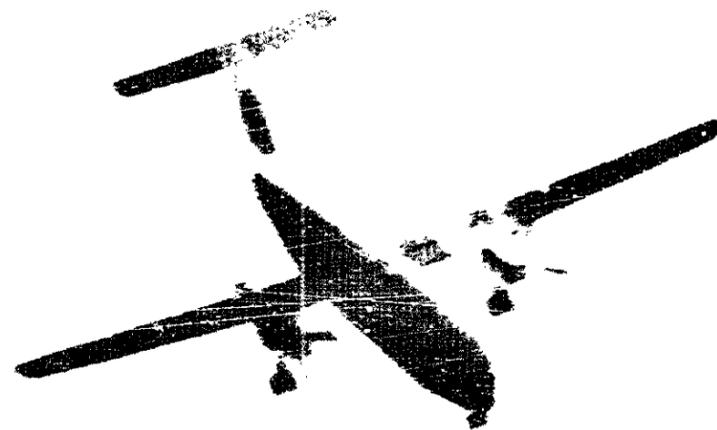
Figure 1. A photograph of N819PH on its final approach

The first officer stated that as he was scanning for traffic out the right side window during the turn to final approach, he observed a "flash" from the right engine. The first officer then observed that the center access panel on the left side of the right nacelle was missing and that an orange/yellow flame was in that area. The passenger in seat 9E also observed the fire and saw sections of engine cowl fall from the right nacelle. At 1831:03 the first officer stated, "We got a fire." Three seconds later the captain stated, "Max power . . .," and at 1831:09 he called for 15° of flaps. According to the FDR, the flaps began to move down shortly thereafter. After informing the captain of the fire, the first officer returned his attention to the engine instruments. The captain then retarded the right condition lever to the Start and Feather position and told the first officer to pull the fuel cutoff T-handle and fire the extinguisher bottles. After the first officer fired the extinguisher bottles and pulled the fuel cutoff T-handle, he observed that the fire was still burning and also that the green landing gear lights were no longer illuminated. (See figure 1.)

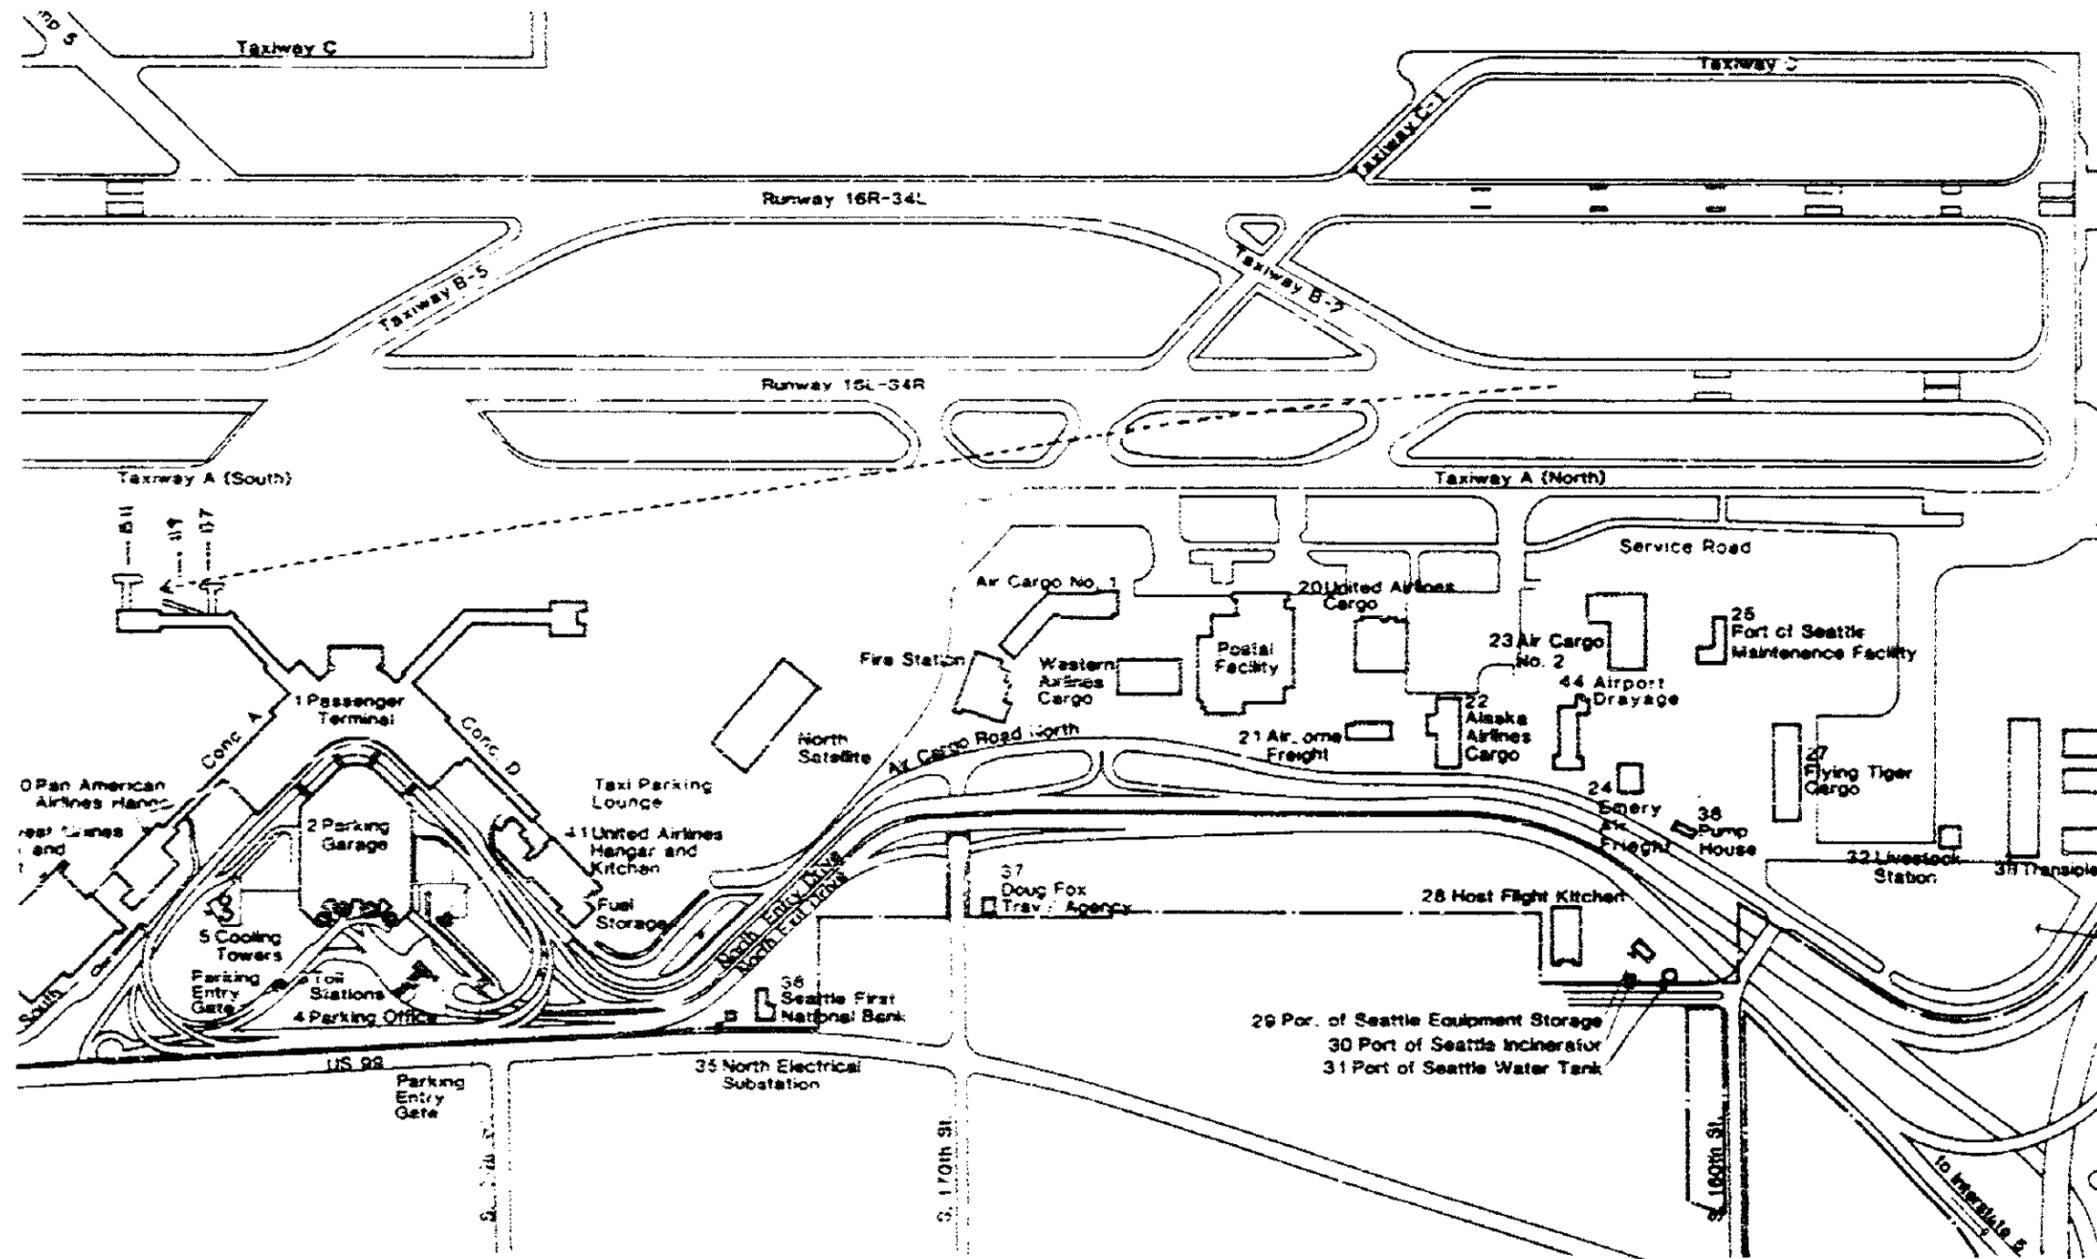
Figure 2. Diagram of the ground path of the airplane

The first officer also tried his right rudder pedal, but it was already full right. He then noticed that the right brake pedal was already depressed and that the emergency brake was locked. He then advised the tower that the airplane was out of control and manually locked his and the captain's shoulder harnesses. As the airplane rolled onto the ramp pavement after crossing grass areas and taxiways on the airport, it struck and destroyed a frangible lighted runway designator sign. By this juncture, the airplane heading had changed another 2° to the left. Neither crewmember felt any deceleration. As the airplane entered the ramp area south of the tower, it struck jetway B7 damaging the outboard left wing. After striking the first jetway, the airplane struck jetway B9 causing the outboard left wing to separate from the airplane. The airplane struck and destroyed several baggage carts and pieces of ground equipment as it traversed the area between jetways B7 and B9 and came to rest against jetway B11 at 1832:31. (See figure 2.)

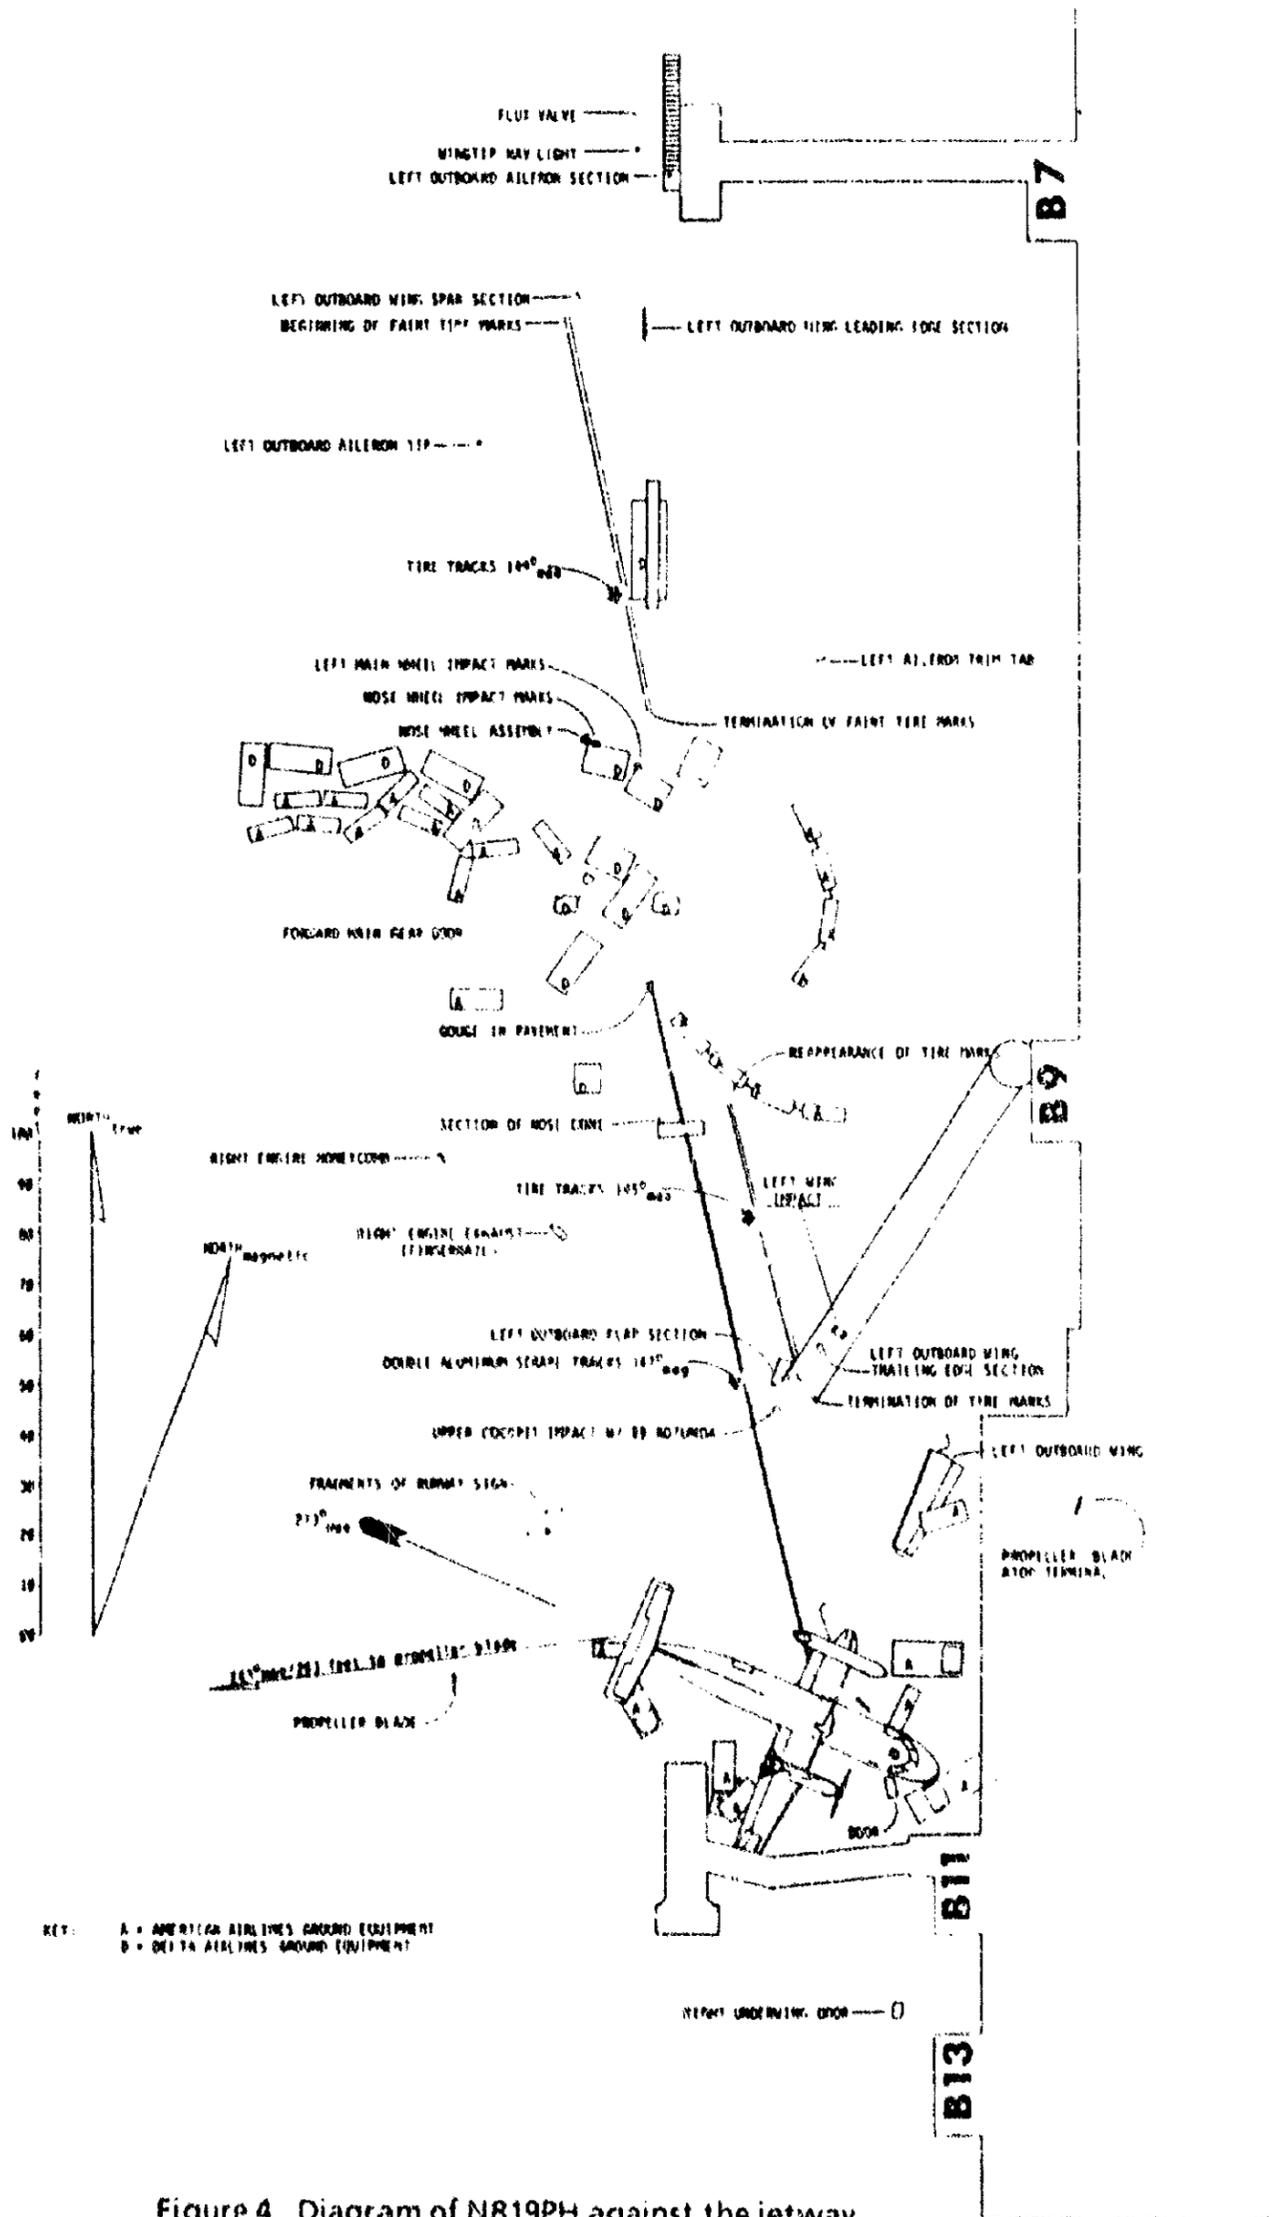
Figure 4 Diagram of N819PH against the jetway

The right wing and right engine/engine nacelle sustained heavy fire damage. The aft portion of the nacelle was consumed by fire. The propeller was attached to the engine; however, one blade had separated and was recovered about 15 feet behind the left engine nacelle. (See figure 4.)

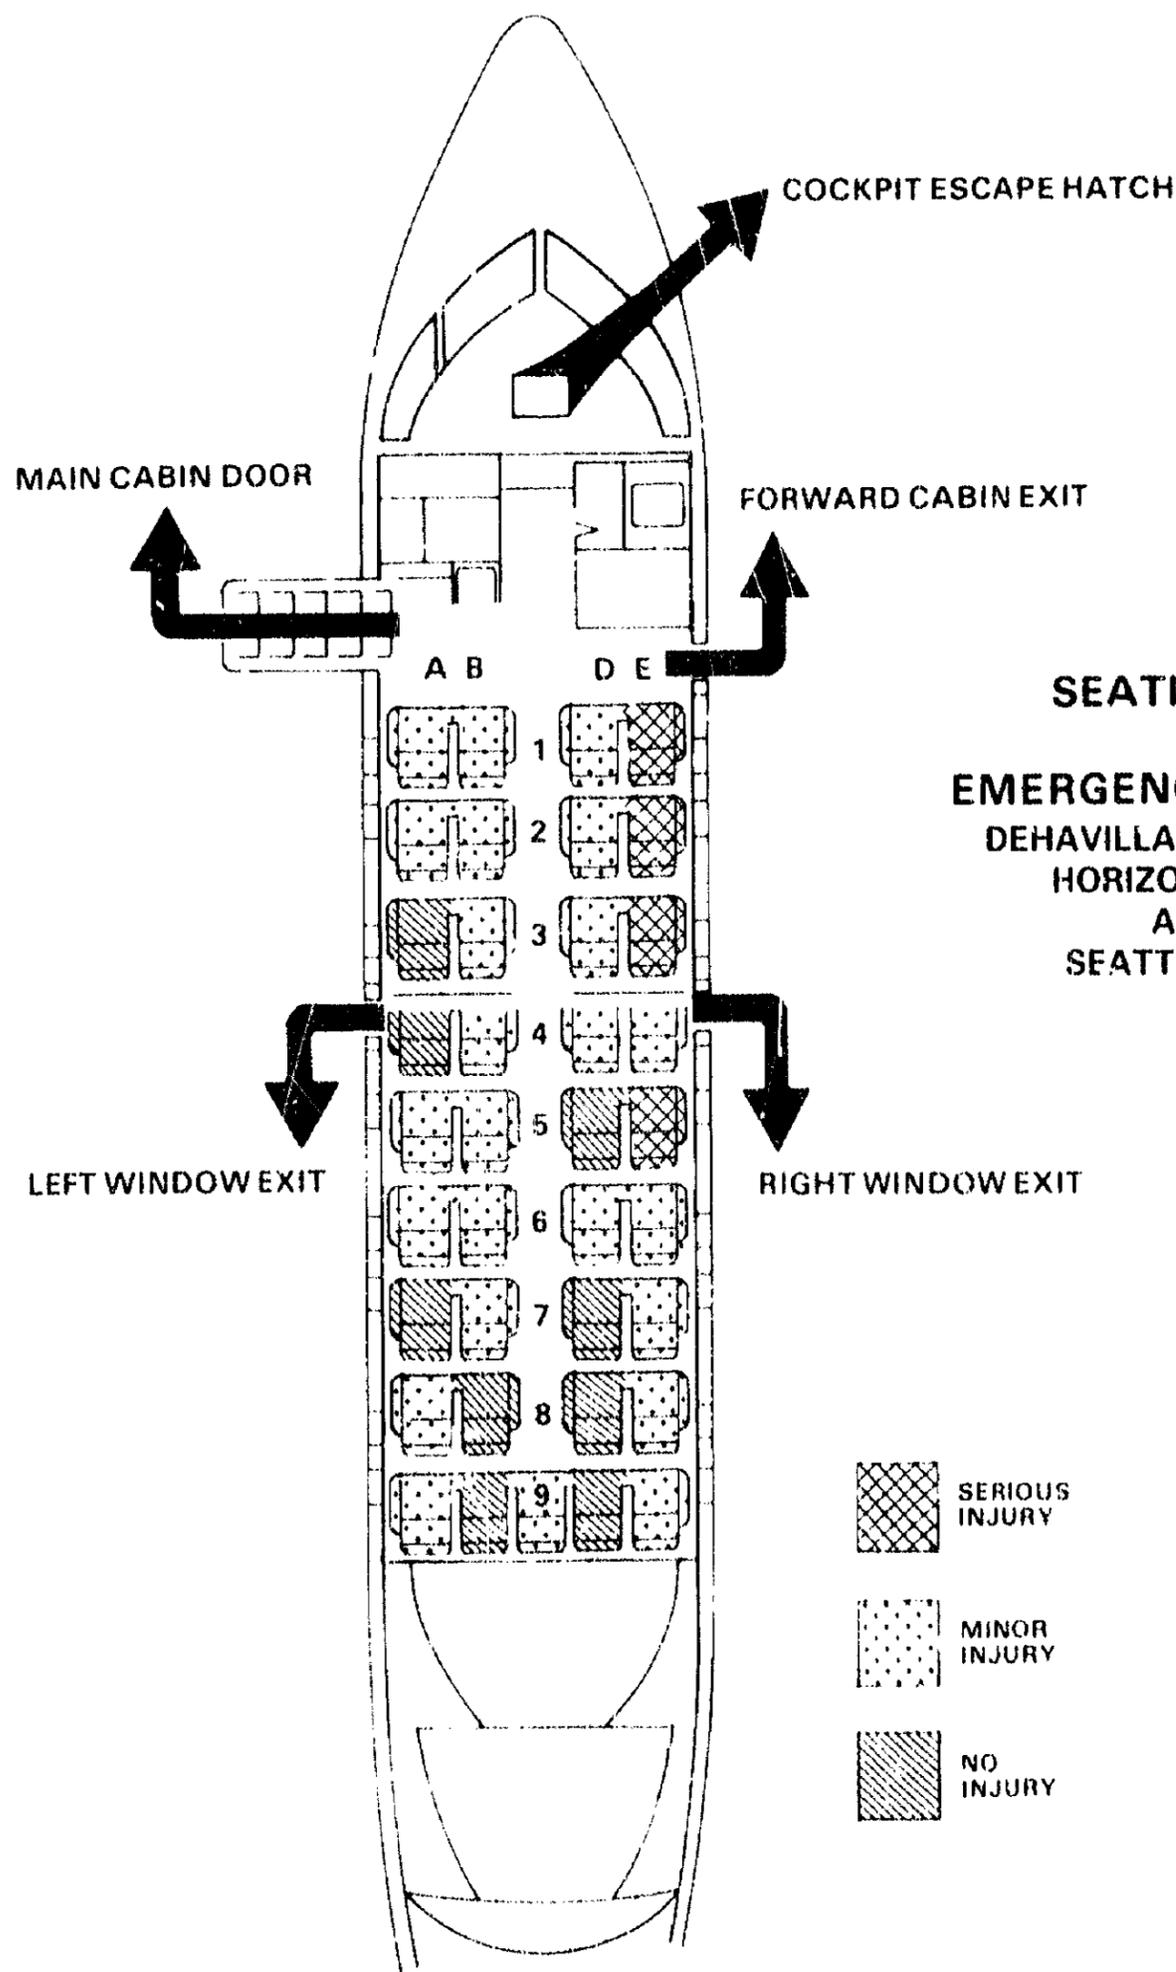
Figure 5. Injury distribution chart and seating arrangement.

Seats 1DE, 2DE, and 3DE, in the area most heavily damaged during impact with ground equipment, were torn loose during the accident sequence. The passengers in seats 3D and 3E were ejected from the airplane while still buckled in their seats. The forward and aft outboard leg attachments of seat 9E separated from the floor track. All other passenger seats as well as the flight attendant's seat remained attached to the airplane floor, although some passenger seats sustained some degree of impact deformation. The overhead compartments over seats 2DE and 3DE were open, while all other overhead compartments were closed.

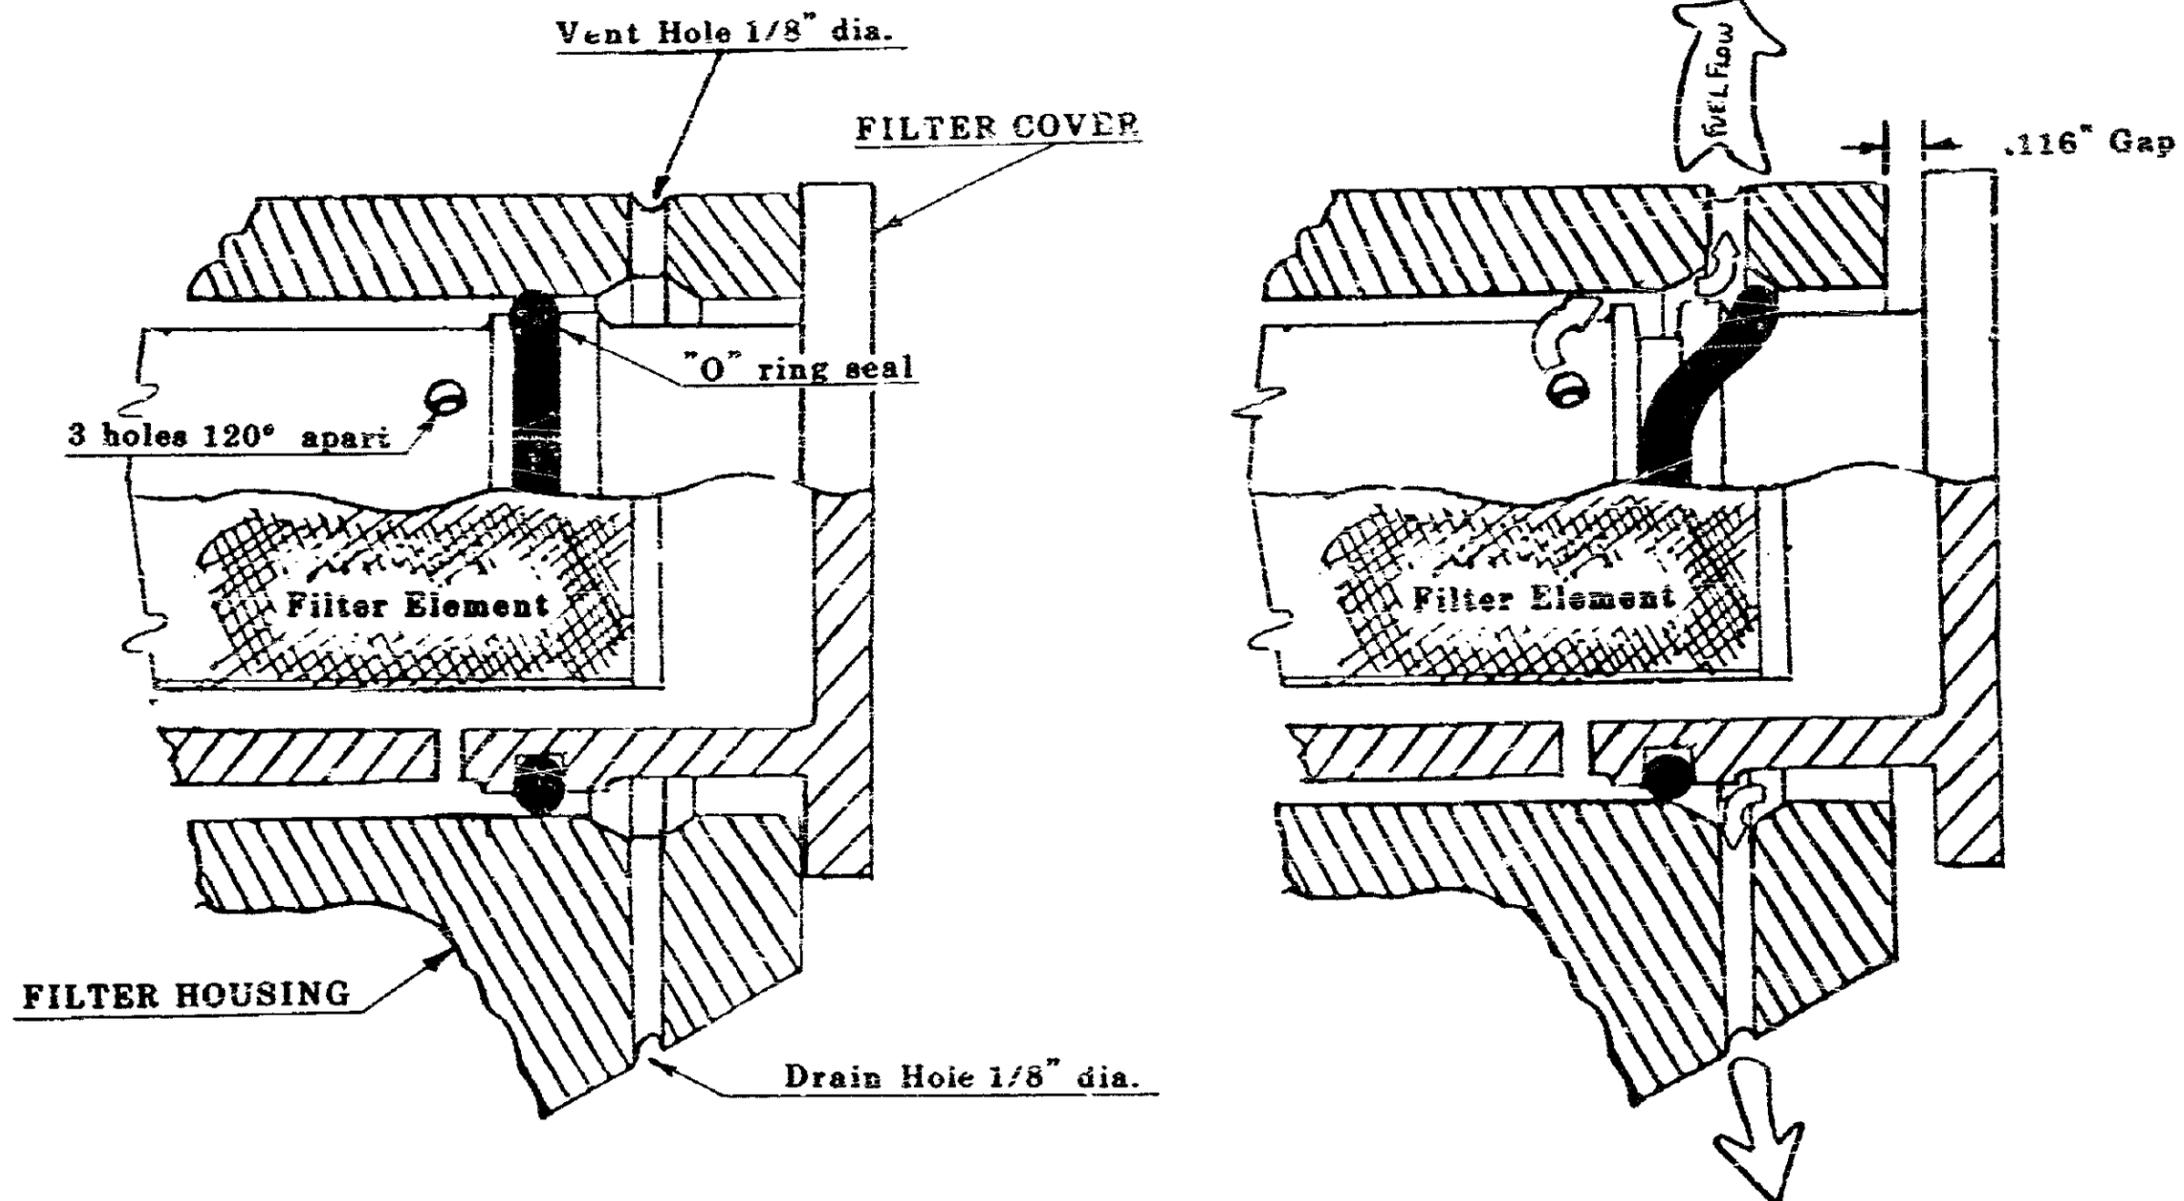
**Stylized Side View**  
**HP Fuel Pump Filter Assembly**

There was a 0.116-inch gap between the HMU high pressure fuel filter cover and the face of the housing. Fuel was observed leaking from the bottom of the gap 22 hours after the accident. The fuel filter cover on the left engine was examined, and the cover was noted to be bottomed against the filter housing; there was no gap. Specified torque on the fuel filter cover is 100 to 150 inch pounds.

Filter Assembly and O-Ring  
In Normal Position

Filter Assembly (with gapped cover)  
and O-Ring in Extruded Position

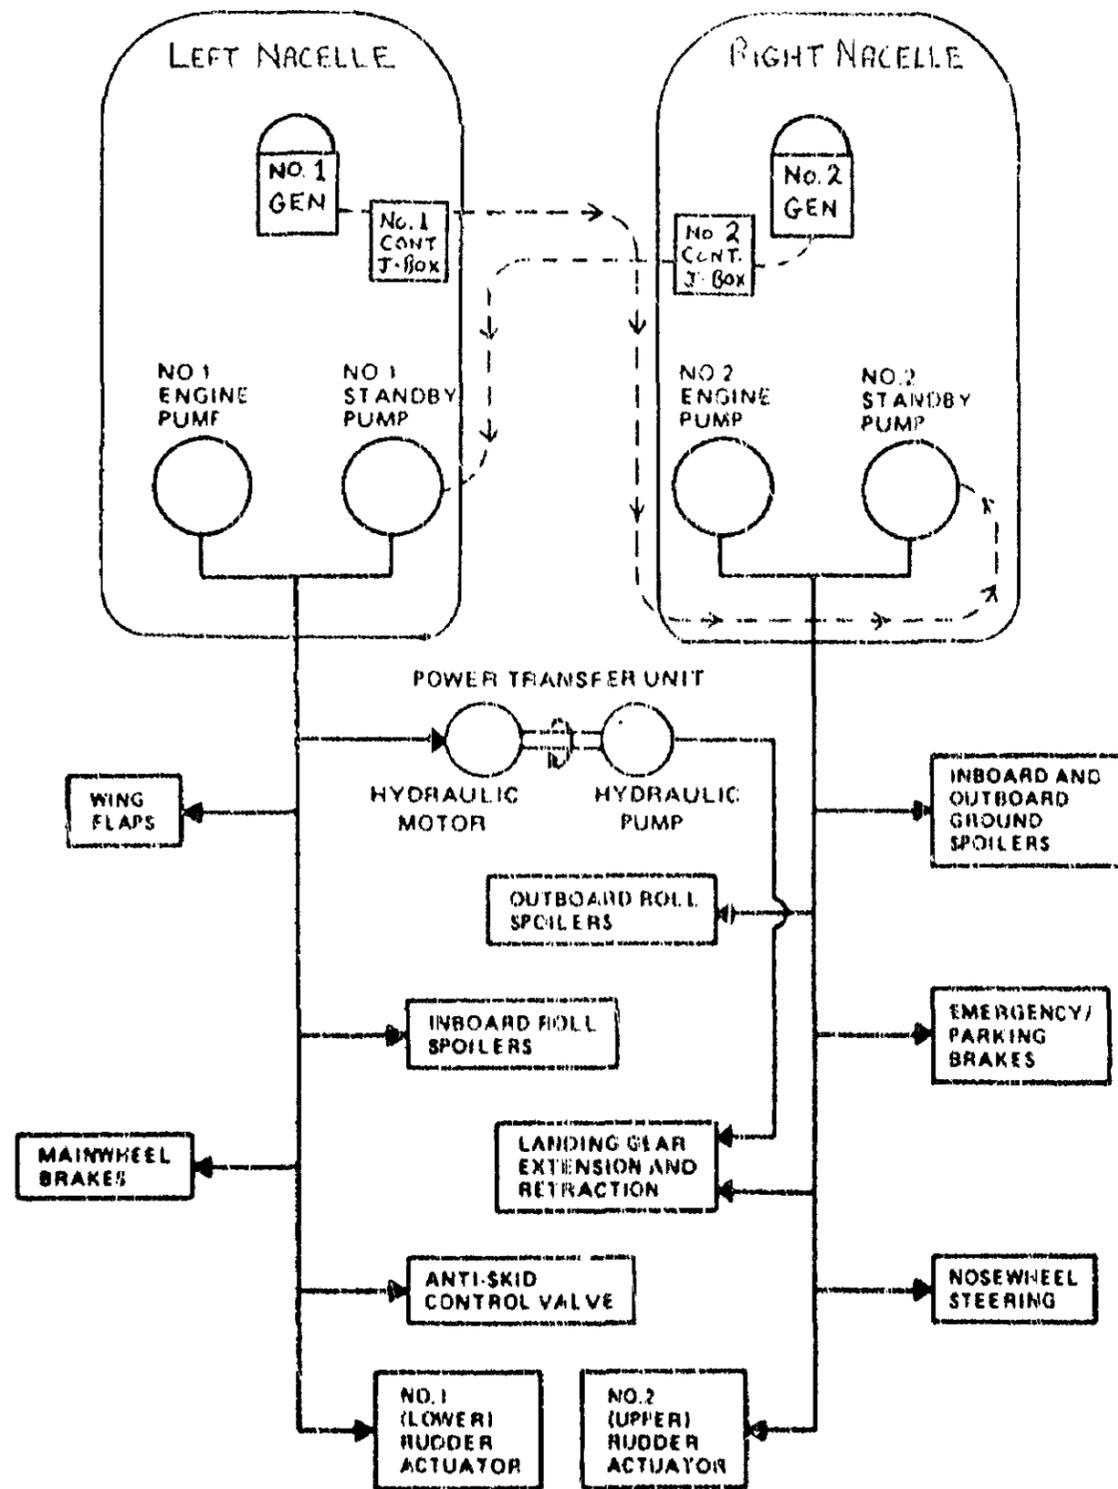
Figure 7. Schematic of the DHC-8 hydraulic system primary component

The N819PH was equipped with two independent constant pressure, variable flow hydraulic systems called the No. 1 (left) and the No. 2 (right) systems. By design, it was not possible to transfer control of hydraulic devices from one system to the other. The airplane was equipped with an emergency hydraulic system hand pump for use during emergency extension of the landing gear. Also, a power transfer unit (PTU) was installed to aid in the retraction of the landing gear in the event of a right engine failure on takeoff. The PTU consisted of a No. 1 (left) system hydraulic motor mechanically linked to a hydraulic pump that provided emergency pressure to the landing gear retract cylinders, a No. 2 (right) system component. No fluid transfer between hydraulic systems could occur normally in the PTU. The output pressure of the engine driven hydraulic pumps was rated at about 3,000 psi. Their flow rate was rated as 9.2 gallons per minute. The output pressure of the electric standby hydraulic pumps was rated as 2,750 psi under load. Their flow rate was rated as 1.56 gallons per minute. The No. 1 (left system) electric standby hydraulic pump received electrical power from the No. 2 (right) electrical supply contactor junction box, and vice versa. (See figure 7.)

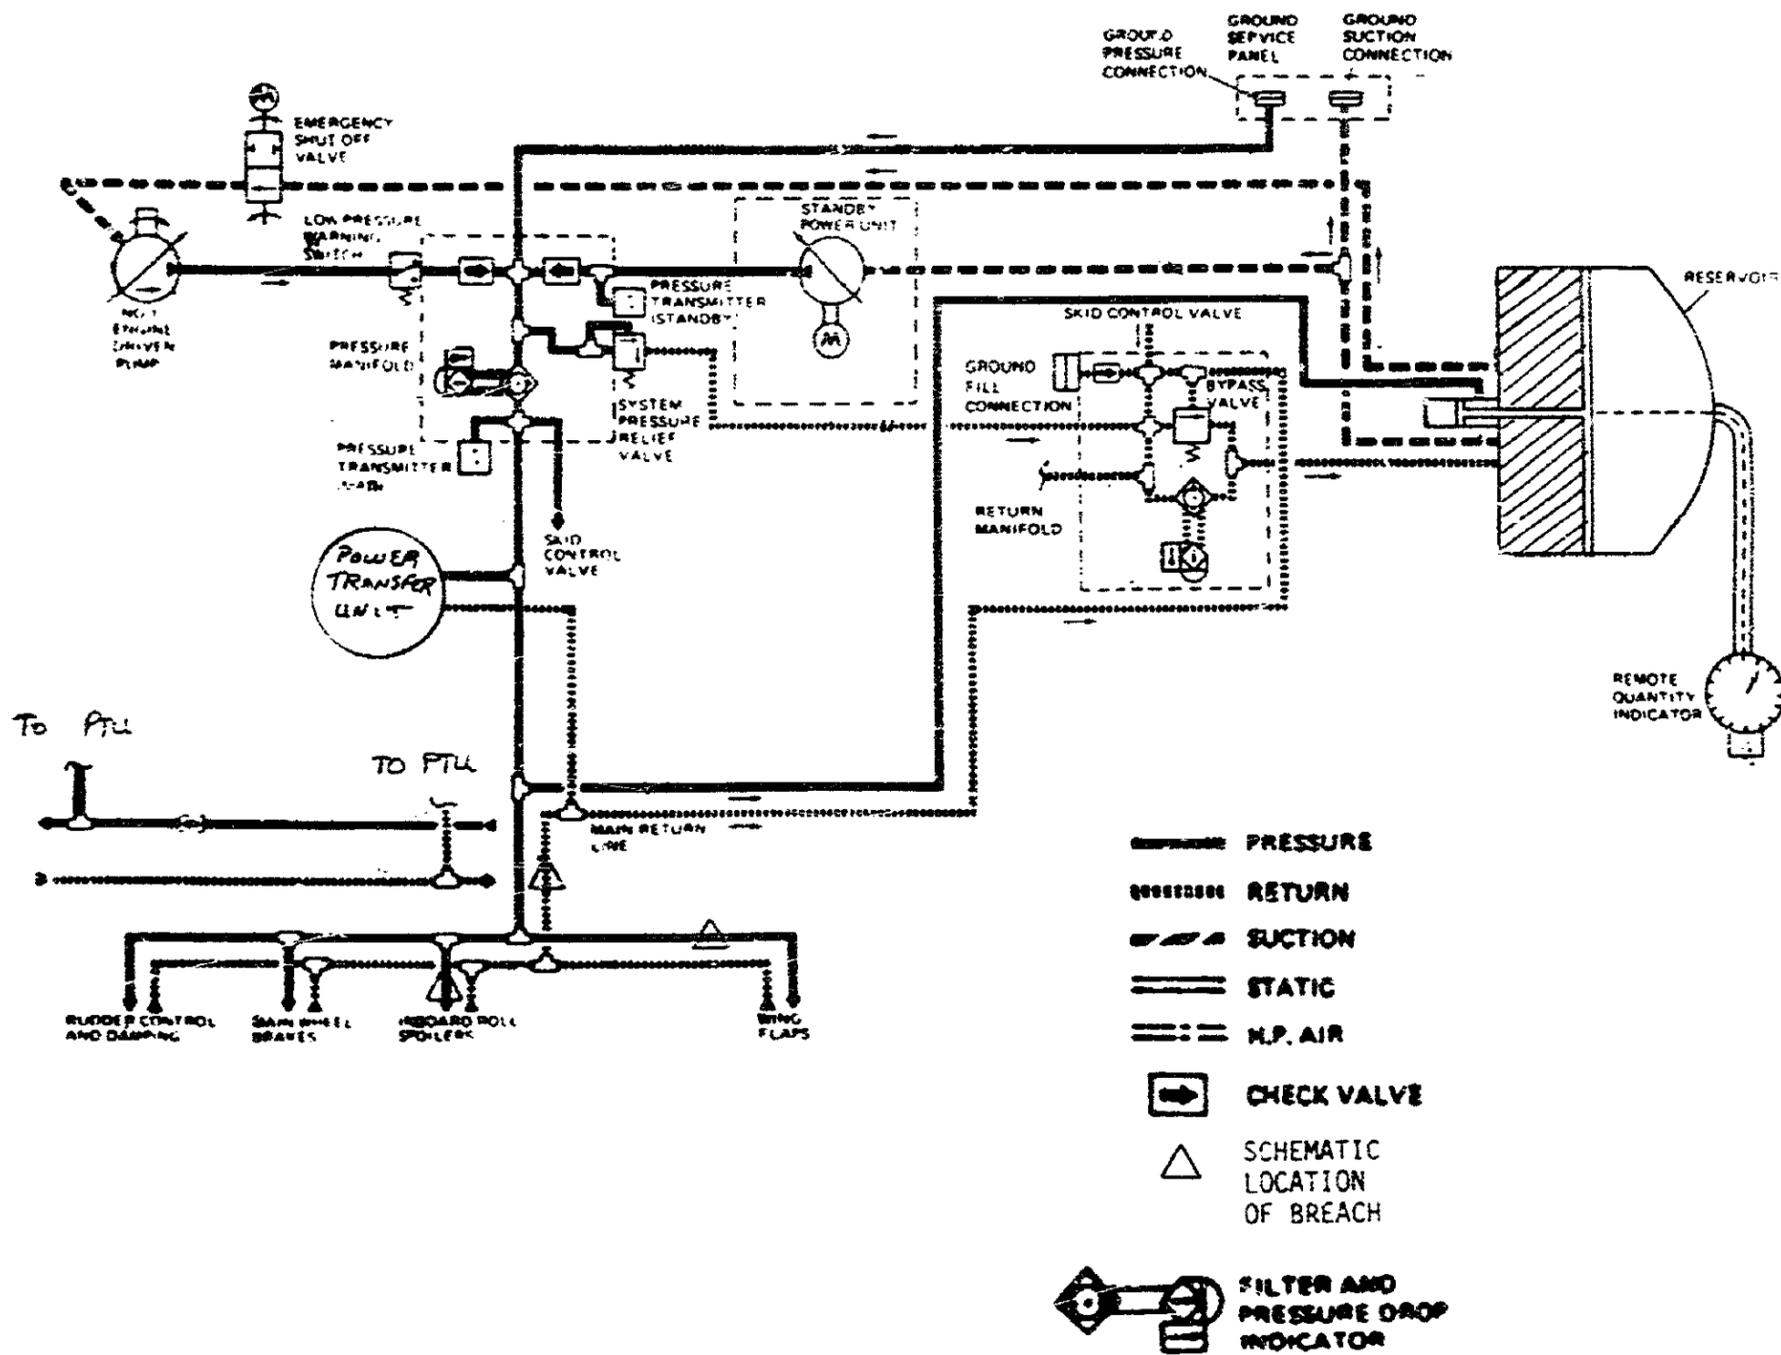
Figure 8. Simplified schematic of the No. 1 hydraulic system

Three No. 1 (left) hydraulic pressure and fluid return lines in the right wing rear spar area of the right wheel well had been burned through by the fire. These fluid return lines included: one 1/4-inch diameter hydraulic pressure supply line to the right wing inboard roll spoilers; one 1/4-inch diameter lift dump pressure line; and one 3/8-inch diameter No. 1 hydraulic system return line. Also, the emergency/parking brake accumulator unit was found intact but both hydraulic lines to it were burned through. (See figure B.) The destruction of these five hydraulic lines disabled both hydraulic systems.

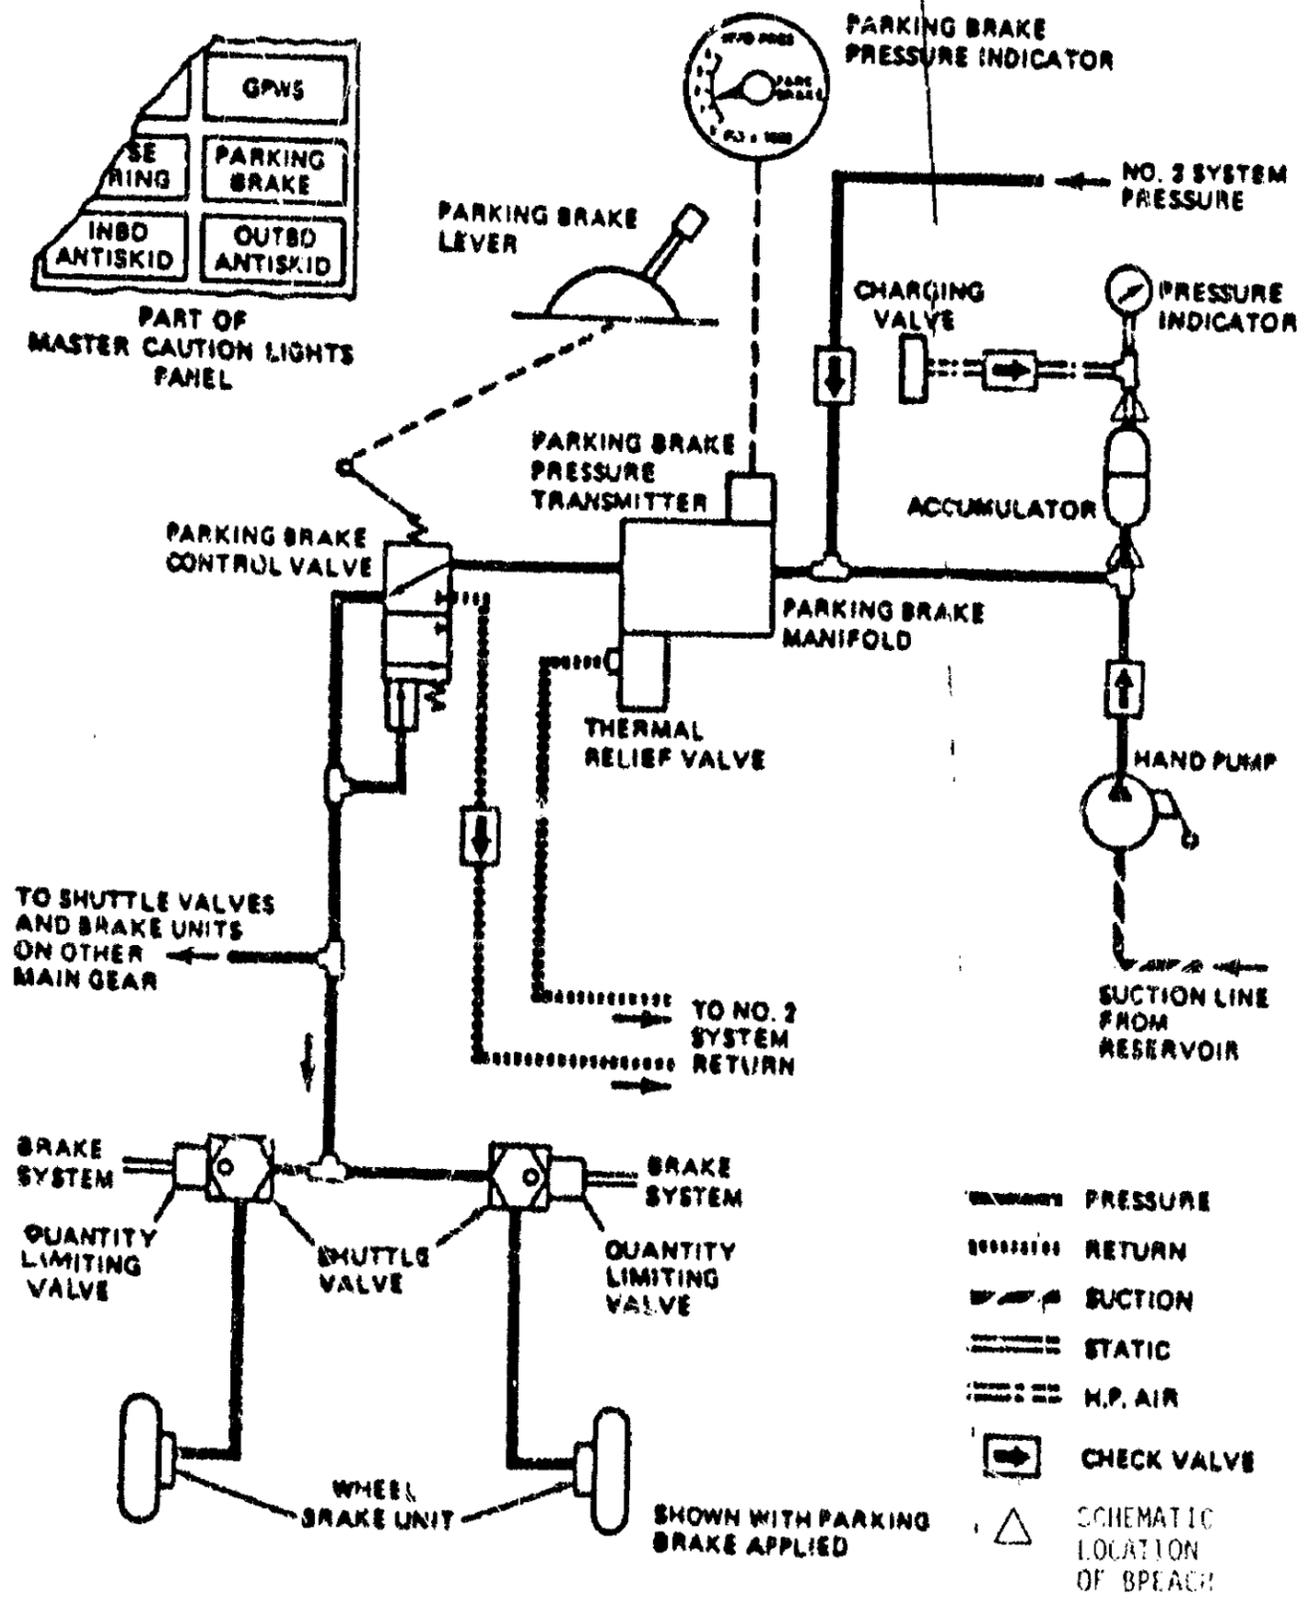
Figure 9 Schematic of the emergency/parking brake system

The DHC-8 emergency/parking brake system provides an independent source of braking to the main wheel brakes. During normal operations, the system receives hydraulic pressure from the No. 2 system engine-driven hydraulic pump. A check valve isolates the system from the No. 2 system pump in the event of an upstream line failure. An accumulator provides power for the system when engine-driven pump pressure is unavailable. The system is operated by a handle on the center console and serves as a parking brake system under normal operations. The crew may activate the lever and use a spring-loaded button on the control lever to lock the lever in the on position. This provides hydraulic pressure to the main wheel brakes through the system powered by the accumulator. In an emergency, the lever is activated to provide braking to the main wheel brakes independent of No. 2 system hydraulic pressure. (See figure 9.)
