PB90-910403  
NTSB/AAR-90/03

# NATIONAL TRANSPORTATION SAFETY BOARD

## AIRCRAFT ACCIDENT REPORT

USAIR, INC., BOEING 737-400  
LAGUARDIA AIRPORT  
FLUSHING, NEW YORK  
SEPTEMBER 20, 1989

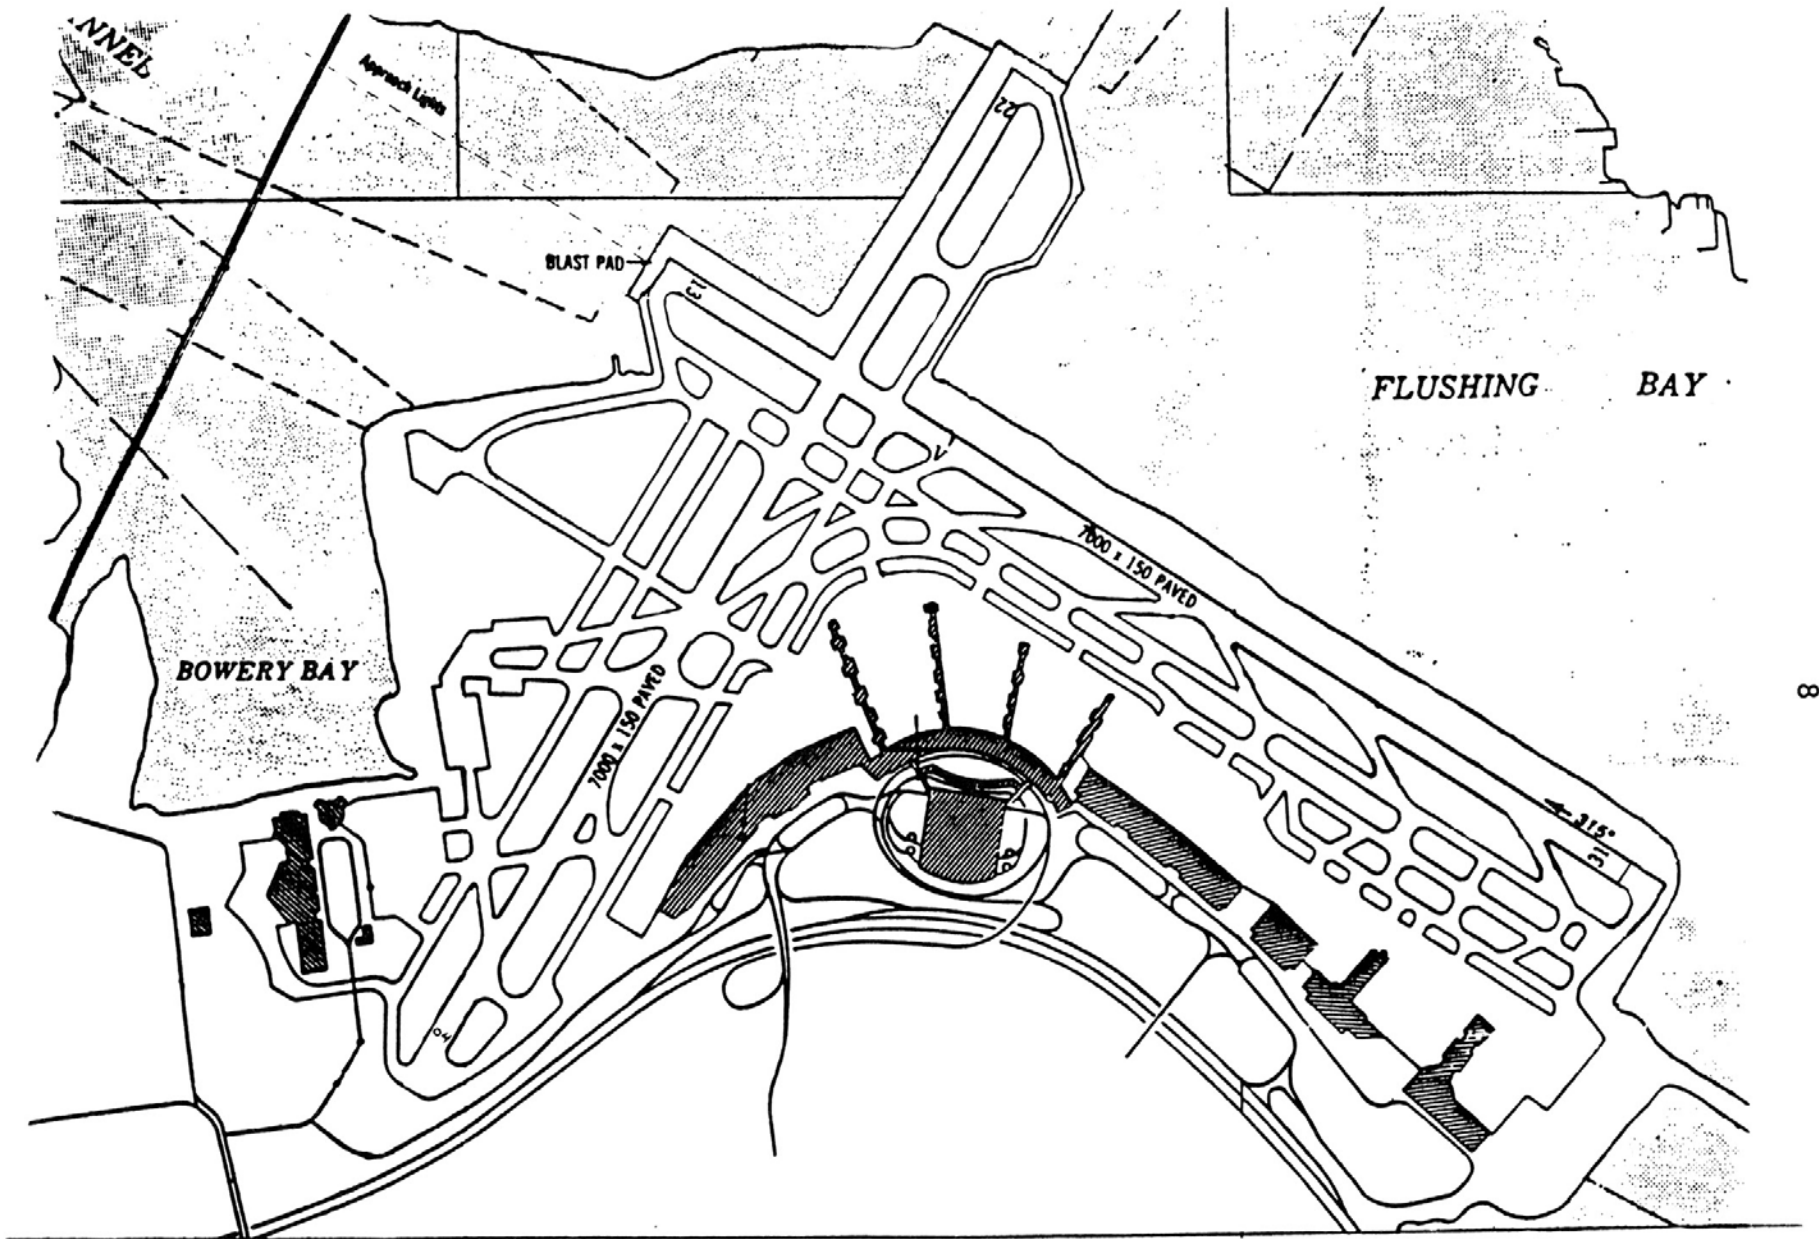
Figure 1.--Airport diagram.

Runway 31 is 7,000 feet long by 150 feet wide with a 100-foot overrun at the departure end (figure 1). The surface is asphalt with saw-cut transverse grooves 1 1/2 inches apart and 1/4 inch wide and deep. About the last 900 feet is concrete with similar, but not uniform, transverse grooves averaging 1/8 inch deep. The concrete portion, including a 100-foot ungrooved and heavily painted overrun before the threshold, is on an elevated deck above Bowery Bay. Runway 31's slope increases from 7 feet msl at the threshold to 13 feet msl at the runway 13 threshold. The surface between taxiways X and L received a rubber-removal treatment on September 3, 1989. Runway 4/22 also is 150 feet wide and crosses runway 31 about 1,300 feet from the departure end. Runway 31 has a three-bar visual approach slope indicator (VASI), centerline and edge lighting, and runway end identifier lights.

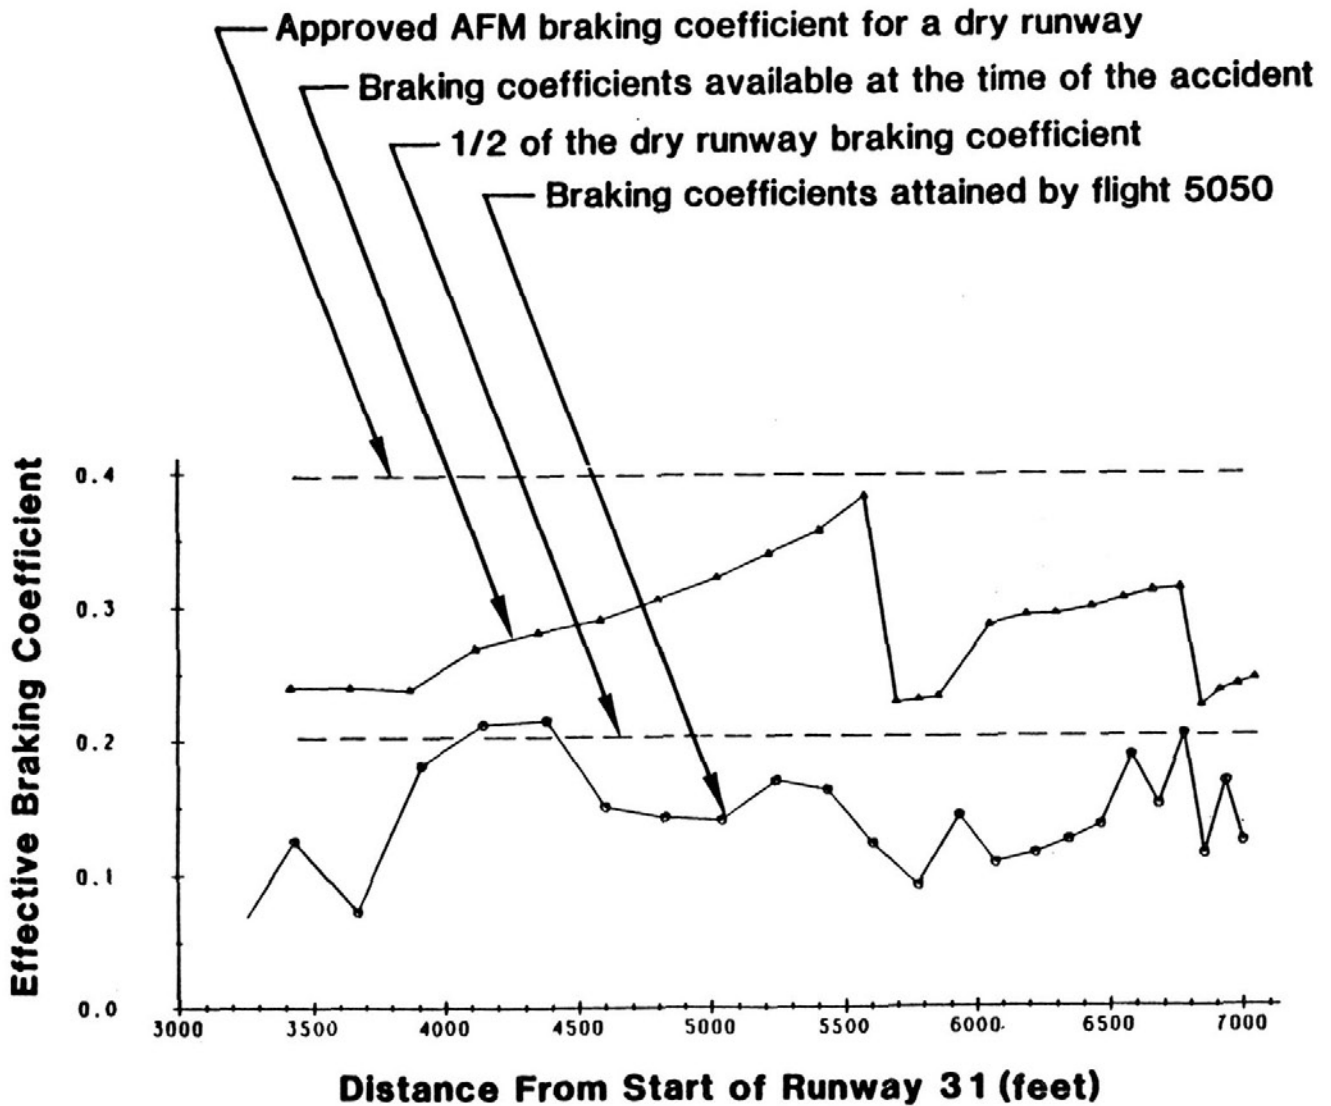
Figure 2.--NASA Evaluation of B-737-400 aircraft rejected takeoff on runway 31 at LaGuardia Airport on September 20, 1989.

Based on runway surface characteristics, crown, and texture depth values, the drainage analysis indicates that runway 31 had excellent water drainage capability (excluding the painted nongrooved blast pad [overrun] area) particularly for the rainfall rate occurring at the time of the accident (.008 in./hr.). With the transverse grooving, and the good tread condition of the main gear tires, hydroplaning was not a significant factor. Except for approximately 1,200 feet near runway 4/22 intersection, the accident aircraft RTO track was established by the white tire erasure marks found on both the asphalt and concrete deck surfaces of the runway. In terms of tire friction performance, the Saab friction tester results indicate that the lateral displacement of the aircraft left of centerline actually provided better friction performance compared to that measured closer to runway centerline.

runway threshold. About 5,000 feet from the threshold, the two nose gear scrub marks merged into one wider mark for a short distance before they disappeared. The scrub marks on the overrun reappeared at the end of the runway near the centerline and extended onto the overrun. The location of the tire marks is depicted in figure 2.

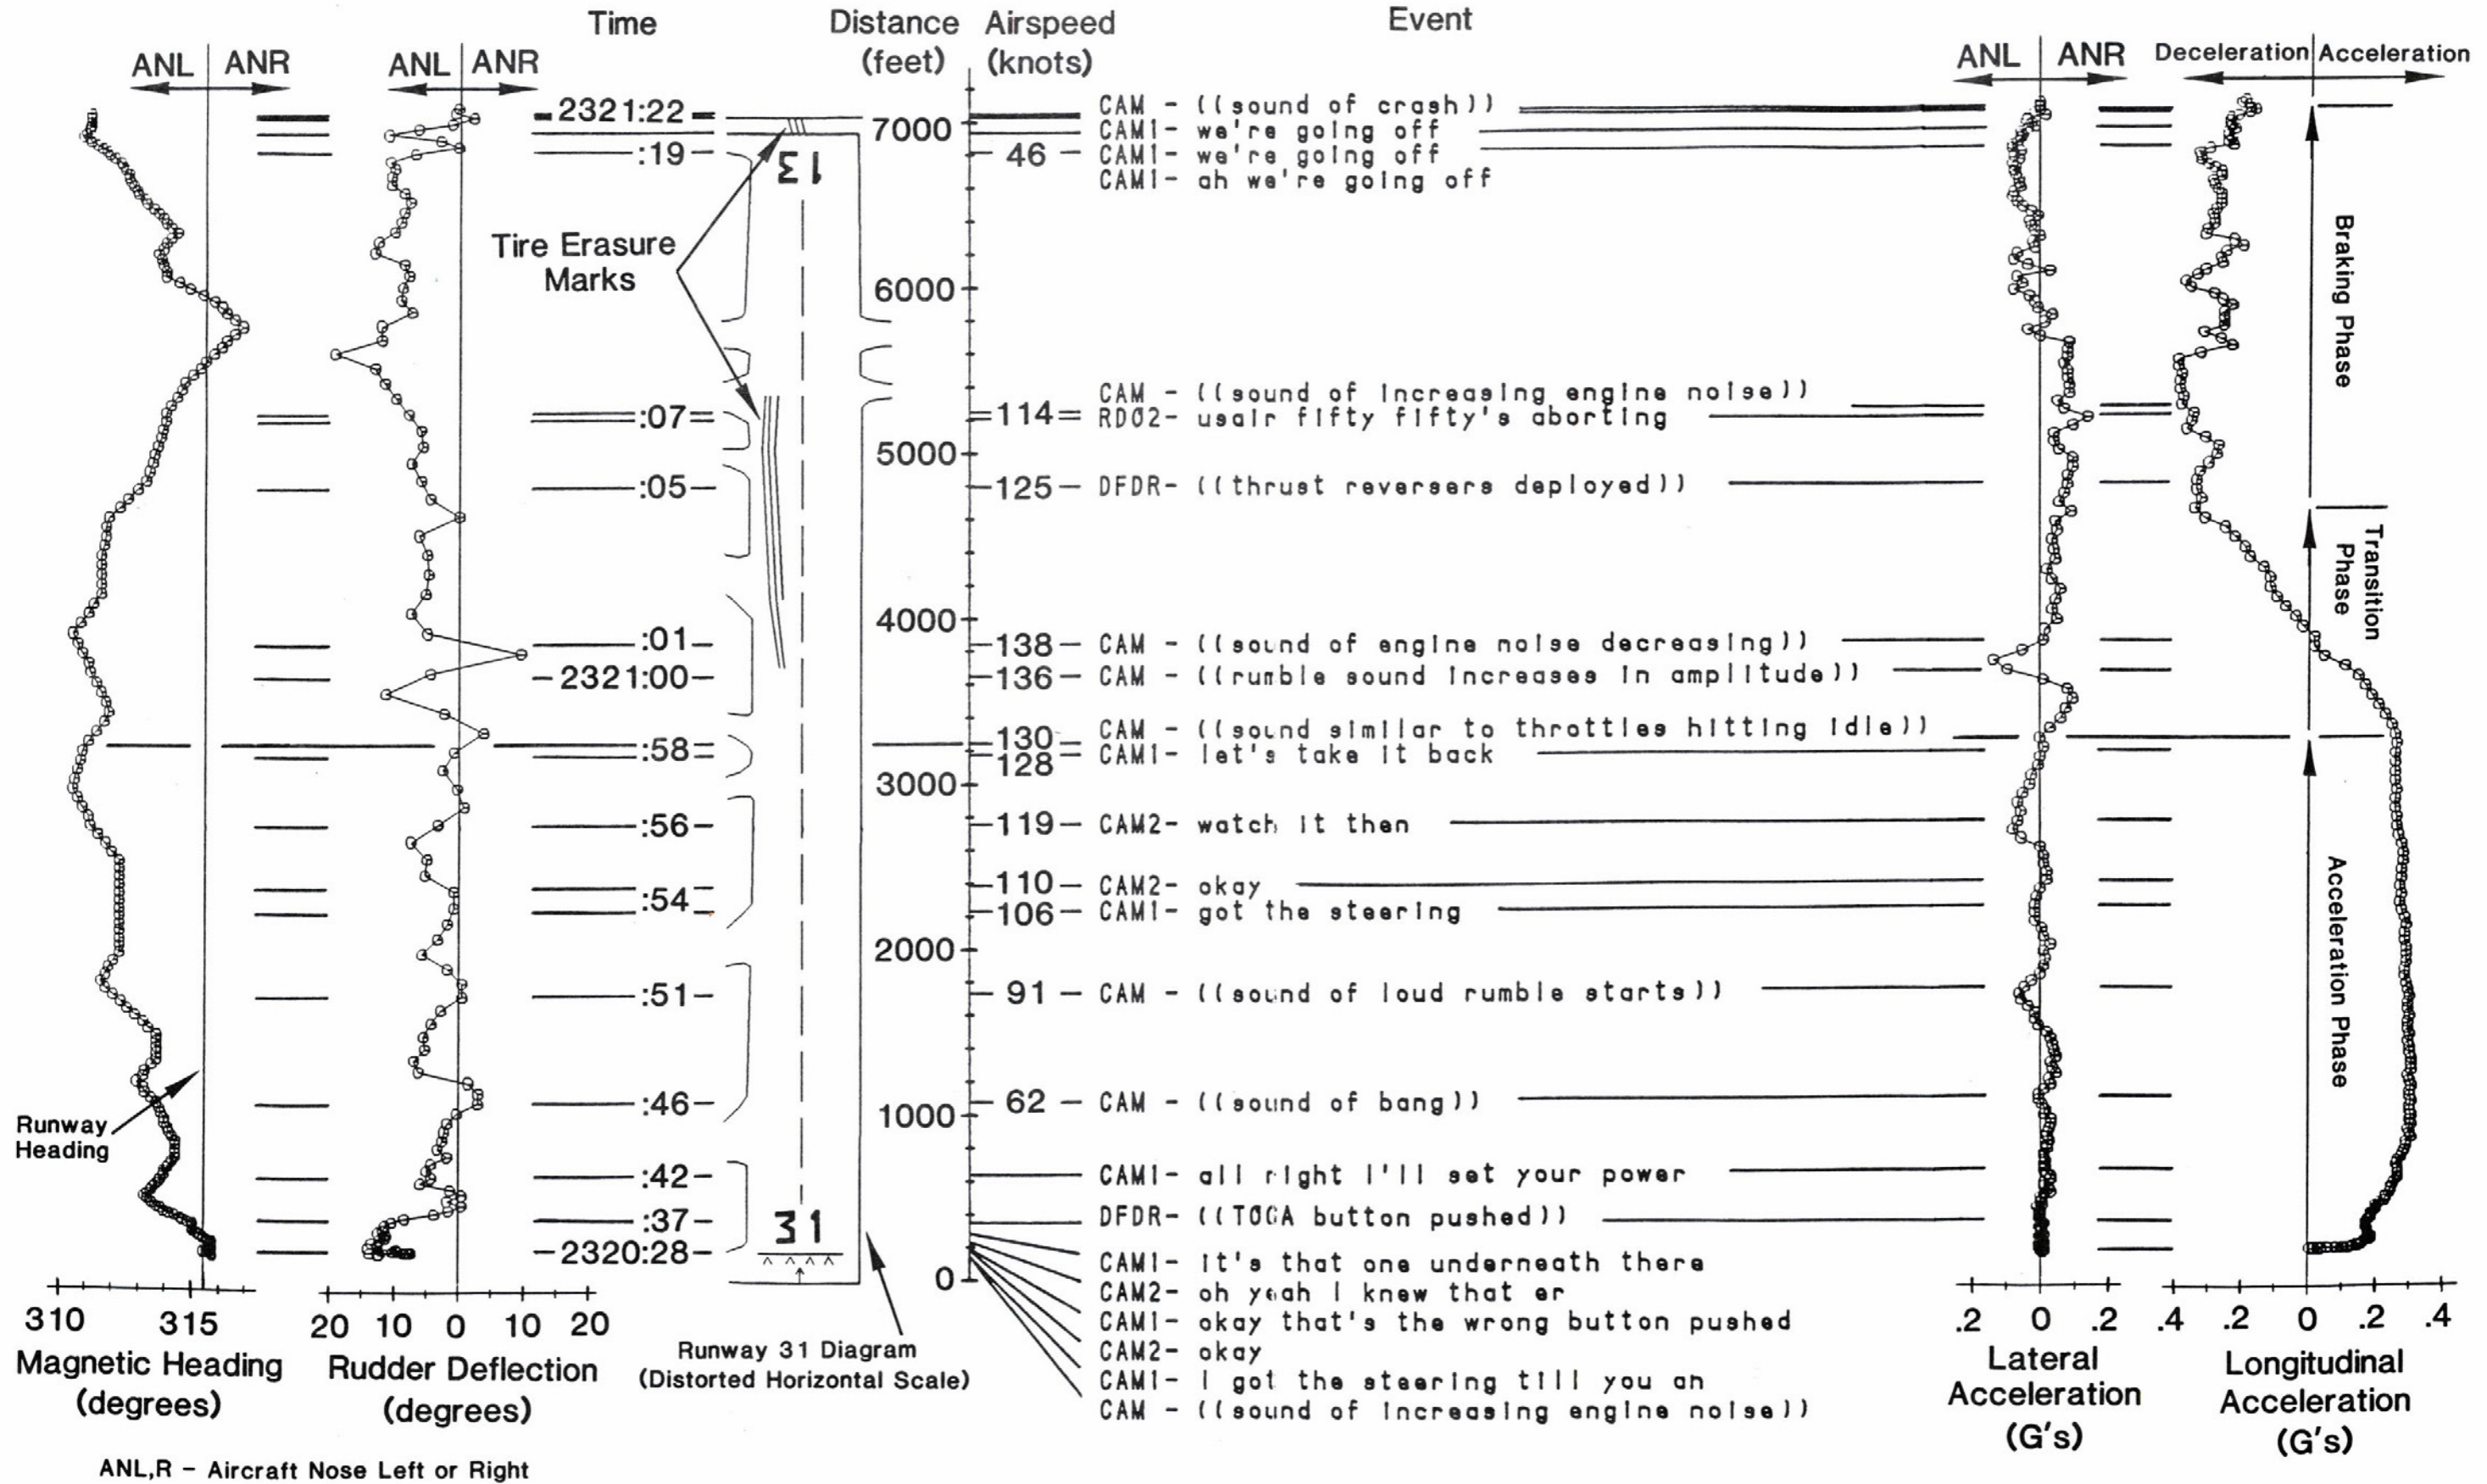
Figure 3.--DFDR/CVR information.

The first indication of the takeoff start was the increasing N1 values for both engines. During the early part of the takeoff, the airplane's heading deviated nearly 2° left of the runway heading, rudder position varied from 0.44° right to 6.9° left, ground speed increased to 91 knots, and N1 values for the left and right engines increased to 91.5 and 94.5 percent, respectively. The airplane's heading was nearly 5° to the left of the runway

heading when an engine power reduction to idle power was recorded. The rudder was nearly centered and the airspeed was about 130 knots.

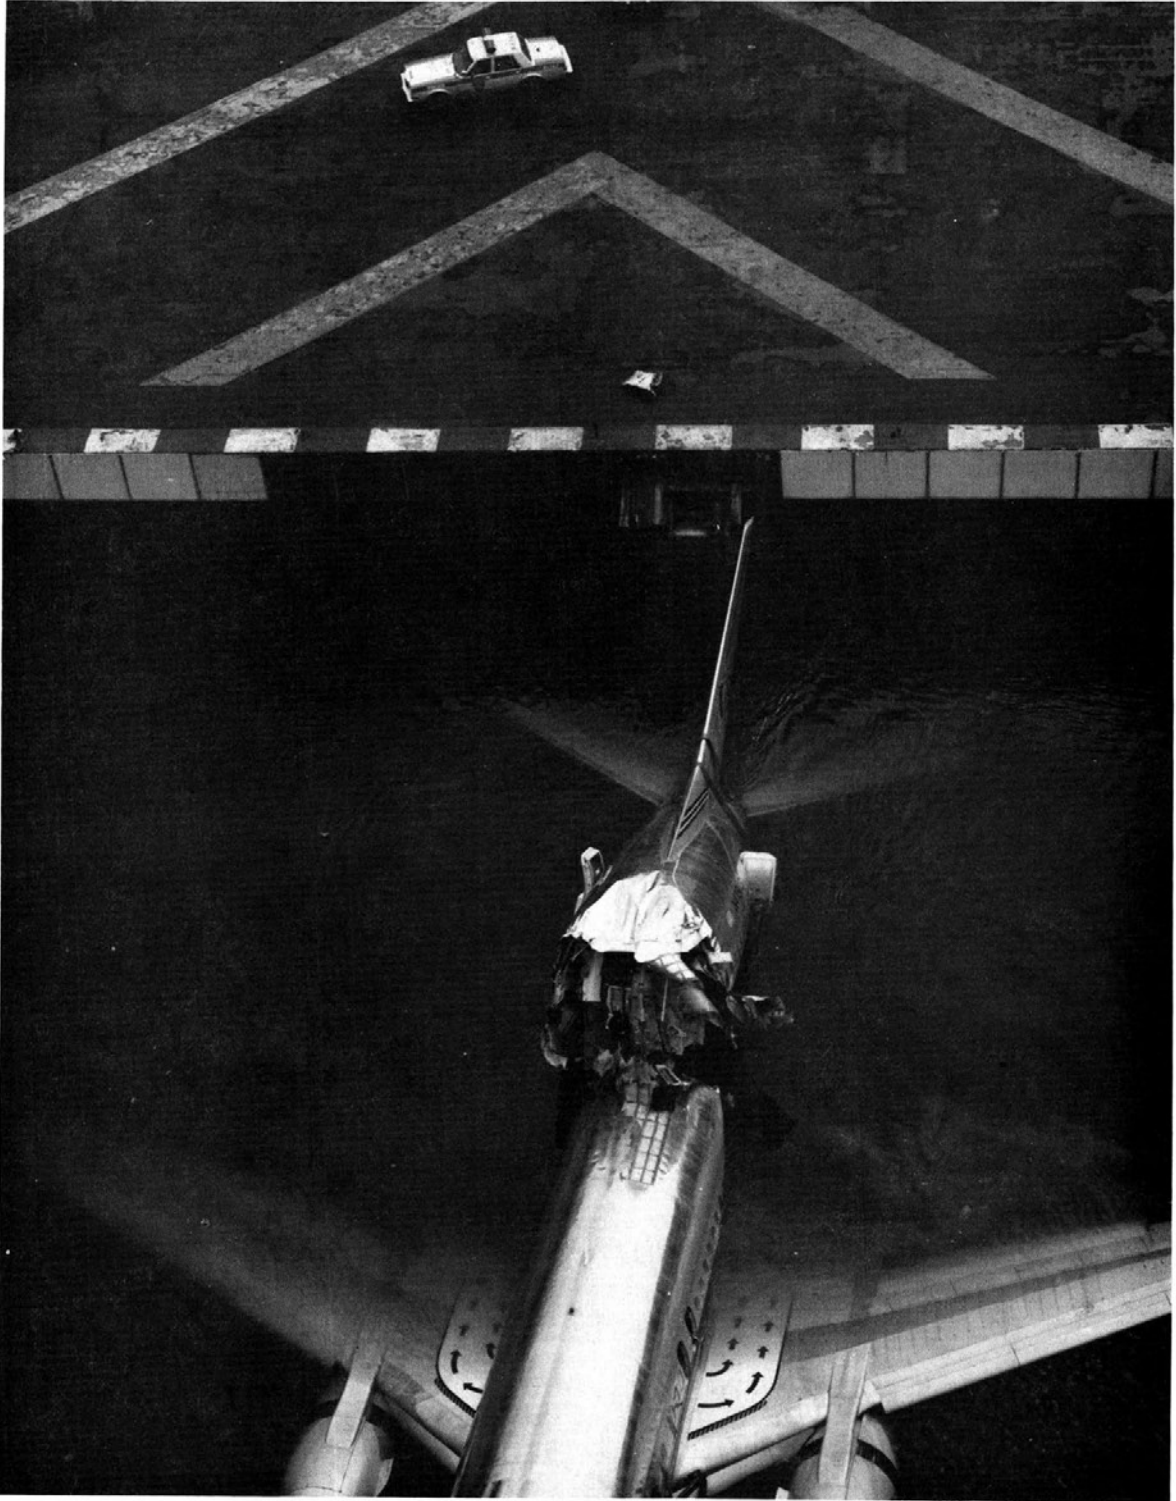
Figure 4.--N416US at low tide.

The airplane collided with a wooden approach lighting stanchion or pier as it went off the end of the overrun. The fuselage separated into three sections with the forward section resting on part of the elevated light stanchion and the aft section partially submerged (see figures 4 and 5). All fuselage fractures were due to overstress.

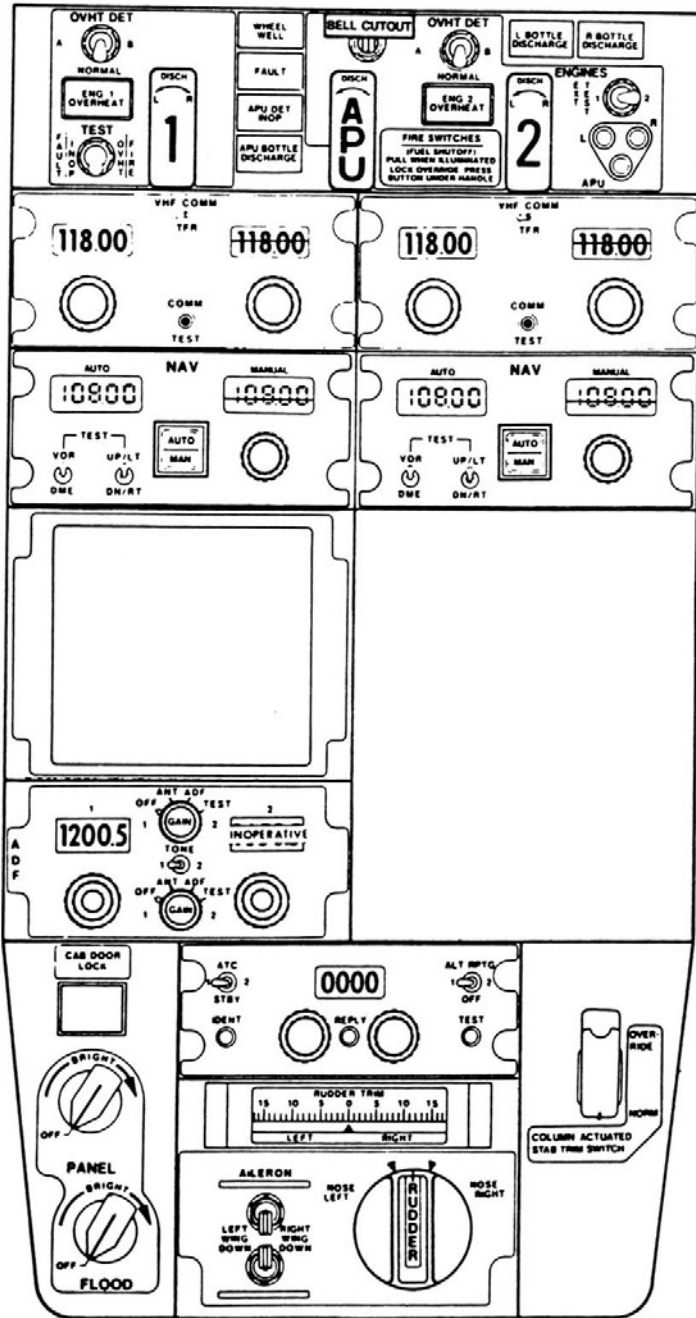
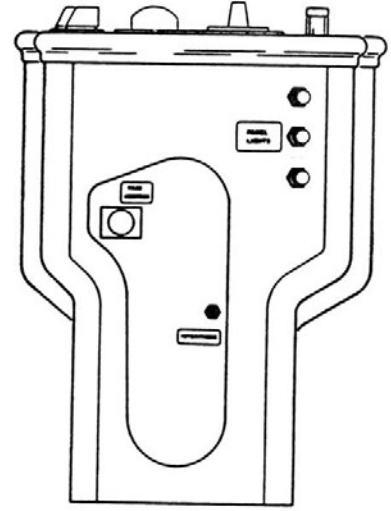
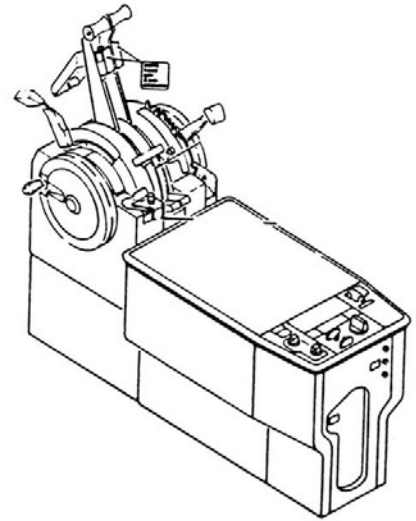
Figure 6.--The B-737-400 cockpit aisle stand.

Out-of-neutral rudder trim also changes the position of the rudder pedals and the steering angle of the nosewheel when on the ground. For example, full left rudder trim will move the nosewheel 4° left, producing an offset between the rudder pedals of 4 1/4 inches. That is, the left rudder pedal will be displaced about 2 inches forward and the right pedal 2 inches aft, which affects the position of the pilot's feet correspondingly. This trim condition will cause the airplane to turn to the left during taxi or takeoff, and right tiller or pedal force must be used to straighten the ground track.

In May 1989, Boeing began to study design improvements to curtail inadvertent disturbance of rudder trim controls. On January 17, 1990, Boeing stated that it would replace the current blade-type trim knob with a round knob having finger grips around its circumference. This design change will apply to the B-737-300/400/500, the B-747-400, the B-757, and the B-767. Boeing also designed a raised shield to protect the aileron and rudder trim
