AIRCRAFT ACCIDENT REPORT

MARKAIR, INC.
BOEING 737-2X6C, N670MA
CONTROLLED FLIGHT INTO TERRAIN
UNALAKLEET, ALASKA
JUNE 2, 1990

On June 2, 1990, at 0937 Alaskan Daylight Time, MarkAir, Inc., flight 3087, a Boeing 737-2X6C, registered in the US as N670MA, crashed about 7.5 miles short of runway 14, Unalakleet, Alaska, while executing a localizer approach to that runway. The flight originated at 0828 at Anchorage International Airport, Anchorage, Alaska. Instrument meteorological conditions existed at the time, and the flight was on an IFR flight plan. The captain, the first officer, and a flight attendant sustained minor injuries. Another flight attendant sustained serious injuries. There were no passengers on board, and the airplane was destroyed. The flight was operated under FAR Part 121.

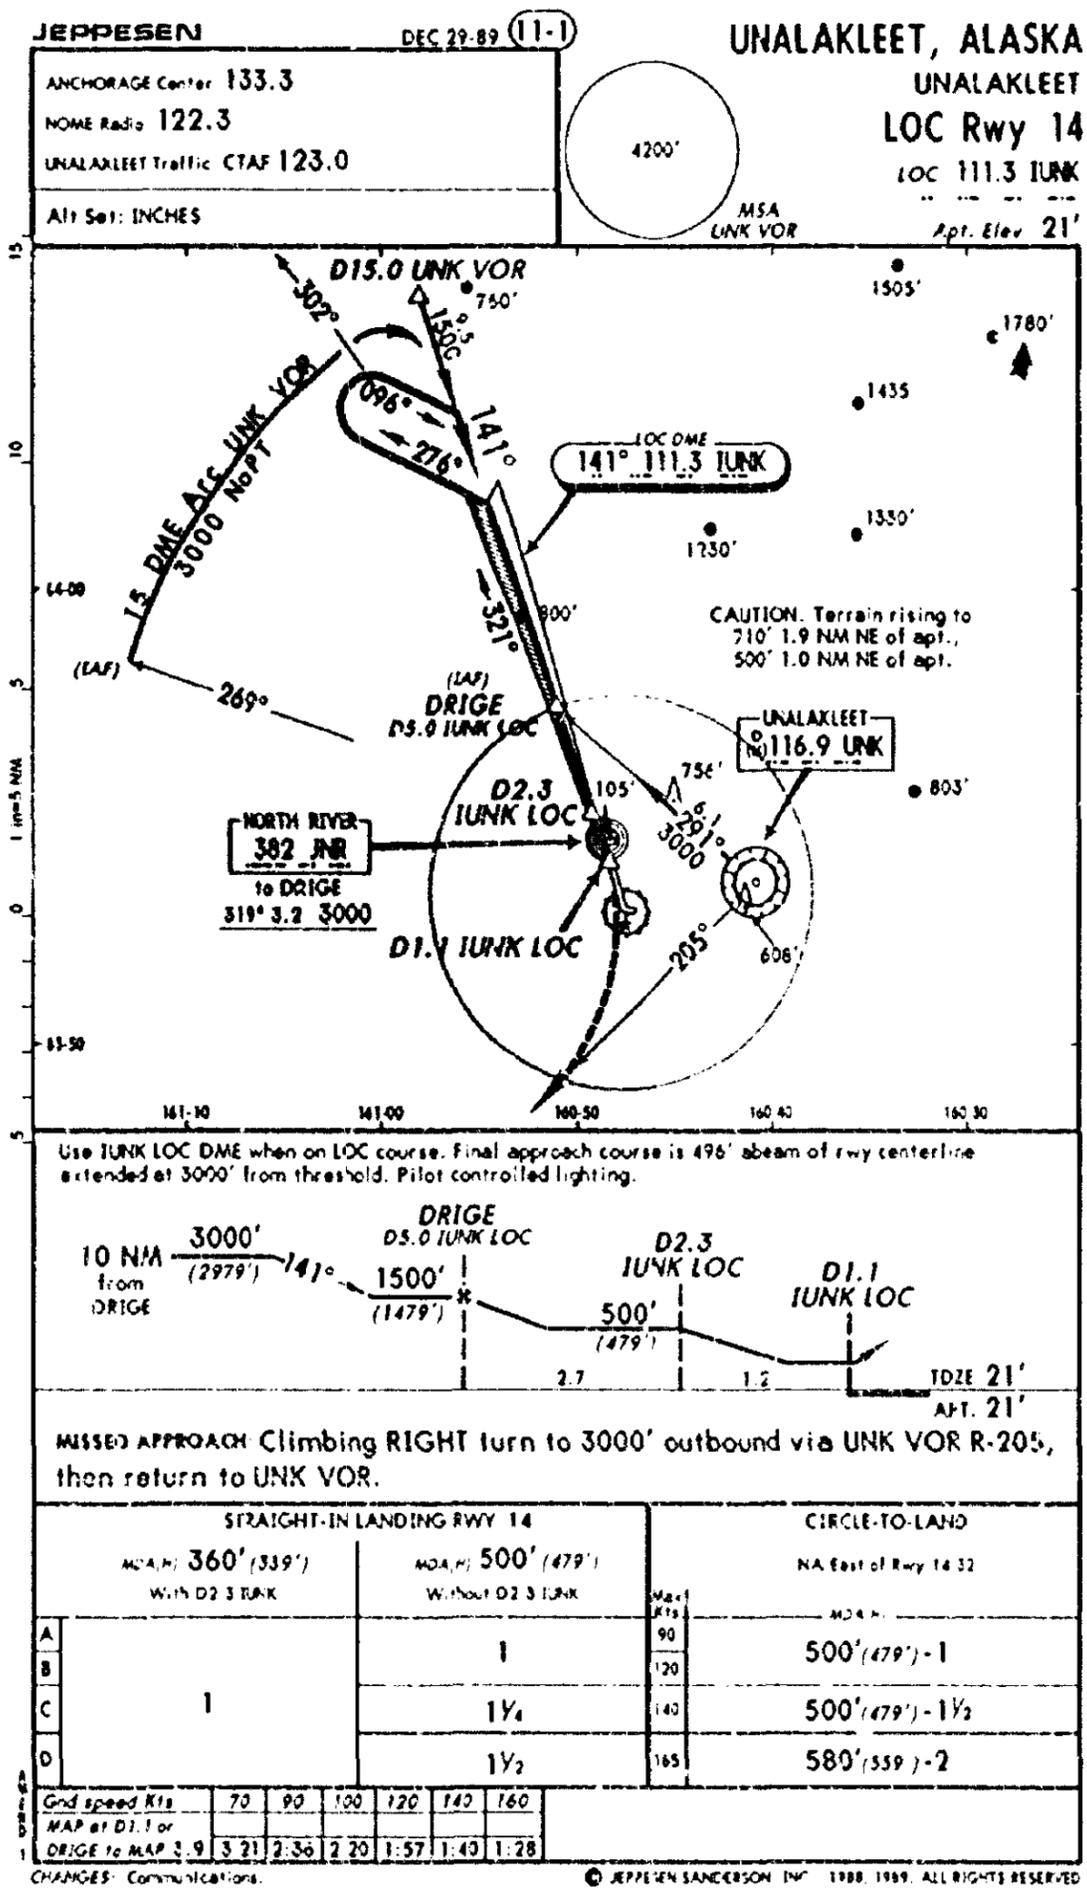
Figure 1.--UNK LOC Rwy 14 Instrument Approach.

These conditions were above minimums for the localizer runway 14 (LOC Rwy 14) instrument approach to be flown by the captain. (See figure 1).

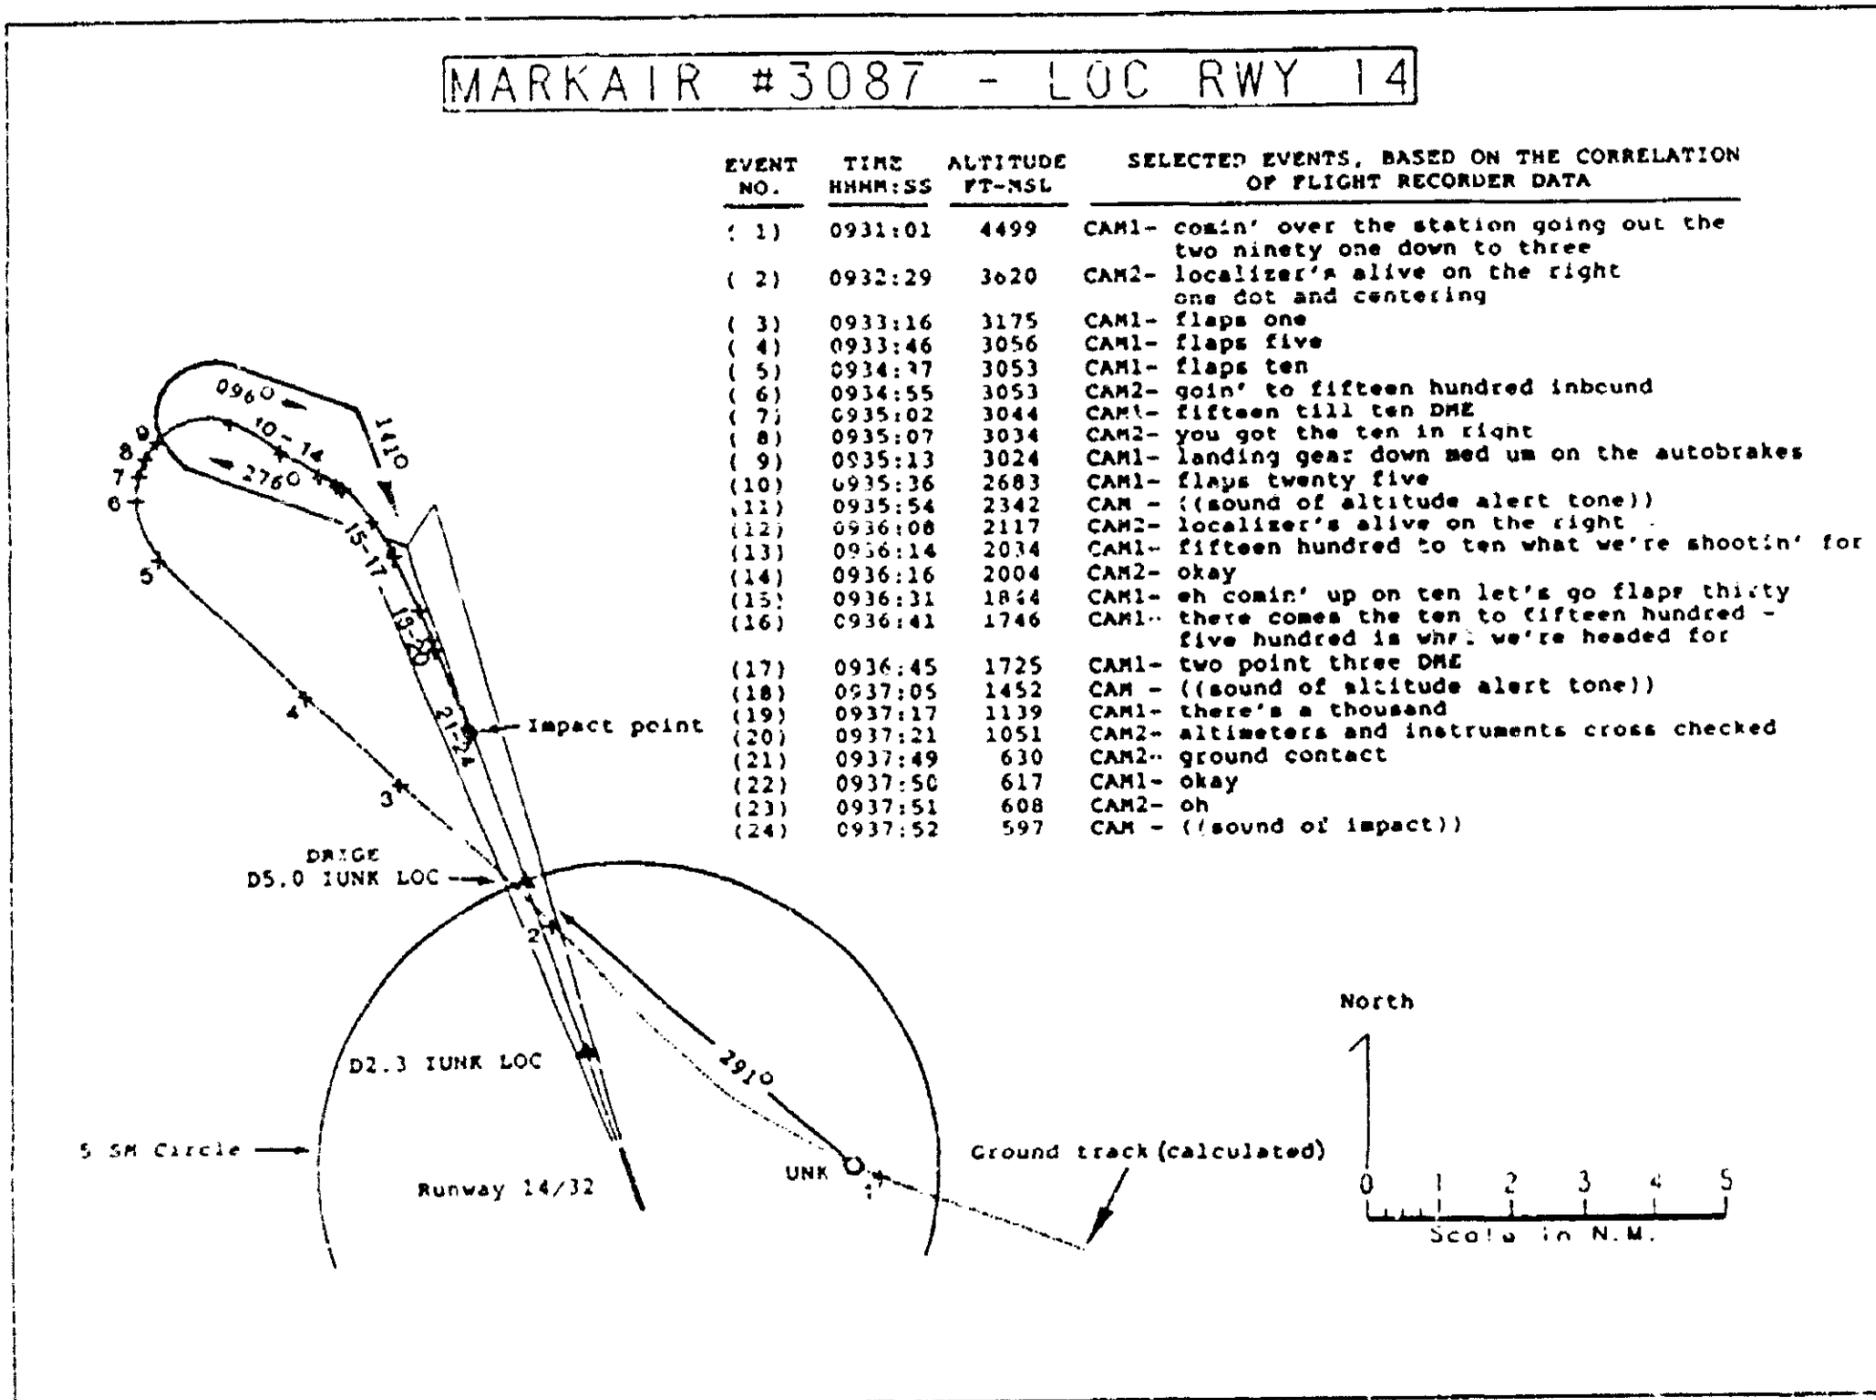
Figure 2.--UNK LOC Rwy 14 planview overlaid with MarkAir flight 3087's calculated ground track, selected altitudes, and CVR comment

At 0936:41, the captain stated. "There comes the 10 to 1,500--500 feet is what we're headed for [lapse of 3 seconds] 2.3 DME." A conversation then ensued about turning the bleed switches off (to aid in avoiding gravel foreign object damage to the engines upon landing) and turning the engine anti-ice system off. This conversation began as the airplane was descending through about 1,700 feet.

During postaccident interviews, the captain could not explain why he developed the mindset that the descent to 500 feet was to be initiated at the 10 DME rather than the 5 DME. It is readily apparent, however, that he did not refer to the approach plate in detail after his initial approach briefing. Had he done so, he should have noted the 5.0 DME legend under DRIGE on the profile view. Also, the 2.7 (NM) distance from DRIGE to the 2.3 DME fix should have been evident.

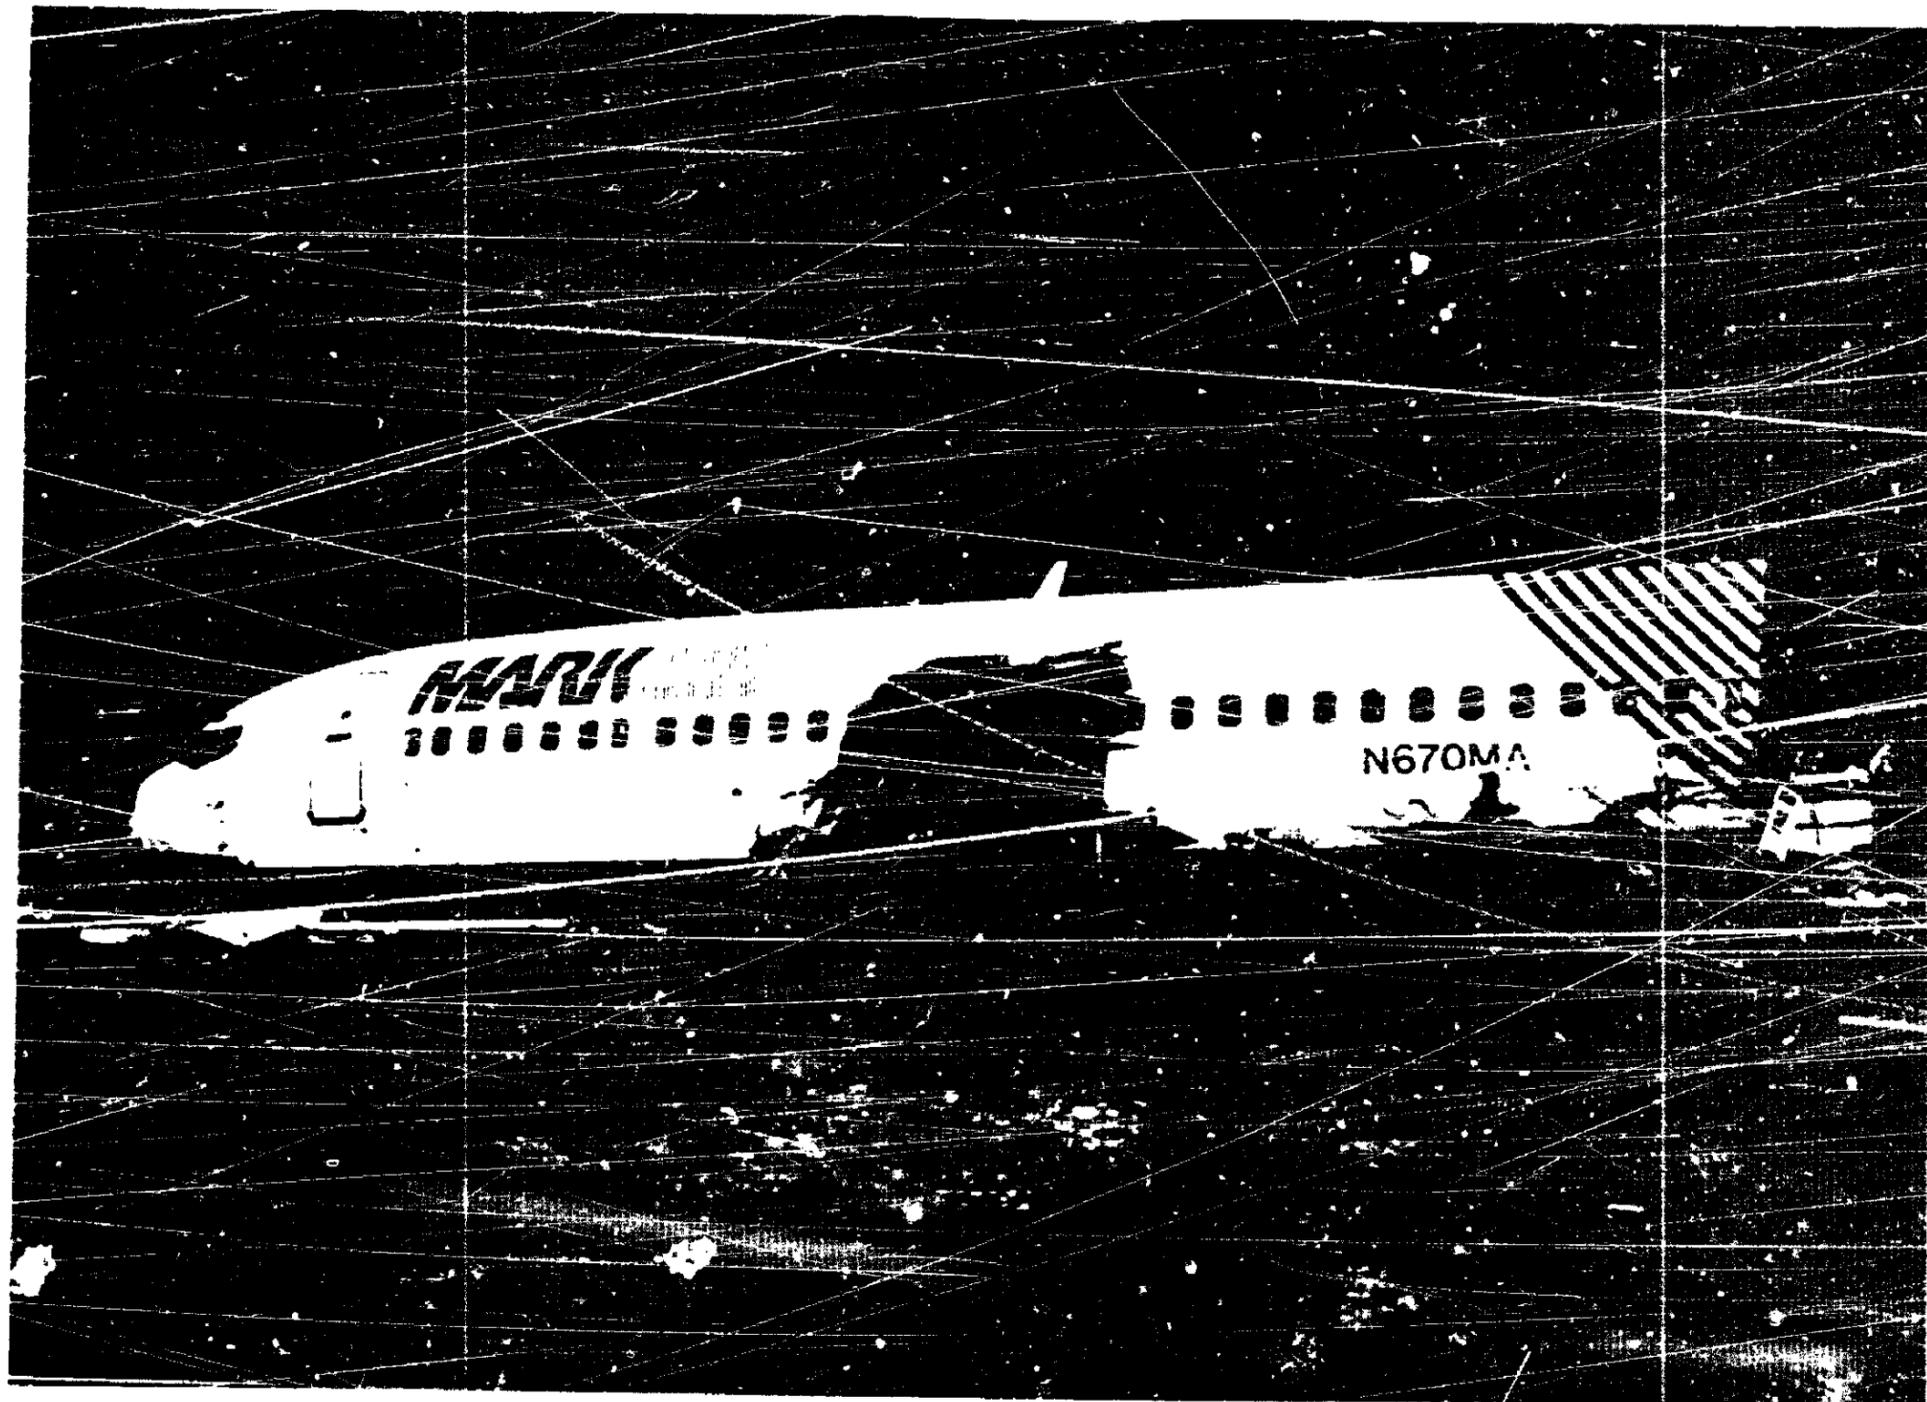
Figure 4.--Flight 3087 fuselage.

Most of the fuselage below the floor level from the nose of the airplane to the wing center section was destroyed during impact and the slide up the hill. The fuselage had rotated clockwise about 165° before coming to rest on the hill. The nose wheel well/nose landing gear assembly was dislodged from the fuselage and was found about 20 feet away from the nose of the airplane. The right forward side of the fuselage was cracked and partially separated behind the cockpit, but this separation was only about half the circumference of the fuselage.

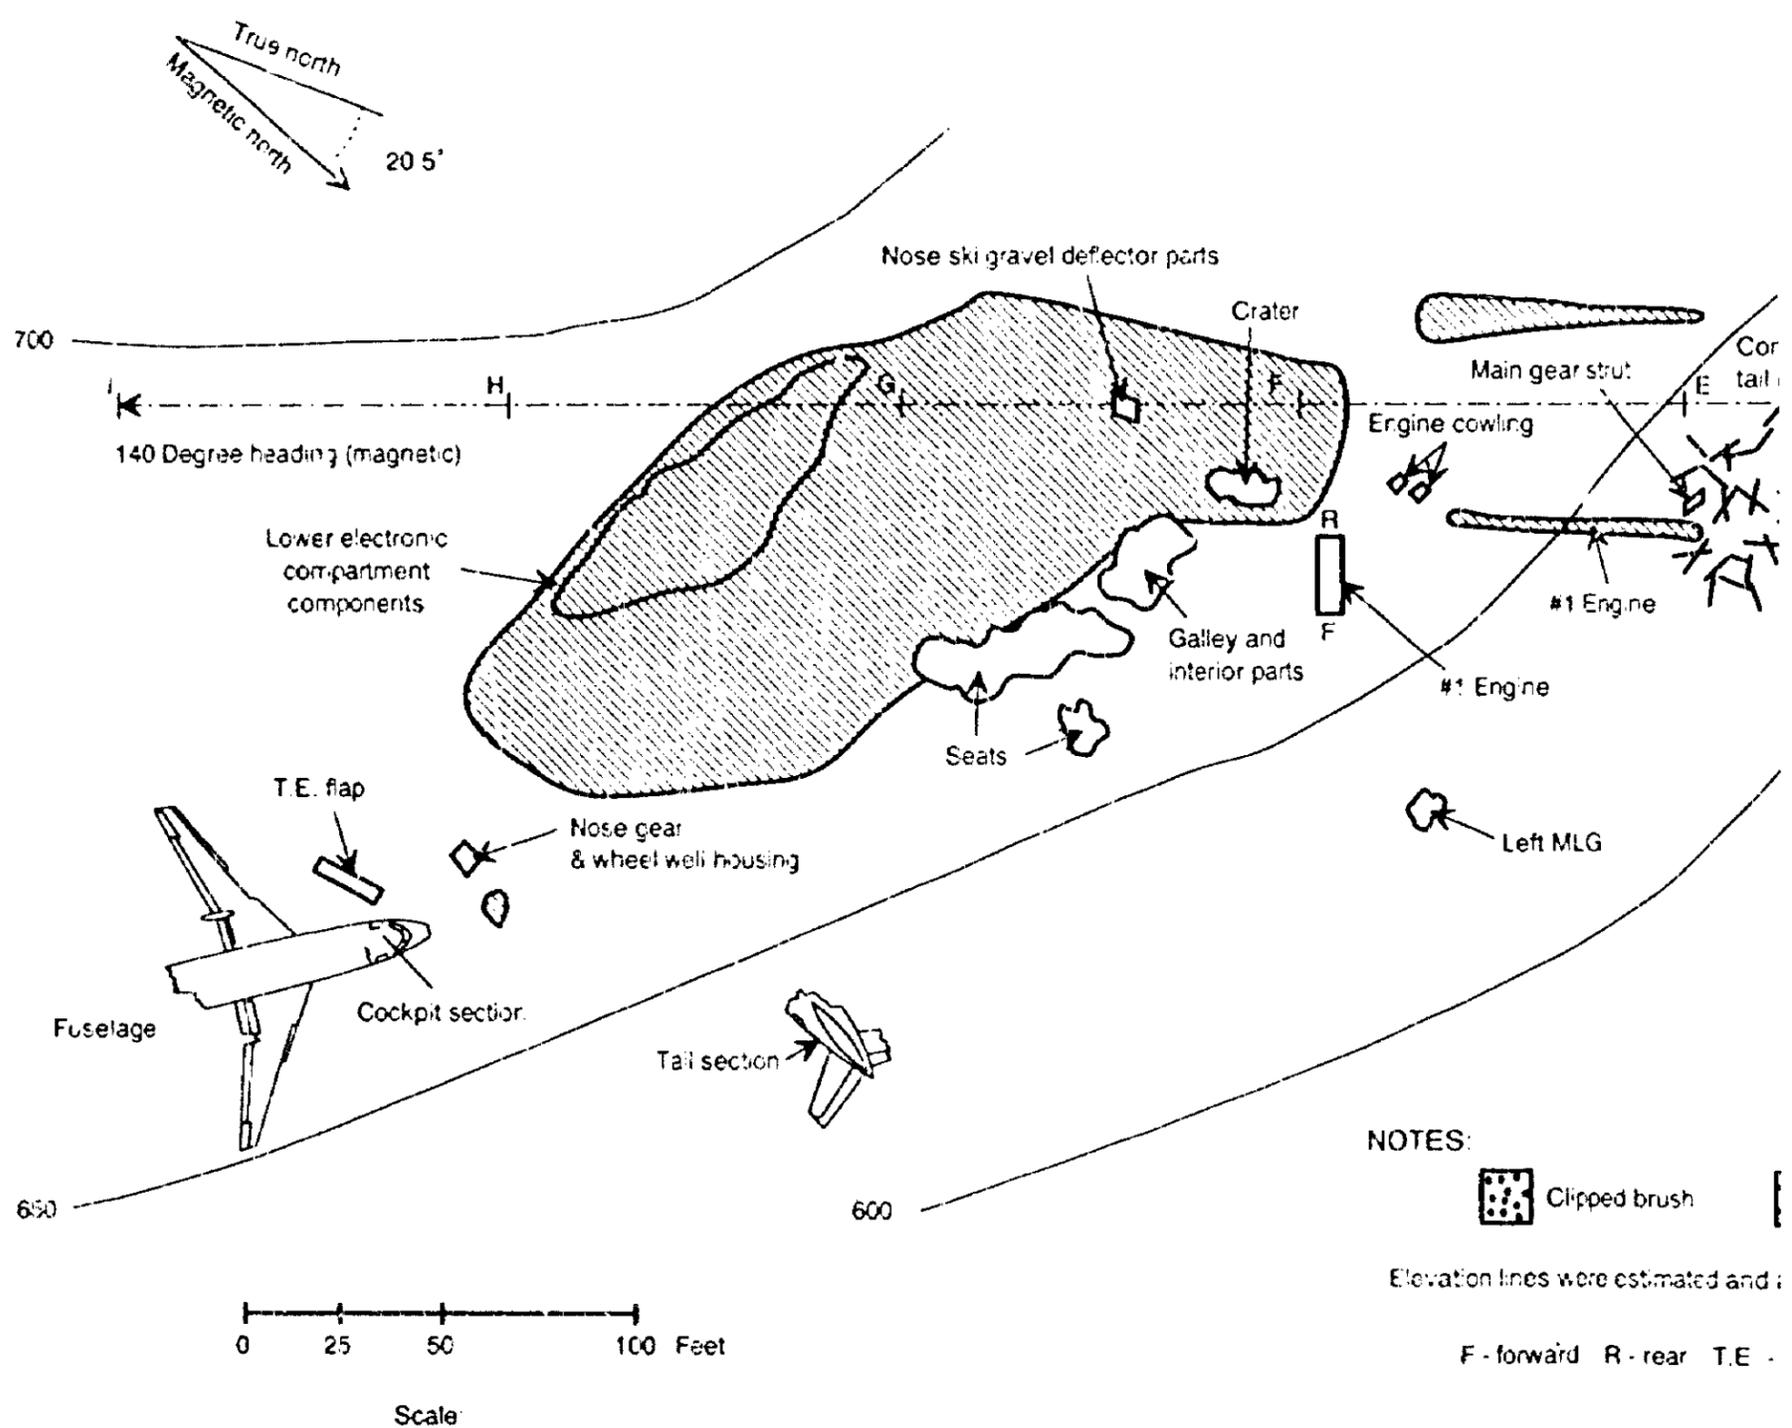
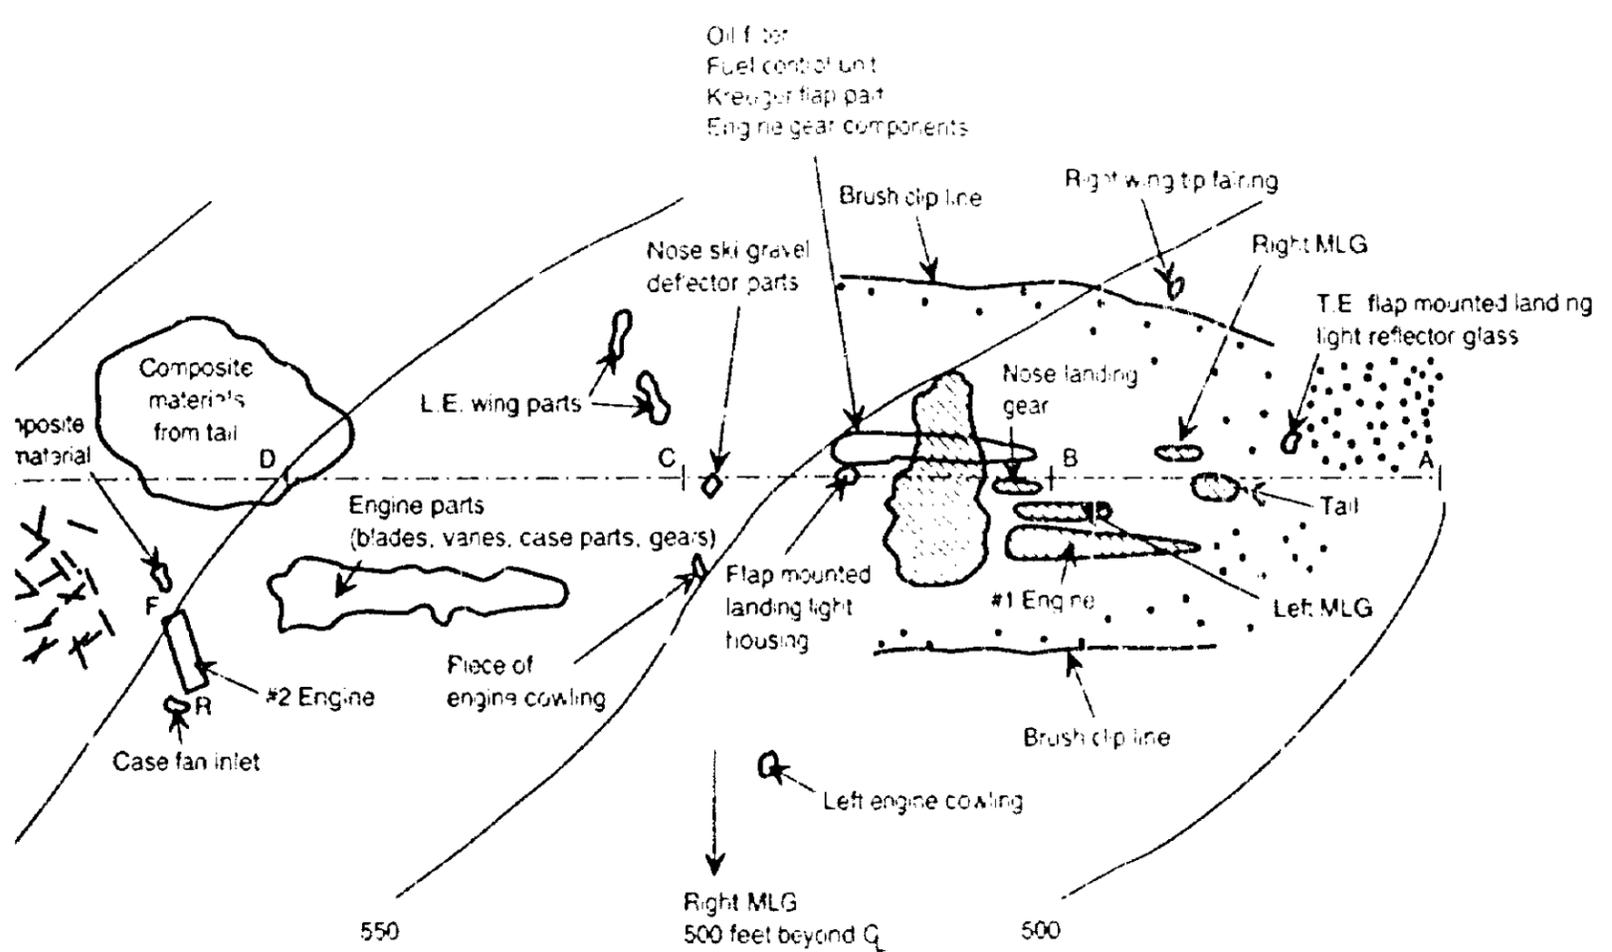
Figure 5.-- Wreckage D
 National Transportati
 Washington
 MARKA
 Boeing 737
 Unalakleet,
 June 2, 1

The airplane impacted the ground on a small level area about 530 feet up the northeast slope of Blueberry Hill. The top of Blueberry Hill is about 700 feet. The first indications of impending terrain contact were broken branches on several alder bushes located about 30 feet prior to the first impact mark on the ground. The aircraft began breaking apart upon ground contact and the wreckage scatter pattern extended about 800 feet up the hill on an average magnetic heading of 140° degrees. The width of the wreckage debris field was about 125 feet. The landscape along the wreckage path was typical tundra, small bushes of various kinds, grass, scattered rocks and shale.
