Aircraft Accident Report - Runway Collision of Eastern Airlines  
Boeing 727, Flight 111 and EPPS Air Service Beechcraft  
King Air A100, Atlanta Hartsfield International Airport  
Atlanta, Georgia, January 18, 1990

(U.S.) National Transportation Safety Board, Washington, DC

29 May 91

**RUNWAY COLLISION  
OF EASTERN AIRLINES BOEING 727, FLIGHT 111  
AND EPPS AIR SERVICE BEECHCRAFT KING AIR A100  
ATLANTA HARTSFIELD INTERNATIONAL AIRPORT  
ATLANTA, GEORGIA  
JANUARY 18, 1990**

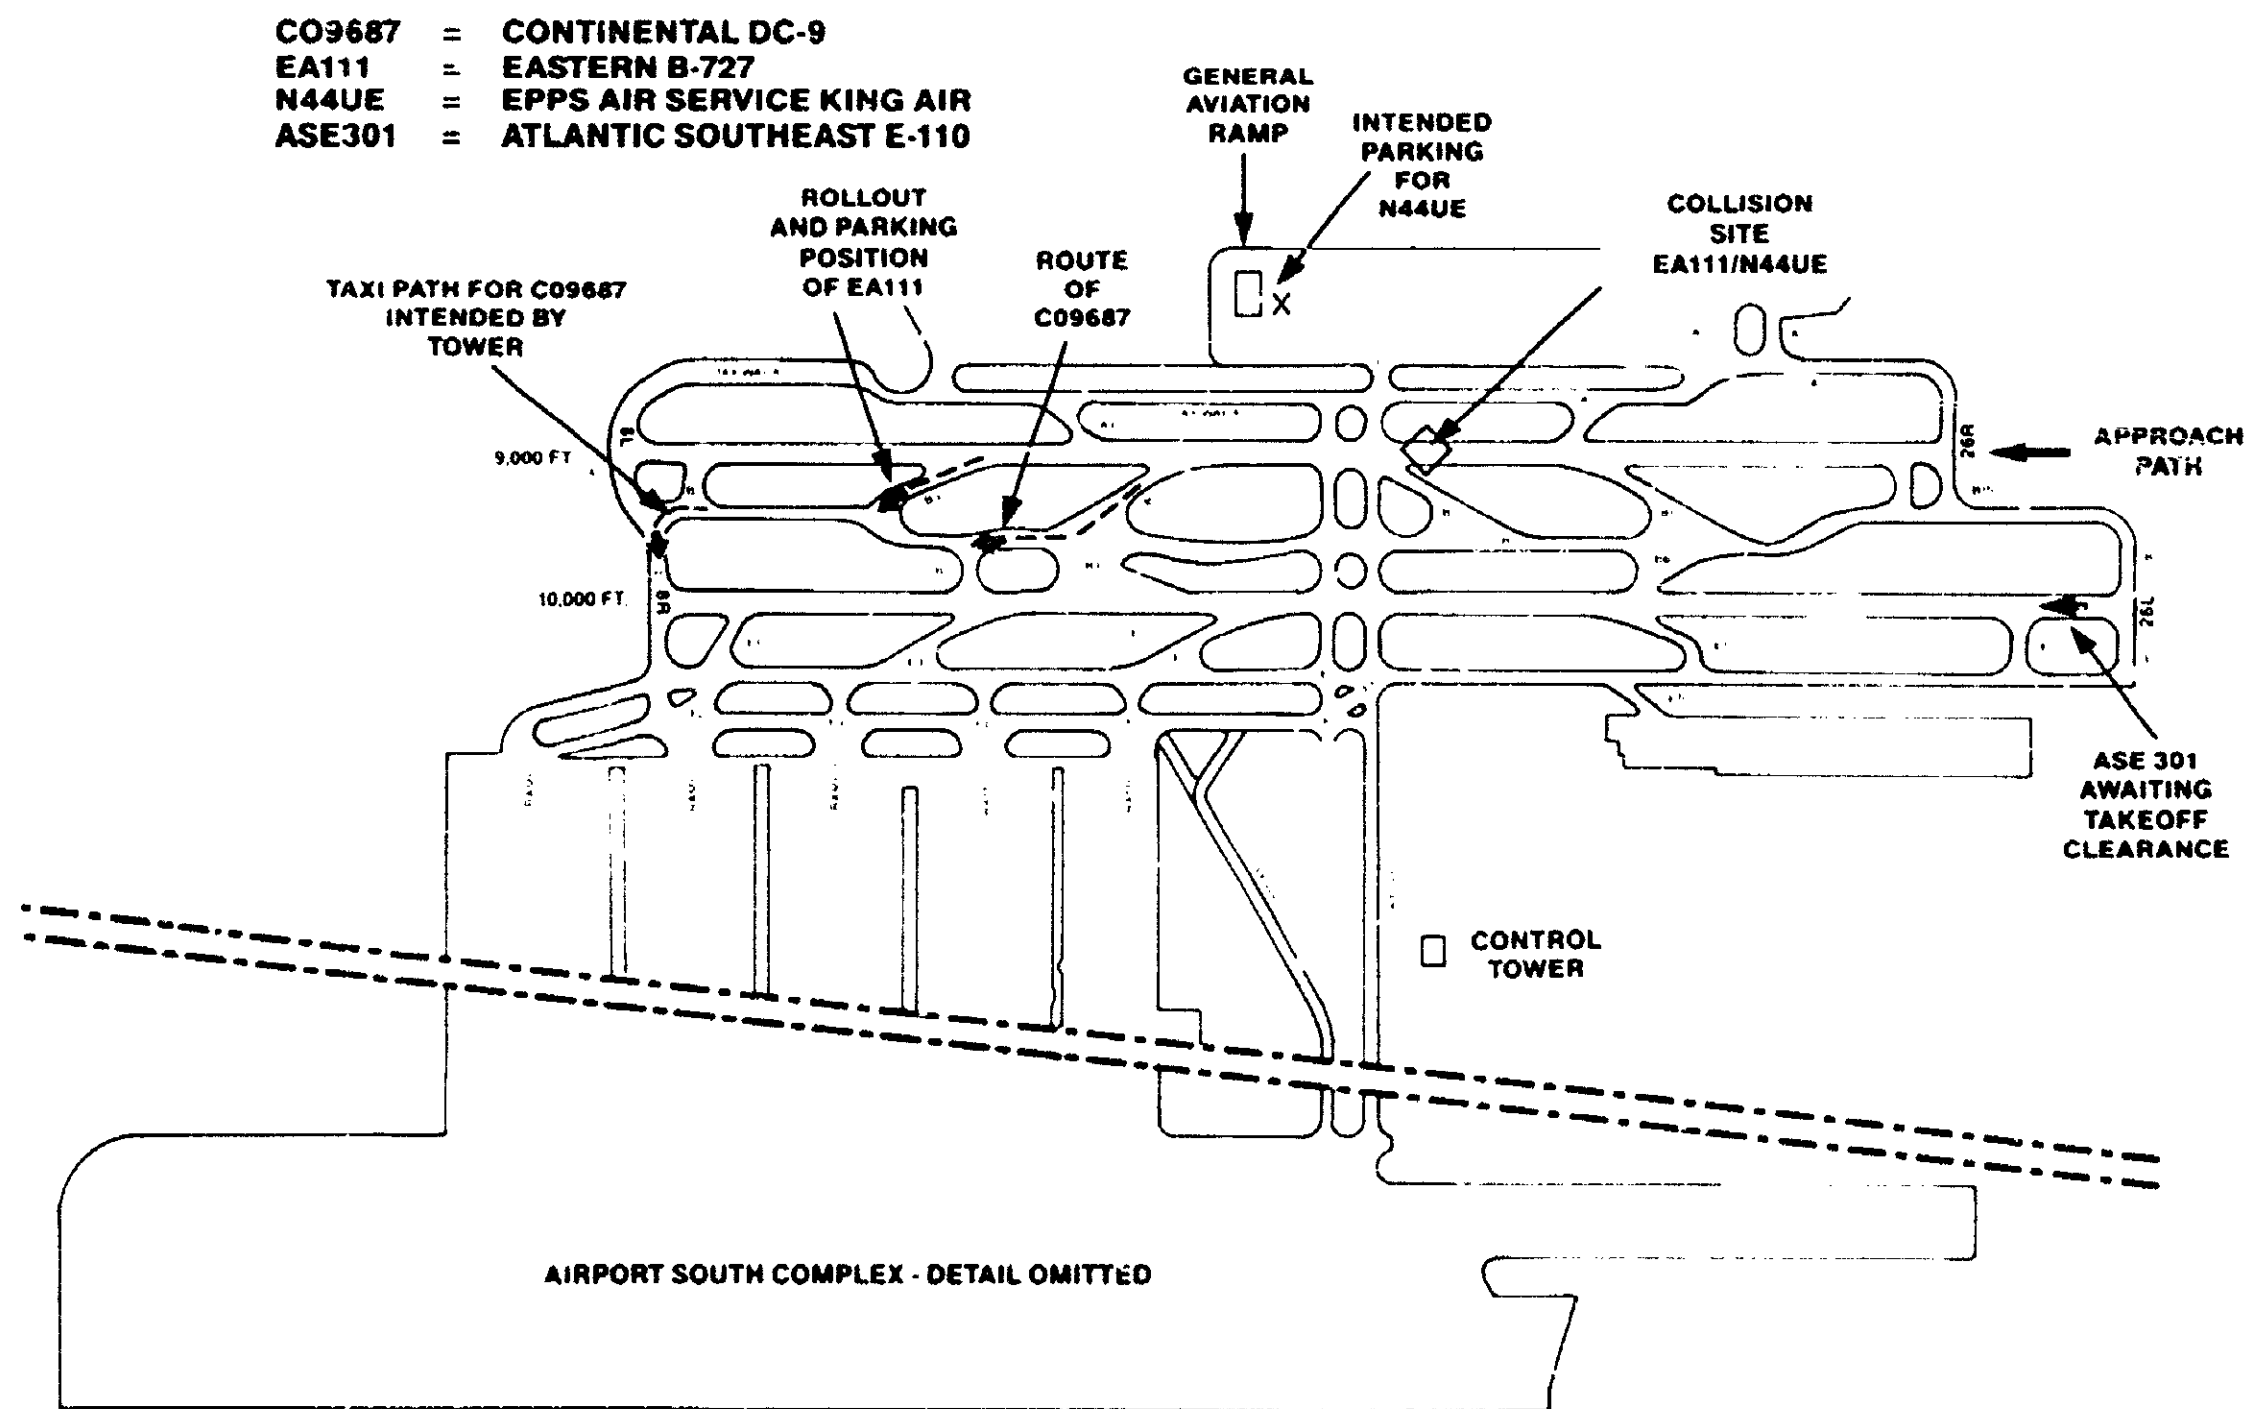
Figure 2.--Airport diagram with overlay of activity related to collision.

Grounds scars from the collision indicated that the King Air had moved to the right side of runway 26 at the time of the collision and was near taxiway "D," the primary taxiway for general aviation airplanes. The turnoff for taxiway "D" was about 3,800 feet from the approach end of the runway. The right wing of the B-727 struck the tail cone and structure of the King Air, separating the horizontal and vertical stabilizers from the fuselage and shearing the top of the fuselage/cockpit from the airplane. The King Air was destroyed. It came to rest at the turnoff for taxiway "D" with the engines still running. There was no postimpact fire. Airport Rescue and Fire Fighting (ARFF) personnel shut down the engines and secured the electrical system.

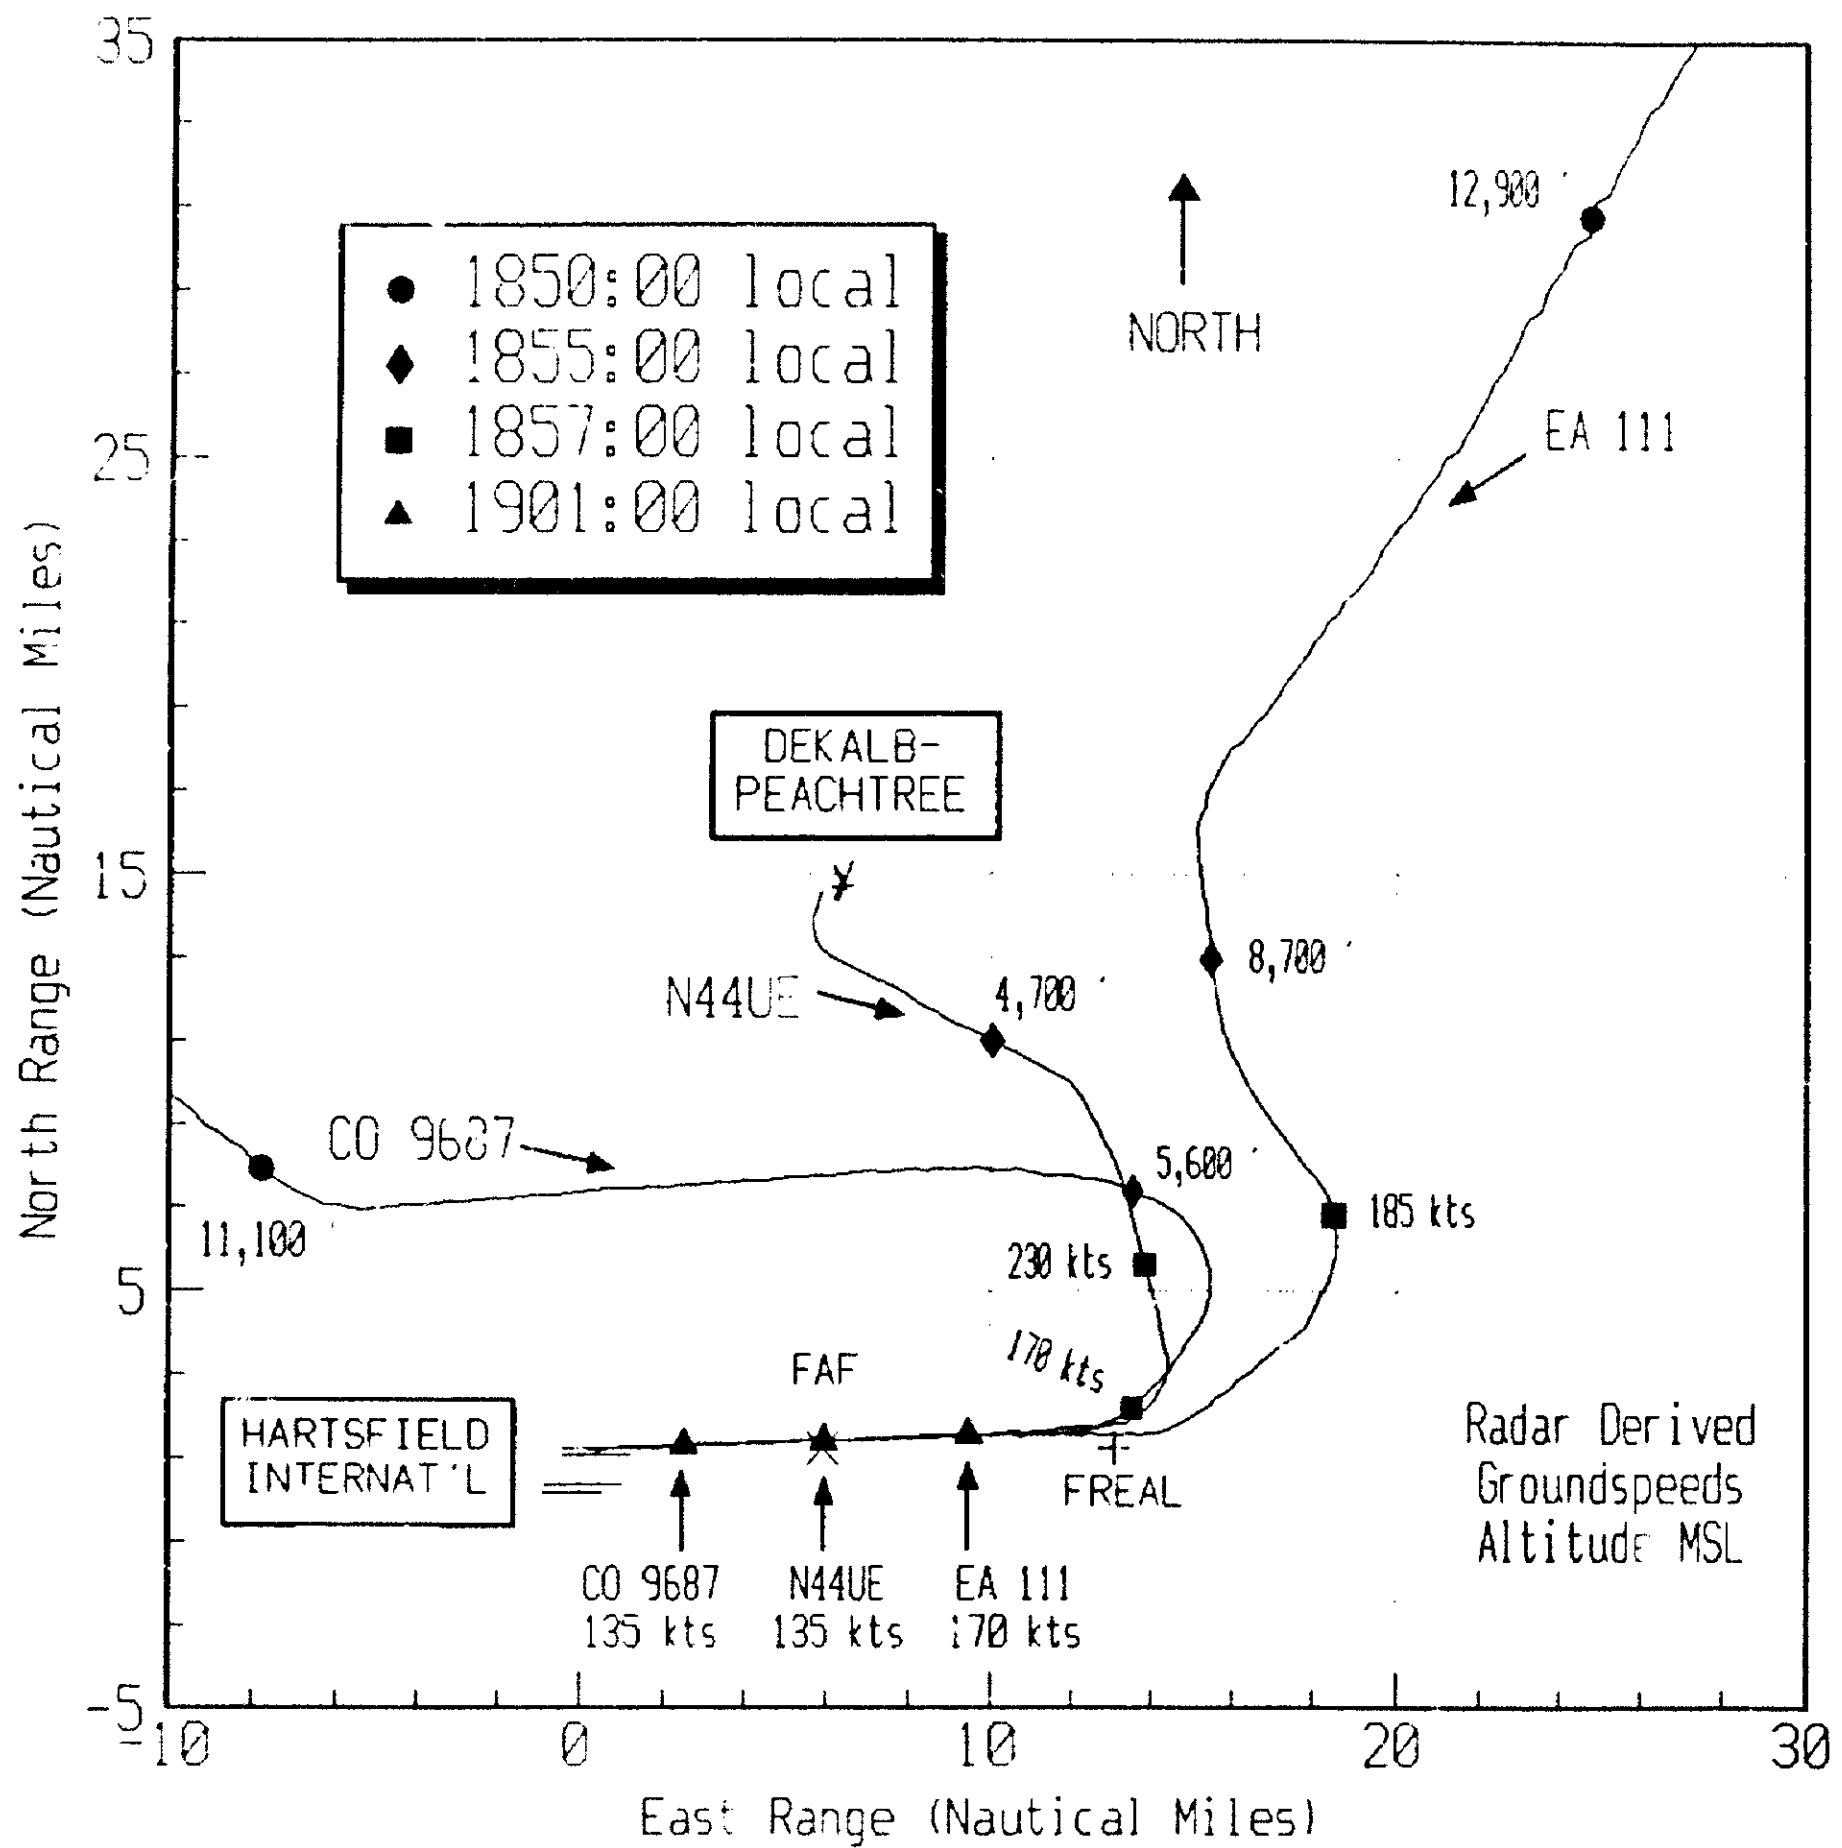
Figure 3.--Data showing landing sequence for runway 26 right.

ATC radar and communications data reveal that vectors were issued to three inbound airplanes to establish the landing sequence for runway 26 right immediately before the accident. (See figure 3). The three airplanes were CO 9687, a Continental Airlines DC-9; N44UE, the Beech King Air; and EA 111. A complete description of the air traffic actions is contained in paragraph 1.17.2, Air Traffic Handling.

the monitor controller initiated a sequence of events that caused the final approach interval spacing to quickly approach the minimum of 2 1/2 miles. Although he was relieved of direct responsibility for the ensuing loss of separation when the north local controller transmitted "EA 111, you are in sight, cleared to land 26 right," the Safety Board believes that the monitor controller's action contributed to the speed differential and to the overtake that ultimately was a factor in the accident. At the time of the north local controller's transmission, EA 111 was almost 6 miles from the runway and the King Air was about 3 miles out. However, the distance between the two aircraft was decreasing at an unacceptable rate and was less than the required 2.5 miles separation as N44UE arrived at the runway threshold.
