PB91-910408
NTSB/AAR-91/07

AIRCRAFT ACCIDENT REPORT

**FUEL FARM FIRE AT
STAPLETON INTERNATIONAL AIRPORT
DENVER, COLORADO
NOVEMBER 25, 1990**

**ADOPTED: October 1, 1991
NOTATION 5576**

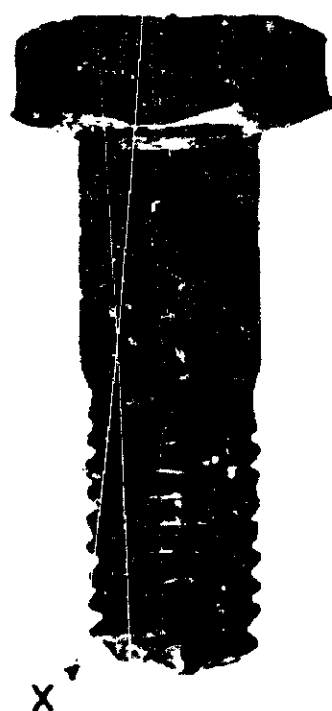
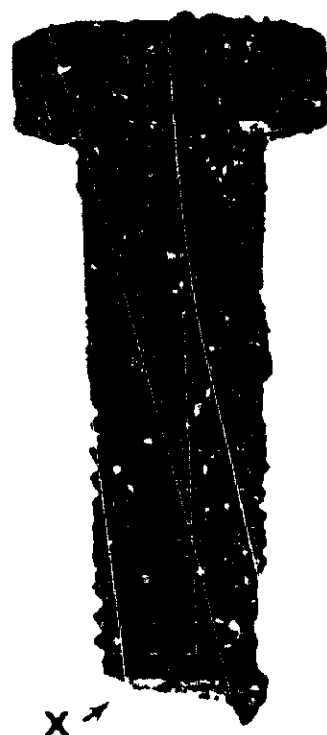
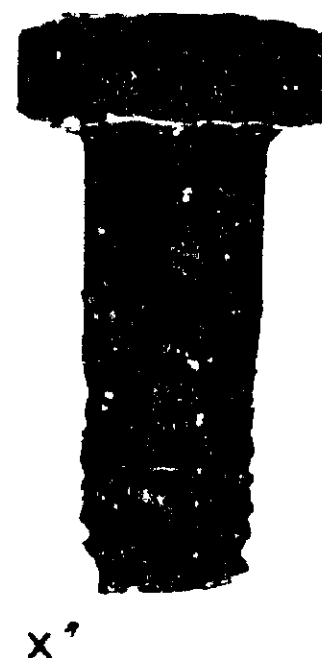
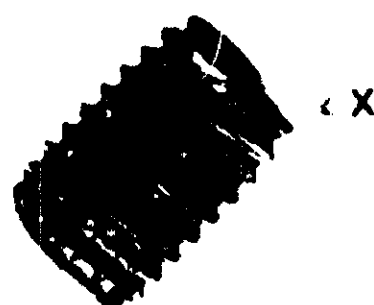
All four 5/8-inch-diameter bolts that secured motor 3 to its pedestal were fractured. These fractures occurred in the threaded area (see figure 10). Remnants of all four bolts remained in the threaded holes of the

Microscopic examination of the fracture surfaces on the three sections of bolts with the heads attached indicated features characteristic of fatigue cracks originating at multiple sites along the thread roots on diametrically opposite sides of the bolts. The remaining fracture surfaces between the fatigued areas revealed features typical of overstress separations. Examination of the fracture surface on the bolt remnant that remained in the left forward hole in the motor pedestal revealed damage consistent with the motor base sliding across the bolt surface.

Figure 10.--Failed motor mount bolts of motor/pump unit 3
(x indicates the fractured surface).

ferrite. For high strength steel bolts, the microstructure should be tempered martensite.

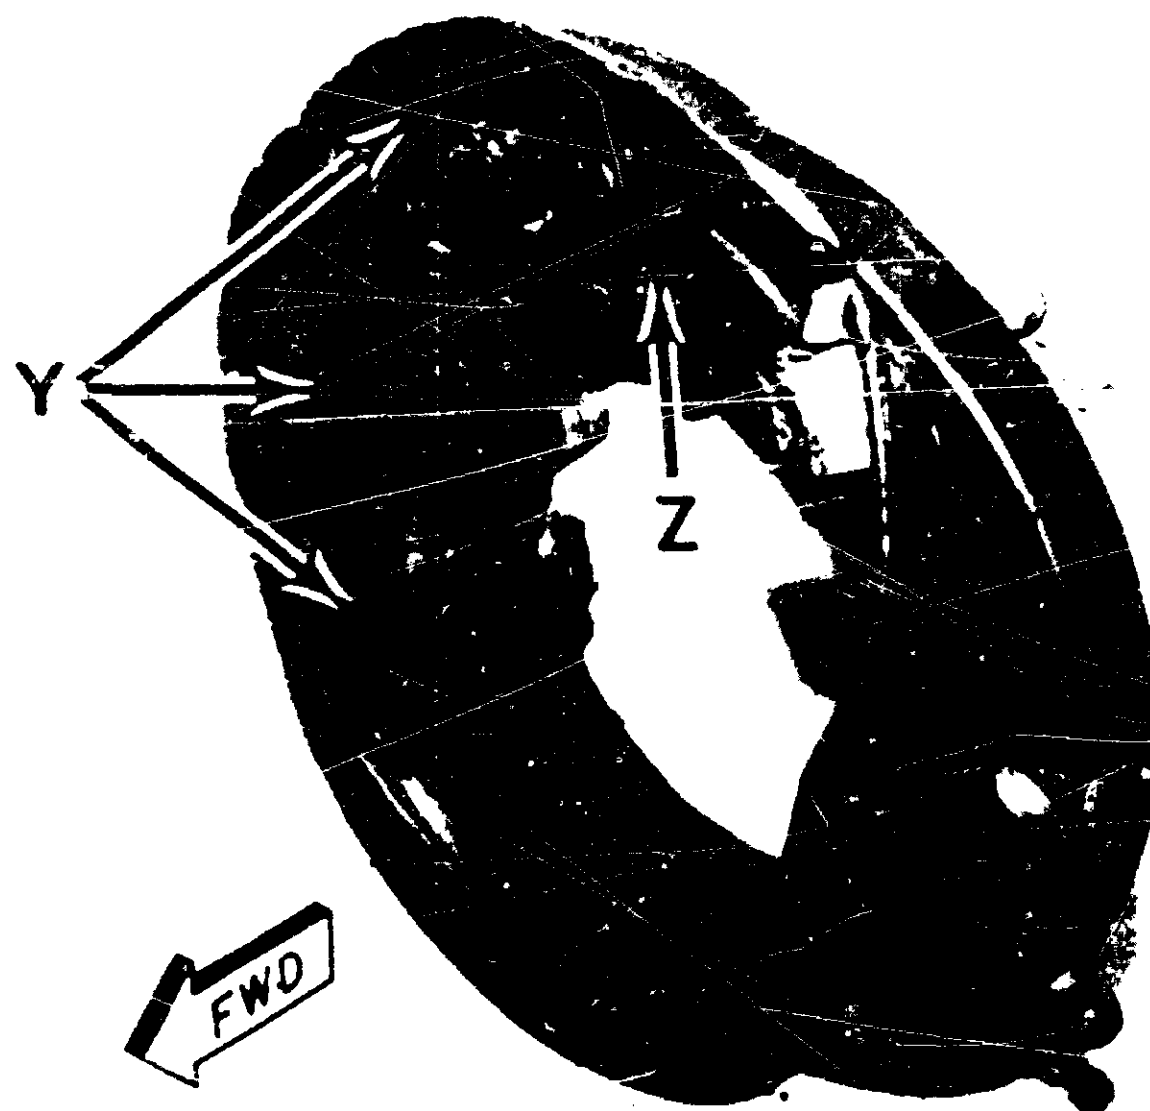
Figure 13.--Disassembled pump shroud of motor/pump unit 3 (arrow 23 in figure 7). Y indicates areas of wear damage and gouge marks; Z indicates area of worn or missing teeth.

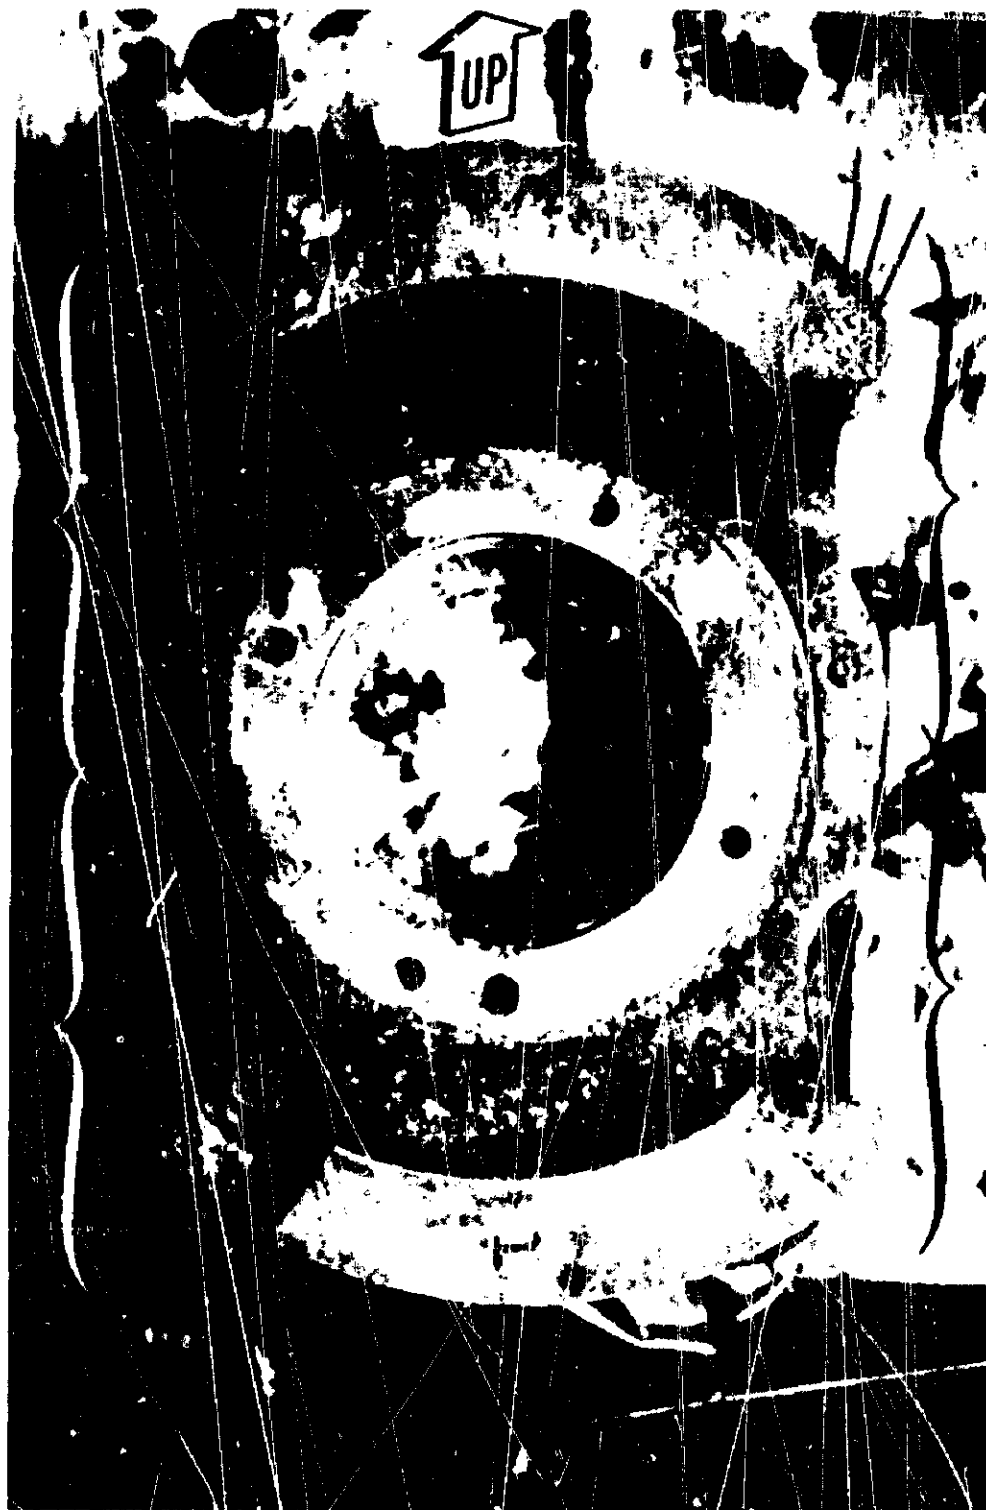
Figure 16.--Fractured bearing case of motor/pump unit 3. Arrows point to beads of molten metal.

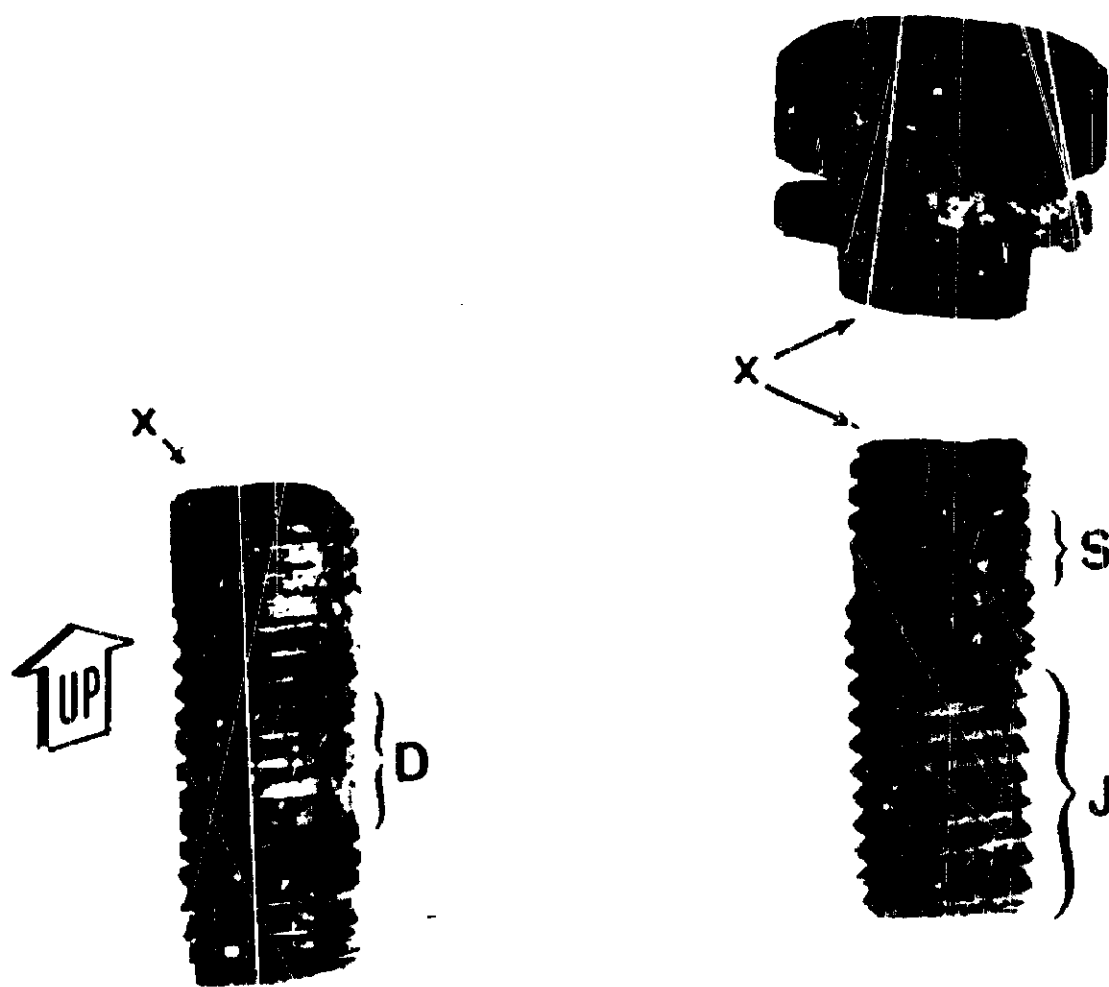
The left rear bolt (as looking forward in figure 6) was separated at the first thread below the hexagonal head (see figure 17). A lock washer was still installed on the bolt head. The remnant of this bolt, a total length of about 18 threads, was found threaded into the pedestal to a depth of about 9 threads. Threads near the top of this remnant (S in figures 17 and 18) were flattened on diametrically opposite sides. The bolt remnant was also bent in the direction of the flattened threads, indicating side loading on the bolt. Secondary cracks were found in the remnant at a location about 7 threads from the top of the remnant. The bolt head, washer, and the top nine threads of the remnant were covered with soot. After electrolytic cleaning, the bolt head, washer, and the top seven threads of the remnant exhibited a copper colored coating. Energy dispersive analysis showed an intense copper spectrum. The bolt was ungraded and had a tensile strength of about 56 ksi, as determined by post-fire hardness measurements.

Examination of fracture surfaces (x on figure 17) on both the left rear and forward bolts showed poorly defined features and oxidation from the fire. The fracture surfaces were normal to the longitudinal axes of these two bolts.

Figure 17.--Fractured left pump bolts of motor/pump unit 3. D and S indicate flattened threads, and x indicates fractured surfaces.

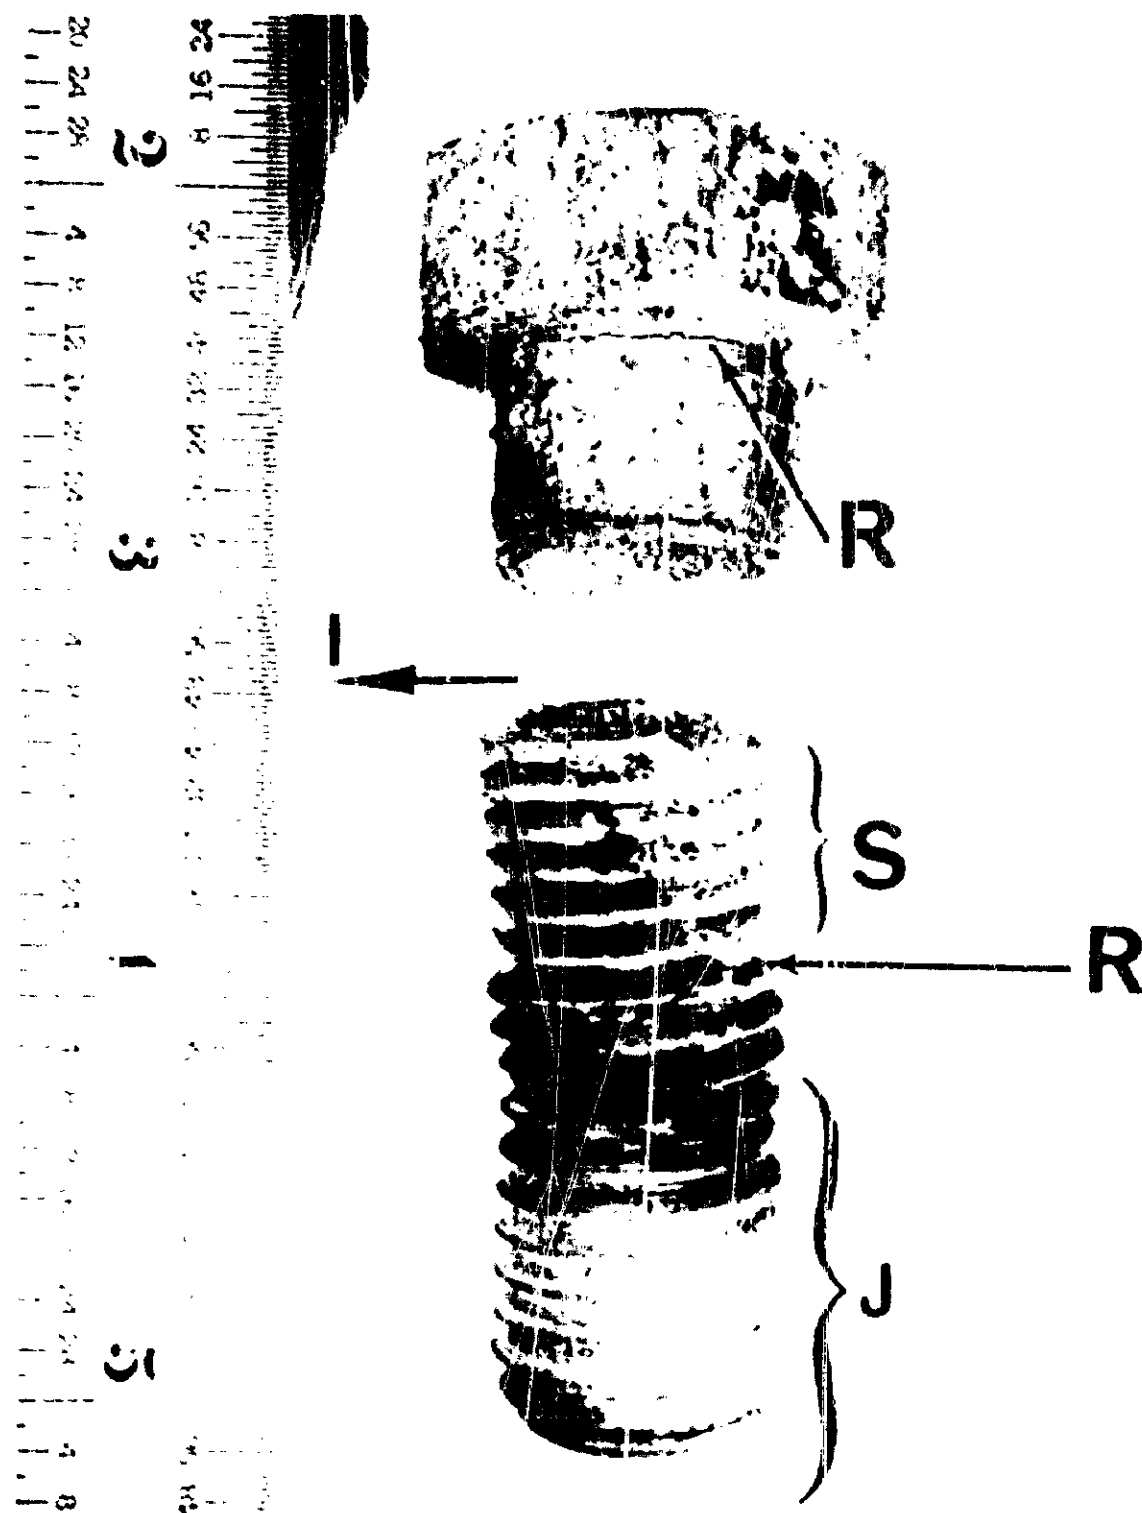
Figure 18.--Fractured pump bolt after electrolytic cleaning. R indicates areas of secondary cracks. S indicates flattened threads.

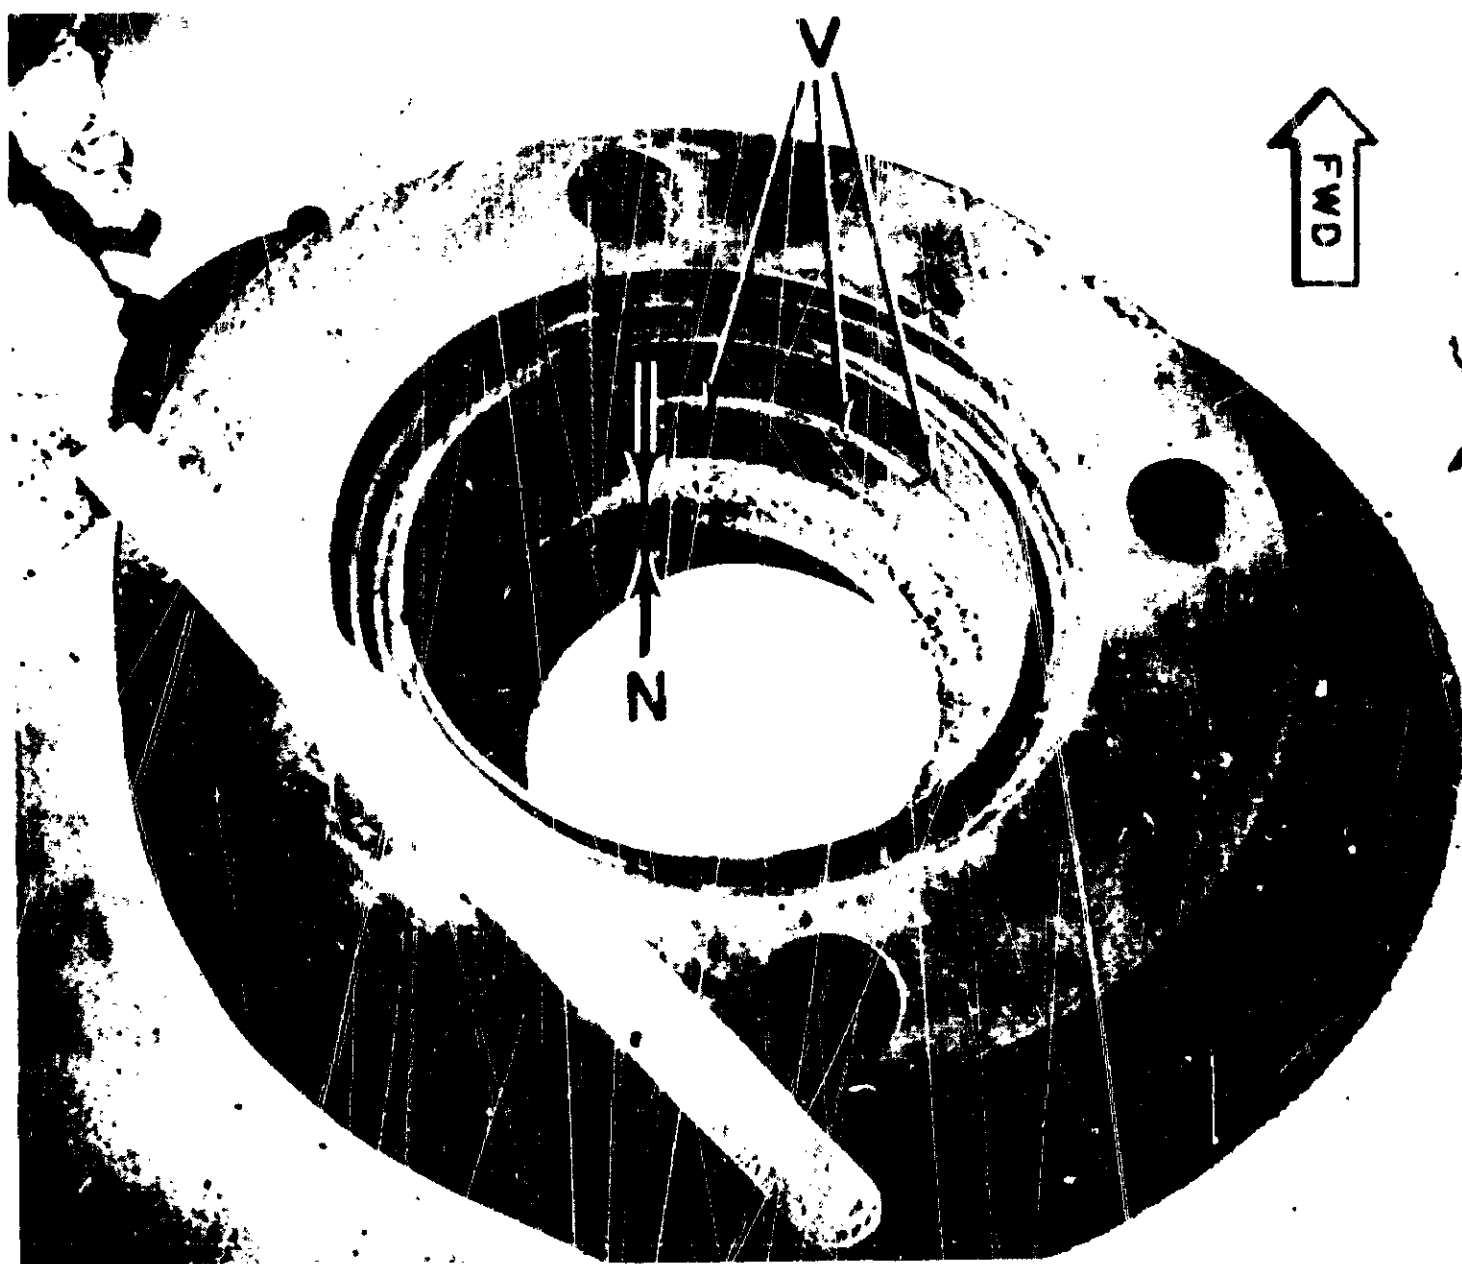
Figure 19.--Gland of pump seal in unit 3 with wear damage (N) around bore and indentation marks (V).

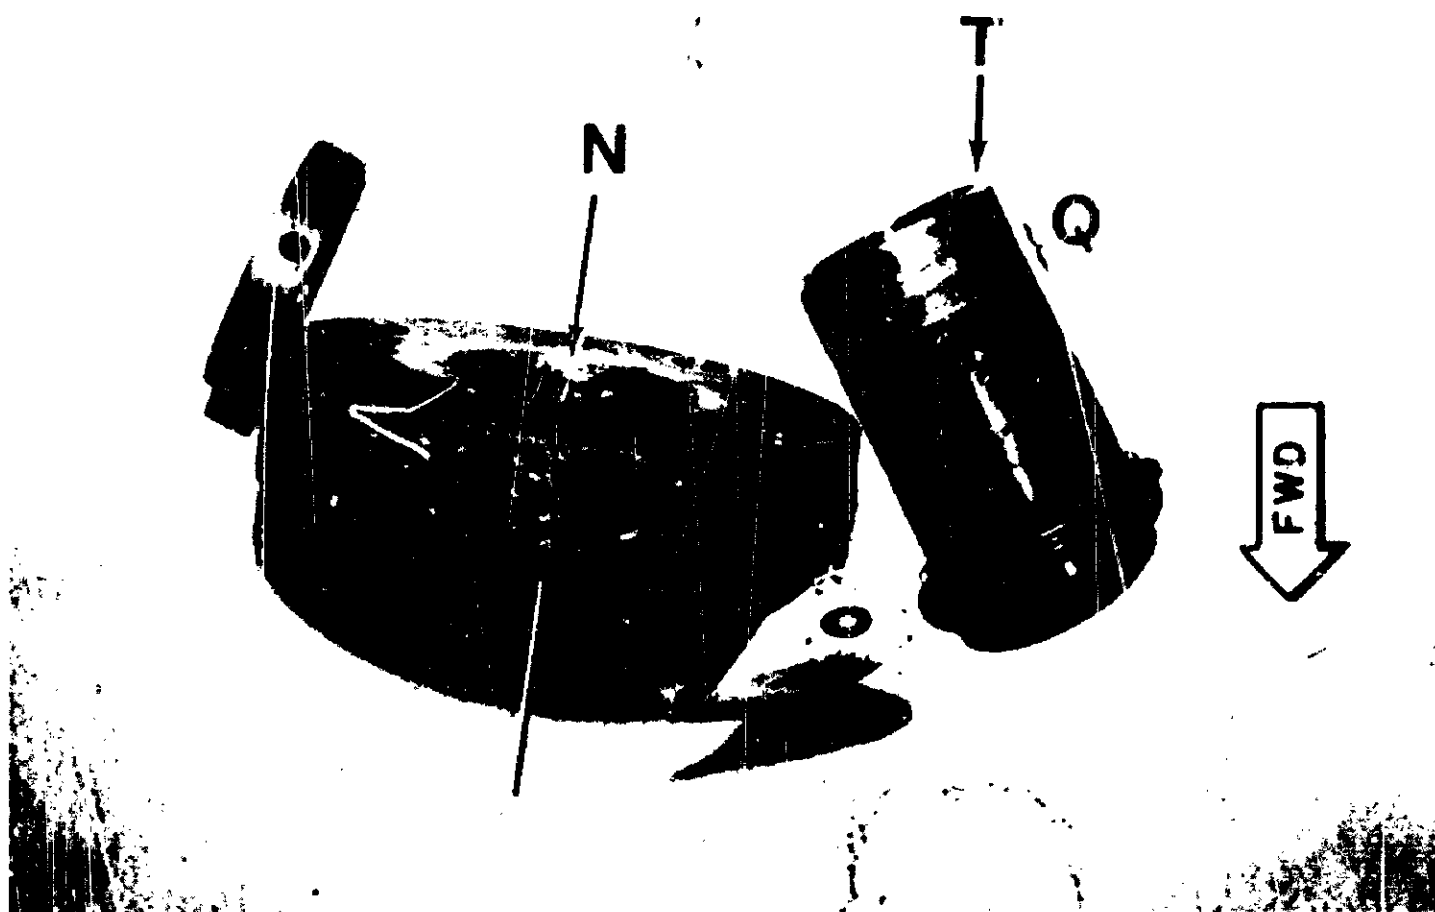
Figure 20.--Mechanical pump seal sleeve of pump unit 3.
N indicates damaged gland around the bore, and Q is
the area of a worn groove.
