AIRCRAFT ACCIDENT/INCIDENT SUMMARY REPORT

LOSS OF CONTROL
BUSINESS EXPRESS, INC.,
BEECHCRAFT 1900C N811BE
NEAR BLOCK ISLAND, RHODE ISLAND
DECEMBER 28, 1991

Accident No.:	NYC-92-FA-053
Airplane Owner/Operator:	Business Express, Inc.
Airplane Type:	Beechcraft 1900C, N811BE
Location:	near Block Island, Rhode Island
Date and Time:	December 28, 1991, 2147 est
Injuries:	3 Fatal
Type of Occurrence:	Loss of Control

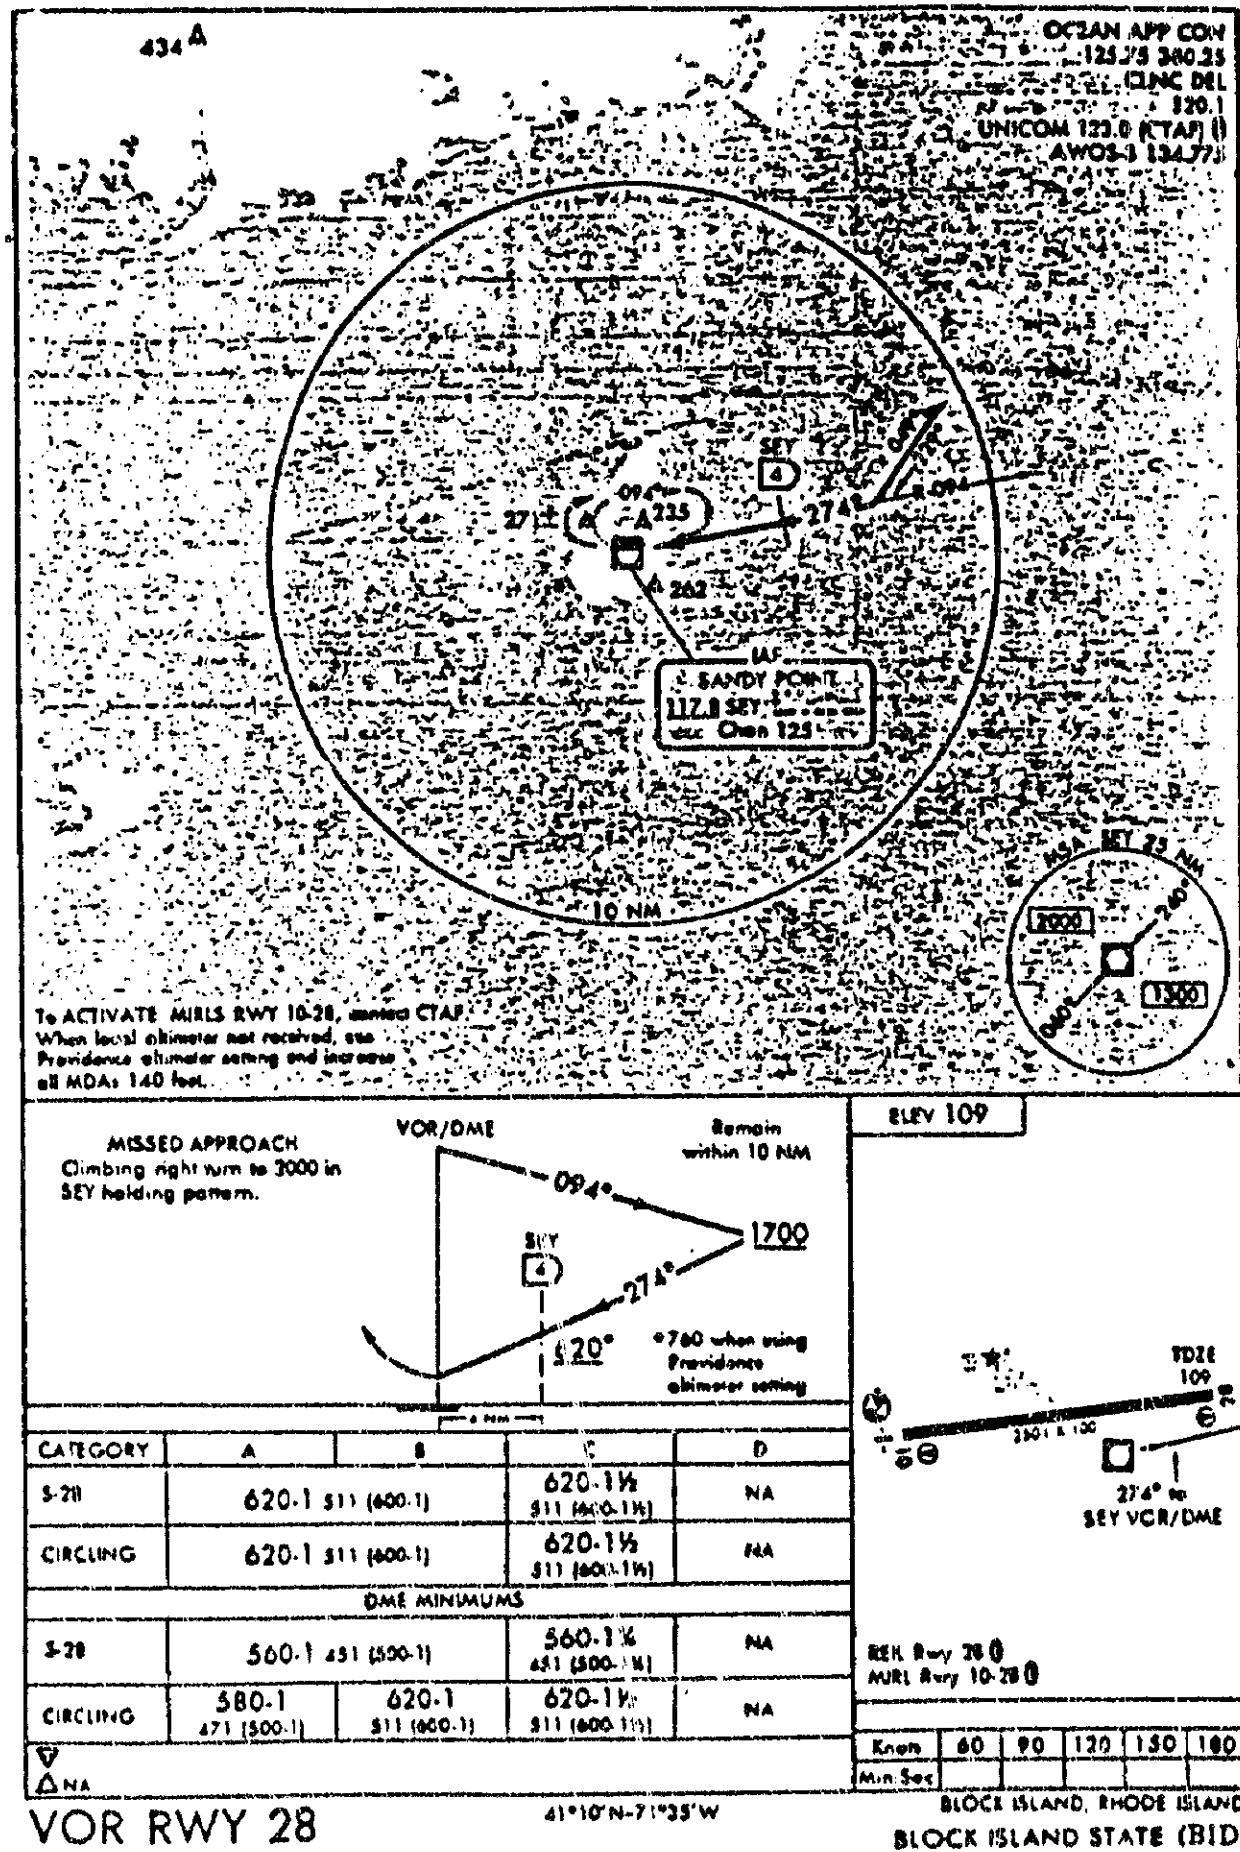
Figure 1--VOR Instrument Approach Procedure

At 2136:27, the IP specified a very high frequency omnidirectional radio (VOR) approach to runway 28 (see Figure 1) and, at 2136:46, the trainee stated, "have a failure on the attitude indicator." At 2139:04, the descent check was accomplished, and the approach check was begun. At 2144:22, a failure of the right engine was simulated by retardation of the power lever to the flight idle position; at 2144:38, the IP confirmed that the right power lever was in flight idle. At 2145:15, the trainee said, "it'll be a single-engine landing...ref gonna be one oh three...that'll be one twenty-three as it stands now."

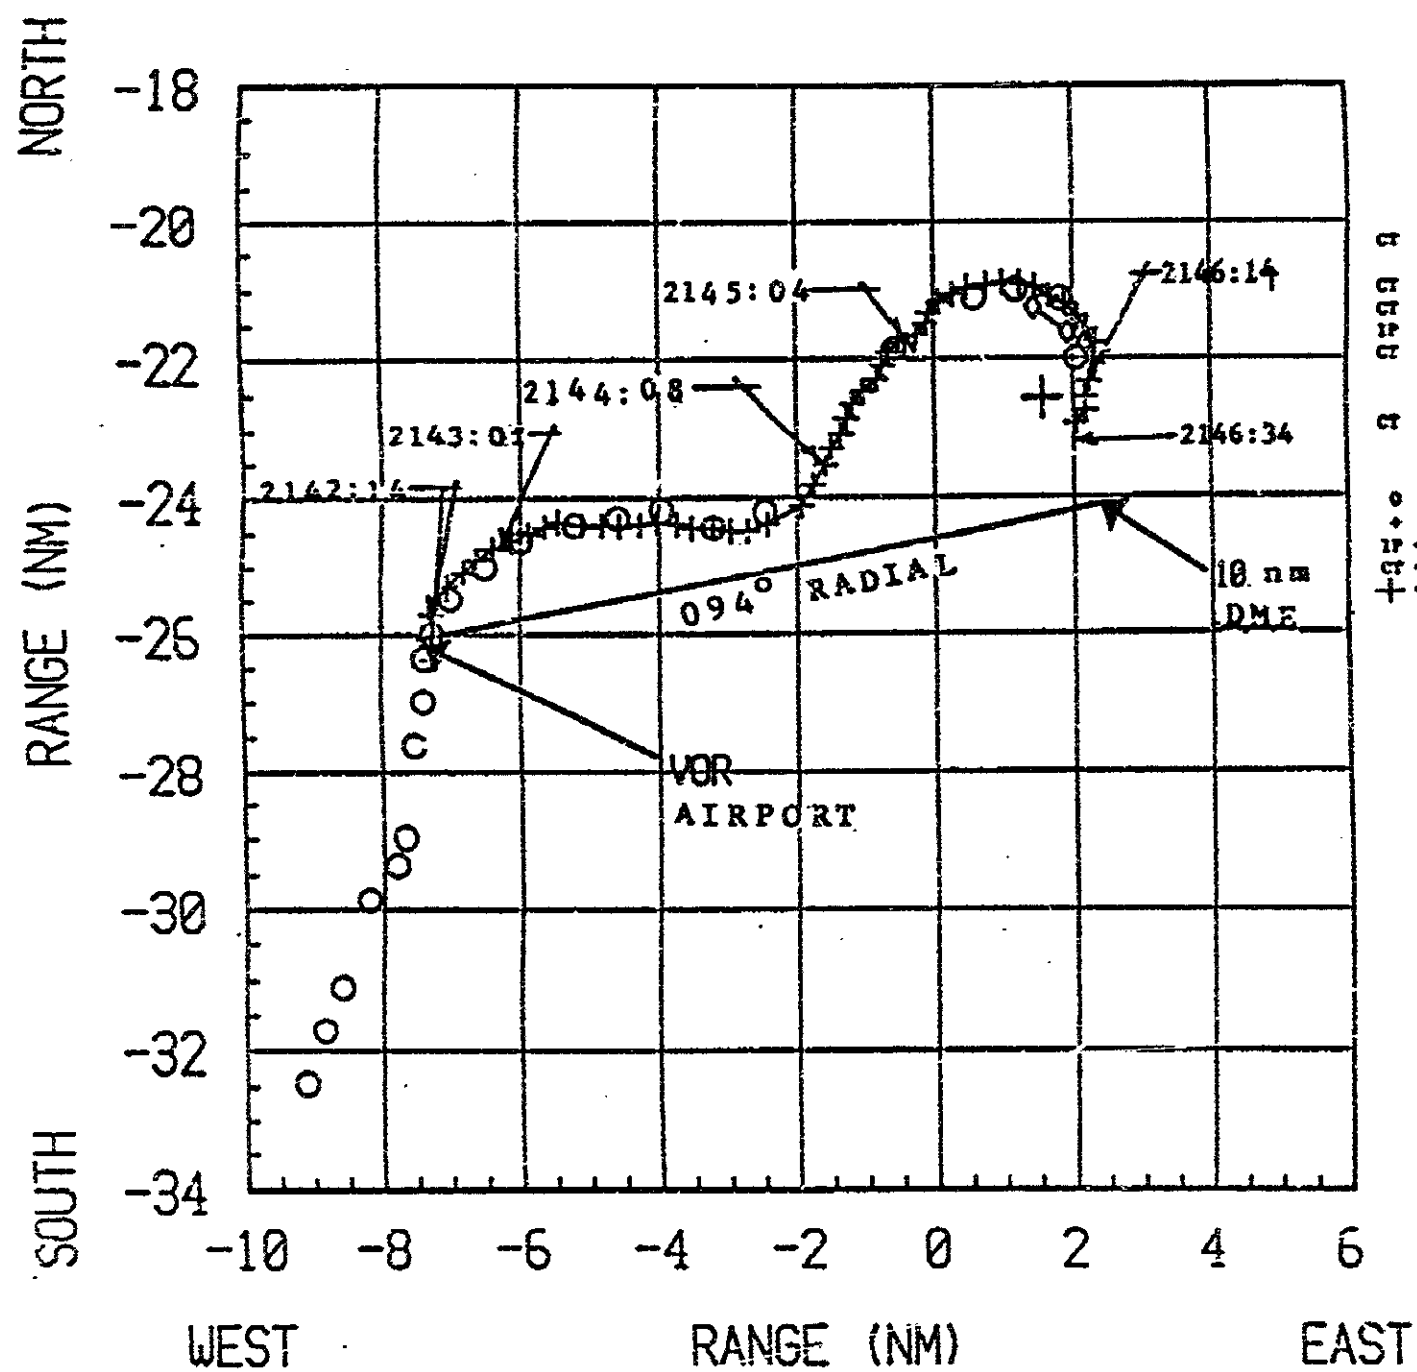
Figure 2--Ground Track of N811BE

The ground track of N811BE was established by aligning both sets of radar data. Figure 2 shows the airplane's ground track as identified by both sets of radar data. The ground track is related to a grid south of the Ocean TRACON antenna site and east and west of a true north-south line through the site. The small open circles represent N811BE's mode C returns recorded at Boston Center and the cross marks represent returns recorded at Ocean TRACON. The final portions of the track are shown in Figure 3. The black dots in Figure 3 show the position of N811BE with respect to the Ocean TRACON antenna site. The dots represent every other transponder-reported position, with the related altitude above each dot, as the airplane was flown into the procedure turn for the VOR approach to runway 28 at Block Island. The last recorded transponder return occurred at 2146:24; the reported altitude was 1,900 feet. The actual times are related to each dot with the hour digits omitted; e.g., 43:47.2 equals 2143:47.2 eastern standard time. Part of the CVR comments are included with "CT" identifying the captain-trainee's comments and "IP" identifying the instructor pilot's comments.

According to the FLIGHT calculations, N811BE was in level flight between 160 and 180 knots indicated airspeed (KIAS) when the last radar return was recorded. It was also in a right bank of about 26°, at a magnetic heading of about 236°, and at an altitude of 1,900 feet.

CT 2142:14 "And out of two and a half
for two thousand"
CT 2143:01 "You want to start the time"
CT 2144:08 "Okay start one minute time"
IP 2145:04 "Okay there's a minute"
CT 2146:14 "And just kinda skosh in here
on the ah little close on the
ah my ten mile"
CT 2146:34 "Oh I ((sound of altitude alert
chime))"

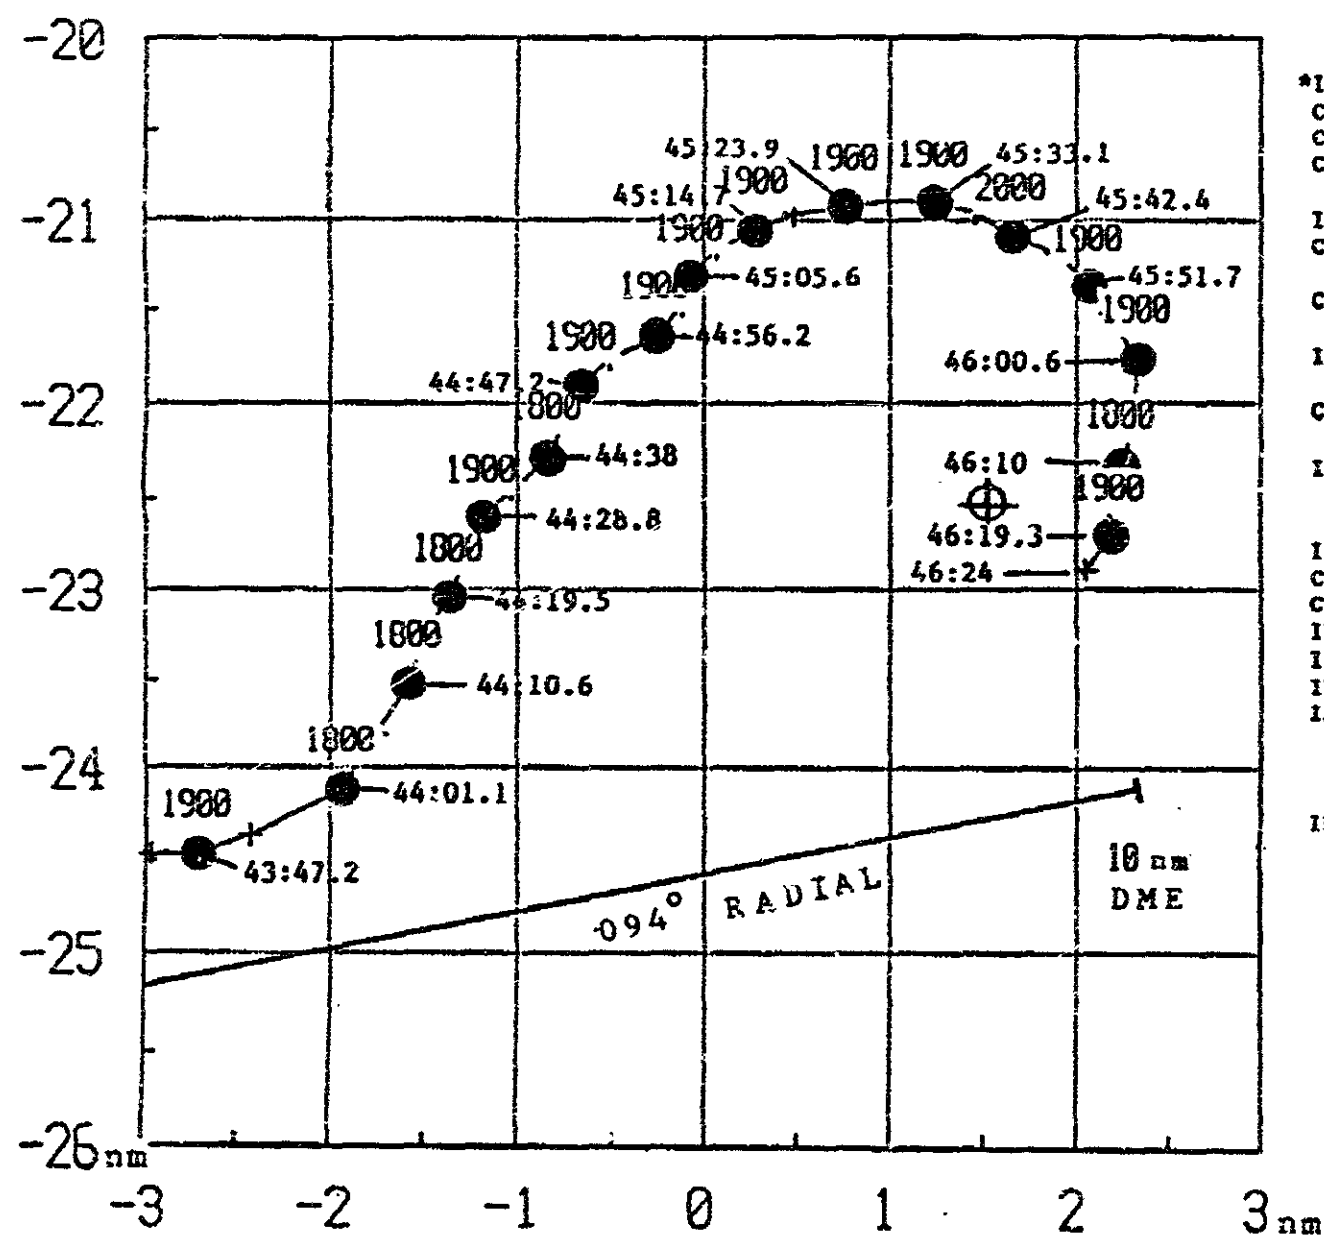
Figure 3--Ground Track of N811BE (expanded continuation)

*IP 2145:04 "Okay there's a minute"
 CT 2145:05 "Okay and in a right turn"
 CT 2145:06 "Course looks to be alive"
 CT 2146:14 "...close on the ah my ten mile"
 IP 2146:17 "Yeah"
 CT 2146:19 "I probably should be wary of that"
 CT 2146:27 "What altitude am i good down to?"
 IP 2146:29 "Ah once you're established inbound you're good to what?"
 CT 2146:34 "Oh / ((sound of altitude alert chime))
 IP 2146:35 "Stop one thing at a time you're in a bad situation so correct one thing first"
 IP 2146:39 "Nope"
 CT 2146:40 "Whoa"
 CT 2146:42 "Your aircraft?"
 IP 2146:42 "No take it"
 IP 2146:44 "Get the bank"
 IP 2146:45 "Power to idle"
 IP 2146:46 "What are you doing that for?"
 2146:46 Sound of landing gear warning horn starts and continues to the end of the recording
 IP 2146:47 "All right"
 2146:49 End of Recording
