National Transportation Safety Board Aircraft Accident Report  
Aborted Takeoff Shortly After Liftoff, Trans World Airlines  
Flight 843, Lockheed L-1011, N11002, John F. Kennedy  
International Airport, Jamaica, New York, July 30, 1992

PB93-910404  
NTSB/AAR-93/04

ABORTED TAKEOFF SHORTLY AFTER LIFTOFF  
TRANS WORLD AIRLINES FLIGHT 843  
LOCKHEED L-1011, N11002  
JOHN F. KENNEDY INTERNATIONAL AIRPORT  
JAMAICA, NEW YORK  
JULY 30, 1992

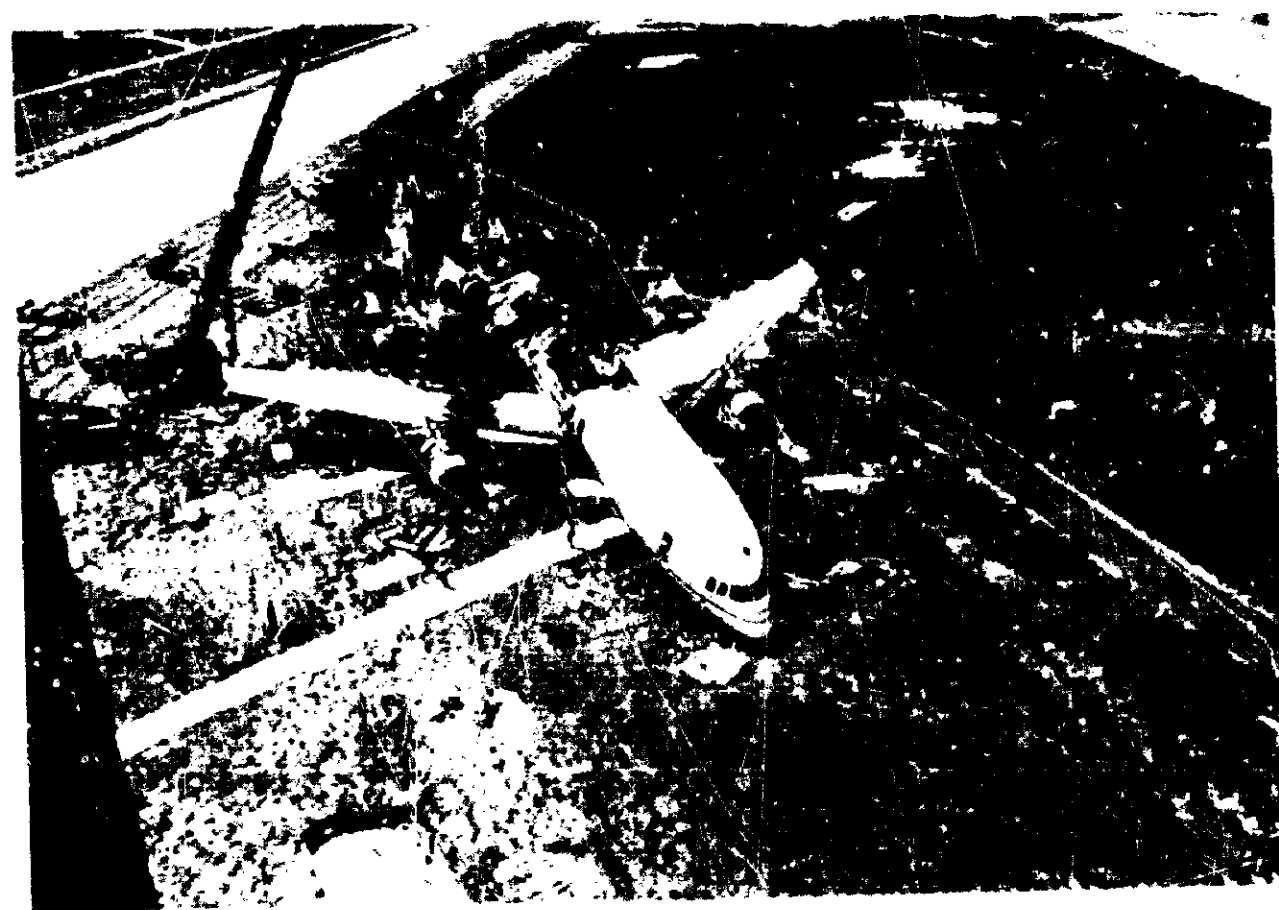
Figure 3.--Airplane wreckage.

Within 2 minutes of the time the airplane came to rest, airport rescue and fire fighting (ARFF) trucks arrived at the site. However, the airplane continued to burn. Before the fire could be extinguished, it consumed the entire aft fuselage, in the area behind the wings and above the cabin floor. The fire also burned through the lower fuselage in two places, so that two sections fell separately to the ground. After the fire was extinguished, the airplane rested on the wheels from the two main landing gear and the structure and skin beneath the forward cockpit and nose. Figures 3 and 4 are photographs of the wreckage.

The airplane was destroyed by fire; however, there was little damage to the fuselage forward of the wing's rear spars. The fire damage was severe in the cabin area, beginning aft of the wing's rear spars.

Intense fire damage existed throughout the empennage. Aft of the forward bulkhead for the coach section, the cabin was substantially burned away. Fuselage skin, frames and stringers were either melted or remained as ash residue, and cabin seats and extensive sections of cabin floor were significantly melted by the fire, leaving a residue of globules of aluminum and ash mixed with the remaining seat and cabin structure. Although the interior of the passenger cabin in the coach class was destroyed, seats forward of the bulkhead between the coach and business class sections were not fire damaged.

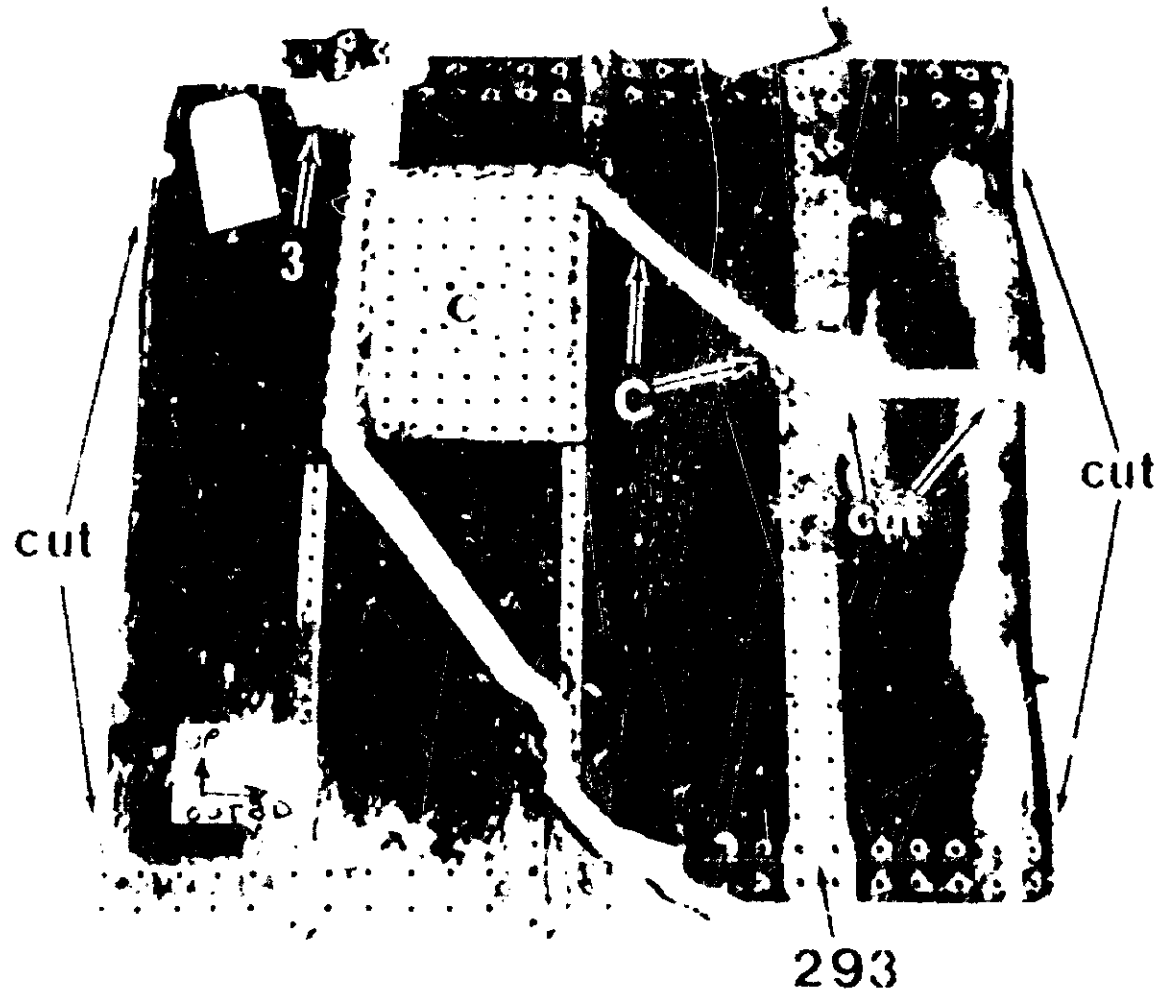
Figure 6.--Right wing spar damage.

The right inboard wing rear spar, which also formed part of the fuel cell wall, was fractured between the right side of the fuselage and the right main landing gear. (See figure 6). After the fire was extinguished, fuel continued to drip out of this fracture. The fractures in the right wing rear spar were examined in the field by structural engineers and metallurgists; portions of the spar web were brought to the Safety Board's Materials Laboratory in Washington, D.C., for detailed metallurgical examinations.<sup>2</sup>

The detailed examinations of the right wing rear spar revealed no evidence of preexisting fatigue damage. All fractures were found to be caused by overstress forces. There was no fatigue cracking or progressive failure found in the spar web fracture, or in any other fracture in the structure of the right wing, including stiffeners, upper and lower spar caps, stringers, and skin. Hardness and conductivity measurements of the fractured web material produced results consistent with the specified material.

<sup>2</sup>Because of a prior history of fatigue cracks in the wing rear spar web, detailed examinations of this area were conducted to verify that there was no preexisting damage or fatigue that may have been a factor in the accident.
