# NATIONAL TRANSPORTATION SAFETY BOARD

## AIRCRAFT ACCIDENT REPORT

IN-FLIGHT LOSS OF PROPELLER BLADE  
AND UNCONTROLLED COLLISION WITH TERRAIN  
MITSUBISHI MU-2B-60, N86SD  
ZWINGLE, IOWA  
APRIL 19, 1993

**Abstract:** This report explains the in-flight loss of propeller blade and subsequent crash of an MU-2B-60 airplane, operated by the South Dakota Department of Transportation, while the flightcrew was attempting an approach to an emergency landing at Dubuque Regional Airport, Dubuque, Iowa, on April 19, 1993. The safety issues discussed in the report include the propeller hub design, certification and continuing airworthiness, and air traffic control training. Recommendations concerning these issues were made to the Federal Aviation Administration.

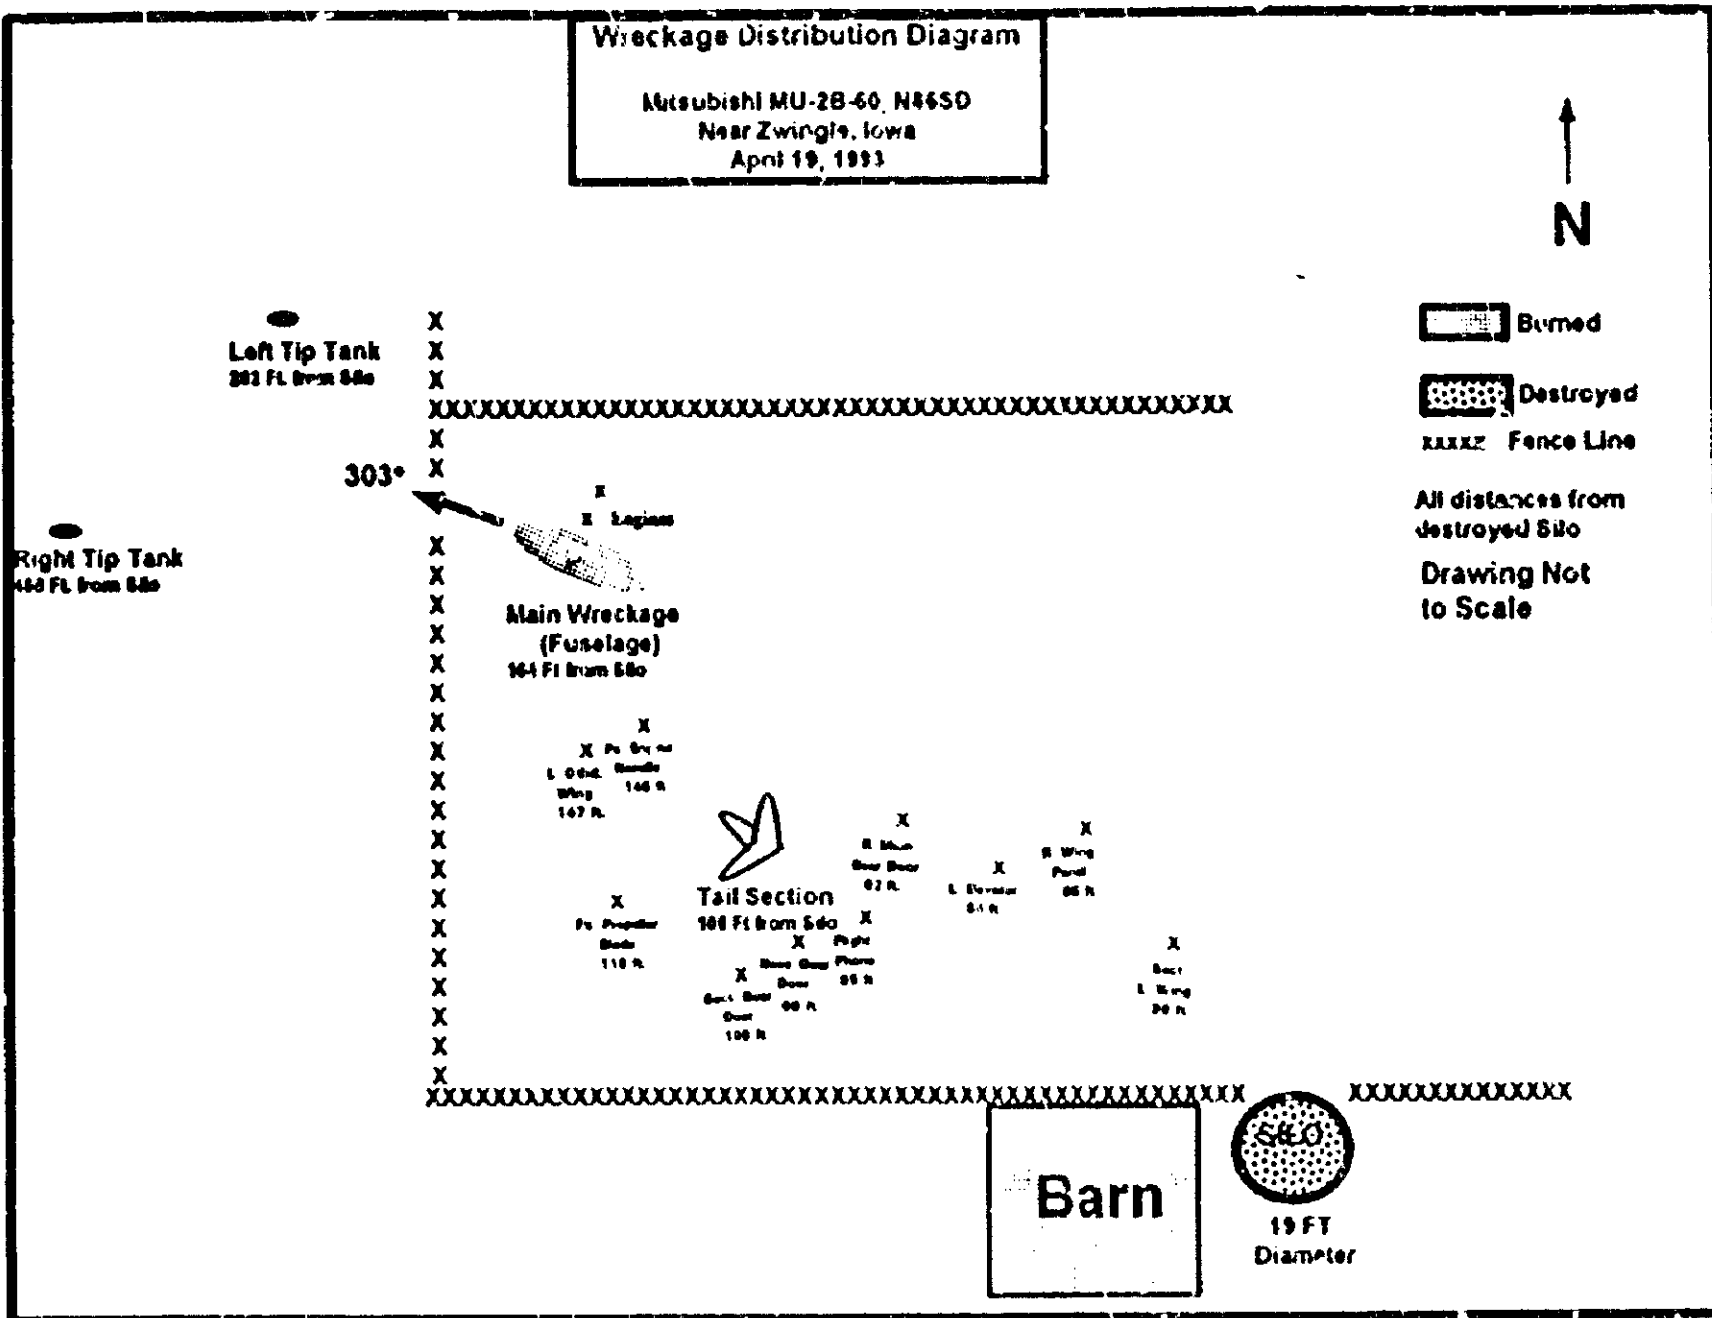
**Figure 2.--Debris field diagram.**

The airplane came to rest on a heading of 303 degrees magnetic in a barnyard. During the postcrash fire, about 75 percent of the fuselage was consumed by fire. The wreckage path began at a demolished 75-foot concrete and steel silo and continued for about 498 feet on a magnetic heading of between 290 and 320 degrees. The farthestmost pieces of airplane debris that were found were the left and right tip tanks, which showed minor frontal damage and no fire damage. The fuselage was found to be heading 303 degrees and was largely consumed by fire from the front to the aft pressure bulkhead. (See figures 2 and 3).

The wreckage path contained pieces of the airplane from the nose to the tail and from the right wing tip to the left wing tip. One propeller blade, one blade tip, and the powerplant top cowling from the left engine nacelle could not be found at the accident site.<sup>6</sup> Pieces of silo material were found throughout the wreckage debris.

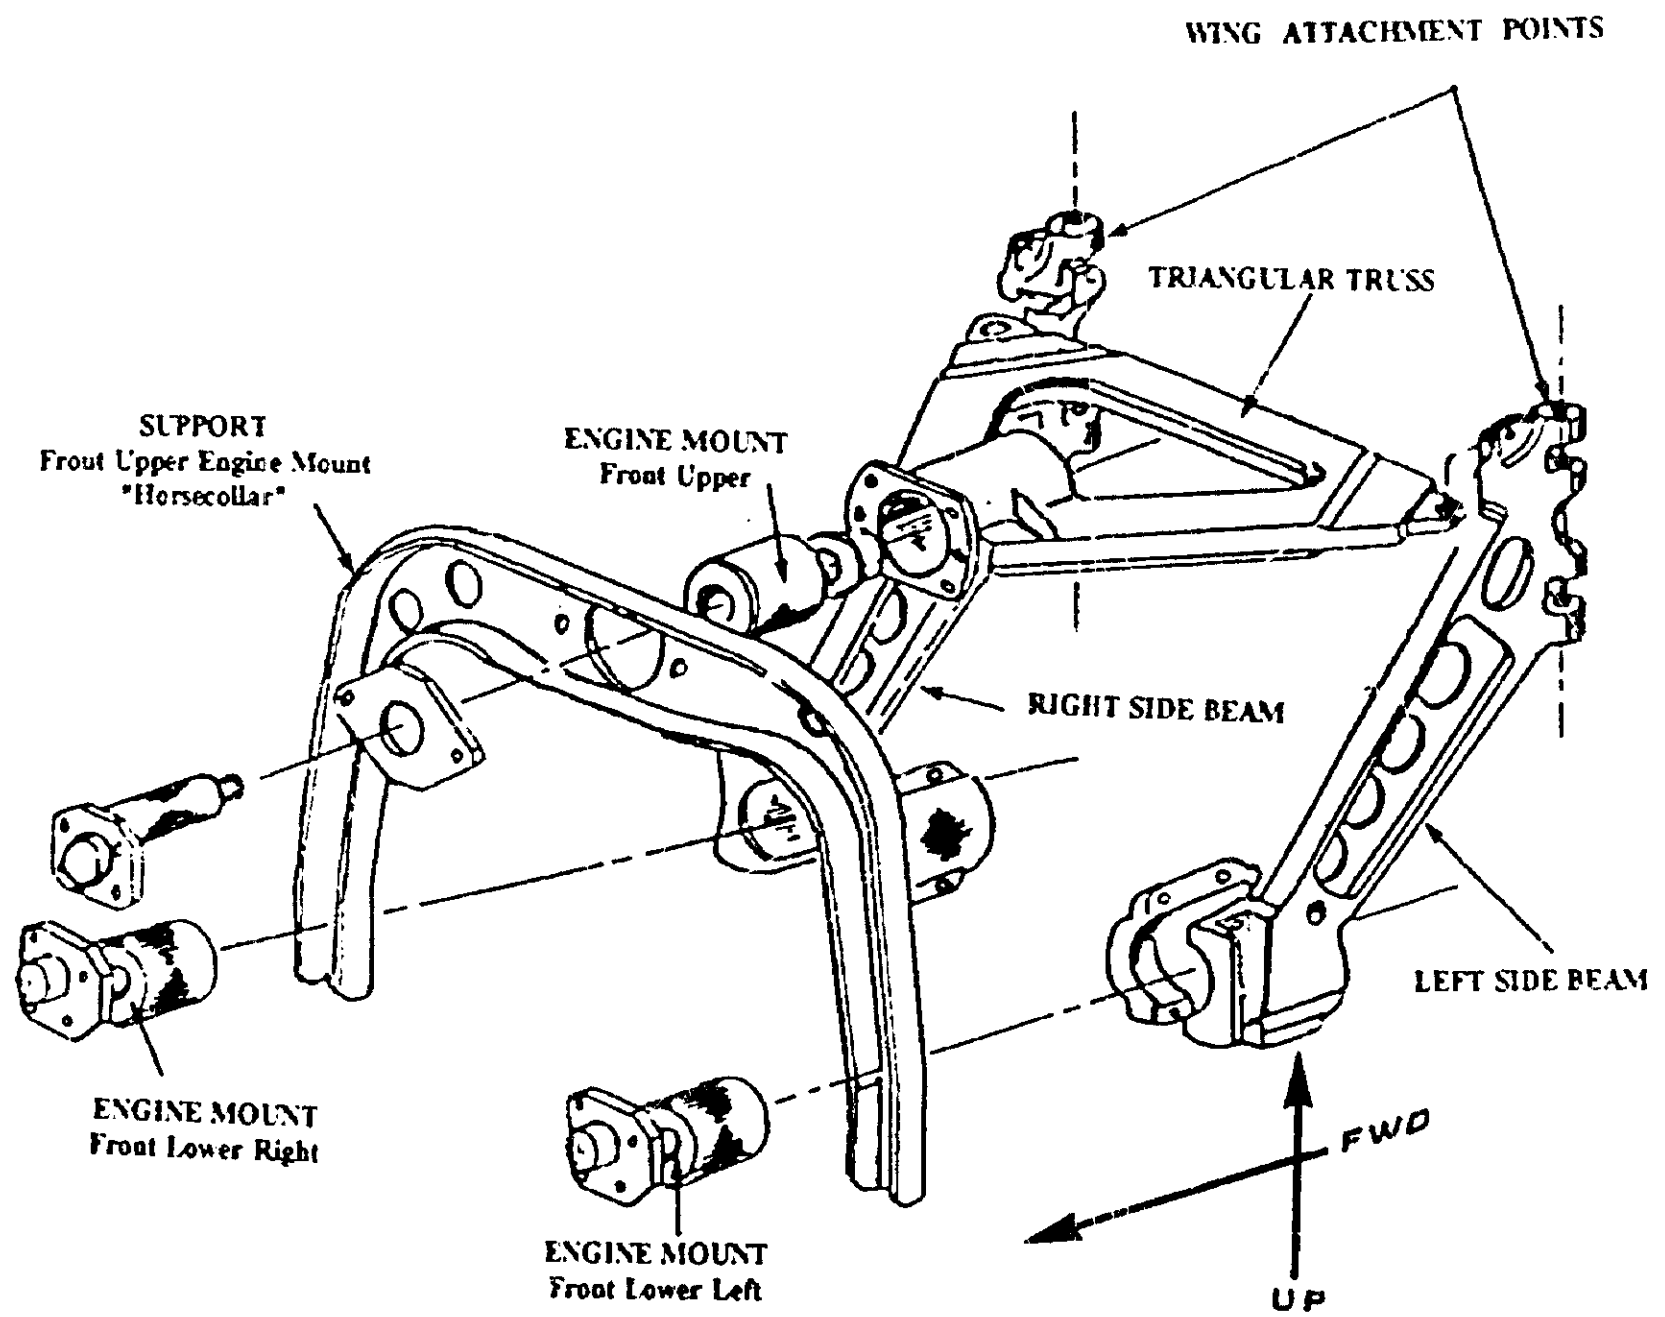
Figure 4.--Engine mount diagram.

The left side panel beam separated from the front wing spar, with the beam hinge type attachment and bolt intact; the separation occurred at the wing spar riveted joint. (See figure 4). The left beam was bent at mid length to the right (aft looking forward) approximately 50 degrees and slightly twisted in a clockwise direction. The cover and vibration isolator were intact and relatively free of damage. The engine mount spindle plate was attached to the vibration isolator; however, the spindle plate separated from the accessory gear box (AGB) when the threaded inserts were stripped from the cast aluminum AGB housing. The inserts made multiple imprints at the attach point on the engine. The right beam also separated at the wing spar in tension and in a forward direction. The separation was at the web just aft of the vertical bolt. However, the right beam was not bent or twisted. The spindle on the right beam spindle plate failed at the minor diameter, and the separated piece of the spindle remained with the vibration isolator.

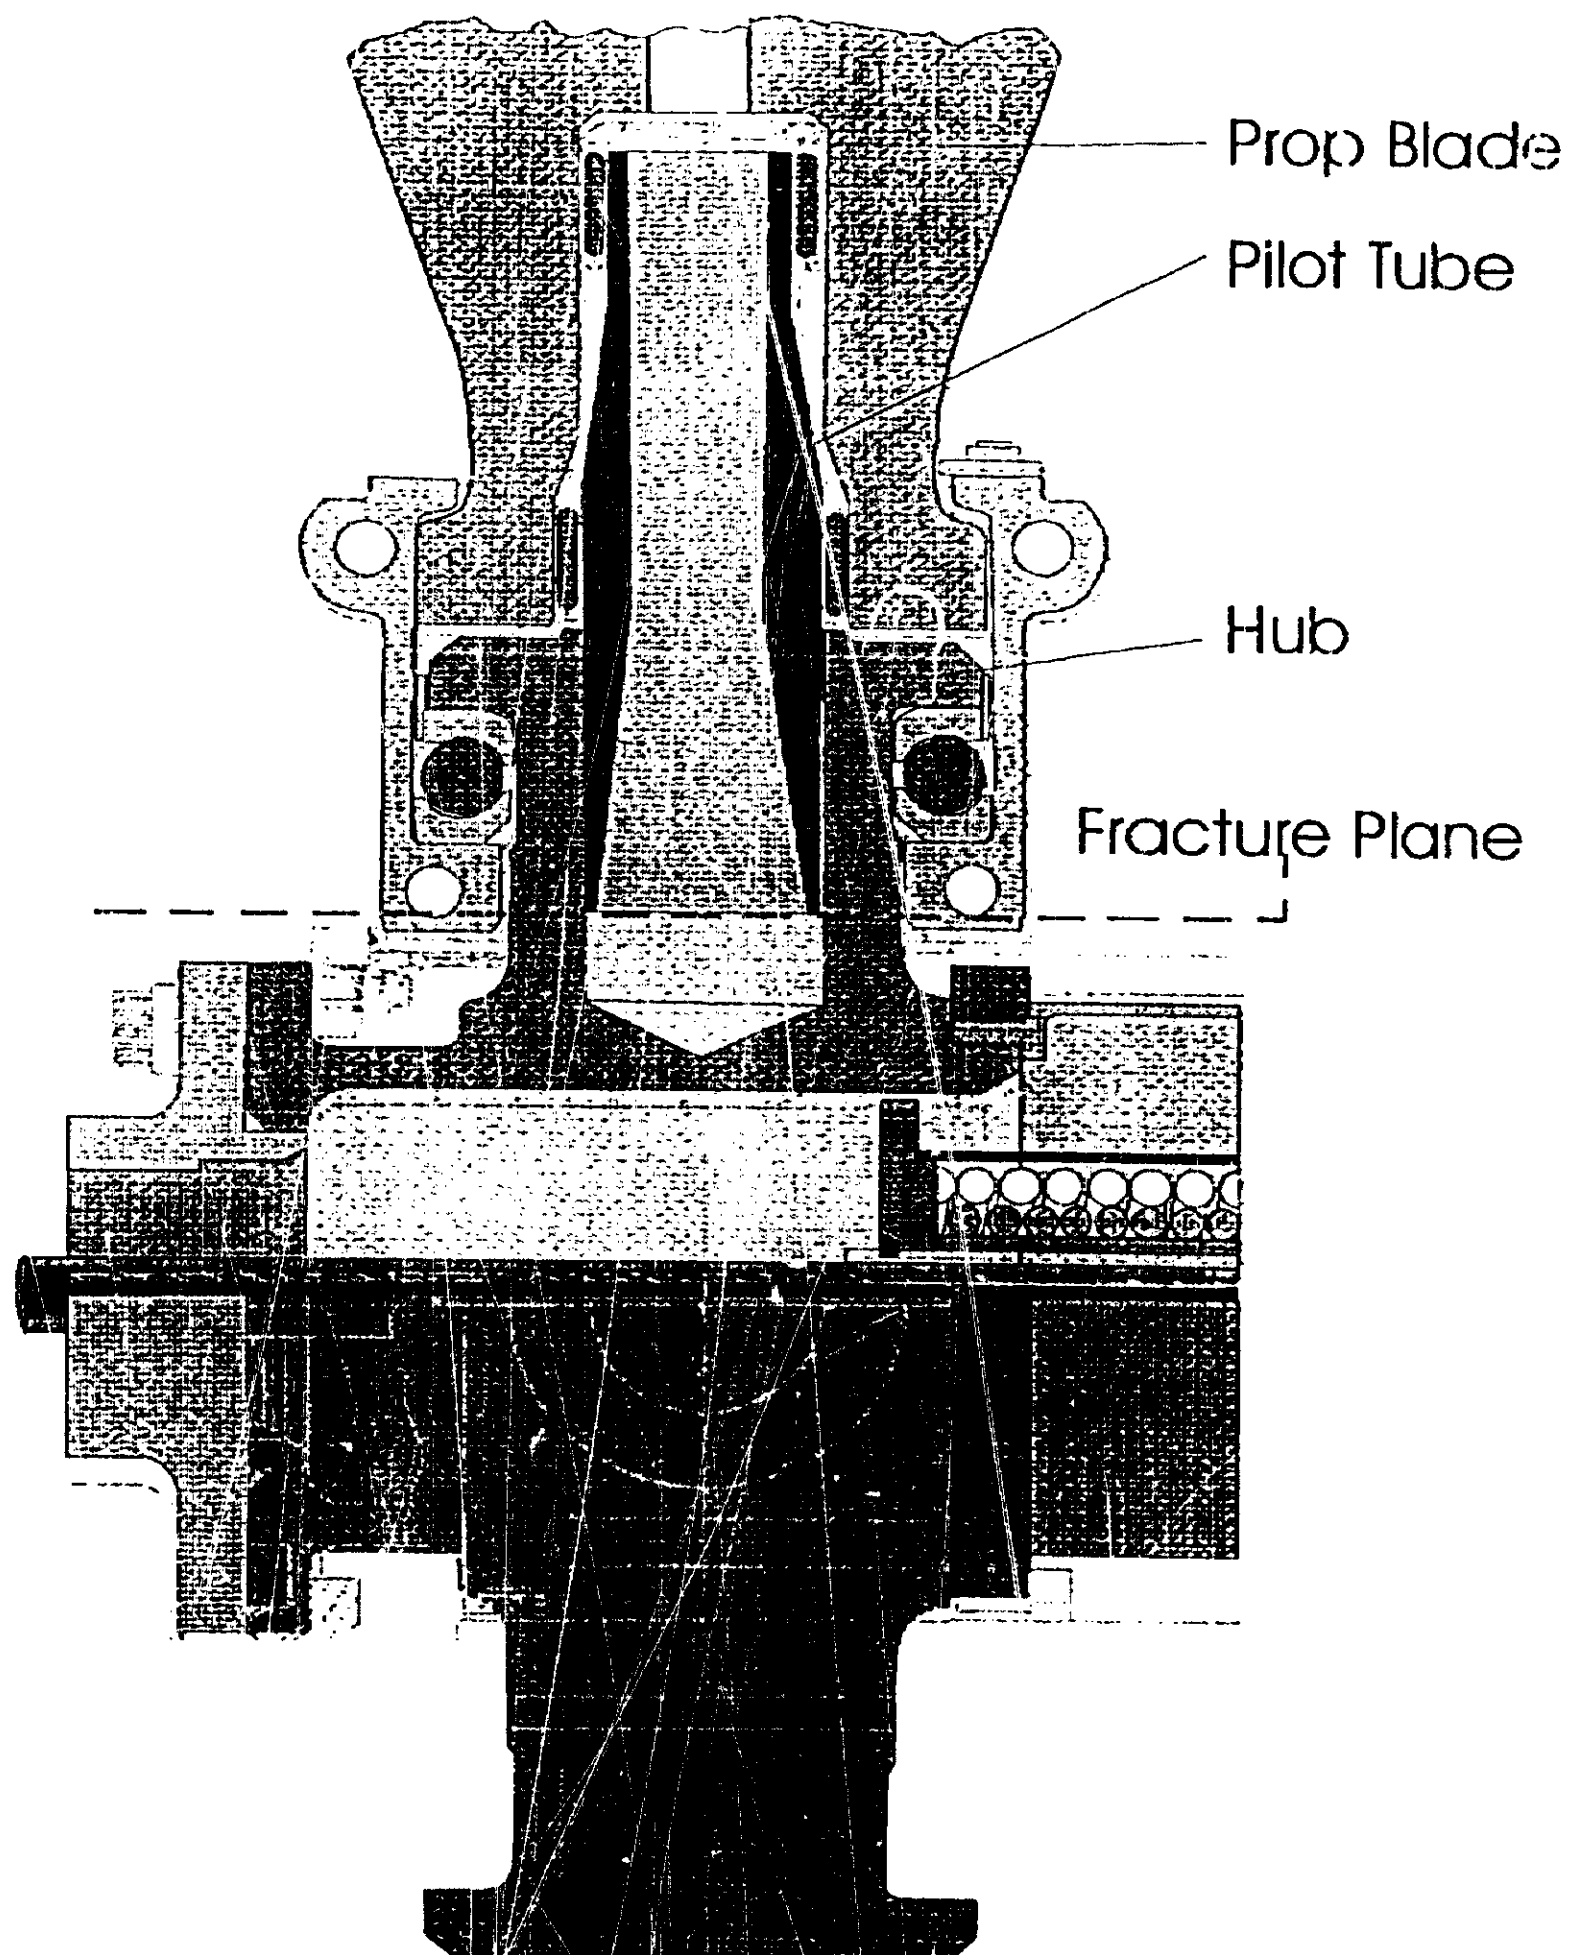
Figure 5.--Cross section of propeller hub arm.

The examination of the left propeller revealed that the fracture in the separated hub arm was the result of a fatigue crack that initiated from the inside diameter of the pilot tube hole in the hub arm. Figure 5 is a drawing of a cross section through the hub arm of the Hartzell HC-B4 propeller, with the location of the fracture indicated. Figure 6 is a view looking inboard on the fracture surface on the main portion of the propeller hub. The circumferential location of the origin area of the fatigue crack was at the 7:30 position, looking inboard at the fracture, with forward at the 12:00 position. This portion of the hub arm would experience maximum tensile stresses during normal operation of the propeller (forward thrust). The axial location of the origin was about 0.020 inch outboard of the bevel on the inboard end of the pilot tube. The fatigue cracking propagated through about 45 percent of the hub arm cross section before final fracture occurred.
