PB94-910404  
NTSB/AAR-94/02/SUM

## AIRCRAFT ACCIDENT/INCIDENT SUMMARY REPORT

IN-FLIGHT LOSS OF CONTROL,  
LEADING TO FORCED LANDING  
AND RUNWAY OVERRUN  
CONTINENTAL EXPRESS, INC., N24706  
EMBRAER EMB-120 RT  
PINE BLUFF, ARKANSAS  
APRIL 29, 1993

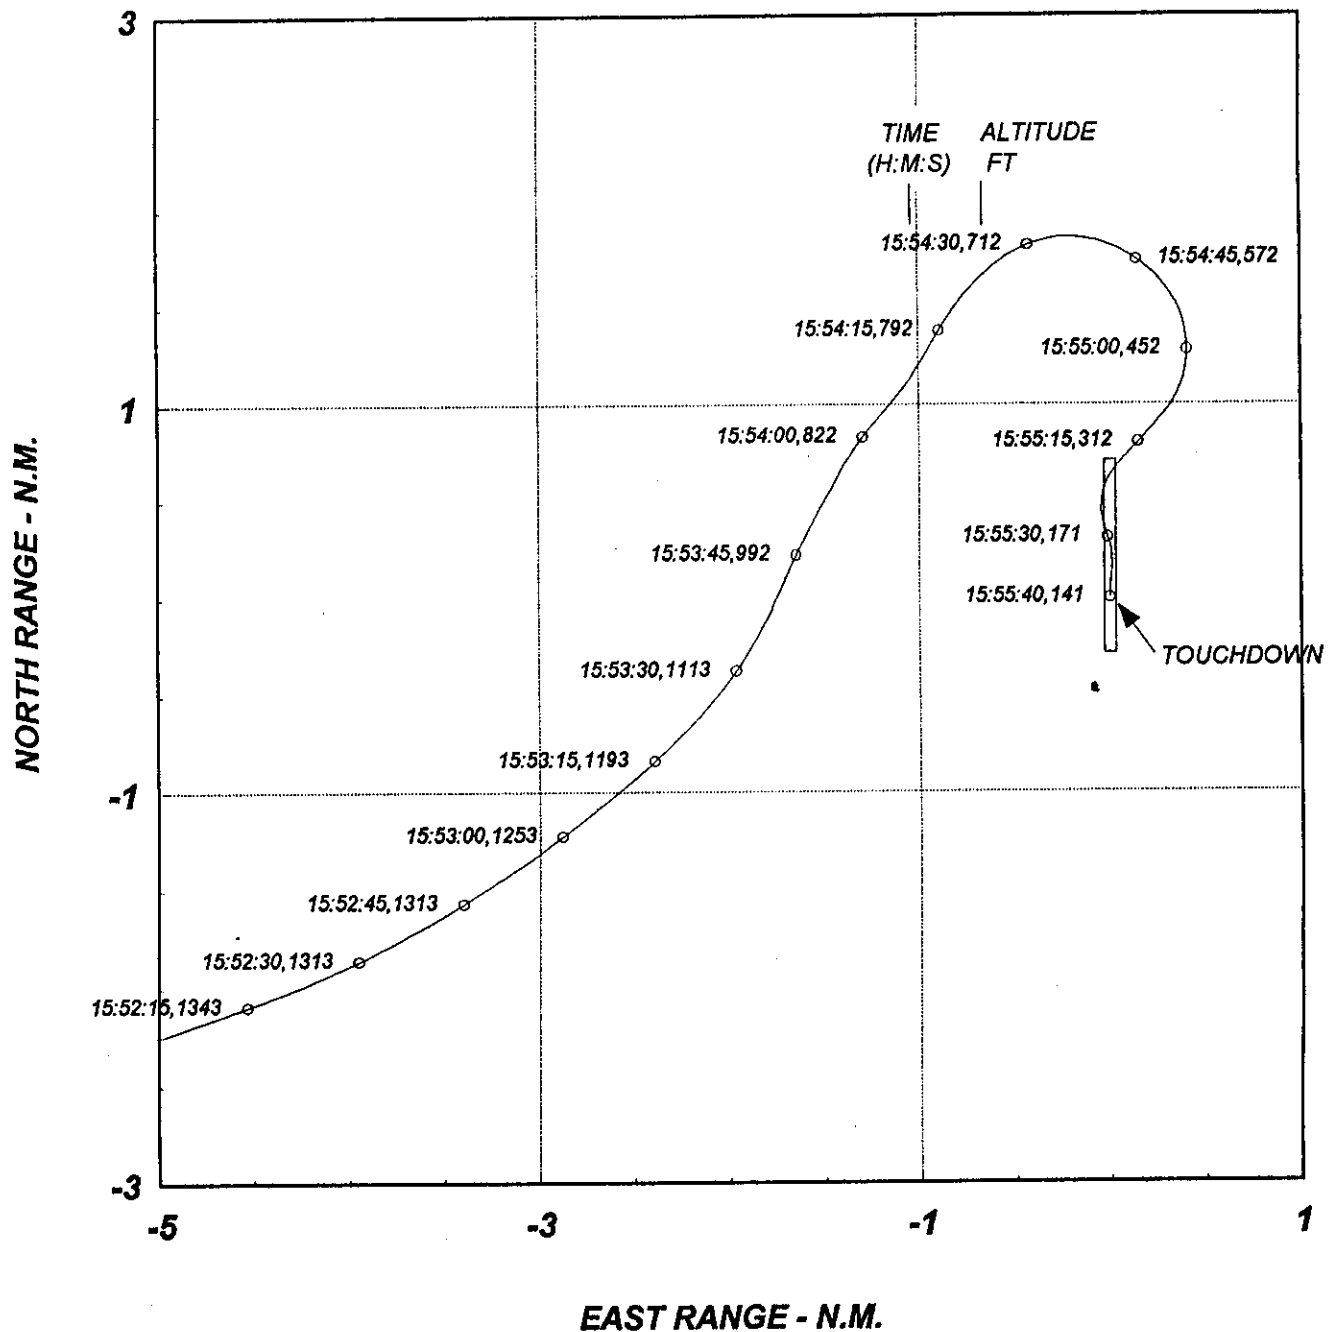
that he overshot the right turn to final for runway 17 due to control problems. The investigation revealed that the airplane touched down with 1,880 feet of runway remaining. The captain further stated that he applied the brakes at touchdown and the airplane immediately began hydroplaning on the wet surface and went off the departure end onto wet rough sod, avoiding the vehicle and construction personnel that remained near the end. Both flightcrew members stated that braking action was nonexistent on the runway and that both braking and steering were nonexistent in the wet grass off the runway. Landing gear tire tracks were found on the runway consistent with those associated with hydroplaning.

Figure 2.--Flightpath of the airplane during the approach to PBF

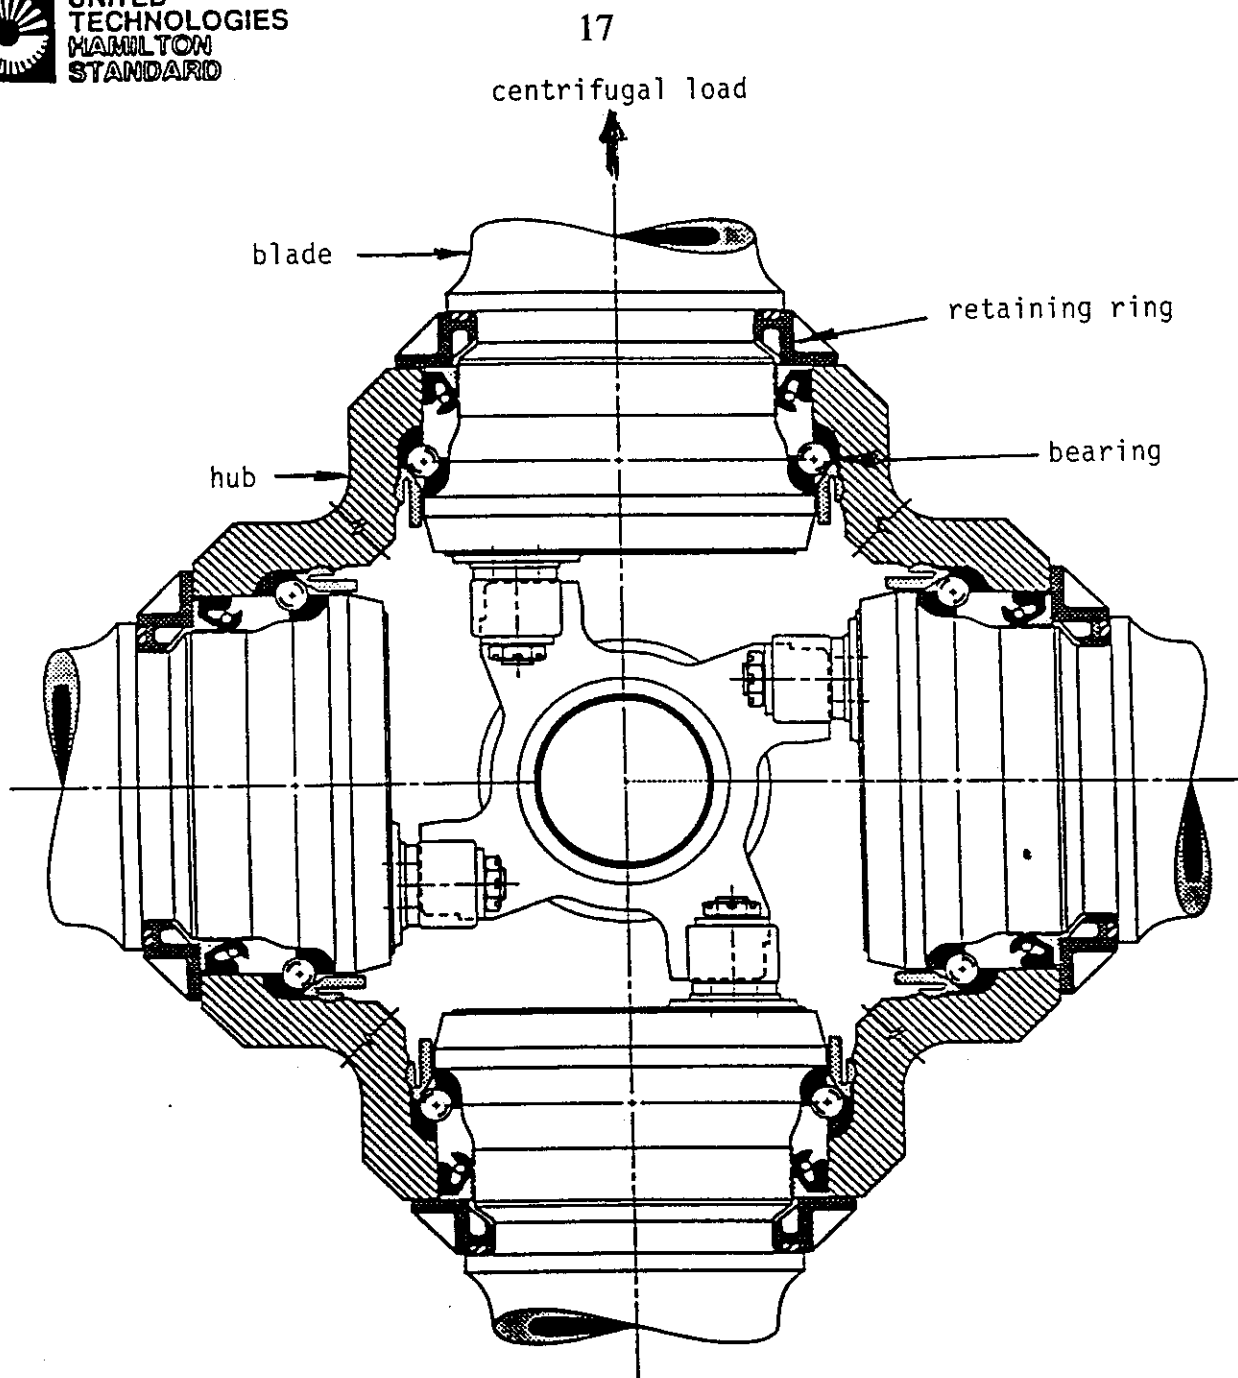
Figure 3.--Hamilton Standard 14RF-9 Propeller Assembly

The Hamilton Standard Model 14RF-9 propeller assembly consists of four blades inserted into a hub as shown in Figure 3. During normal operation, the blades are retained in the hub by high centrifugal loads holding the blade outward against the bearing, and any bending loads are overcome by the high centrifugal loads. When there are no centrifugal loads on the propeller assembly, the retaining rings will retain the blades statically from dropping into the hub.

The three propeller blades that separated from the left hub following the loss of control were never found. The fourth blade remained loose in the hub. Its pitch change pin and roller were pinched in the actuator yoke by a bent yoke arm. The FDR, flight data acquisition unit (FDAU), and CVR data indicated that the blade separation sequence probably started about 35 seconds after the onset of the loss of control. Postaccident examination of remnants of the left propeller system indicated that the hub was intact, and the individual blade deice leads were attached at the time of separation.

The hubs installed on the accident airplane were equipped with composite material (Rynite) retaining rings for each blade. The evidence indicated that the composite blade retaining rings fractured and led to the blade loss. During departure from normal flight attitudes, the roll and yaw oscillations cause significant angle-of-attack changes on the blades, which produce increasingly severe propeller cyclic loads. Damage signatures observed in the left propeller hub were consistent with the blade departing the hub by rocking in the plane of rotation. The rocking motion of the blades would load the retaining rings so as to produce a fracture.

Following earlier blade loss events on other Hamilton Standard Model 14 propellers installed on other types of airplanes, the FAA issued AD 88-20-08 requiring the replacement of composite material blade retaining rings on those propellers with aluminum blade retaining rings. The 14RF-9 submodel, installed on the EMB-120, and the 14RF-21 submodel, installed on the CASA CN-235, were excepted from this AD. When AD 88-20-08 was created, it was thought that because the 14RF-9 and 14RF-21 models were turned by lower power engines, their blade retaining rings did not need to be made of aluminum. Following this

accident, however, the FAA issued a notice of proposed rulemaking<sup>5</sup> to propose an AD that would require the submodels 14RF-9 and 14RF-21 to also have aluminum retaining rings. The final rule has not been issued as of the date of this report.
