AIRCRAFT ACCIDENT REPORT

CONTROLLED COLLISION WITH TERRAIN
TRANSPORTES AEREOS EJECUTIVOS, S.A. (TAESA)
LEARJET 25D, XA-BBA
DULLES INTERNATIONAL AIRPORT
CHANTILLY, VIRGINIA
JUNE 18, 1994

**Adopted: March 7, 1995
Notation 6527**

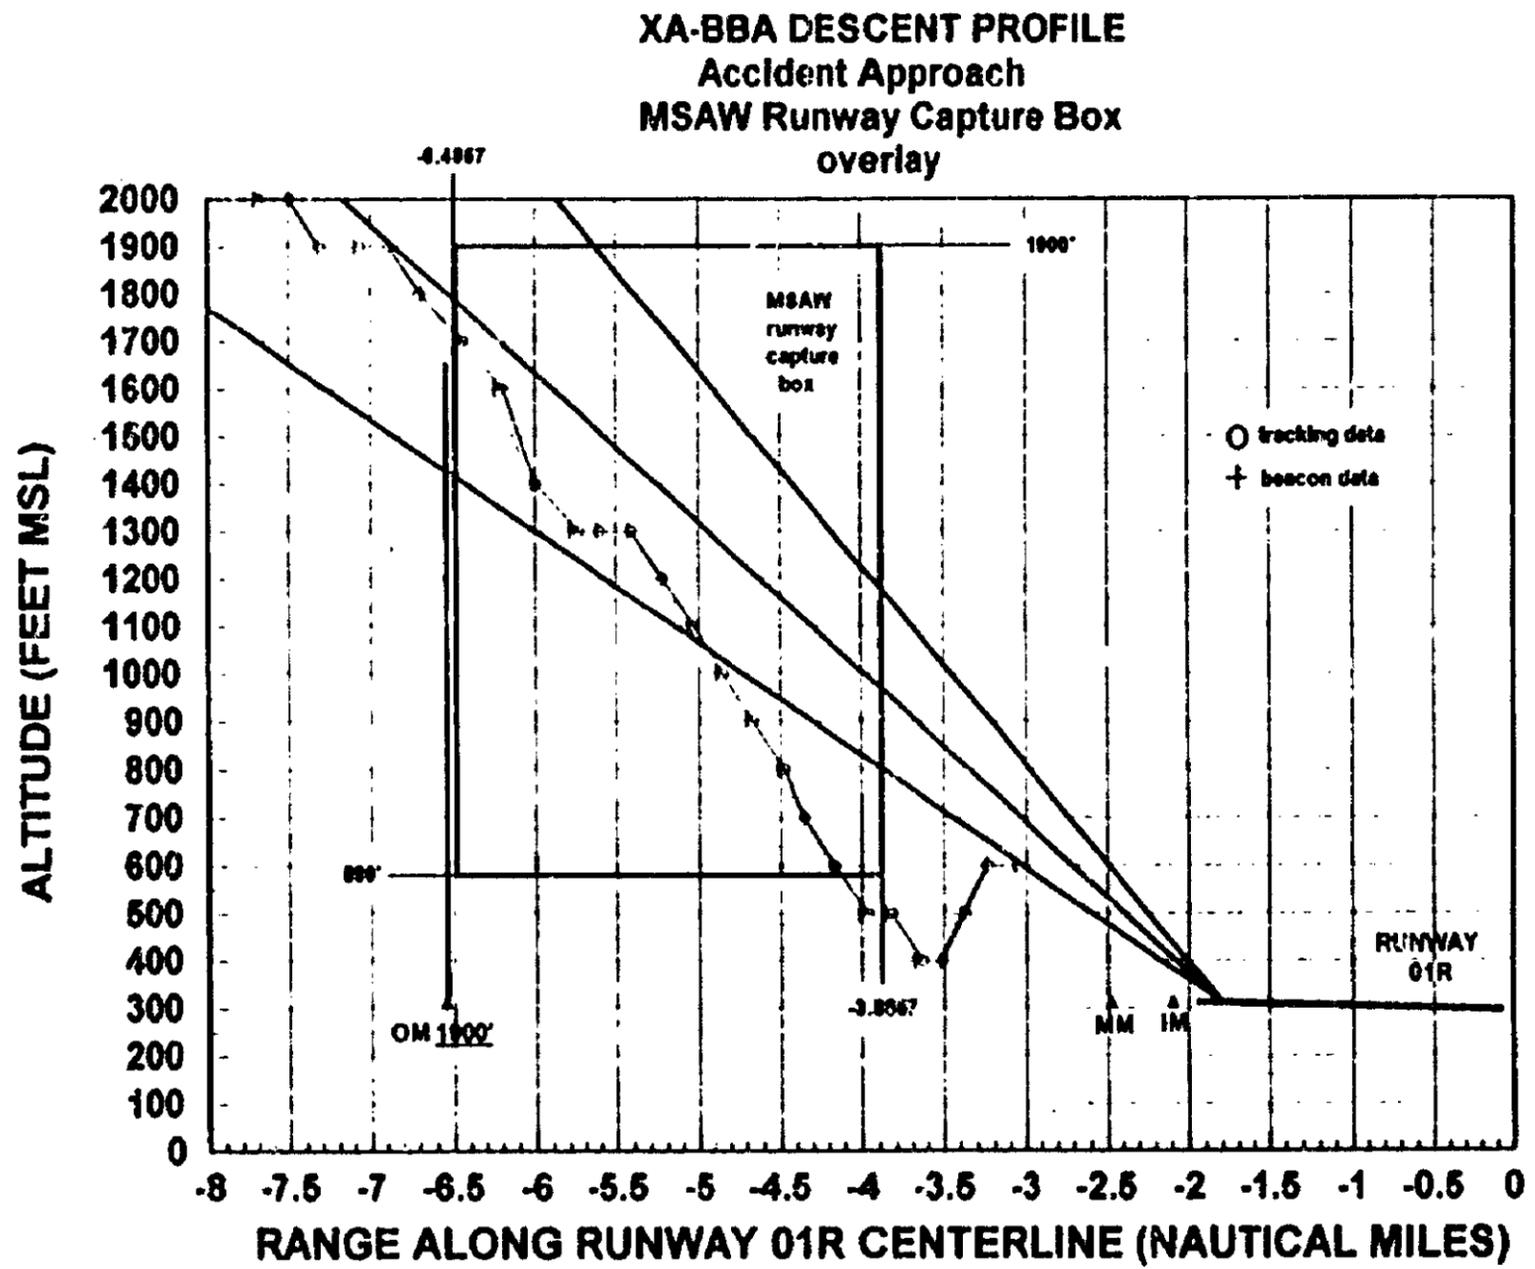
Figure 1.--Airplane descent profile.

There were no primary radar targets found in the vicinity of XA-BBA, and there were no minimum safe altitude warning (MSAW)⁷ alerts during the period of the approaches. A plot of the MSAW site variable parameters and the XA-BBA radar track indicated that XA-BBA had one return below the alarm altitude of the runway 1R capture box in both tracking and beacon data (see figure 1). However, the FAA states in their MSAW system functional specifications, two "current position" hits, or three "predicted position" hits must be received on radar before an alert will activate the aural and visual warnings.

Inspection of the MSAW site variable parameter that defined the runway threshold indicated a discrepancy between the MSAW-defined runway location and the actual threshold location. The prescribed magnetic variation of 10 degrees west was applied to the MSAW-defined threshold coordinates which created a position offset of 700 feet to the northeast from the actual runway 1R threshold. However, when a 7-degree west variation was applied, a match between the MSAW-defined threshold and the actual runway threshold was established. Furthermore, inspection of the other site variables revealed that a localizer-only minimum descent altitude (MDA) was used to establish the base of the runway capture box (680 feet).

On November 21, 1994, the Safety Board issued Safety Recommendations A-94-186 and A-94-187 to the FAA concerning the MSAW system at IAD and all radar environments using the system, respectively. See appendix D for correspondence concerning these safety recommendations.

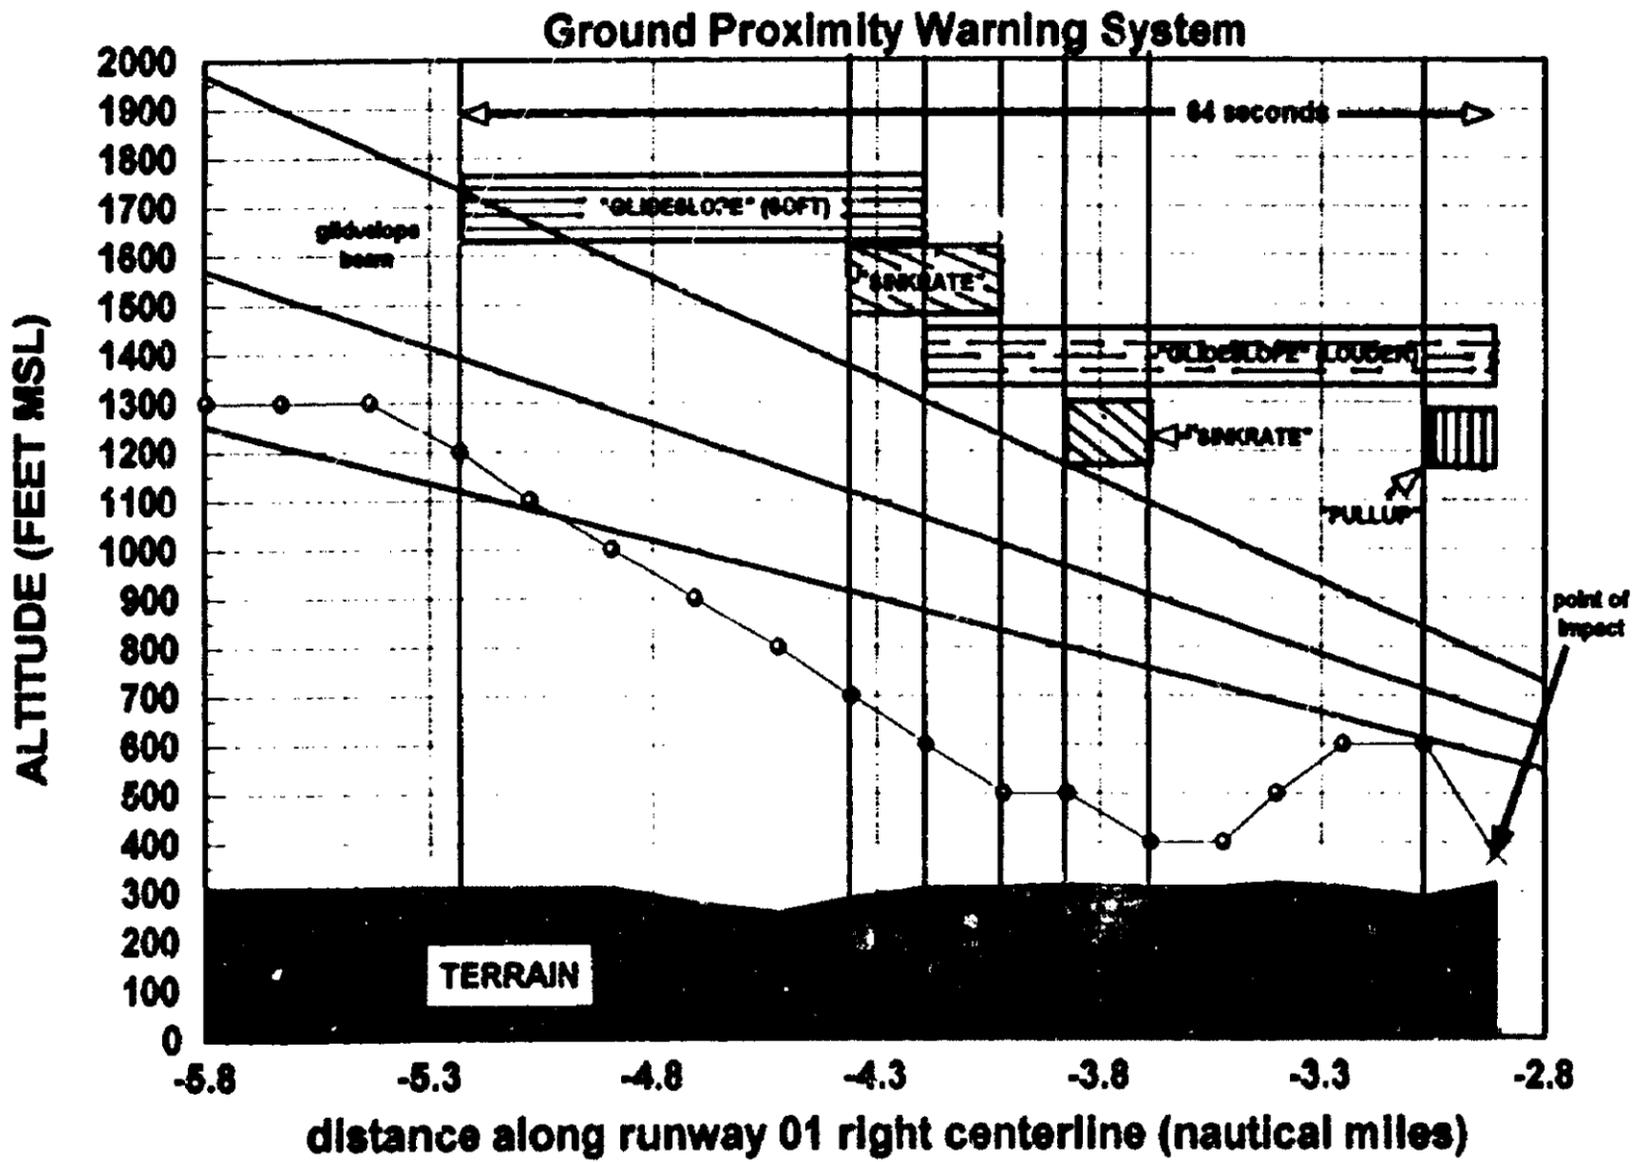
MODE 1 - Excessive Rate of Descent
 - "sink rate"
 - "pull up"

MODE 5 - Descent Below Glideslope
 - "glideslope"

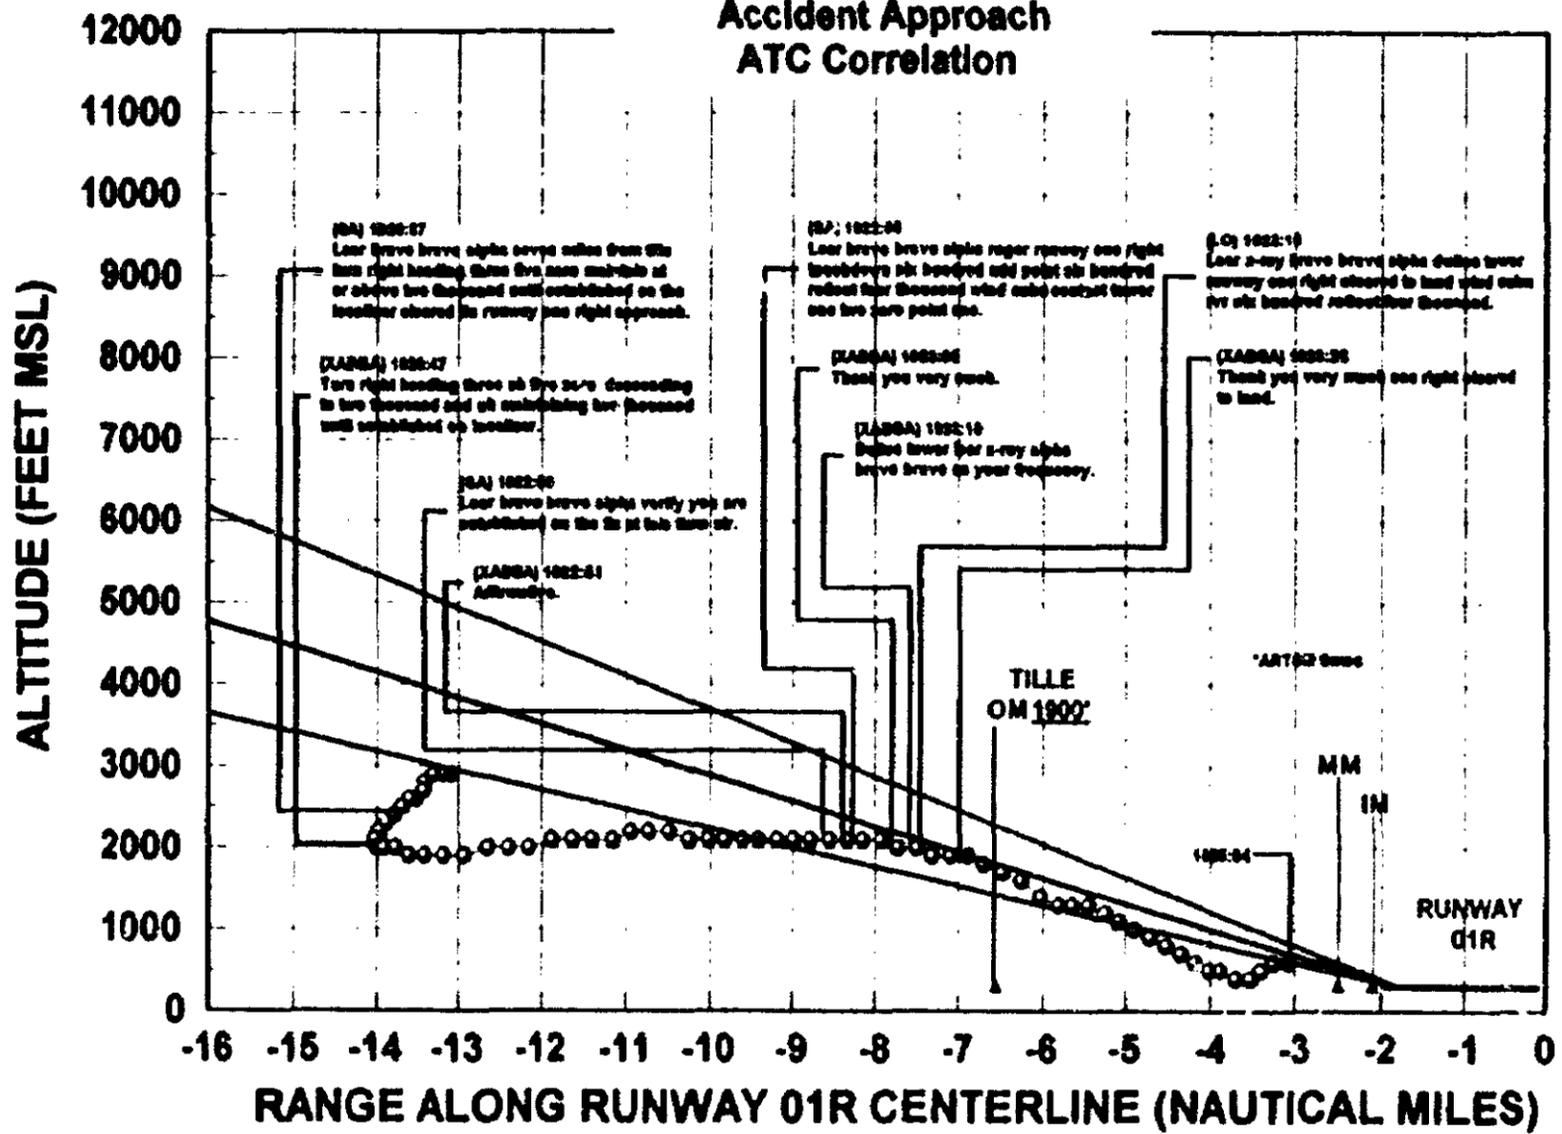
**XA-BBA DESCENT PROFILE
Accident Approach
ATC Correlation**

The radar track of the airplane suggests that the captain was actually attempting to establish visual contact with the runway during this time, to assess the conditions. He leveled off at 600 feet msl and maintained that altitude until he was about a mile north of the runway. This was not in accordance with company procedures. He did not exhibit any attempt at a missed approach until the controller inquired about his intentions.
