PB95-910404
NTSB/AAR-95/04
DCA95MA007

AIRCRAFT ACCIDENT REPORT

CRASH DURING EMERGENCY LANDING
PHOENIX AIR
LEARJET 35A, N521PA
FRESNO, CALIFORNIA
DECEMBER 14, 1994

**Adopted: August 1, 1995
Notation 6588**

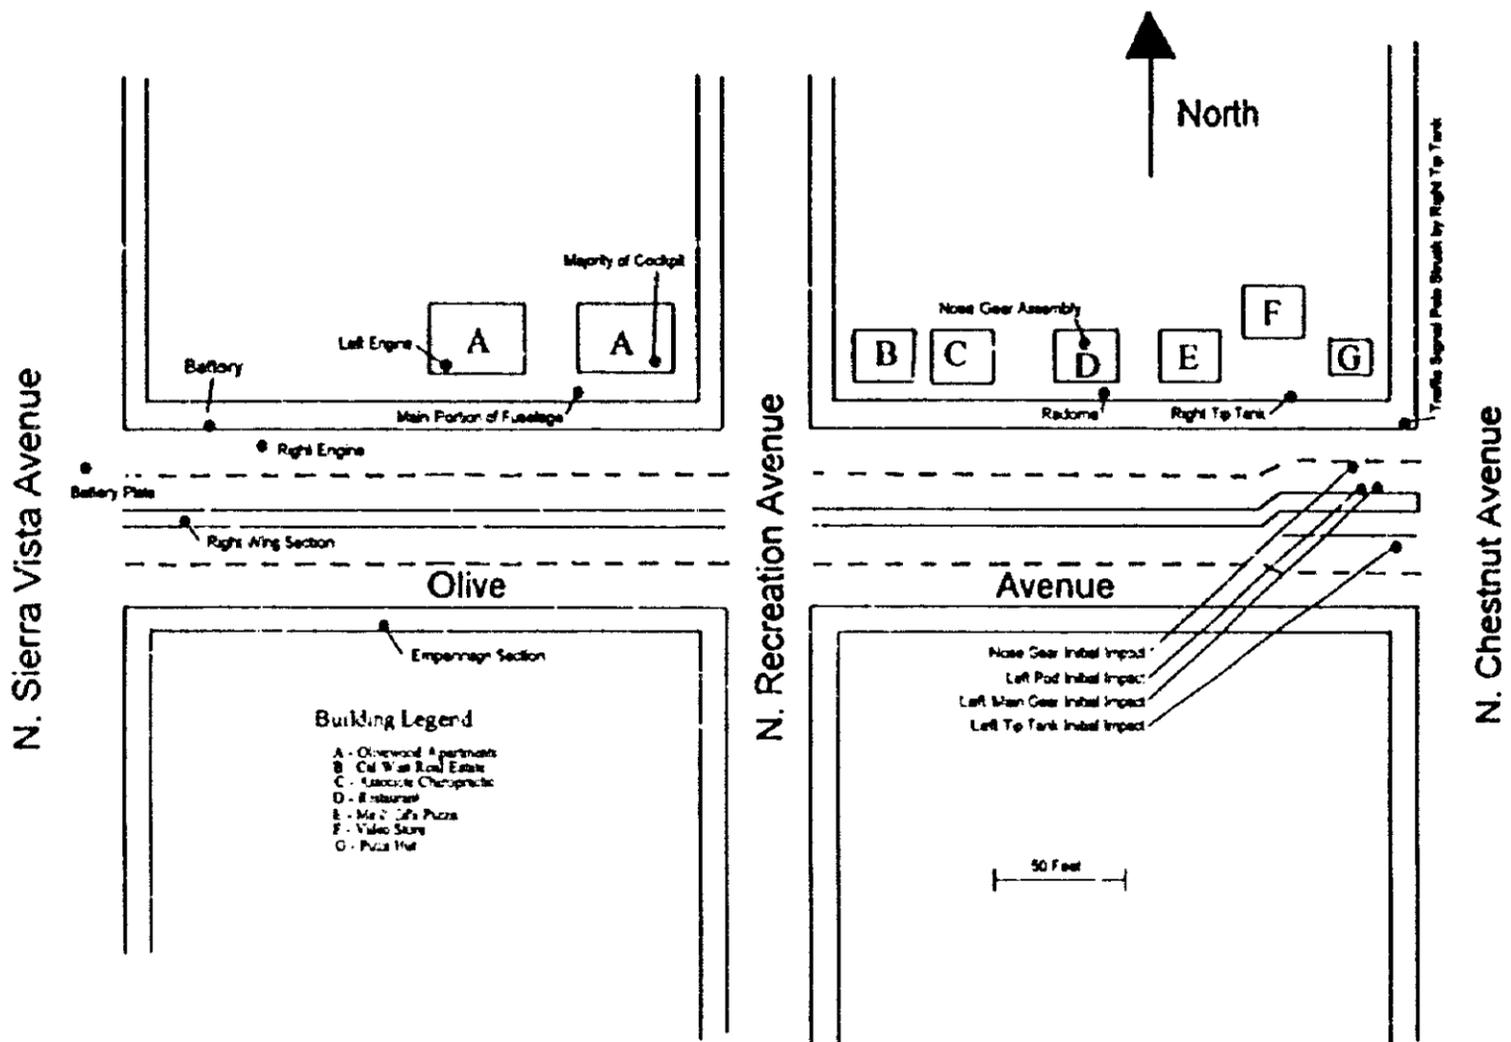
Figure 2c.--Wreckage path diagram.

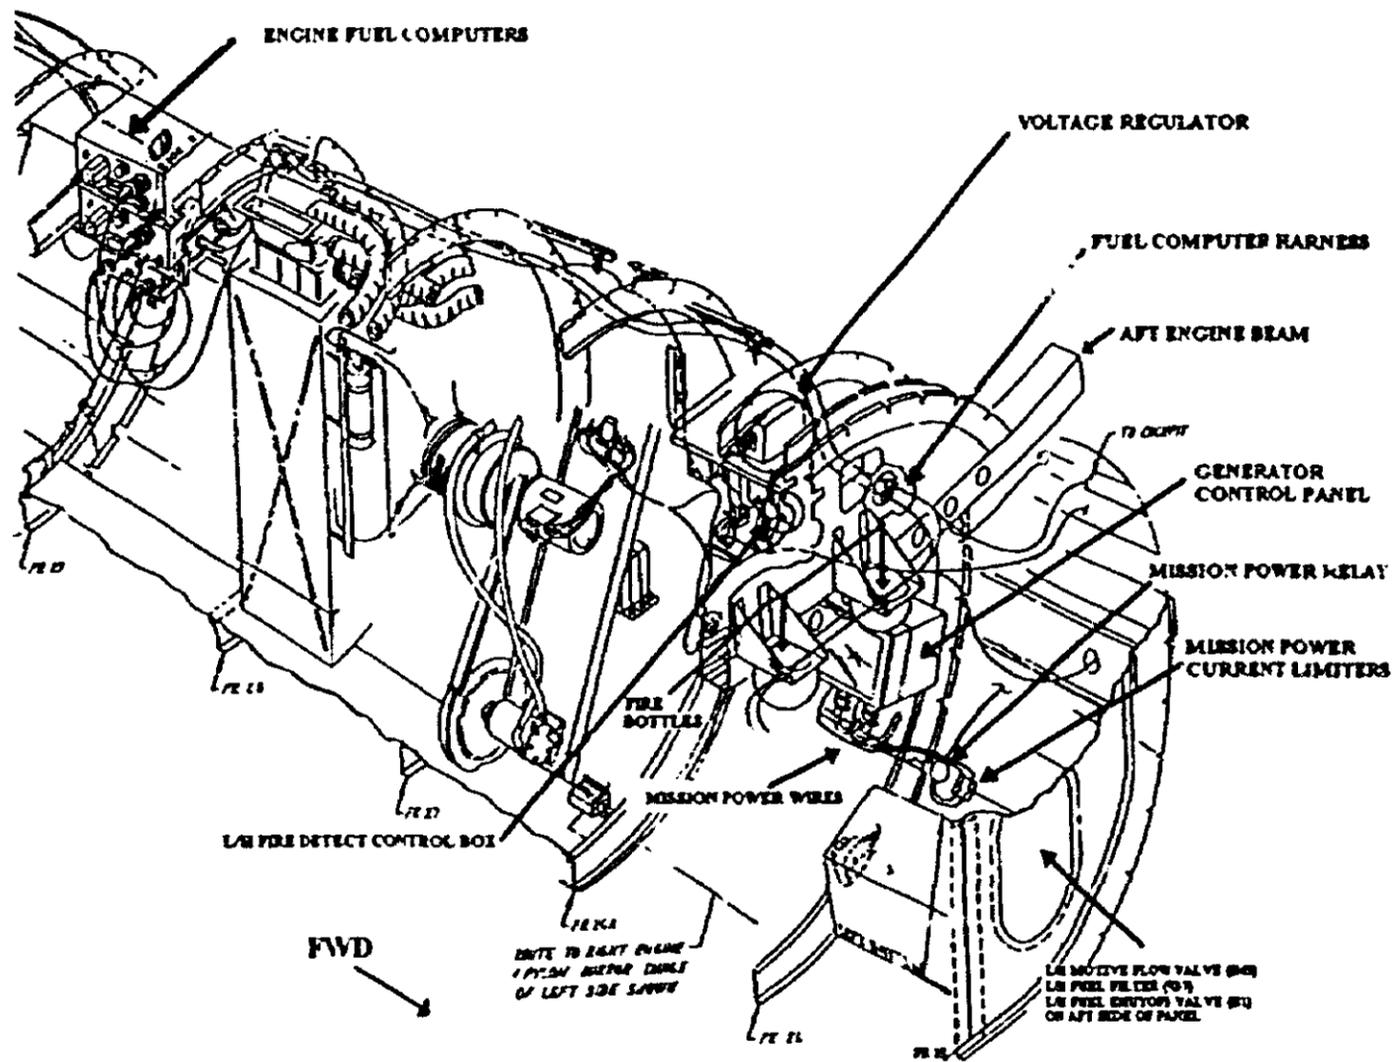
The investigation found that in the actual mission equipment wiring of N521PA, the power wires were routed directly to the battery charging bus. (Figure 3a is a drawing of major components in the tailcone. Figure 3b shows the intended versus actual routing of the power wires in N521PA.)

Figure 3a.--Components in tailcone.

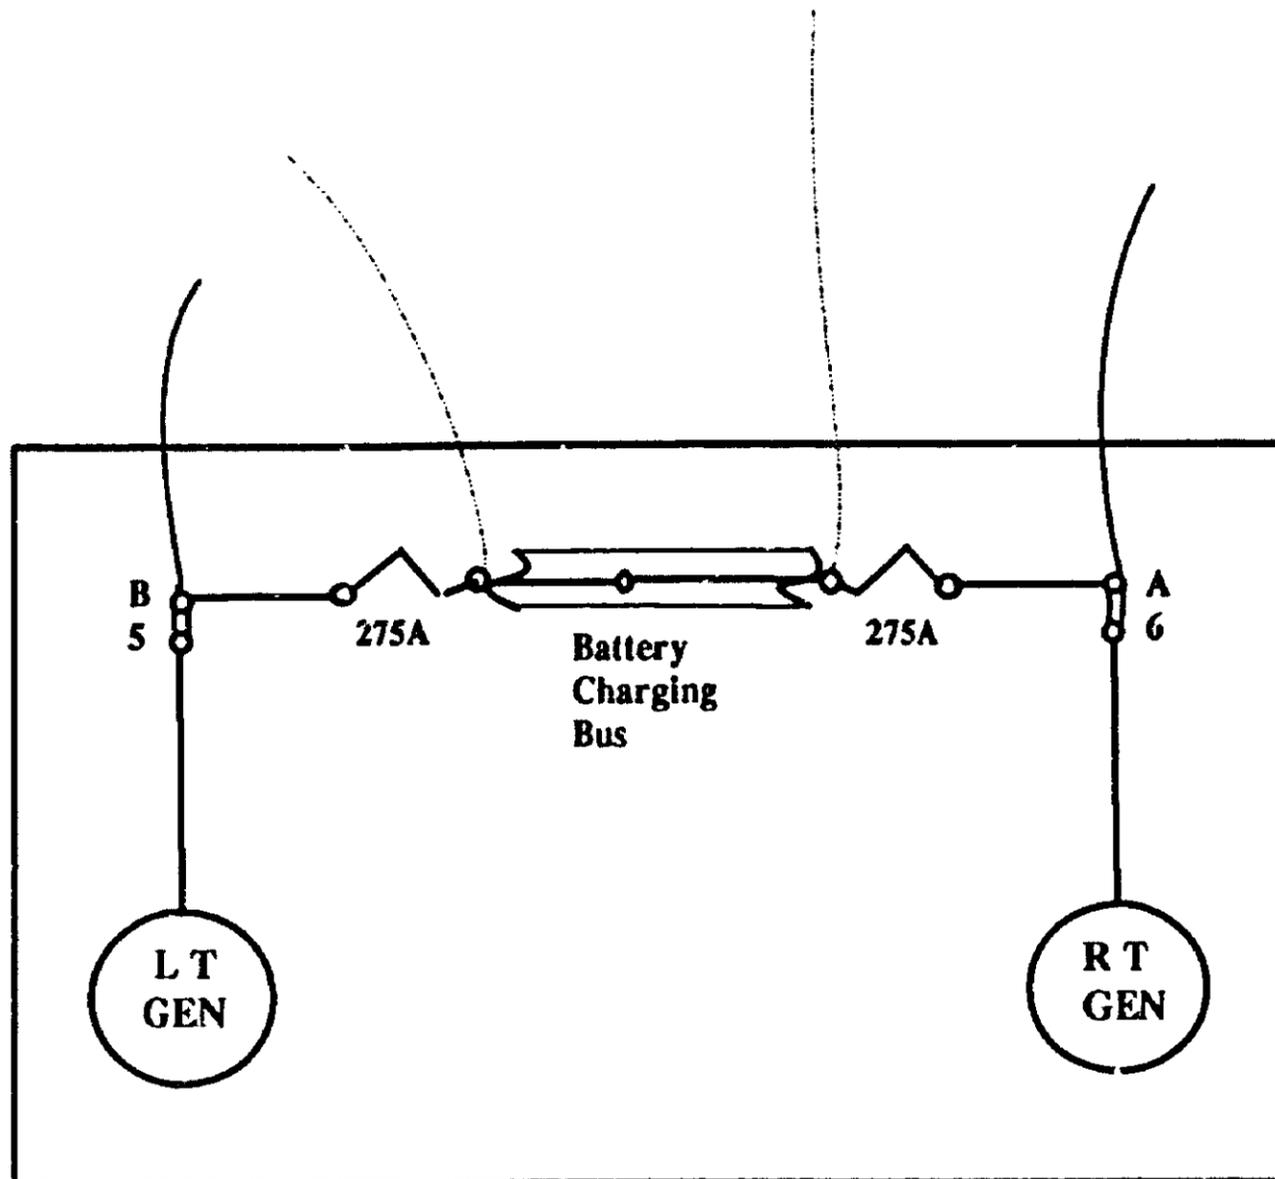
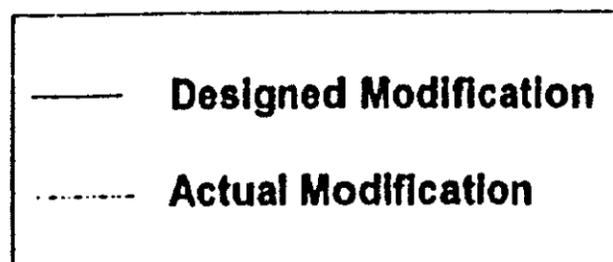
Figure 3b.--Mission power wiring.

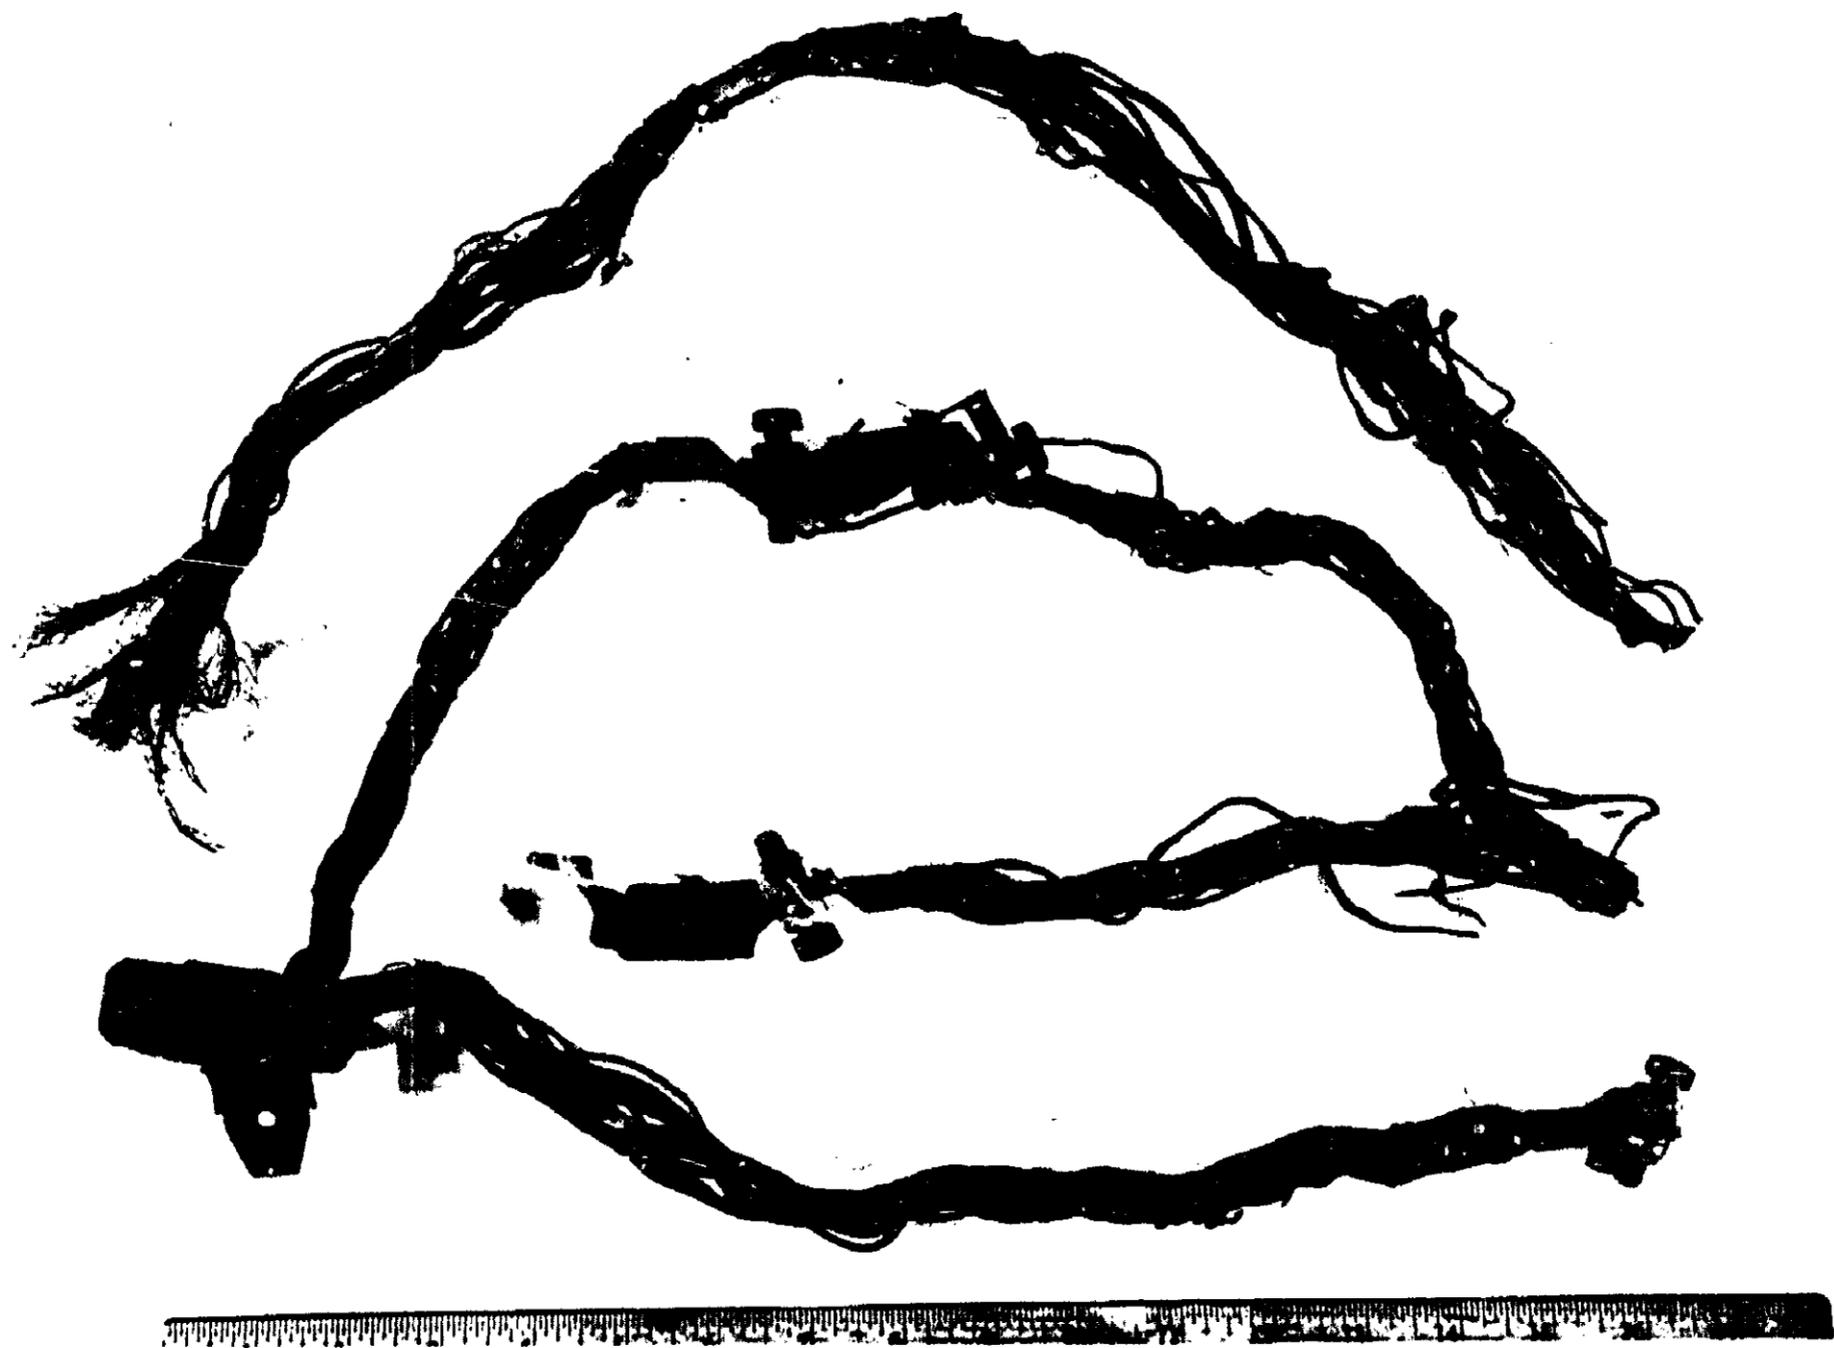
Portions of the wires, identified as part of the electrical power source for the special mission package, were size No. 0 awg and were found on E. Olive, near the wheel of an unburned vehicle. The wires had evidence of high heating prior to impact, including areas fused together for about 2 inches in length, and individual strands of the wires had a beaded appearance. (See figure 4.) Current limiters (fuses) were found attached to the nonwelded ends of one of the two sets of wires. In subsequent testing, the current limiters were found to provide electrical continuity (in the closed position).

Figure 4.--View of cables as received for examination.
