AIRCRAFT ACCIDENT REPORT

GROUND SPOILER ACTIVATION IN FLIGHT/HARD LANDING

VALUJET AIRLINES FLIGHT 558

DOUGLAS DC-9-32, N922W

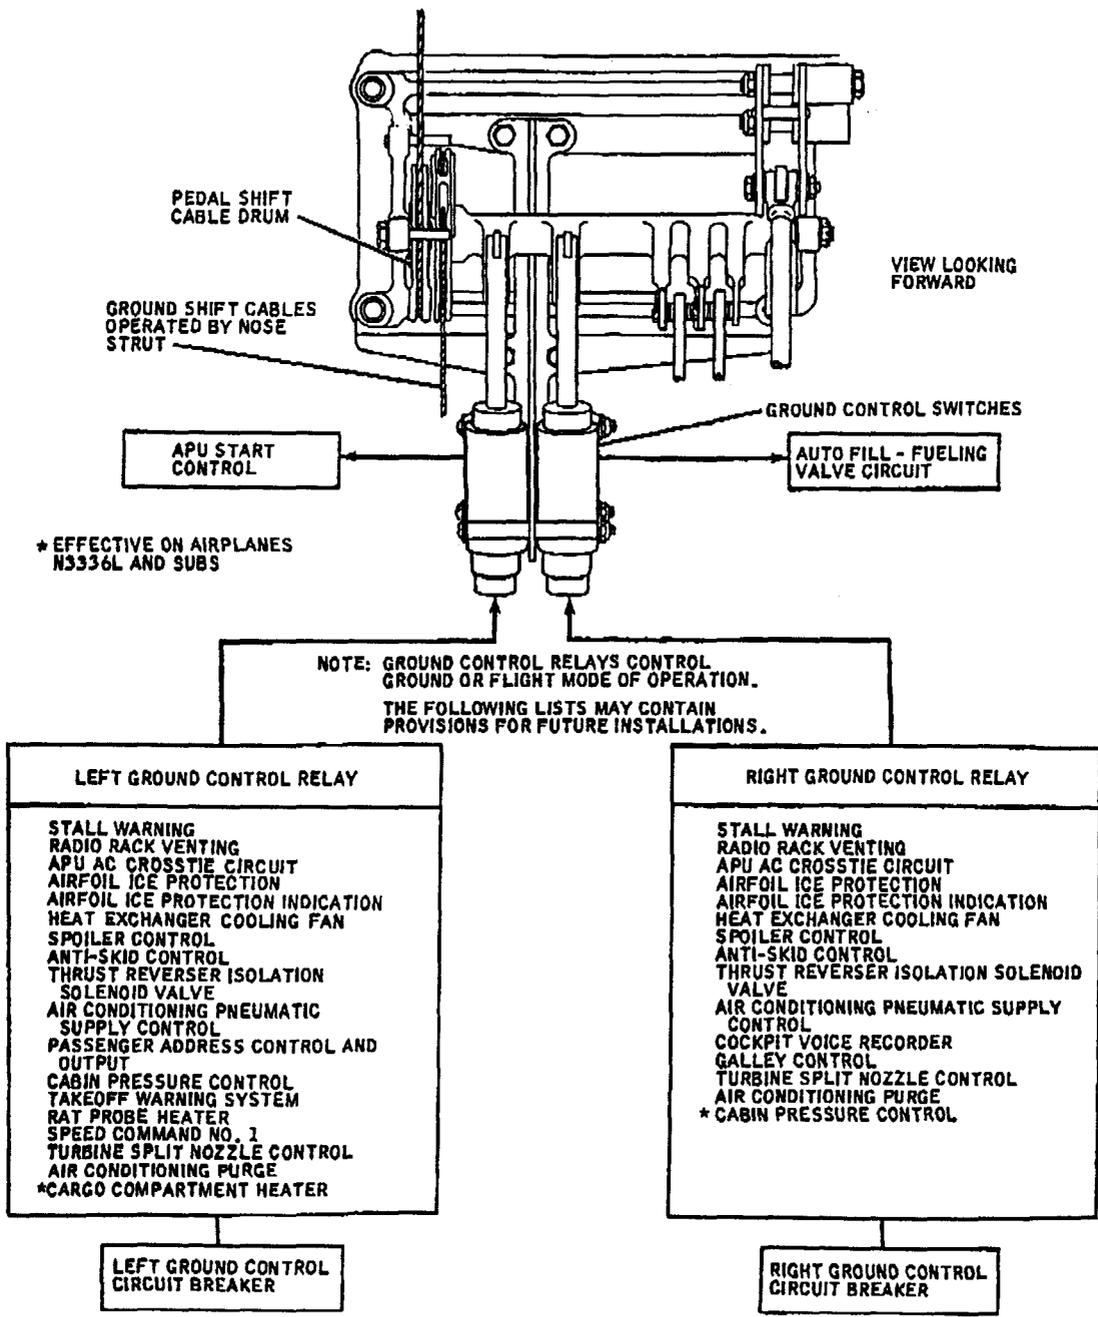
Figure 2—DC-9 Ground Shift Mechanism

The ground shift mechanism, which is actuated by nosegear shock strut extension/compression, controls whether certain aircraft systems operate in the ground or flight mode.²¹ When the nosegear shock strut is compressed by the weight of the aircraft, the ground shift mechanism causes those aircraft systems to be operated in the ground mode. When the nosegear shock strut is extended after takeoff, it triggers the ground shift mechanism,

According to Douglas representatives, when the nosegear shock strut is underserviced/underinflated, strut extension after liftoff may not be sufficient to activate the ground shift mechanism to shift the aircraft systems into the flight mode and release the gear lever anti-retraction mechanism. Douglas representatives indicated that this is a commonly reported occurrence during cold weather operations. They stated that Douglas had issued numerous service bulletins (SBs) and all operator letters (AOLs) describing the anomaly and recommending maintenance procedures to avoid underserviced/underinflated nosegear shock struts during cold weather operations.²³

It is likely that the nosegear shock strut did not extend far enough to actuate the ground shift mechanism because it was underserviced/underinflated for the cold/winter weather conditions. The en route portion of the flight proceeded uneventfully. When the airplane was about 100 feet above the ground during the approach to Nashville, the pilots reset the ground control relay circuit breakers, thereby unintentionally shifting the airplane systems from the flight mode to the ground mode. The ground spoilers subsequently extended in flight, and the airplane descended suddenly, impacting the ground in the runway approach light area.

Accordingly, the Safety Board believes that ValuJet should develop, immediately, a more extensive and accurate winter operations manual, with corresponding adjustments to maintenance procedures, to reflect the manufacturer's cold weather nosegear servicing procedures. Further, because no airline is exempt from encountering a range of weather extremes, the Safety Board believes that the FAA should require all airlines to review their operations and maintenance manuals and, if necessary, adjust or expand these manuals to reflect the manufacturer's recommended cold weather nosegear servicing procedures.

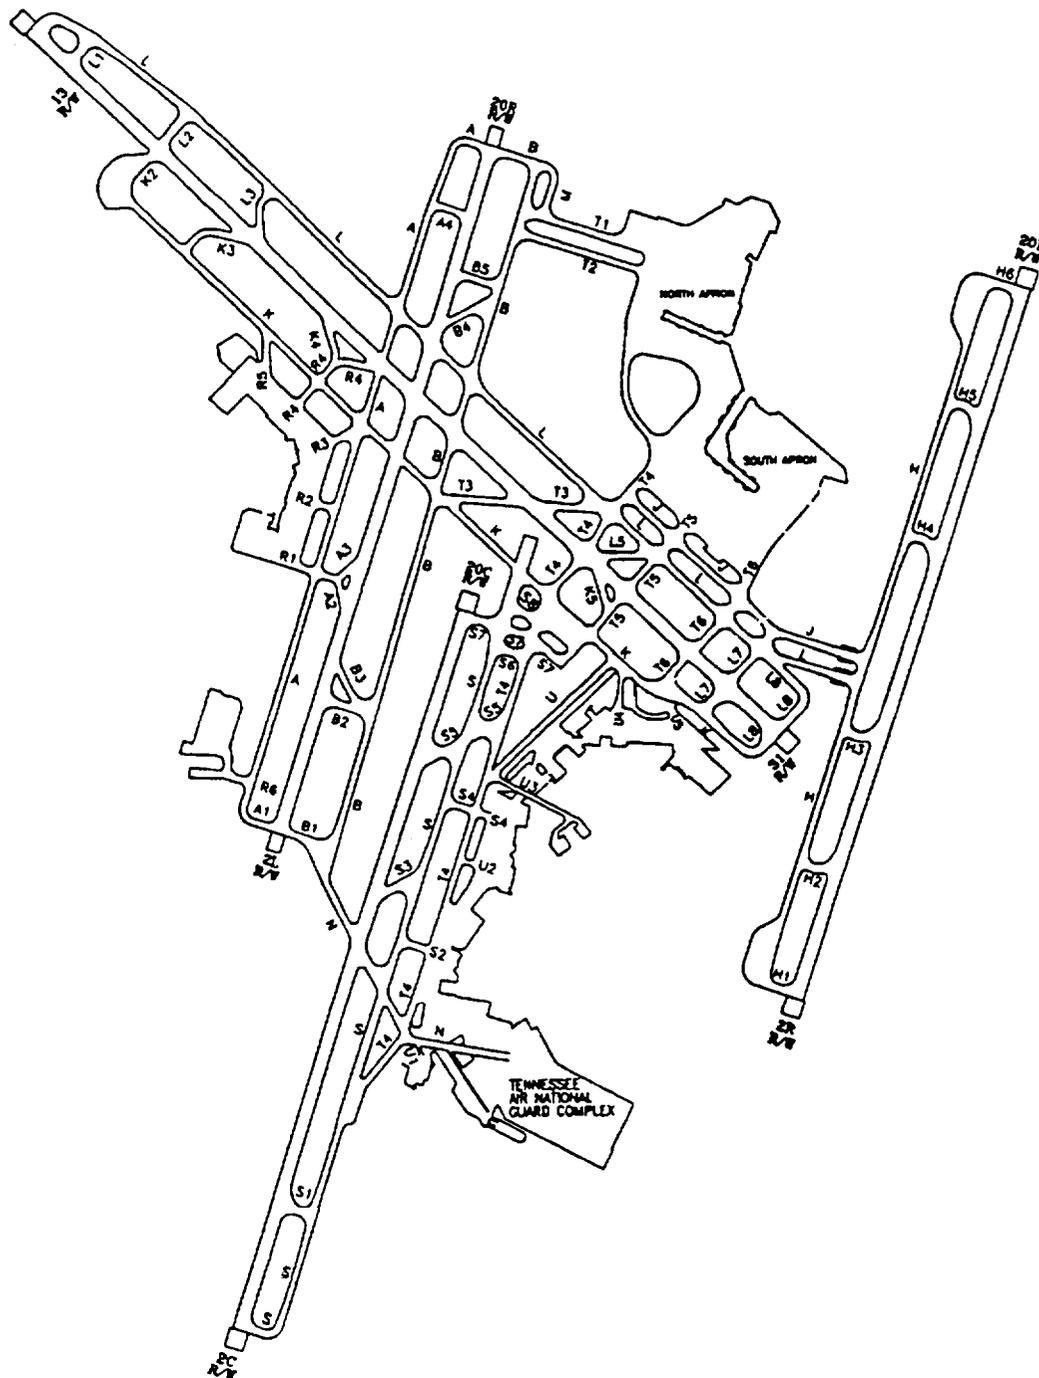
Figure 3—Nashville International Airport Diagram

Meanwhile, the pilots continued the approach to runway 31. The captain was flying the airplane, while the first officer advised the captain of their relative position to runway 31 and the length of the runway and briefed the approach. The pilots completed the "Before Landing" checklist, and the first officer extended flaps and slats for landing. The pilots decided not to arm the spoilers for landing because they planned to manually deploy the ground spoilers during the landing roll. As they approached the runway, the pilots observed emergency equipment with flashing lights moving into position near runways 2R and 31. (See figure 3, "Airport Diagram.")

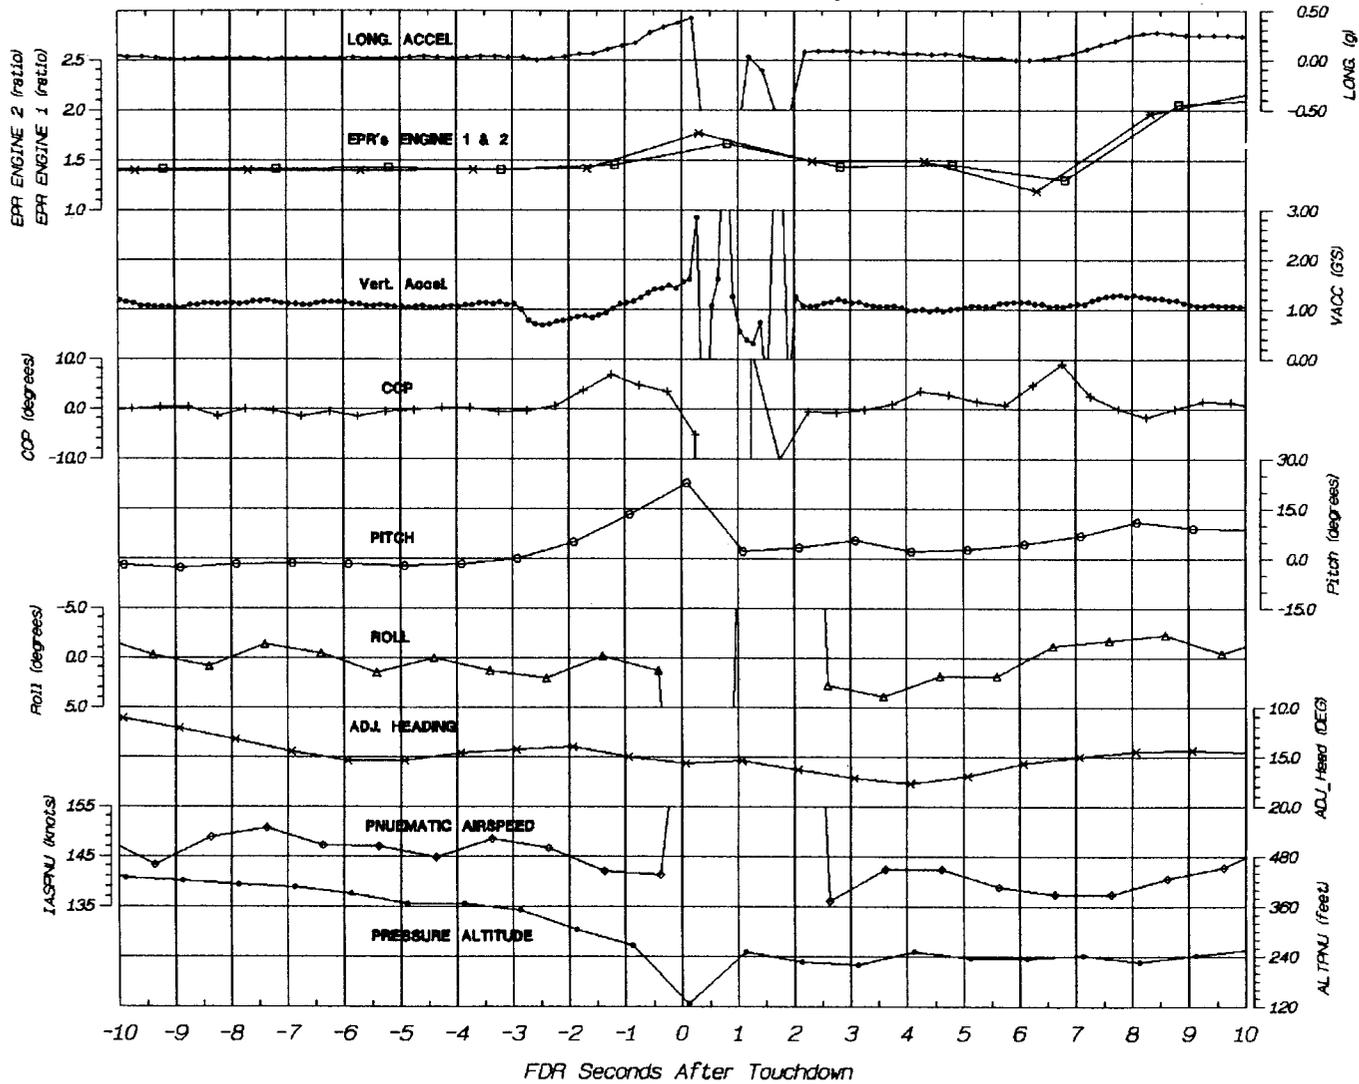
Initial Touchdown Plot
Revised: December 11, 1996

Debris from the nose landing gear and the runway approach lights was found at the approach end of runway 2R. The first indications of impact were ground scars in the runway approach light area, about 90 feet before the runway threshold lights. Two runway threshold lights and two runway approach lights were damaged.
