AIRCRAFT ACCIDENT REPORT

IN-FLIGHT FIRE AND IMPACT WITH TERRAIN
VALUJET AIRLINES FLIGHT 592
DC-9-32, N904VJ
EVERGLADES, NEAR MIAMI, FLORIDA
MAY 11,1996

AIRCRAFT ACCIDENT REPORT
NTSB/AAR-97/06(PB97-910406)

**Adopted: August 19, 1997
Notation 6704B**

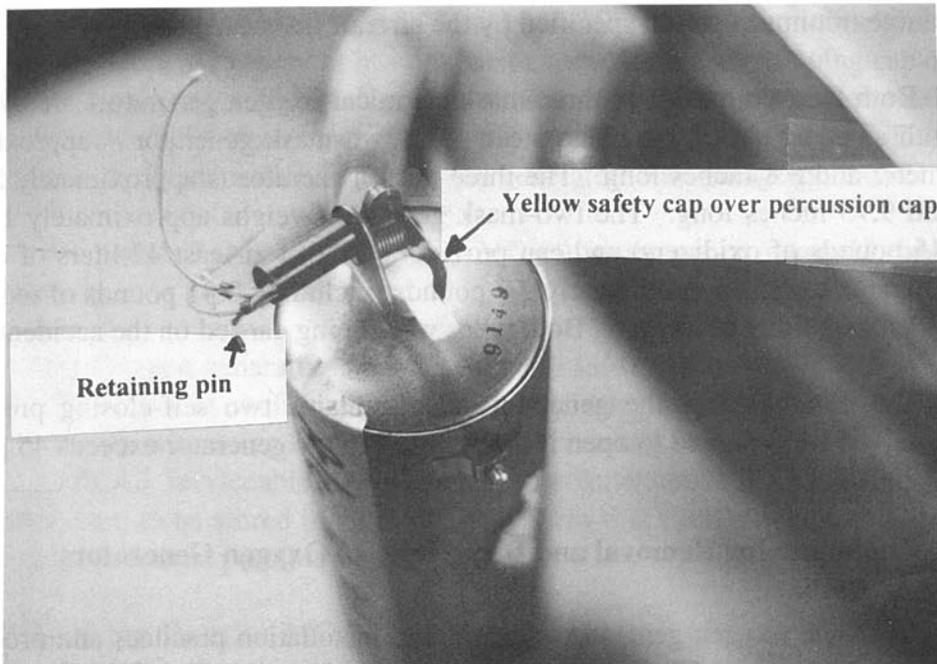
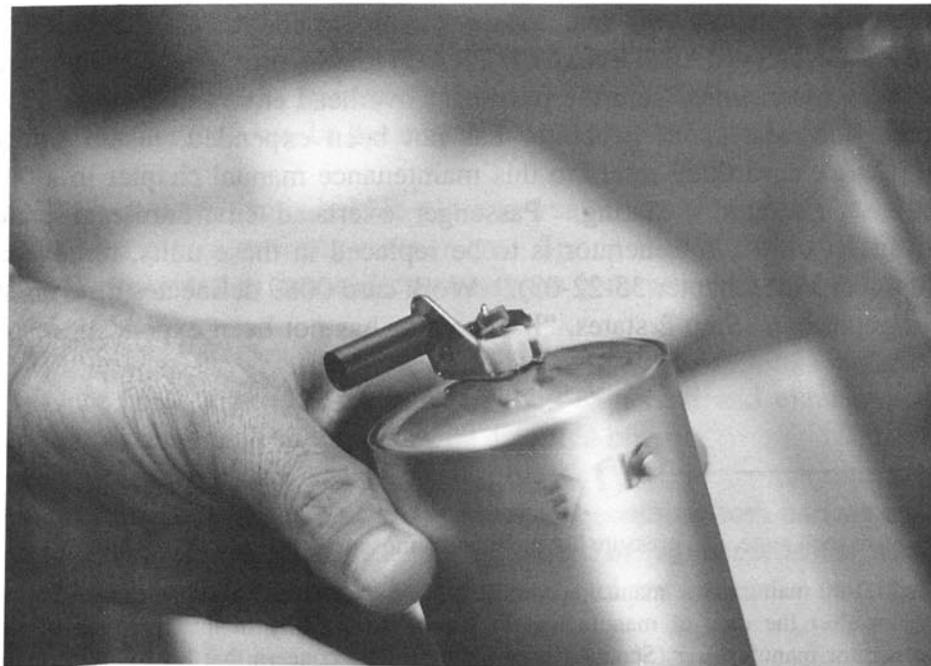
Figure 2b—Photographs of passenger oxygen generator unit

Both the two-mask and three-mask chemical oxygen generators are cylindrical in appearance with an outer skin of stainless steel. The two-mask generator is approximately 2.5 inches in diameter and 8.8 inches long. The three-mask generator is approximately 2.75 inches in diameter and 9.75 inches long. The two-mask generator weighs approximately 1.25 pounds (including 0.45 pounds of oxidizers) and can provide a total of at least 42 liters of oxygen; the three-mask generator weighs approximately 1.7 pounds (including 0.81 pounds of oxidizers) and can produce at least 62 liters of oxygen. Both types were being carried on the accident airplane.

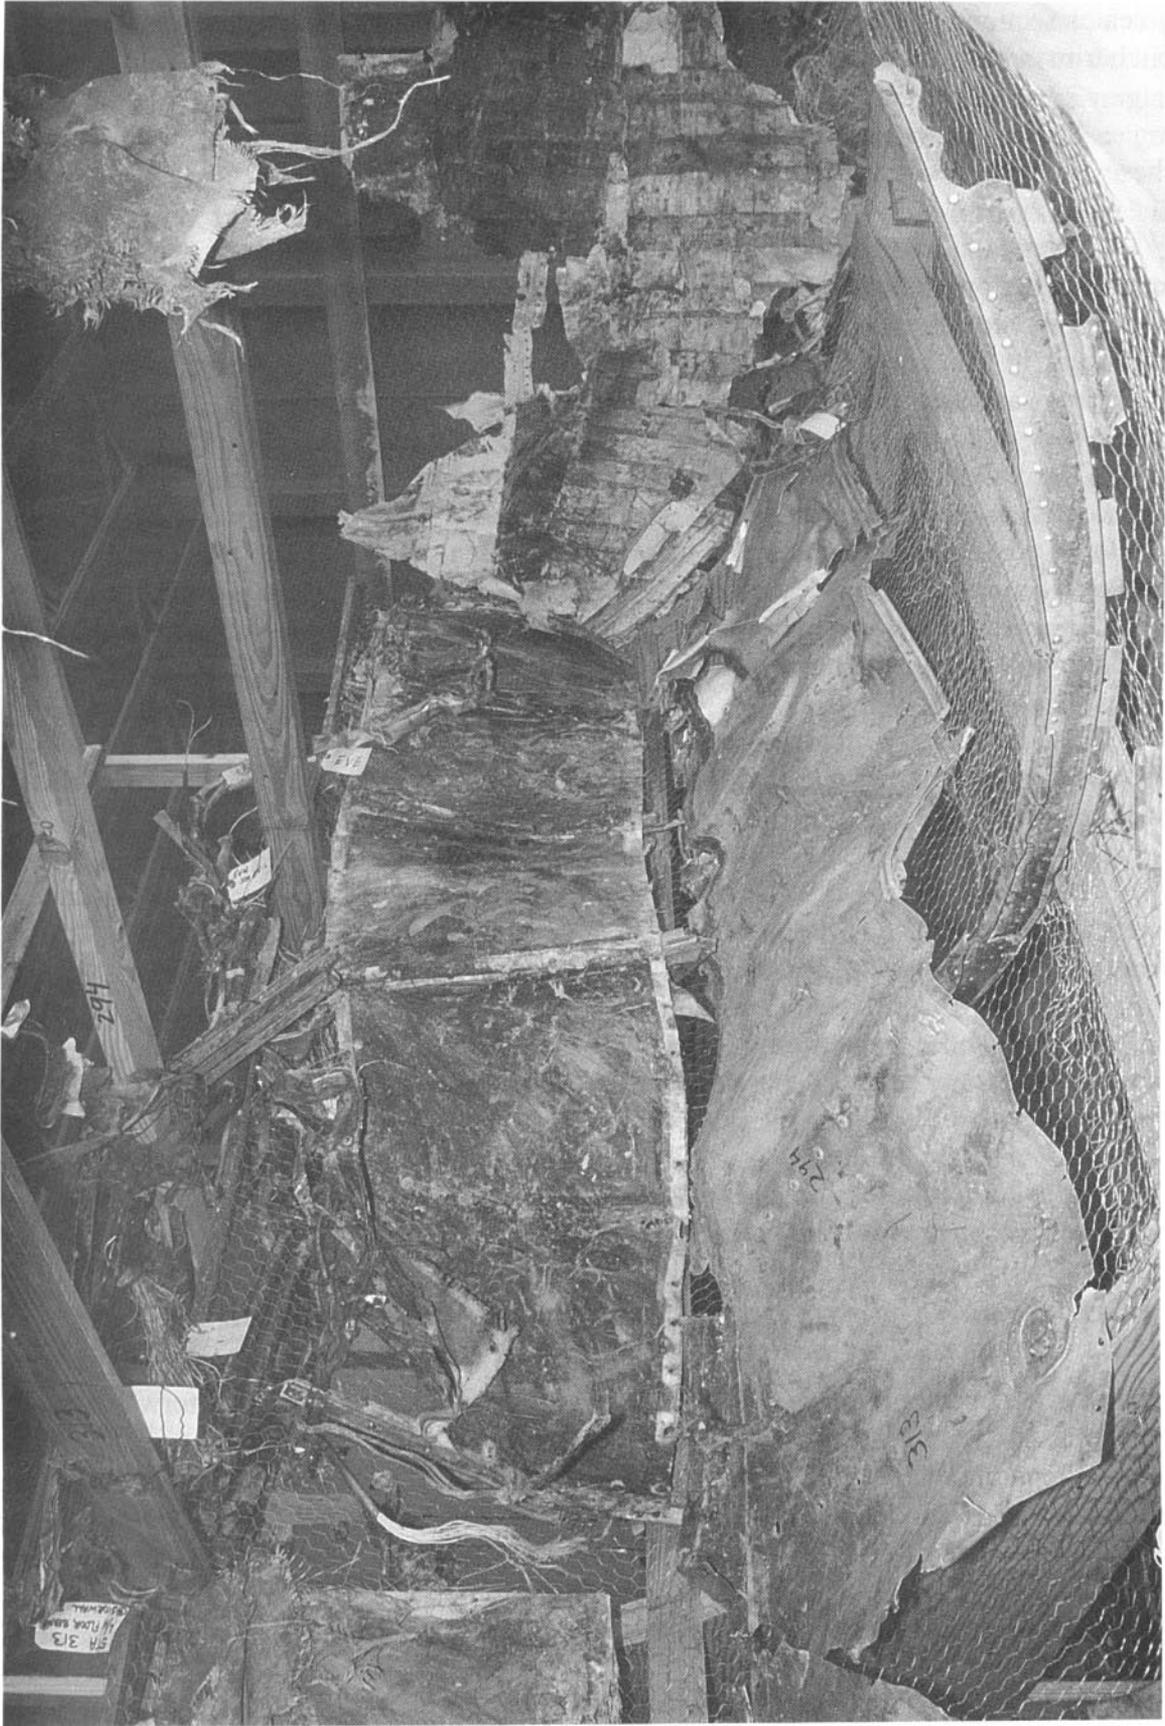
Figure 5—Cargo compartment mockup

All recovered wreckage identified as being from the area of the forward cargo compartment was assembled into a full-scale, three-dimensional mockup. (See figure 5.) The forward cargo compartment extended from fuselage station (FS) 218 to 581. The forward edge of the forward cargo door was located at FS 373 and the aft edge was located at FS 425. Most of

these pieces, which included the cargo floor, cargo liners, and fuselage structure, exhibited soot and heat damage.
