Aviation Investigation Report AIR-26-05

# In-Flight Loss of Control and Impact with Pack Ice

## Bering Air Flight 445

## Textron Aviation 208B, N321BA

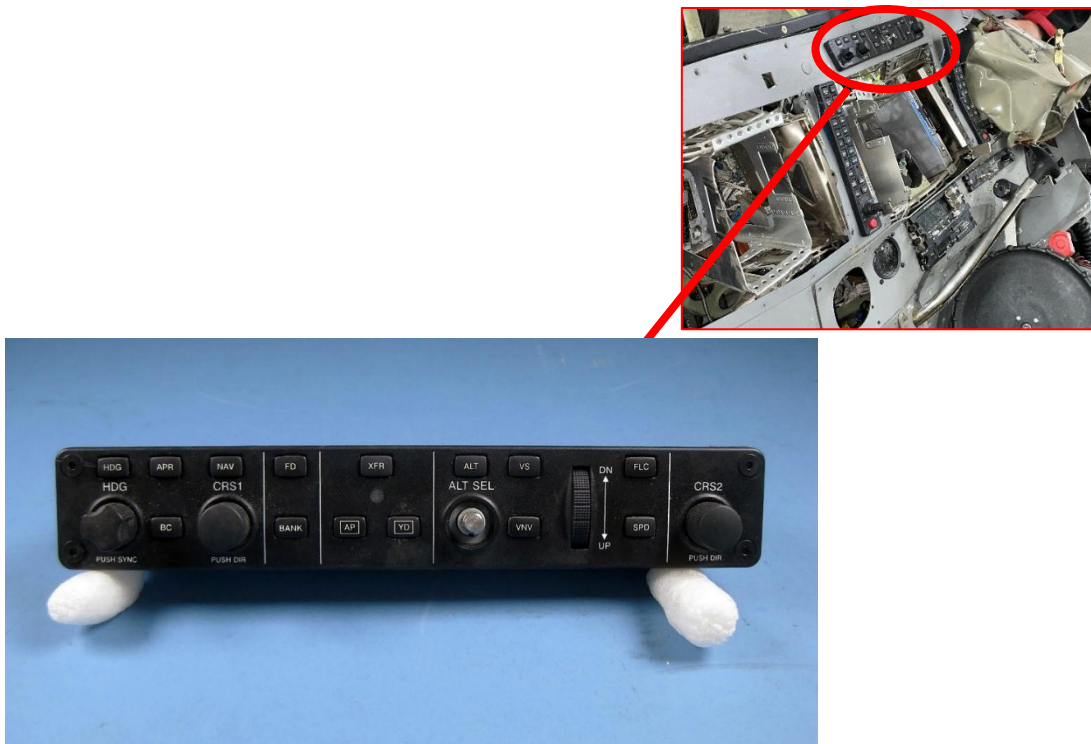
**Figure 5.** The autopilot mode controller panel from the accident airplane with inset showing its location on the instrument panel.

Note: The cover for the ALT SEL (altitude select) knob is missing.

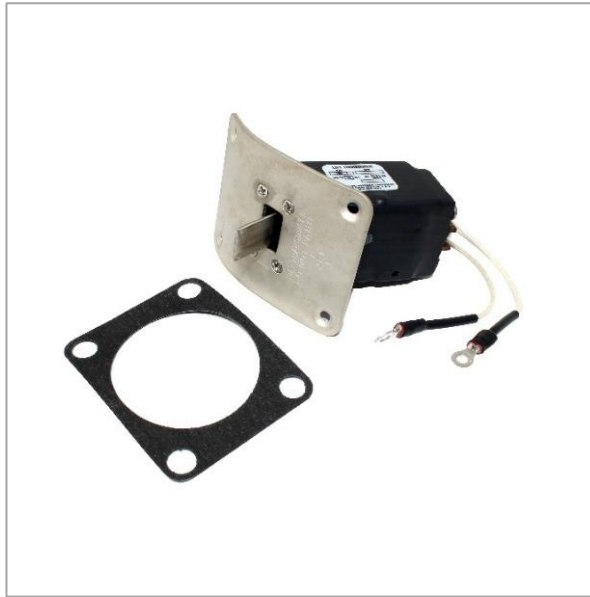
The airplane aerodynamic stall warning system vane assembly was removed from the left-wing leading edge. The transducer was visually examined; no faults were found. The lift vane could be moved by hand with no restrictions noted. The lift vane was operational when tested with a multimeter. The plate-heating elements were confirmed as operational when electrical power was applied.

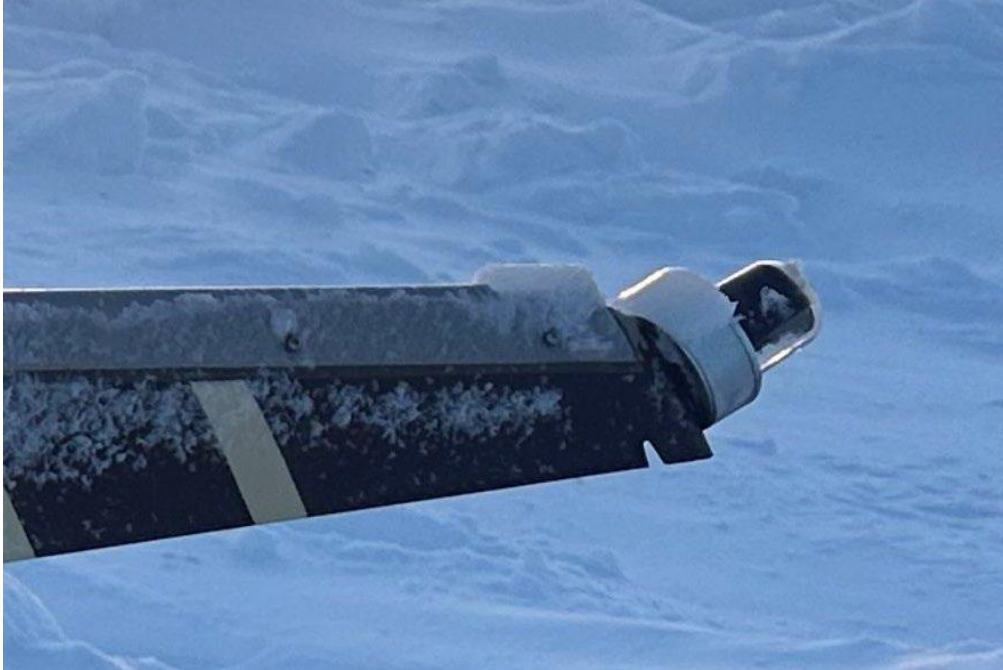
Some ice accumulation was observed on the leading-edge surfaces aft of the TKS porous membranes. Significant icing accumulation was observed on the base of the beacon/strobe light located at the top of the vertical stabilizer (see figure 9).

**Figure 9.** Photograph of the vertical stabilizer with ice accumulation.
