February 22, 2022

Require Common Traffic Advisory Frequency Areas in Alaska

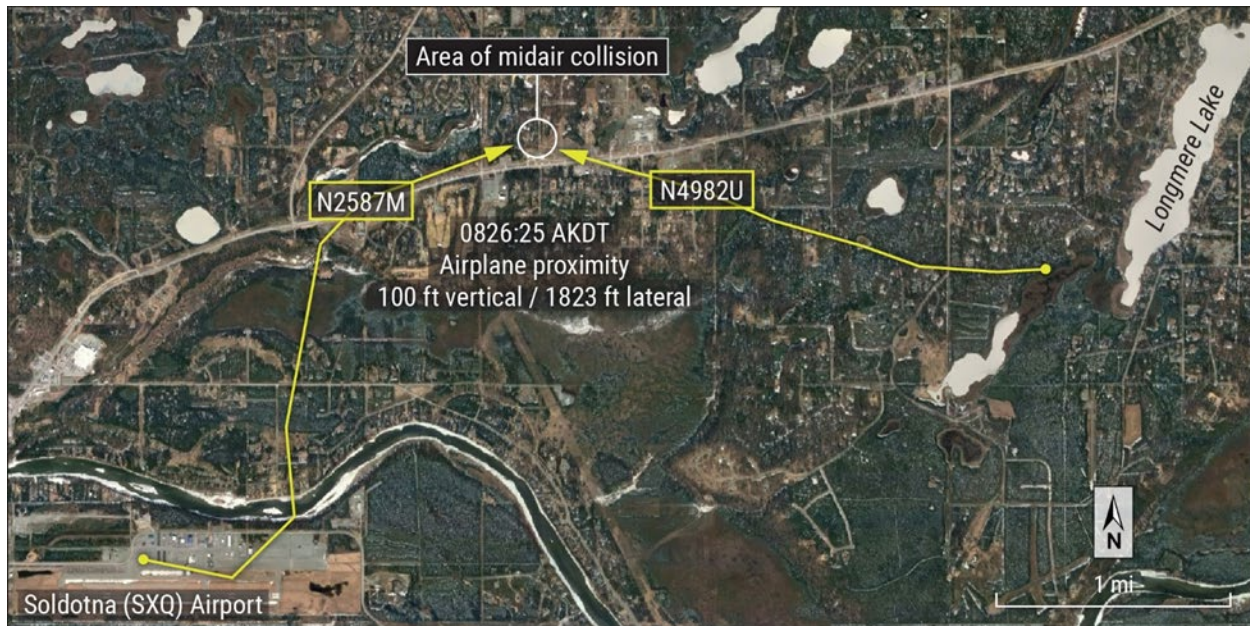
According to flight track data, after departure from SXQ, the PA-12 traveled on a north-northeast heading until it crossed over a highway then turned right to an east-northeast heading on a converging course with the DHC-2. After the DHC-2 departed from Longmere Lake, it climbed on a west-northwest heading. The DHC-2 crossed over the highway a few seconds after the PA-12. Both airplanes continued on their respective headings and collided about 0827, about 2.5 miles northeast of SXQ, and about 3 miles west of Longmere Lake, at an altitude of about 1,200 ft (see figure 1).

Figure 1. Radar data tracks for both airplanes and location of midair collision.

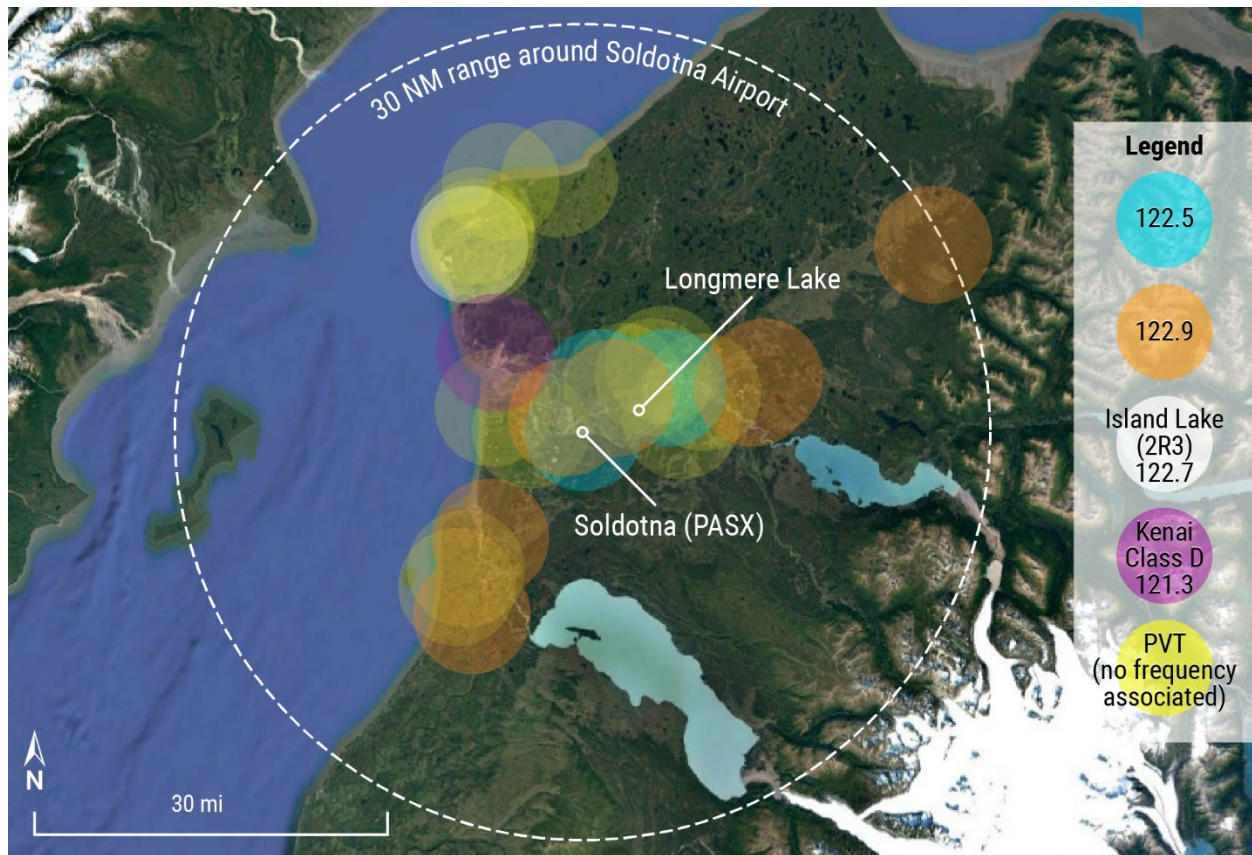
While SXQ was the closest airport to Longmere Lake with a CTAF channel, the NTSB's investigation determined that 21 airports were within a 30-mile radius of SXQ, with five different charted communication frequencies (one ATCT frequency and four different CTAFs) (see figure 2), many of which overlapped.³ A postaccident

Figure 2. CTAF locations within a 30-mile radius of SXQ (note: One additional CTAF, 123.05, was used by oil platforms in Cook Inlet. Because its location frequently changed, it is not indicated on figure 2).

For example, as discussed previously regarding the Soldotna accident, 21 airports were within a 30-mile radius of SXQ, with 5 different charted communication frequencies, many of which overlapped. Additionally, in the Talkeetna accident discussed previously, FAA guidance was unclear regarding which CTAF should be used in the area and as a result, the pilots were communicating on two different radio frequencies before the collision. These accidents demonstrate the possibility for confusion regarding which frequency pilots should be using in a particular area. Further, if pilots are communicating on two different frequencies within the same area, they may not be aware of the presence of the other airplane.

Establish additional common traffic advisory frequency (CTAF) areas in locations throughout Alaska at high risk of midair collisions, designate one frequency that is associated with all non-towered airports within the geographical boundaries of these CTAF areas, and define mandatory position reporting locations and reporting requirements within these areas. (A-22-5)
