NTSB/AIR-22-05

Collision into Terrain

Safari Aviation Inc.

Airbus AS350 B2, N985SA

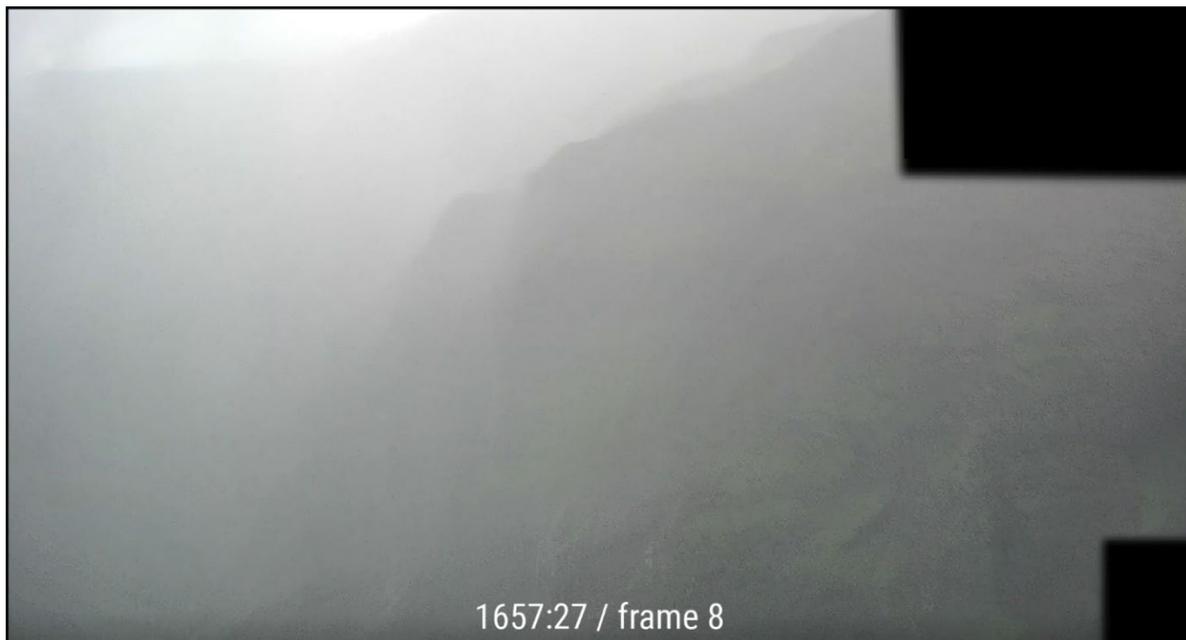
that his tour arrived at the north end of Waimea Canyon about 1657 and encountered visible moisture in the canyon (see Figure 5).

Figure 5. Company 2 pilot's tour in north end of Waimea Canyon about 1657.

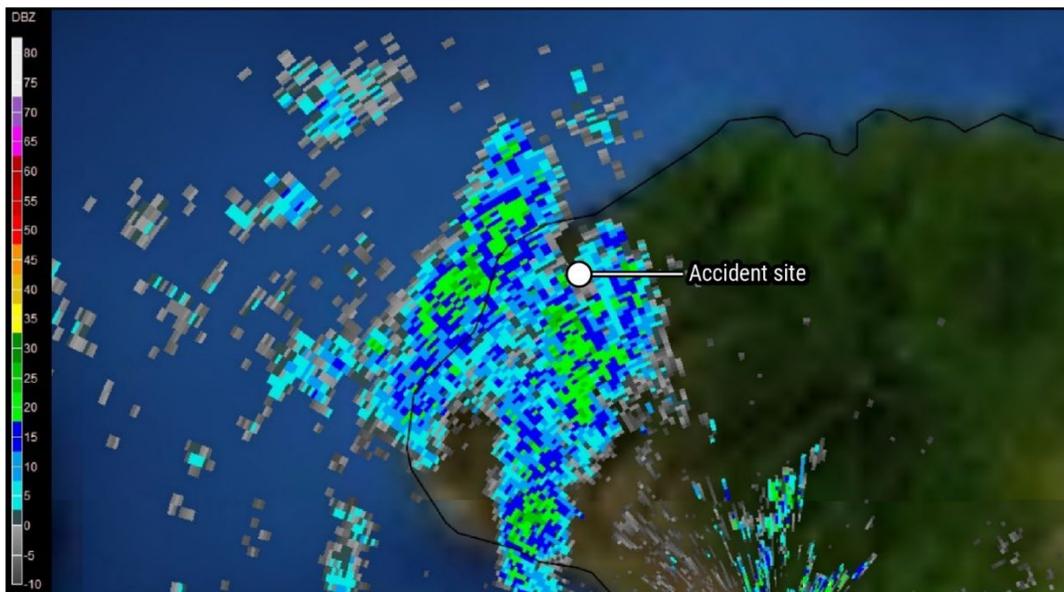
Weather radar from a National Weather Service (NWS) facility located in south Kauai, about 16 miles south-southeast of the accident site, had limited line-of-sight coverage of altitudes below 5,000 ft msl in the area above the accident site and some areas farther east over the northern part of the island due to blockage from high terrain (see section 1.4.3.2). The weather radar imagery showed reflectivity values consistent with light precipitation at altitudes between about 4,700 and 5,400 ft msl over the area of the accident site about the time of the accident (see Figure 9).

Figure 9. Weather radar image from a sweep initiated at 1656:20 showing reflectivities between about 4,700 and 5,400 ft msl.

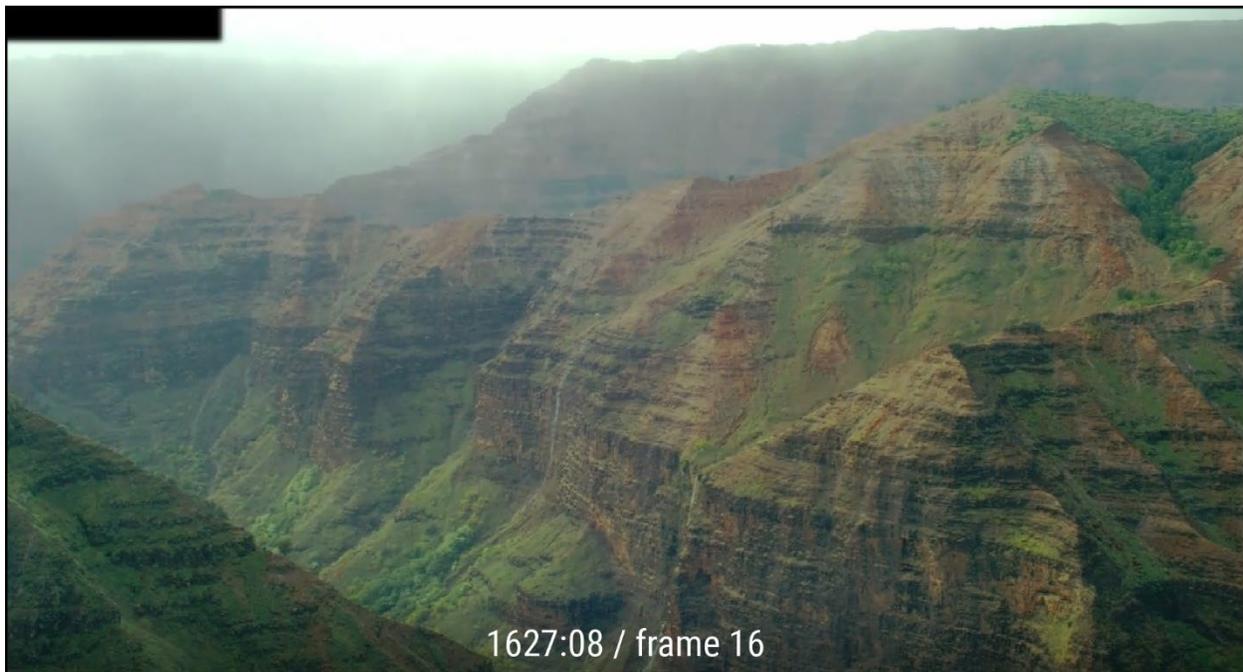
The Company 1 pilot referenced above flew a subsequent tour that departed LIH about 1610 and flew in the vicinity of Waimea Canyon between about 1622 to 1629. He said he saw "a big front coming in or at least...clouds and rain.... from the west." He said "upper mic" was obscured and "lower mic" was almost obscured.¹² Onboard video from this pilot's tour showed that, about 1627, his tour was in Waimea Canyon, and an area of visible moisture was ahead (see Figure 10).

Figure 10. Company 1 pilot's tour in Waimea Canyon about 1627.

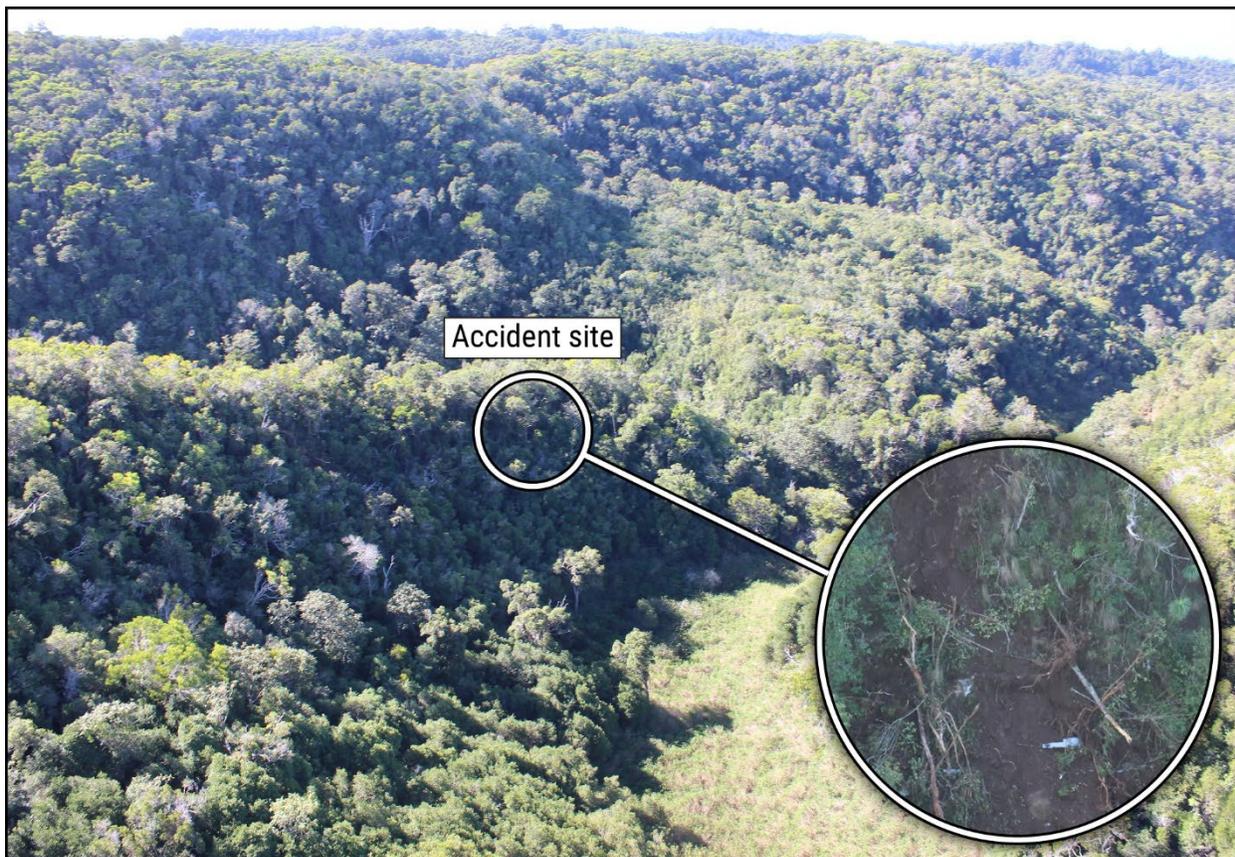
The accident site was located on the north face of a steeply sloping ridge that rose about 200 ft above the floor of an east-west oriented valley. The impact area, which consisted of disturbed terrain extending from just below the ridge top downslope to the main wreckage, was about 100 ft long and 30 ft wide (see Figure 16). Tree branches near the top of the impact area were cleanly severed at an angle with respect to the horizon (see Figure 17).

Figure 16. Accident site location on ridge and impact area (inset).

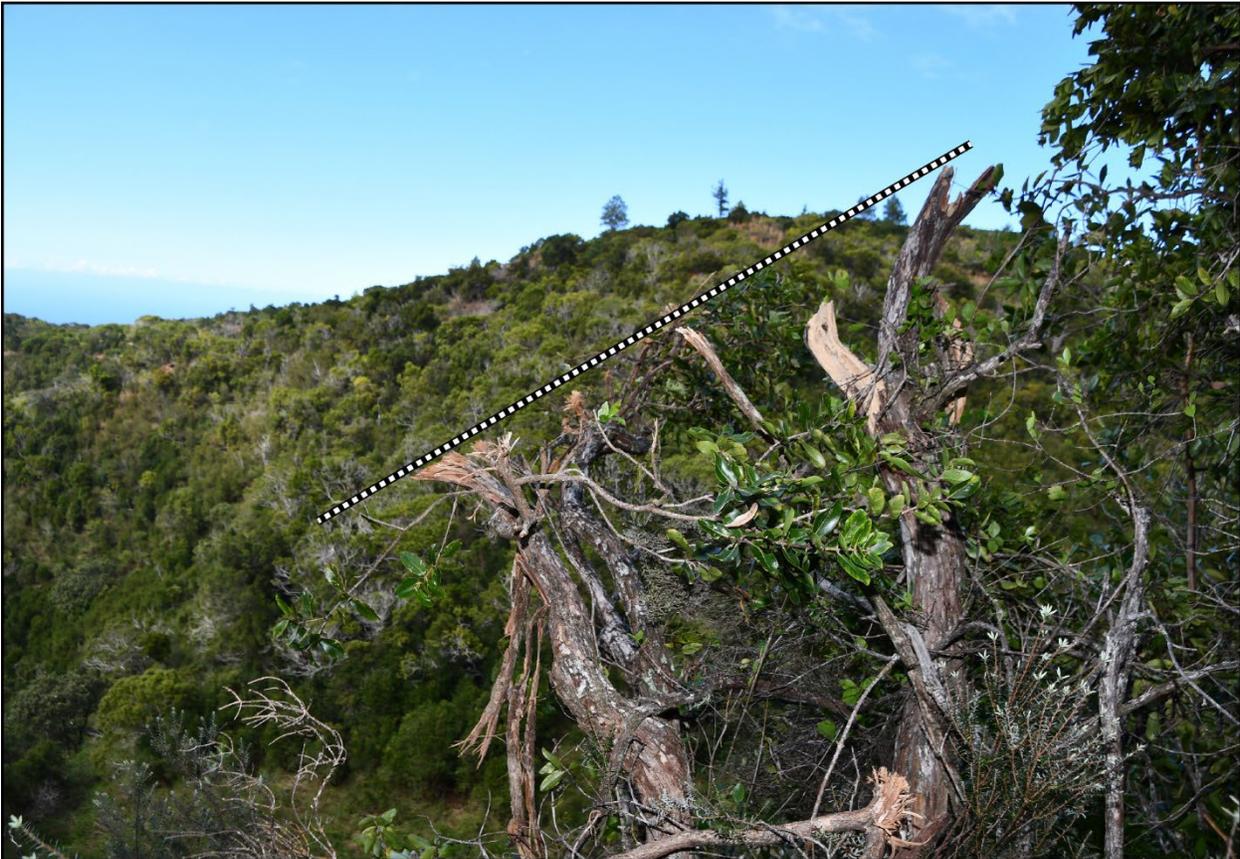
Figure 17. Severed branches (with line showing alignment) near top of the impact area (Source: County of Kauai).
