May 4, 2022

AIR-22-06

# Require Safeguards to Prevent Cessna 560XL Takeoff with Parking Brake Engaged

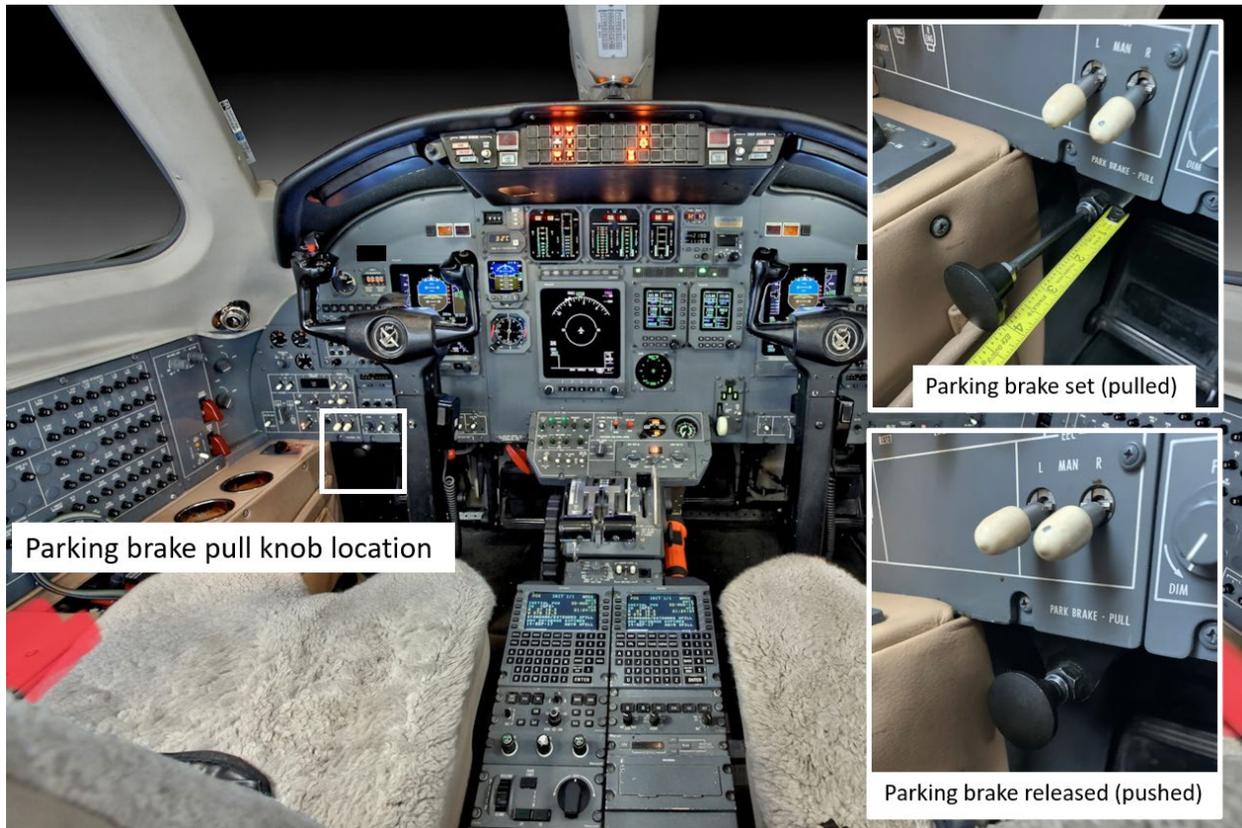
Only the left-seat pilot of a Cessna 560XL may set the parking brake at various points before takeoff, such as when holding short of the runway, before receiving clearance to take off, or before initiating takeoff. For example, the pilot flying (who was in the left seat of the Oroville accident airplane) recalled that he likely set the parking brake while holding short of the runway as he finished the items in the taxi checklist.<sup>7</sup> To set the parking brake in a Cessna 560XL airplane, the left-seat pilot depresses the toe brakes while pulling the parking brake pull knob, which is shown in the figure below. The amount of wheel brake pressure applied depends on how fully the toe brakes are depressed when the parking brake pull knob is pulled. To release the parking brake pressure, the left-seat pilot pushes the parking brake pull knob forward. Given the Cessna 560XL parking brake pull knob’s location on the lower left side of the left-seat pilot near that pilot’s knee, the pull knob is not visible to the right-seat pilot.

**Figure 1.** The location of the parking brake pull knob in a Cessna 560XL exemplar airplane (XLS model). (Source: Delta Private Jets)
