October 26, 2022

AIR-22-08

Require Immediate One-Time Inspection of De Havilland Canada DHC-3 Horizontal Stabilizer Actuator

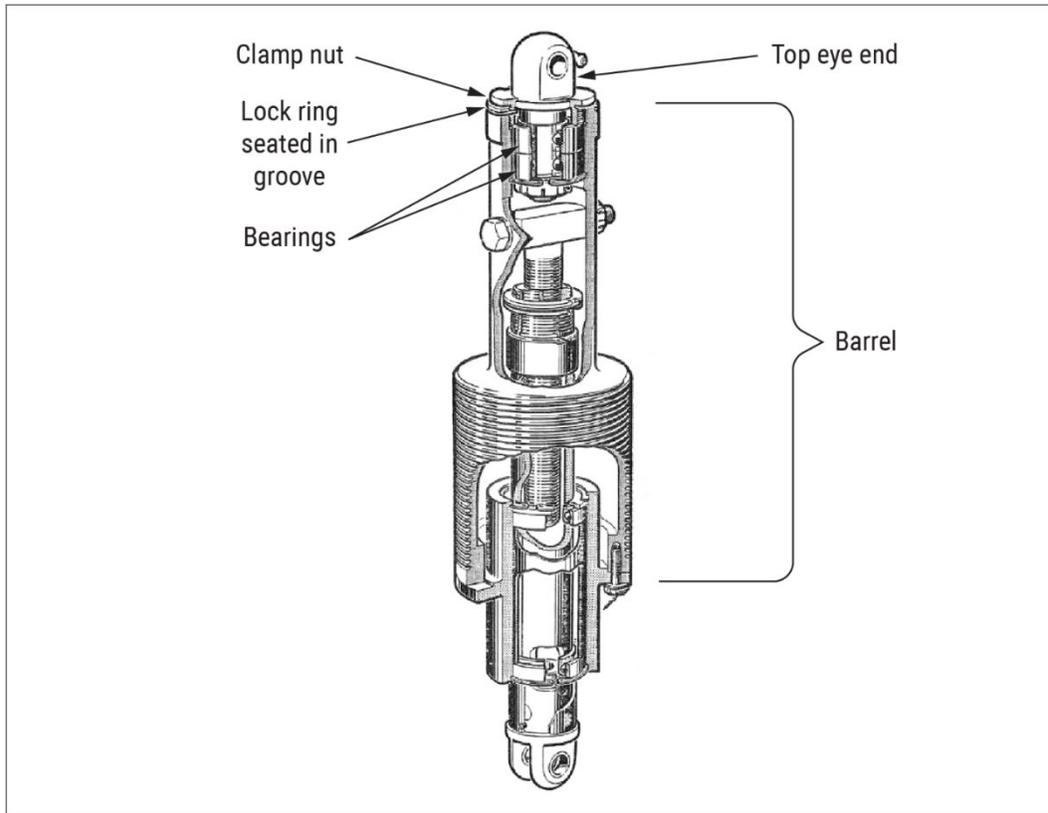
Figure 1. Horizontal stabilizer actuator (Source: Viking Air Limited).

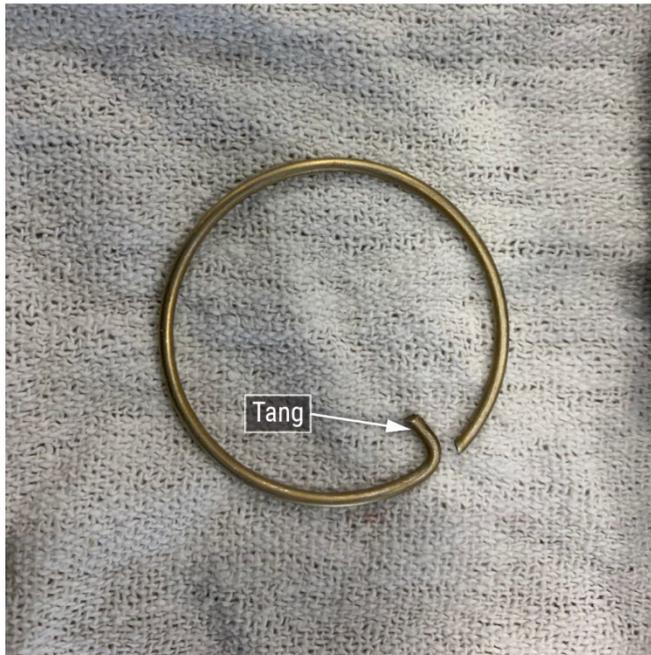
Figure 2. Exemplar lock ring.

During normal assembly, once the clamp nut is tightly screwed into the horizontal stabilizer actuator barrel, a hole is drilled through the clamp nut so that the hole aligns with another hole in the lock ring groove on the actuator barrel.⁵ The part of the lock ring that is bent inward (the tang) fits into the drilled hole, engaging both the barrel and the clamp nut and preventing the clamp nut from unscrewing from the

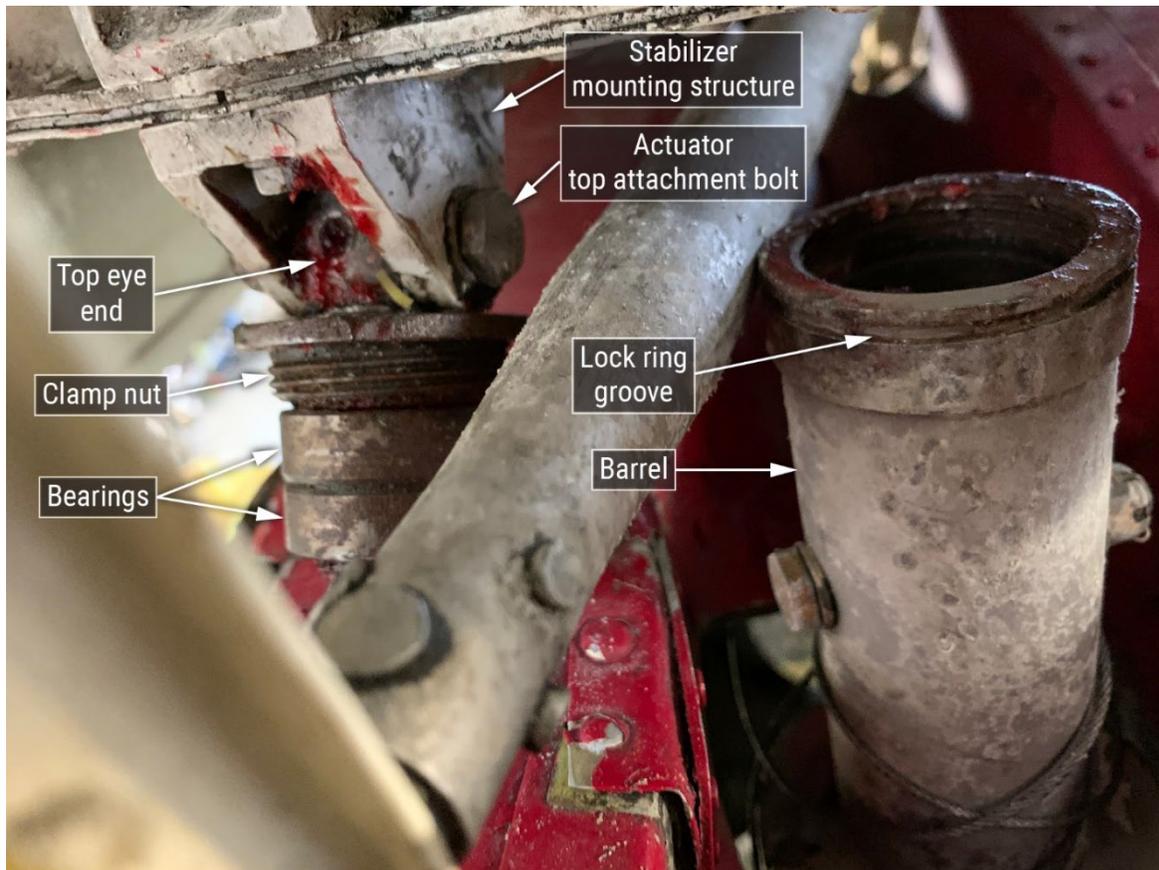
During the examination of the airplane wreckage, the NTSB found that the clamp nut that attaches the top eye end and bearing assembly of the horizontal stabilizer actuator (also referred to as the trim jack assembly) to the actuator barrel had unscrewed from the barrel.³ The examination also found that the circular wire lock ring, which was designed to prevent the clamp nut from unscrewing, was not present.⁴ Examination of the threads of the clamp nut and actuator barrel at the NTSB's Materials Laboratory showed no evidence that the threads failed in overstress or that the clamp nut and the horizontal stabilizer actuator barrel pulled apart from each other (that is, no evidence of stripped threads was found). Figure 1 shows a diagram of a horizontal stabilizer actuator, figure 2 shows an exemplar lock ring (with the tang that is secured into the clamp nut), and figure 3 shows the clamp nut and the lock ring groove around the barrel separated, as found during the airplane examination.

Figure 3. Clamp nut and barrel separation on accident airplane.

As shown in figure 3, the actuator is attached to the horizontal stabilizer with a bolt that connects the top eye end of the actuator to the rear mounting structure on the stabilizer. According to the DHC-3 aircraft maintenance manual, a clamp nut attaches the top eye end and bearing assembly to the barrel of the actuator. Both the clamp nut and the barrel end of the horizontal stabilizer actuator are threaded so that the clamp nut can be securely screwed into the actuator barrel.

⁵ Five holes had been drilled into the accident clamp nut threads; three holes were damaged to the extent that they would not have allowed for the full insertion of the lock ring pin. Thus, it is possible for a lock ring not to be fully inserted into the clamp nut through those holes. The maintenance manual does not specify whether it is acceptable for the clamp nut to have multiple holes drilled; the investigation is exploring this issue.

barrel. If the actuator barrel and the clamp nut are not secured together and become separated, the actuator would not be able to control the position of the horizontal stabilizer, resulting in a reduction or loss of pitch control.⁶

Require all operators of De Havilland Canada DHC-3 airplanes to conduct an immediate one-time inspection of the horizontal stabilizer actuator lock ring in accordance with the instructions in Viking Air Limited Service Letter DHC3-SL-27-001 and report their findings to the Federal Aviation Administration. (A-22-23) (Urgent)

Require all operators of De Havilland Canada DHC-3 airplanes to conduct an immediate one-time inspection of the horizontal stabilizer actuator lock ring in accordance with the instructions in Viking Air Limited Service Letter DHC3-SL-27-001 and report their findings to Transport Canada. (A-22-24) (Urgent)
