Aviation Investigation Report AIR-23-01

# Abrupt Loss of Pitch Control and Water Impact

## West Isle Air dba Friday Harbor Seaplanes de Havilland DHC-3, N725TH

Mutiny Bay, Washington  
September 4, 2022

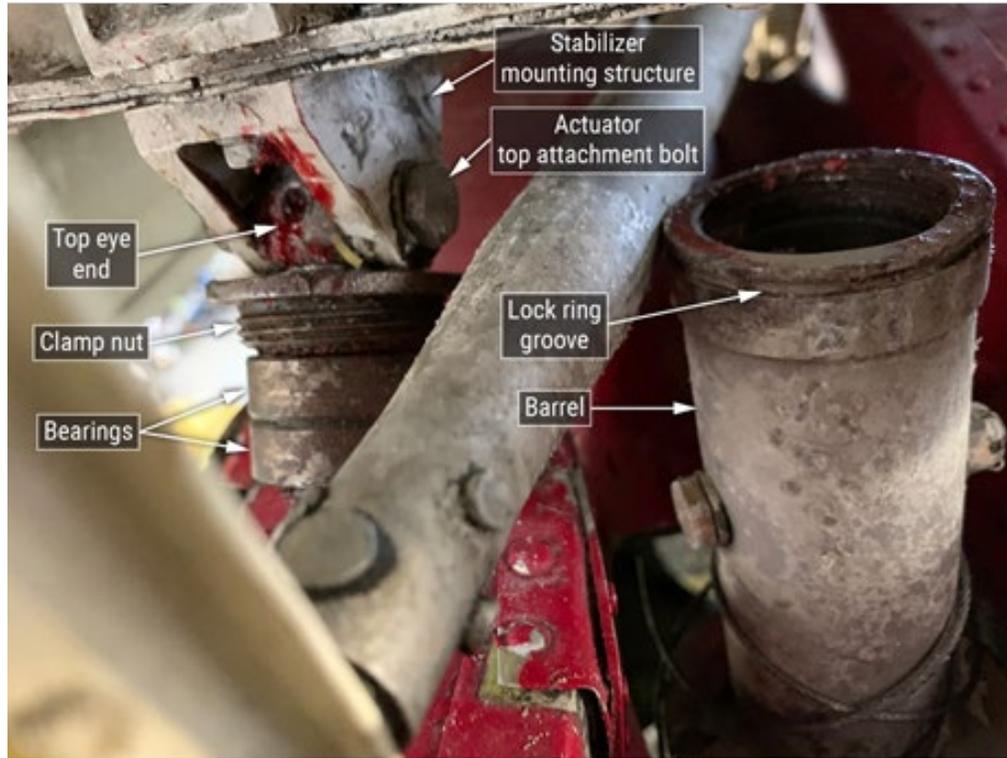
The horizontal stabilizer trim actuator's top eye end and bearing assembly clamp nut were found unscrewed from the actuator's upper housing with no obvious damage to the threads. The top eye end and bearing assembly remained connected to the horizontal stabilizer mounting bracket by the upper actuator attachment bolt (see figure 7) and could pivot freely about this bolt. The clamp nut could spin about

the top eye end. The lower actuator housing could rotate freely fore-aft about the lower attachment bolt.

**Figure 7.** Photograph of the clamp nut and barrel separation on the accident airplane.

When the barrel assembly was rotated full forward about the lower attachment bolt, the barrel contacted structure (which was bent inward and downward in this location). The lower center skin of the horizontal stabilizer was punched through at a 90° angle directly above the actuator when it was in the full-forward position. The punch-through was round and left a circular grease imprint on the contact surface that was consistent with the top of the actuator barrel assembly without the top eye end and bearing assembly present. The lock ring was not present in the lock ring groove of the upper barrel assembly. The through-hole in the lock ring groove was mostly clean, and light could be seen through it. The area below the actuator, as well as inside the horizontal stabilizer in the area of the punch-through, was searched for the lock ring both visually and with a magnet, but the lock ring was not found.<sup>19</sup>

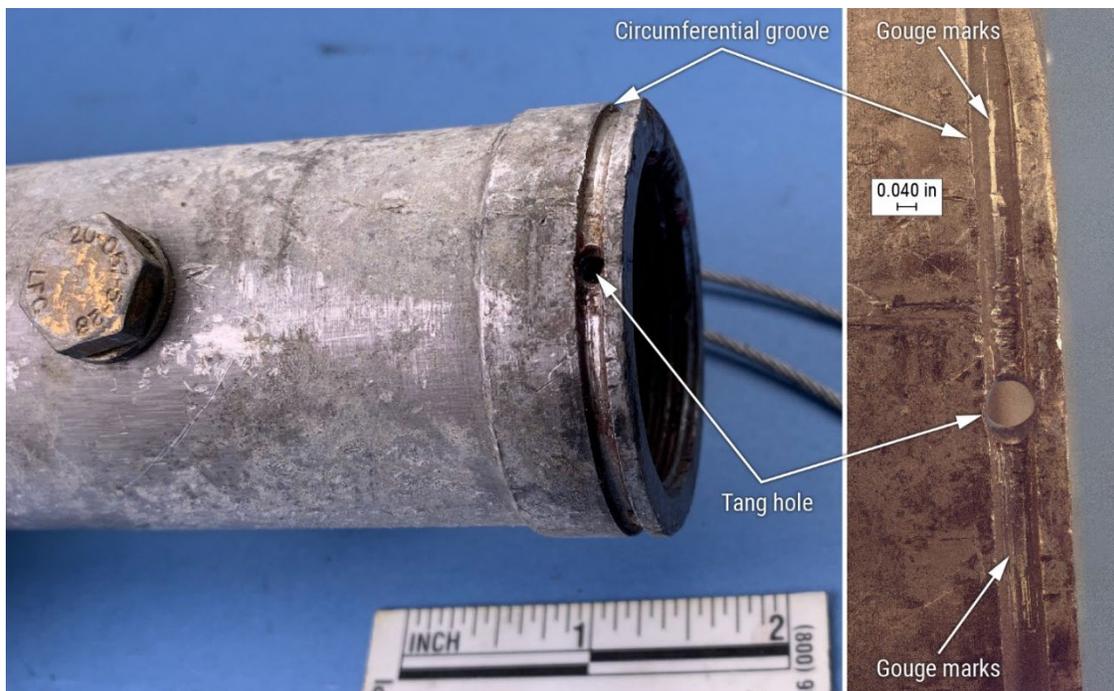
The manufacturer specification for the diameter of the tang hole in the barrel (intended for engaging the lock ring) was 0.098 inches; the specified diameter was confirmed by easily inserting the shank portion of a 0.098-inch nominal diameter drill bit into the tang hole. The tang hole at the outer surface exhibited evidence of elongation deformation on both lateral sides (perpendicular to the length of the barrel). The groove portion of the barrel contained circumferential gouge marks that extended about 0.9 inches to either side of the tang hole (see figure 8). The groove in areas outside of the gouge marks exhibited light contact (polished) marks consistent with the size of a lock ring.

**Figure 8.** Photographs of the top end of the horizontal stabilizer actuator barrel.

Note: The left image shows the circumferential groove and tang hole for the lock ring; the right image is a close-up view of gouge marks in the groove.

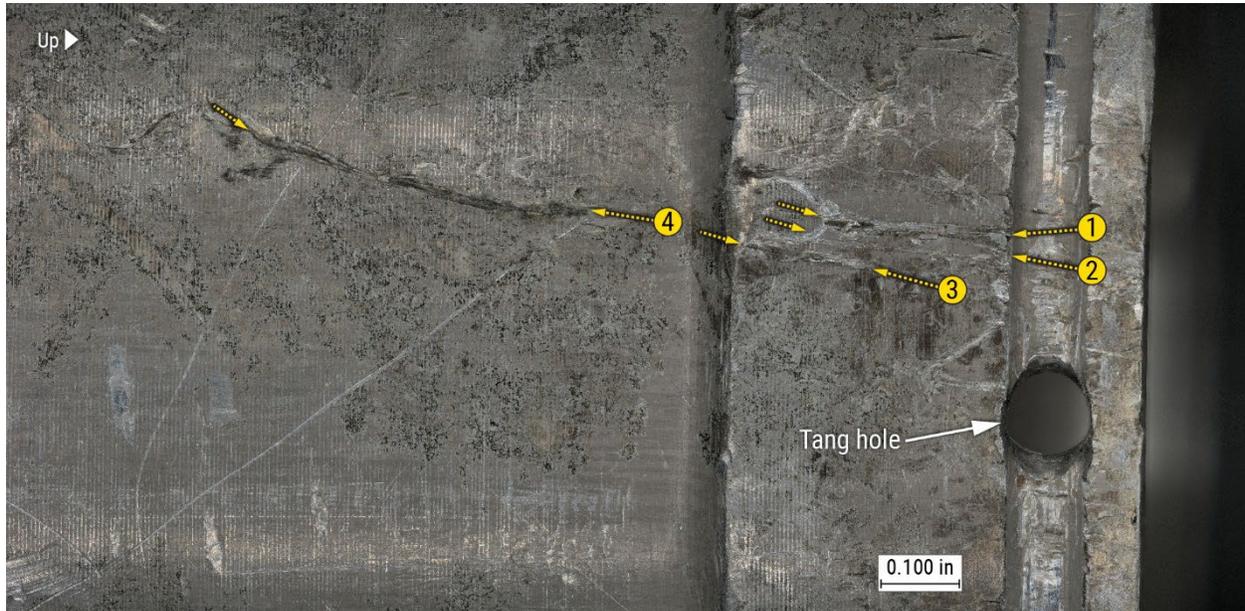
Several longitudinal gouge marks were noted in the general area of the tang hole (see figure 9).

**Figure 9.** Side view of the horizontal stabilizer actuator barrel.

Note: The image shows the longitudinal-like gouge marks that extended from the circumferential groove, in the areas between arrows "1" through "4".

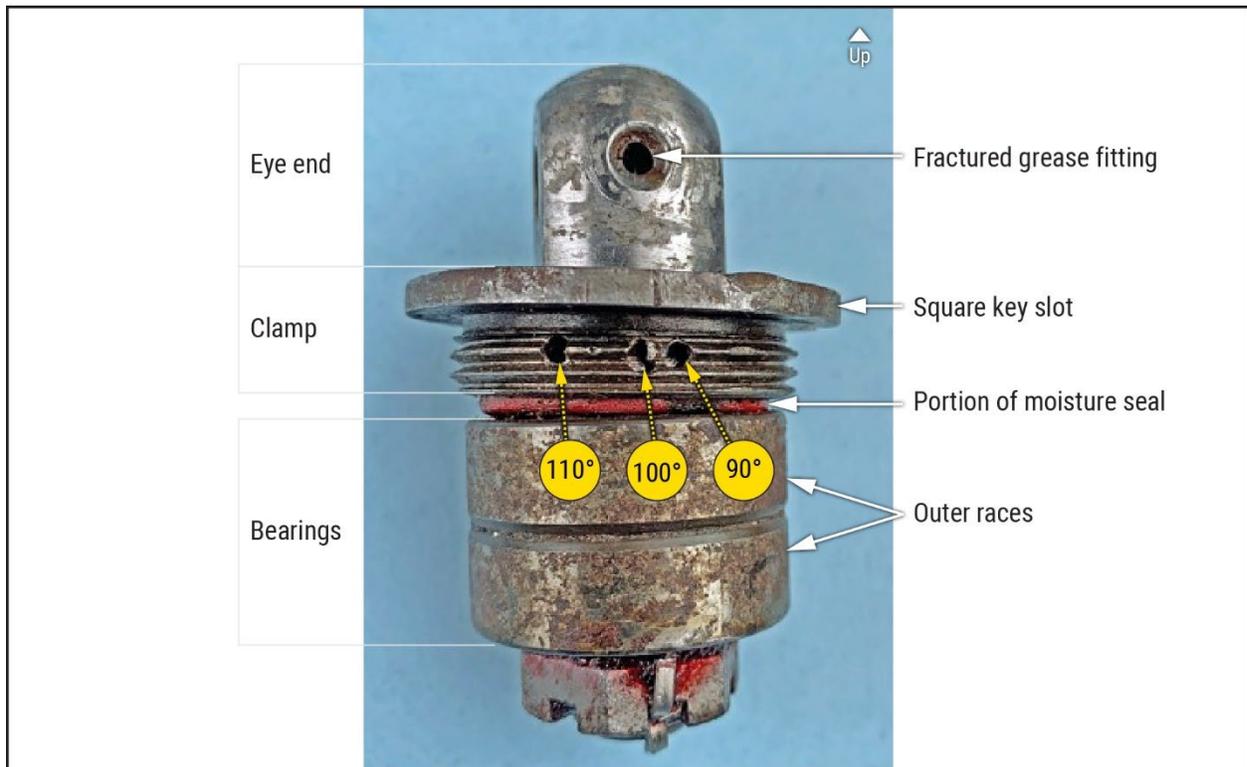
**Figure 10.** Photograph of the top eye end and bearing assembly showing three of five holes drilled into the clamp nut.

Five drilled through-holes were observed in the area of the clamp nut's external threads. None of the holes contained a fragment of the lock ring or foreign material. The positions of the drilled holes around the clamp nut were measured relative to the square key slot (which was arbitrarily assigned the 0° position). Two of the five drilled through-holes (located at 90° and 110°) were unobstructed, and the remaining through-holes (located at 100°, 230°, and 310°) were obstructed by wall deformation that reduced the diameter of the through-holes.<sup>22</sup>

During interviews, the DOM and AMT both reported that they never drilled holes into the clamp nut. The DOM further stated the AMM contained no instructions for when the lock ring and hole do not line up.<sup>23</sup> A review of the AMM confirmed there was no information pertaining to multiple holes in the clamp nut (no authorization was given to drill additional holes or what to do if multiple holes were observed). Interviews with personnel from Viking Air indicated there should only be one hole drilled in the clamp nut.

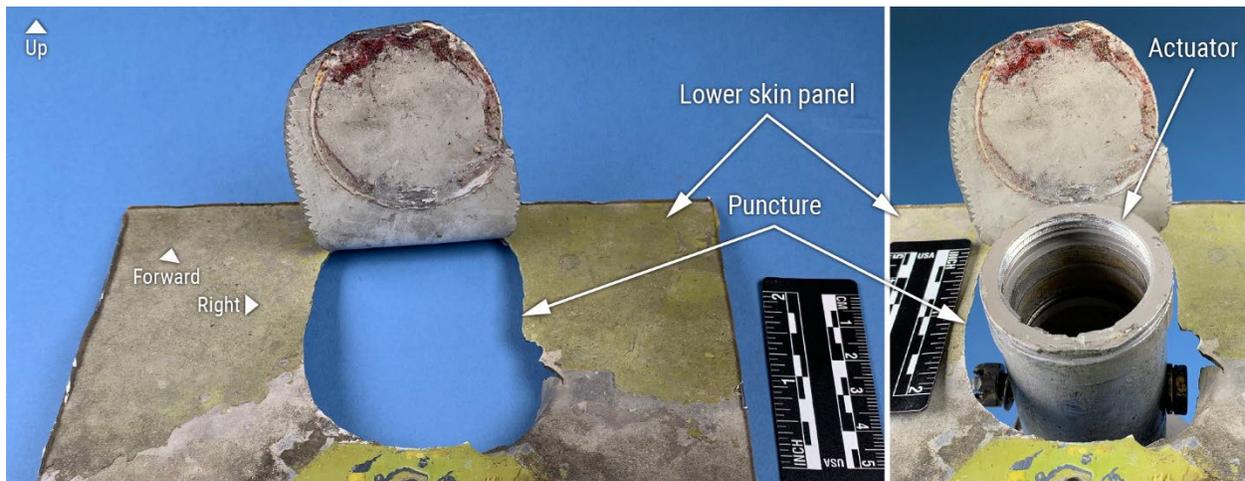
A lower skin panel from the horizontal stabilizer was examined at the NTSB Materials Laboratory. The panel contained a puncture with the ruptured flap portion that was deformed upward. The bottom face of the punctured skin exhibited a deformed curved pattern that was consistent with the shape and size of the horizontal actuator barrel outer diameter when the top eye end and bearing assembly was not present (see figure 11). The bottom surface of the flap was covered with translucent red grease (around and within the impression mark).

**Figure 11.** Photographs of the lower skin panel for the horizontal stabilizer.

Note: The left side of the image shows the puncture, and the right side of the image shows the barrel portion of the horizontal stabilizer trim actuator inserted into the open end of the puncture.

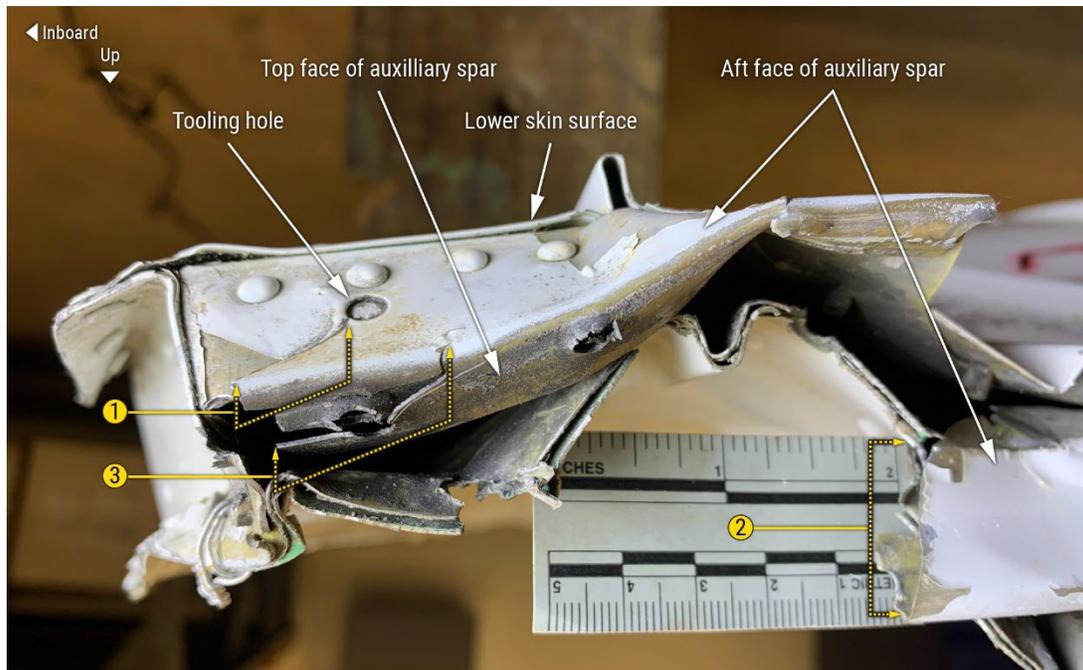
Examination of the left elevator assembly revealed the inboard end of the auxiliary spar contained three cracks (arbitrarily referred to as cracks "1", "2", and "3") (see figure 12). Cracks "1" and "3" were located in the same area that contained a

2-inch-long repair doubler (installed at the inboard end on the forward face of the auxiliary spar).<sup>31</sup>

**Figure 12.** Photograph of the auxiliary spar for the left elevator, after the tab was removed, showing cracks "1", "2" and "3" (view looking forward).

The cracks were examined by bench binocular microscope and scanning electron microscope. Cracks "1" and "3" revealed fracture features consistent with fatigue cracking, and crack "2" revealed evidence of overstress separation with no evidence of fatigue cracking. The repair doubler was intact, and no cracking was noted on it. The outboard end of the auxiliary spar was disassembled (de-riveted) from the left elevator to expose all surfaces of the auxiliary spar. The remaining portion of the auxiliary spar contained no evidence of cracks.
