March 7, 2025

Aviation Investigation Report AIR-25-01

Deconflict Airplane and Helicopter Traffic in the Vicinity of Ronald Reagan Washington National Airport

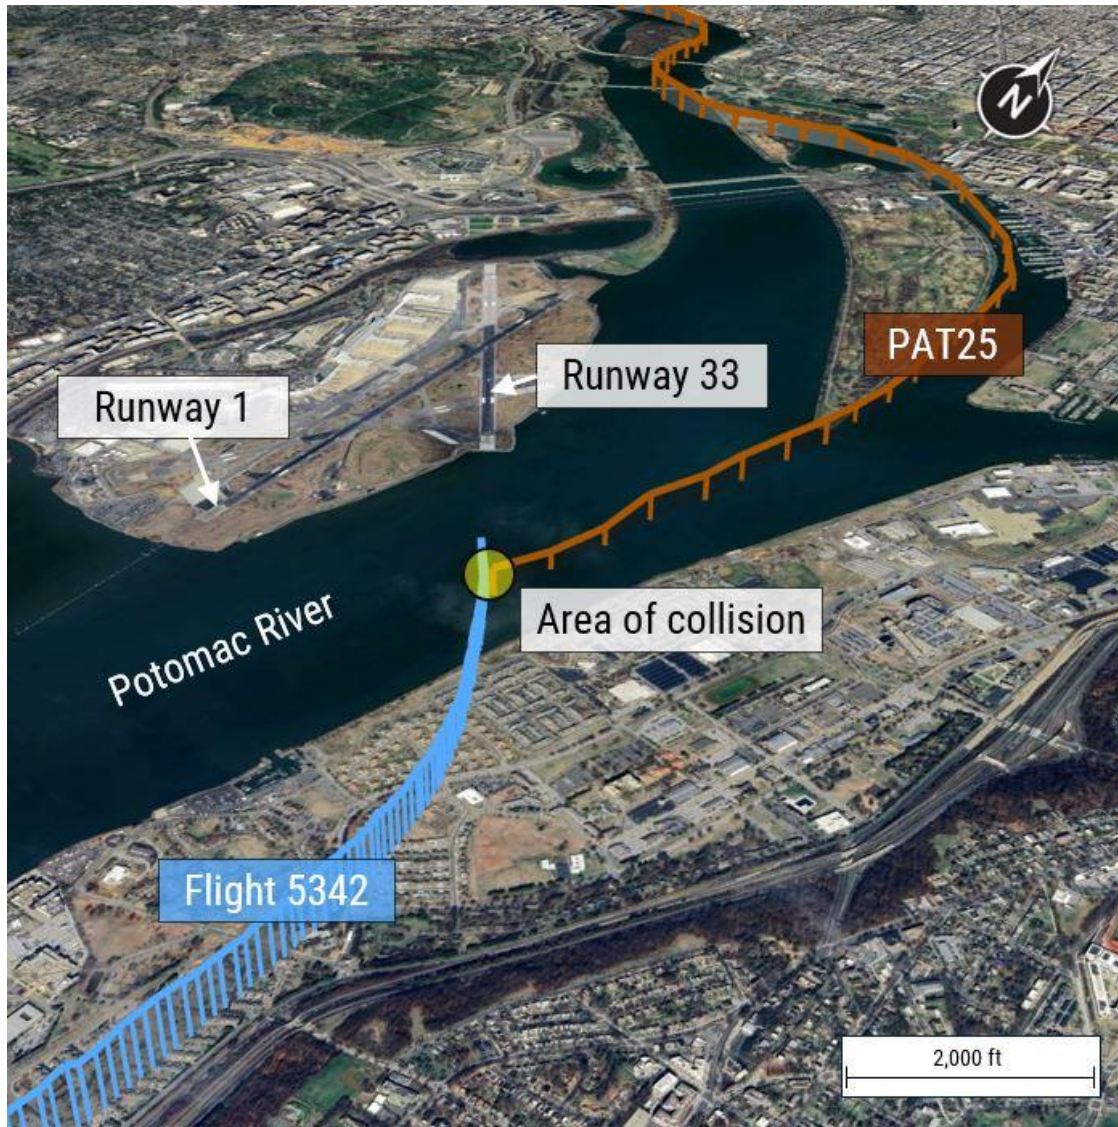
At 2047:39, with the helicopter south of Hains Point (located at the confluence of the Potomac and Anacostia rivers and a "noncompulsory" reporting point, as indicated on the FAA's Baltimore-Washington Helicopter Route Chart), the controller asked the crew of PAT25 to confirm that they had the CRJ in sight. An aural conflict alert in the tower can be heard in the background of the ATC recording at this time. About 4 seconds later, the controller instructed PAT25 to pass behind the CRJ; PAT25 immediately confirmed that the traffic was in sight and again requested visual separation, which the controller approved. The collision occurred at 2047:59, at an altitude about 300 ft, while flight 5342 was on final approach to land on runway 33 (see figure 1).

Figure 1. Google Earth image with preliminary ADS-B flight track for flight 5342 (blue line) and preliminary radar data for PAT25 (orange line).

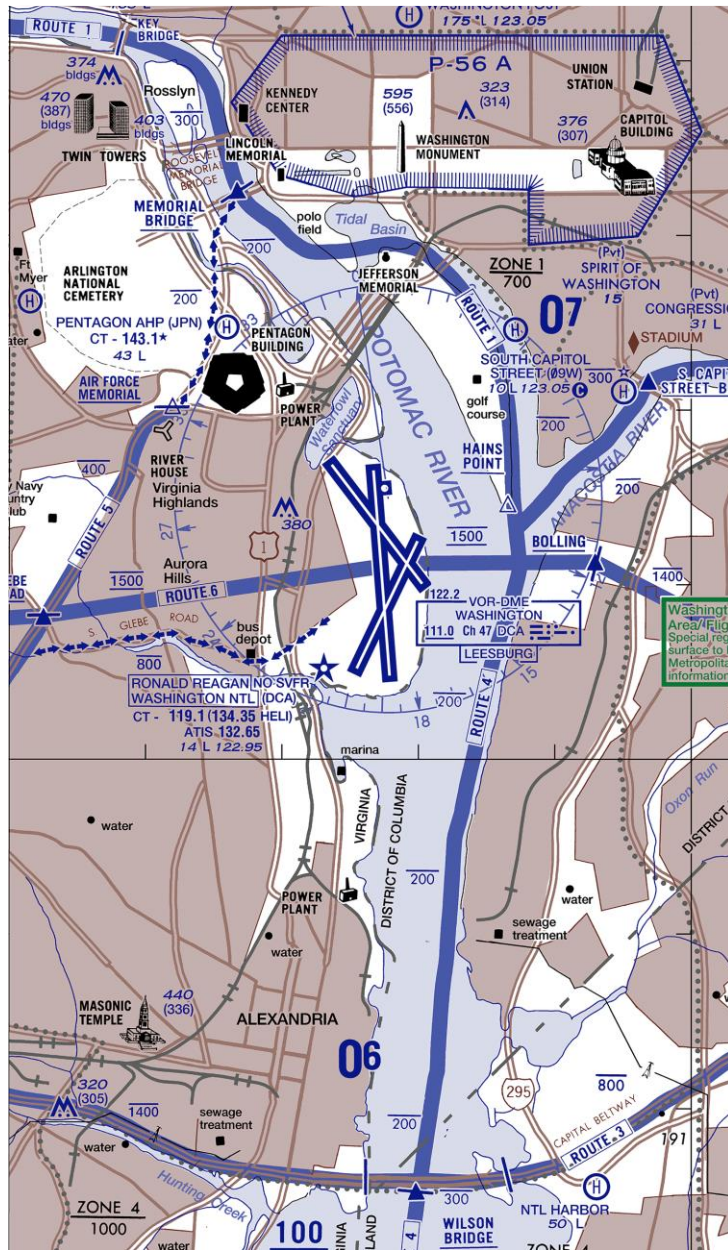
PAT25's VFR flight plan entailed transiting Washington, DC, airspace following standard helicopter routes established by the FAA: Route 1 to Route 4. Beginning at the American Legion Bridge near Cabin John, Maryland, Route 1 follows the western shore of the Potomac River before crossing Key Bridge in Washington, DC. Route 1 then follows the eastern shore of the Potomac with the Kennedy Center and Lincoln Memorial to the east and Rosslyn to the west, avoiding prohibited airspace, and crosses Memorial Bridge, a compulsory reporting point (see figure 2).⁵ At this point, the maximum allowable altitude on Route 1 is 200 ft above mean sea level (msl).

Route 1 then continues south of the Washington Monument, crossing the Tidal Basin before following the Washington Channel along East Potomac Park. Hains Point, the southernmost tip of East Potomac Park, is identified as a noncompulsory reporting point and the area where Route 4 intercepts Route 1; the maximum altitude on Route 4 remains 200 ft msl.⁶ Route 4 continues south toward the Woodrow Wilson Bridge along the Potomac River's eastern shore, with DCA to the west. South of the Wilson Bridge, the maximum allowable altitude along Route 4 increases from 200 ft msl to 300 ft msl.

Figure 2. An excerpt of the FAA’s Helicopter Route Chart for the area surrounding DCA.
Source: FAA.

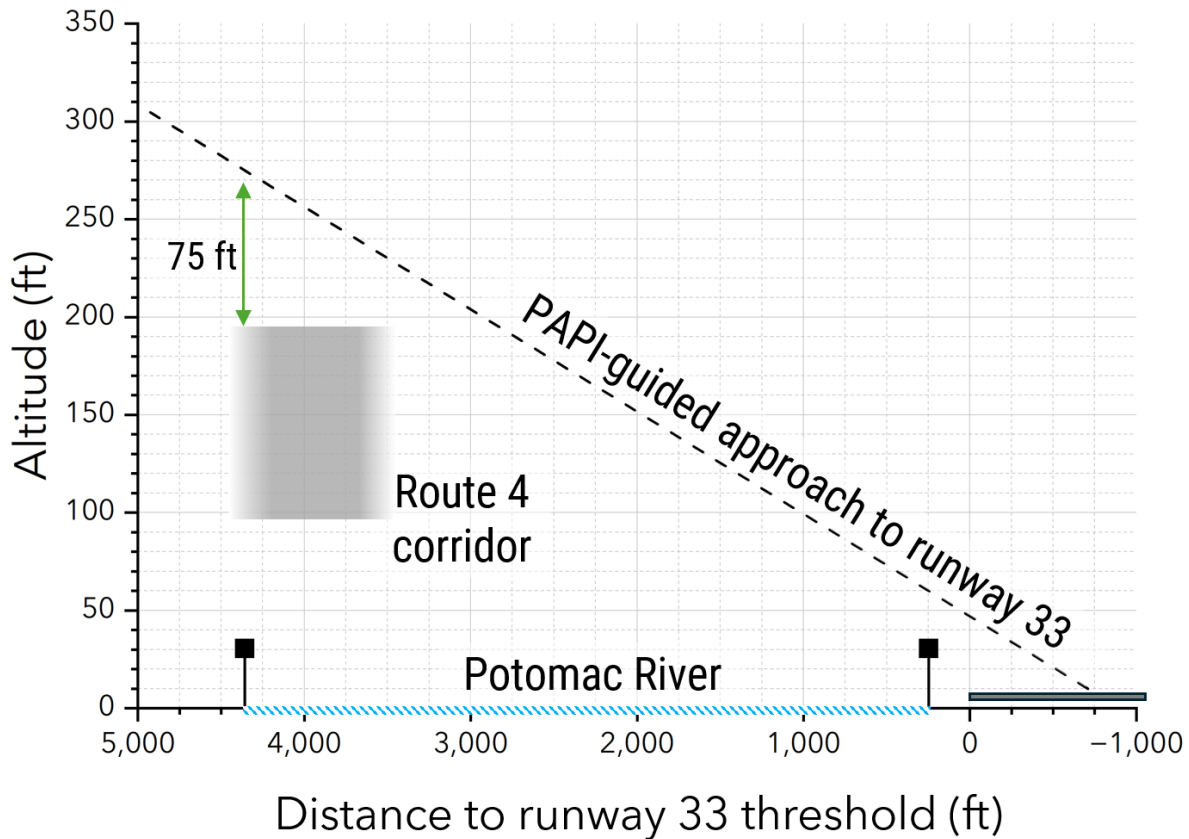
Figure 3 presents a cross-section of the airspace that extends from runway 33’s centerline, spanning from the runway 33 threshold markings to the east bank of the Potomac River. The figure shows the separation distance that would exist, according to FAA charts, with a helicopter on Route 4 and an airplane descending on a 3° visual glideslope (as provided by the PAPI’s glidepath indication) to runway 33.

Figure 3. Cross section showing the notional separation between Route 4 and a PAPI-guided visual approach to runway 33, according to FAA charts and aerial photogrammetry analysis.

Because helicopter routes established by the FAA have no lateral boundaries and the Baltimore-Washington Helicopter Route Chart includes no warning for helicopters to operate a defined distance from the shoreline, the shaded region represents an approximation of the area in which helicopters could be flown. At an altitude of 200 ft, a helicopter operating over the eastern shoreline of the Potomac River would have about 75 ft of vertical separation from an airplane approaching runway 33, and this distance decreases if the helicopter is operated farther from the shoreline. This vertical separation also decreases if an airplane is operating below the 3° visual glidepath provided by the runway 33 PAPI.

The NTSB's investigation of this accident is ongoing; however, preliminary findings suggest that the existing separation distances between helicopter traffic operating on Route 4 and aircraft landing on runway 33 are insufficient.⁹ Therefore, the NTSB concludes that existing separation distances between helicopter traffic operating on Route 4 and aircraft landing on runway 33 are insufficient and pose an intolerable risk to aviation safety by increasing the chances of a midair collision.

Therefore, the NTSB recommends that the FAA prohibit operations on helicopter Route 4 between Hains Point and the Wilson Bridge when runways 15 and 33 are being used for departures and arrivals, respectively, at DCA. As noted

Prohibit operations on helicopter Route 4 between Hains Point and the Wilson Bridge when runways 15 and 33 are being used for departures and arrivals, respectively, at Ronald Reagan Washington National Airport. (A-25-1) (Urgent)

Designate an alternative helicopter route that can be used to facilitate travel between Hains Point and the Wilson Bridge when that segment of Route 4 is closed. (A-25-2) (Urgent)
