March 27, 2025

Aviation Investigation Report AIR-25-02

Address Noncompliant Evacuation Slide Components on Boeing Airplanes

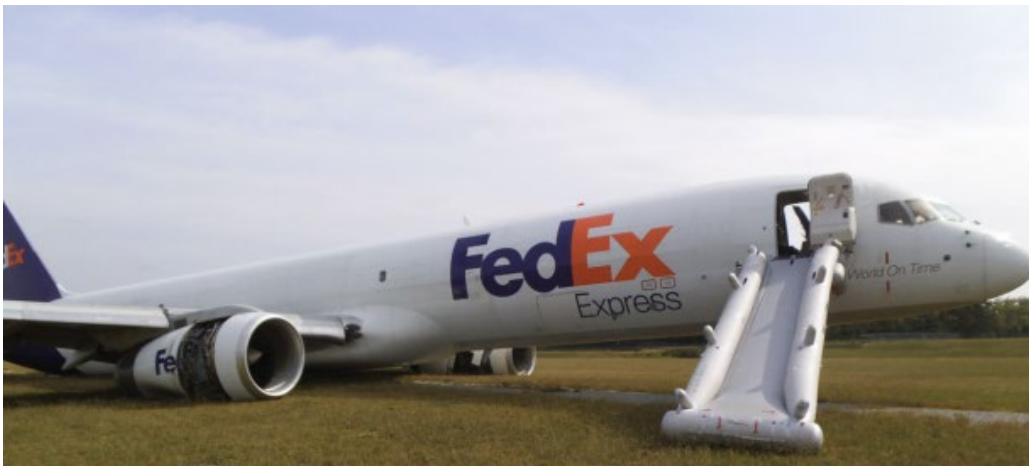
The jumpseat occupant then attempted to open the right (R1) door, but it lodged on the slide pack.³ The jumpseat occupant used force to open the R1 door, and the slide deployed normally (see figure 1). The flight crew and the jumpseat occupant exited the airplane via the R1 door and slide. Both flight crewmembers and the jumpseat occupant were uninjured. The event was classified as an accident because the airplane sustained substantial damage. The flight was operating under the provisions of Title 14 *Code of Federal Regulations* Part 121 as a non-scheduled domestic cargo flight from CHA to Memphis International Airport (MEM), Memphis, Tennessee.

Figure 1. Airplane in its final resting position, with the R1 slide deployed. (Source: Federal Aviation Administration)

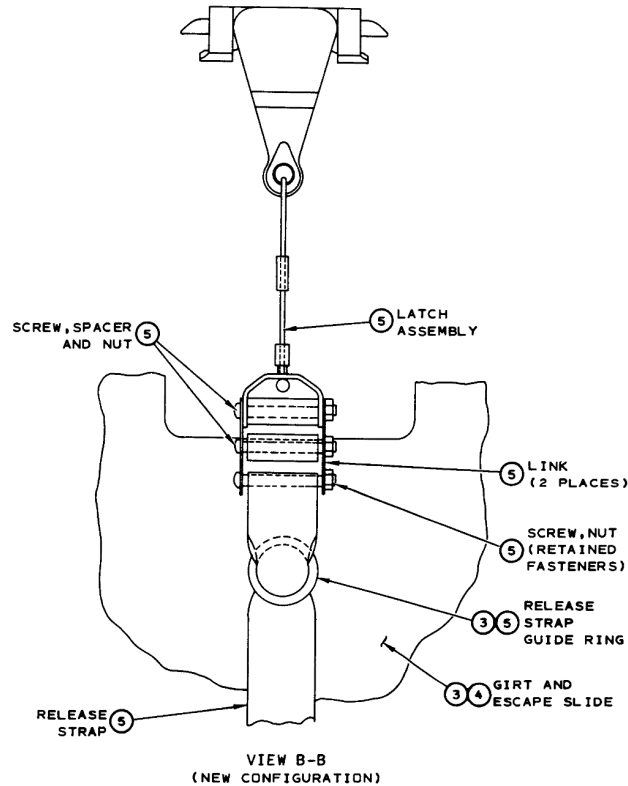
Boeing Service Bulletin (SB) 757-25A0058, dated April 18, 1986 (see figure 2).⁴ Instead, the R1 bannis latch on the accident airplane had only one link and lacked other required hardware (see figure 3), which caused the slide pack to jam before the jumpseat occupant was eventually able to force the door to open. Postaccident examination of the L1 door found that, although its bannis latch conformed to required modifications, the deployment strap was incorrectly routed, which prevented the door from opening.

Figure 2. Boeing SB 757-25A0058 modifications of slide pack release cable assembly required by AD 86-09-09. (Source: Image Copyright © Boeing. Reproduced with permission.)

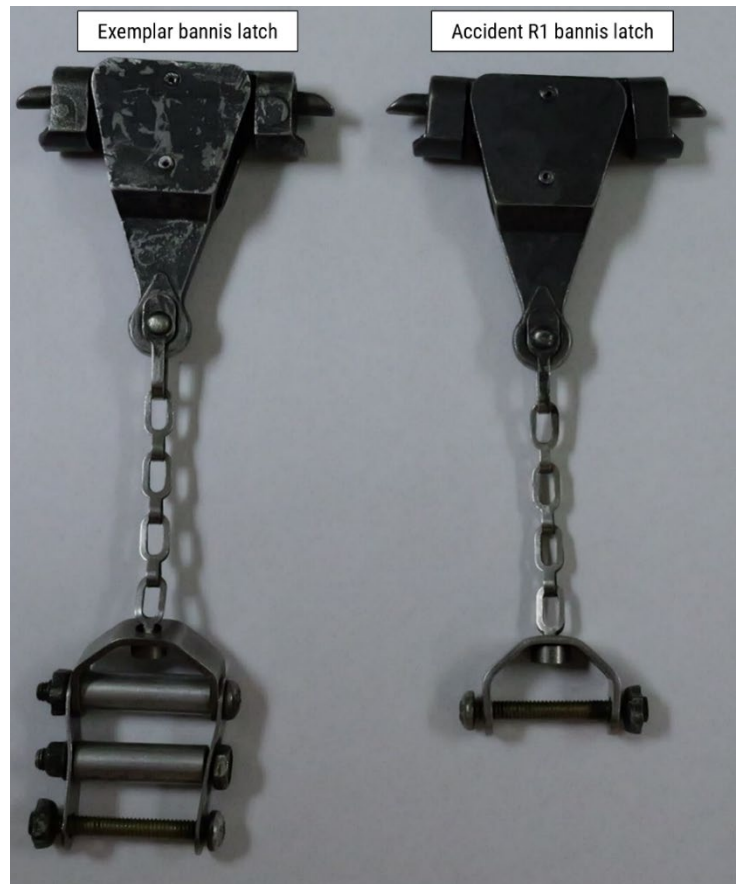
Preliminary findings from the NTSB's ongoing investigation indicate different reasons for the jumpseat occupant's difficulty opening the L1 and R1 doors to deploy the respective evacuation slides. Postaccident examination of the R1 door found that the R1 bannis latch (which releases the slide pack when an armed door is opened) did not conform to the then-current configuration of the release cable assembly. Specifically, the assembly is supposed to have three links added with two spacers and hardware, as required by FAA Airworthiness Directive (AD) 86-09-09 by reference to

Figure 3. Exemplar bannis latch (left) with three links and accident airplane R1 bannis latch (right) with one link

Require all Boeing 757 operators to inspect the bannis latches on Boeing 757-200, -200CB, and -300 series airplane doors and, if necessary, modify or replace them so they comply with the correct configuration. (A-25-3)

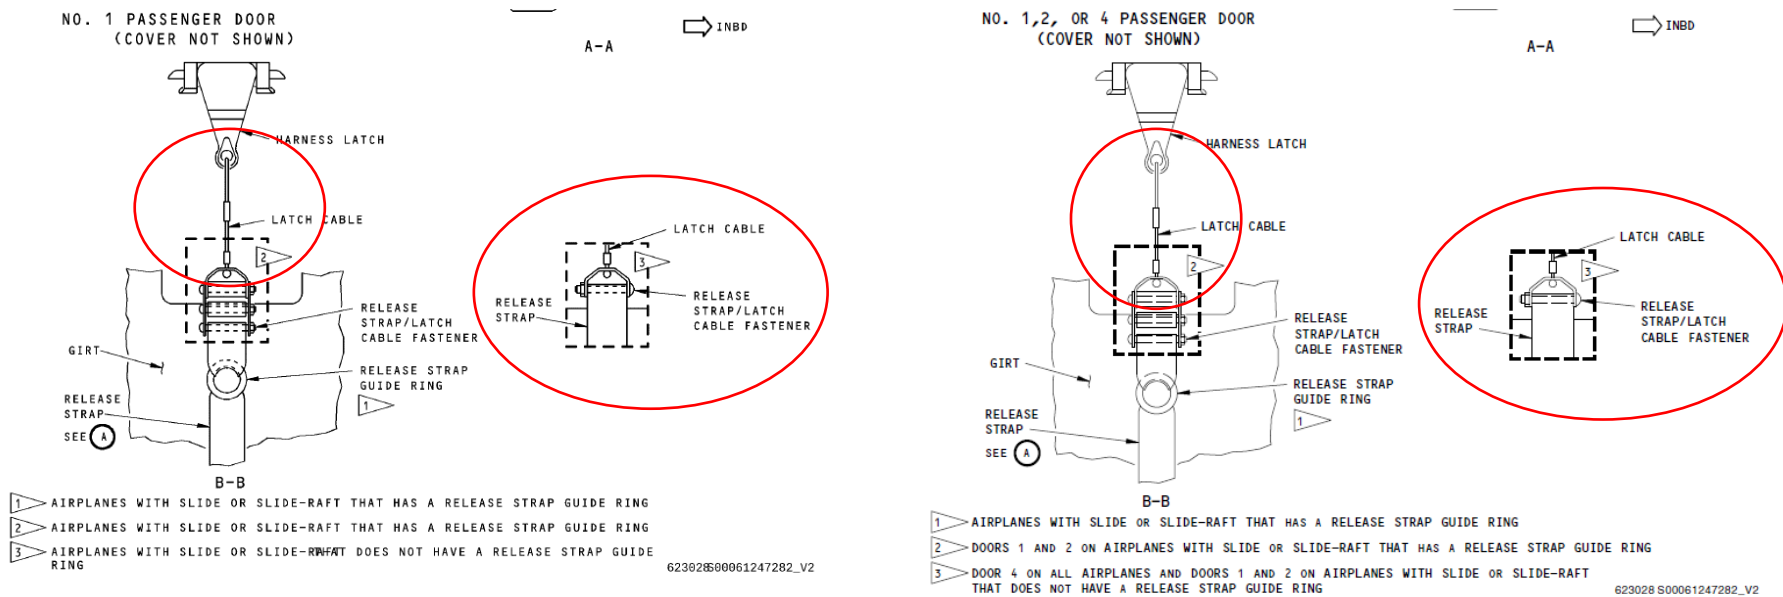
The NTSB's review of the Boeing 757 and FedEx aircraft maintenance manuals (AMMs) and the Boeing illustrated parts catalog (IPC) found that all contained inconsistent depictions of the bannis latch configuration as required by ADs 86-09-09 and 2001-15-01. For example, the illustrations shown in figures 4 and 5 depict different versions of the release assembly and both the three- and one-link configurations, circled on each illustration. Both illustrations in figure 4 indicate a cable rather than the required chain, and the inset image to the right of each full image indicates a single link rather than the required three links. The illustration from the Boeing IPC in figure 5 displays both the chain configuration (correct) and the cable and thimble configuration (incorrect), and both the single-link configuration (incorrect) and the three-link configuration (correct). It is also noted that Boeing does not have a single part number that covers the entire latch assembly. The current part number includes both the one-link and the three-link configurations.

Figure 4. Boeing 757 bannis latch configuration in the FedEx AMM (left) and Boeing AMM (right). (Source: Image Copyright © Boeing. Reproduced with permission.)

None of these resources depict the bannis latch with all required modifications. These inconsistent, conflicting depictions would likely be confusing to maintenance personnel and could lead to the installation of and failure to detect nonconforming latches, which could result in another incident of an evacuation slide not deploying properly when needed. After the NTSB urged Boeing to look into the high incidence of noncompliant in-service bannis latches that were identified during FedEx's fleet inspection, Boeing's revision groups for the 757 AMM and IPC reached a consensus that the correct hardware for the bannis latch assembly could be clarified. Boeing anticipates releasing updates to the AMM and IPC in May 2025 to provide a consistent and accurate depiction of the bannis latch assembly.

Require all Boeing 757 operators to update their Boeing 757-200, -200CB, and -300 series airplane aircraft maintenance manuals (AMM) in accordance with the revised Boeing AMM and illustrated parts catalogs. (A-25-5)

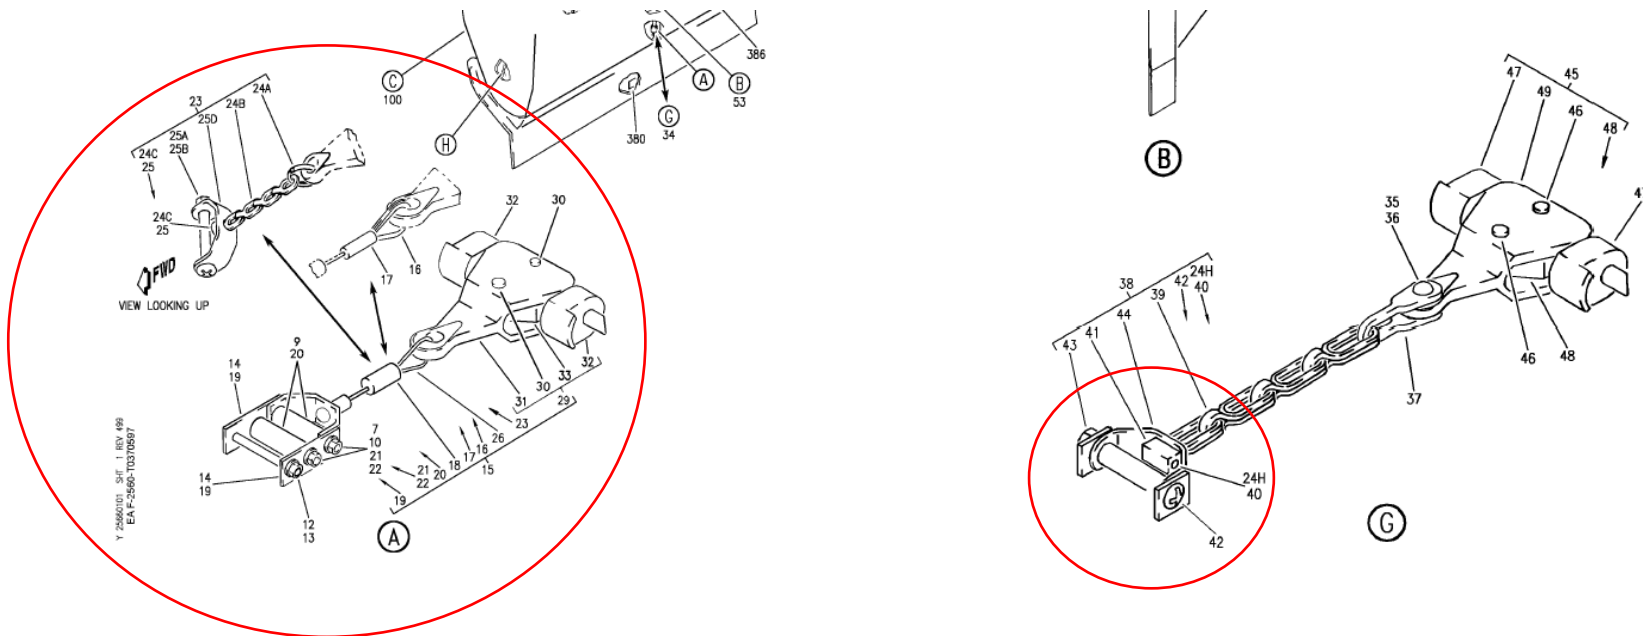
Figure 5. Boeing 757 bannis latch configuration in Boeing illustrated parts catalog. (Source: Image Copyright © Boeing. Reproduced with permission.)
