Aviation Investigation Report AIR-25-04

In-Flight Separation of Left Mid Exit Door Plug, Alaska Airlines Flight 1282, Boeing 737-9, N704AL

Portland, Oregon

January 5, 2024

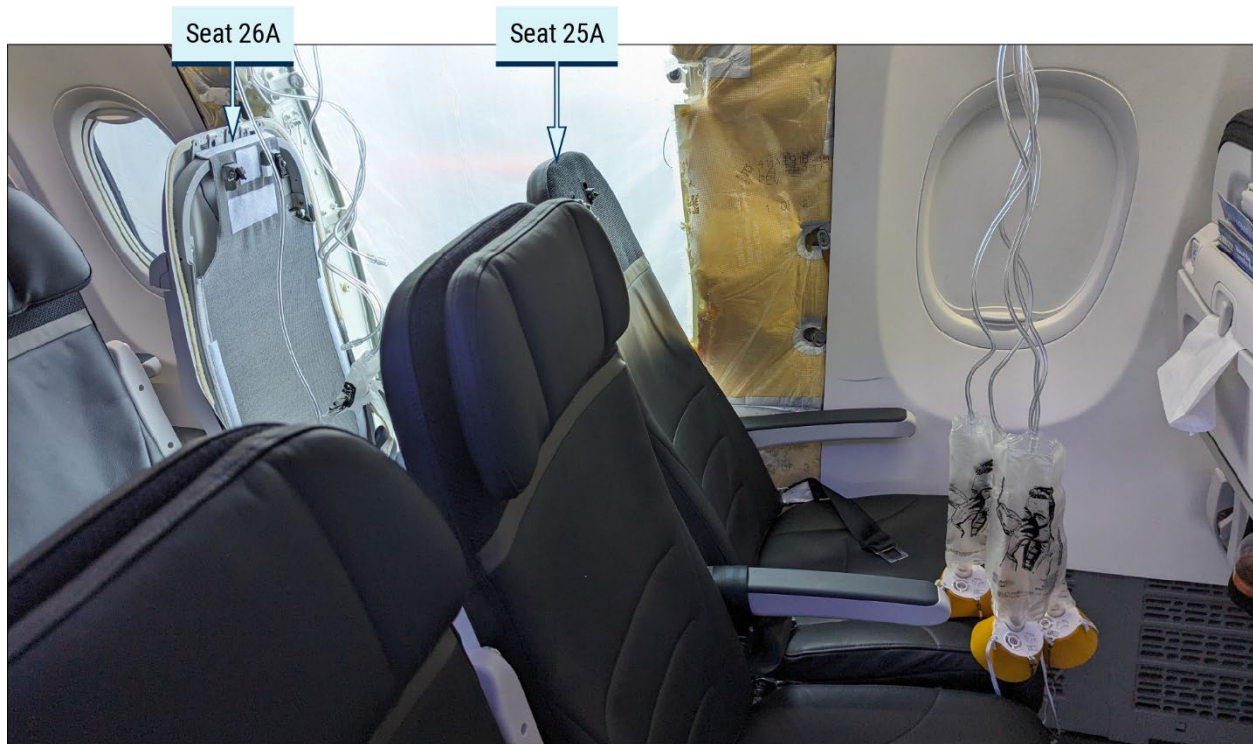
Examination of the airplane revealed a hole in the left fuselage next to seating row 26 where the left MED plug was missing. Damage was observed on various components on the fuselage frame that surrounded the hole, including fittings and assemblies associated with the left MED plug installation. Interior sidewall panels were missing, and insulation was exposed on both sides of the opening where the left MED plug had been (see figure 1).

Figure 1. Interior view showing hole in left fuselage at row 26.

The seat unit 25ABC frame was structurally intact and undamaged. It was connected firmly to the floor with spacers in place between rows 24 and 25. The seatback for seat 25A was deformed outboard and aft, the seats 25A and 25A headrests were missing (see figure 1), and the seat 25A bottom cushion was displaced upward.

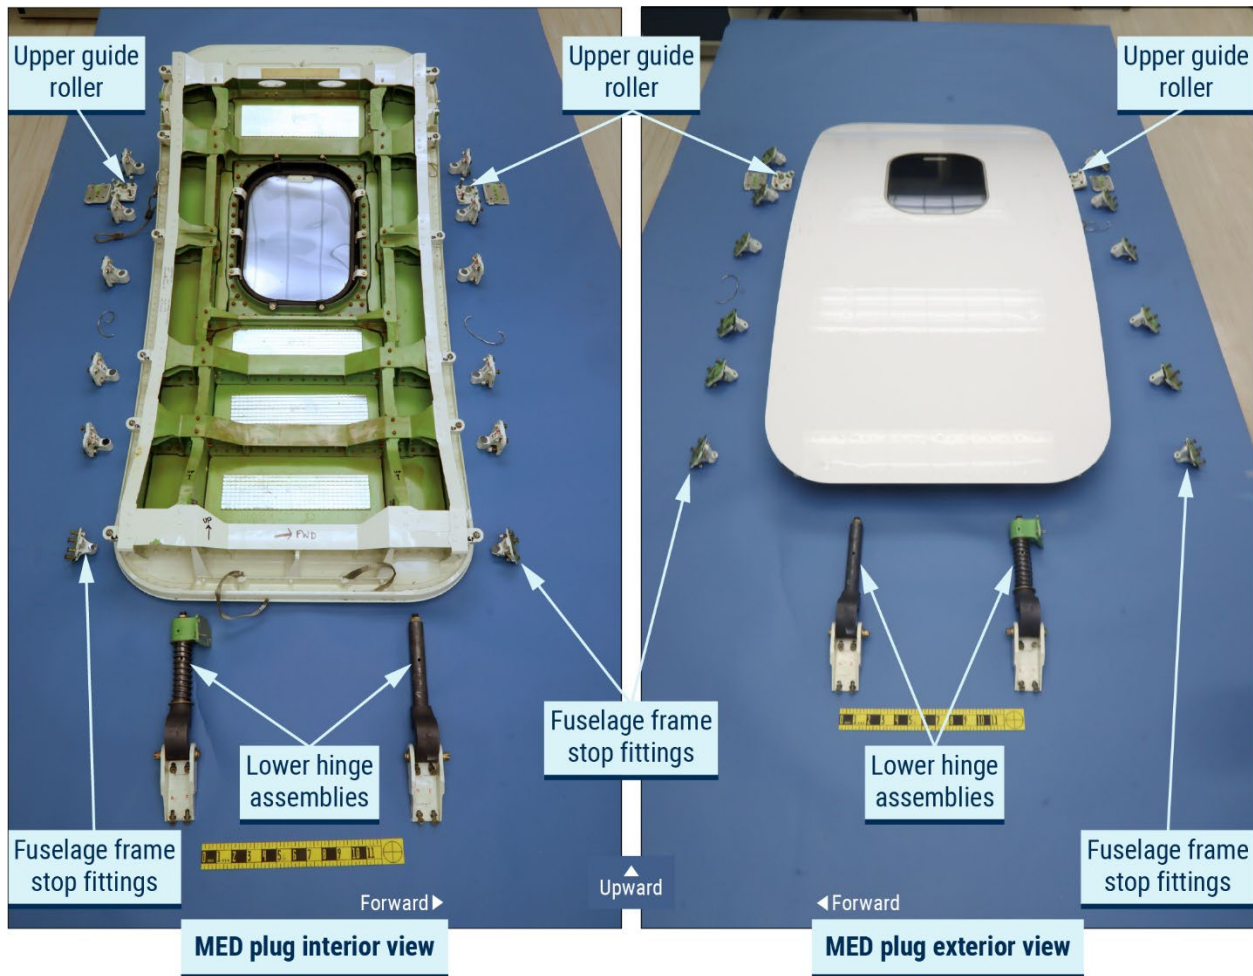
Multiple components were missing and not recovered, including the two vertical movement arrestor bolts and two upper guide track bolts (and associated

washers, castle nut, and cotter pin for each). Also, the forward lower hinge guide fitting flange was fractured, and the lift assist spring, washers, and pieces of guide fitting were missing (see figure 10).

Figure 10. Photographs of the left MED plug and associated components showing an interior view (left) and exterior view (right).

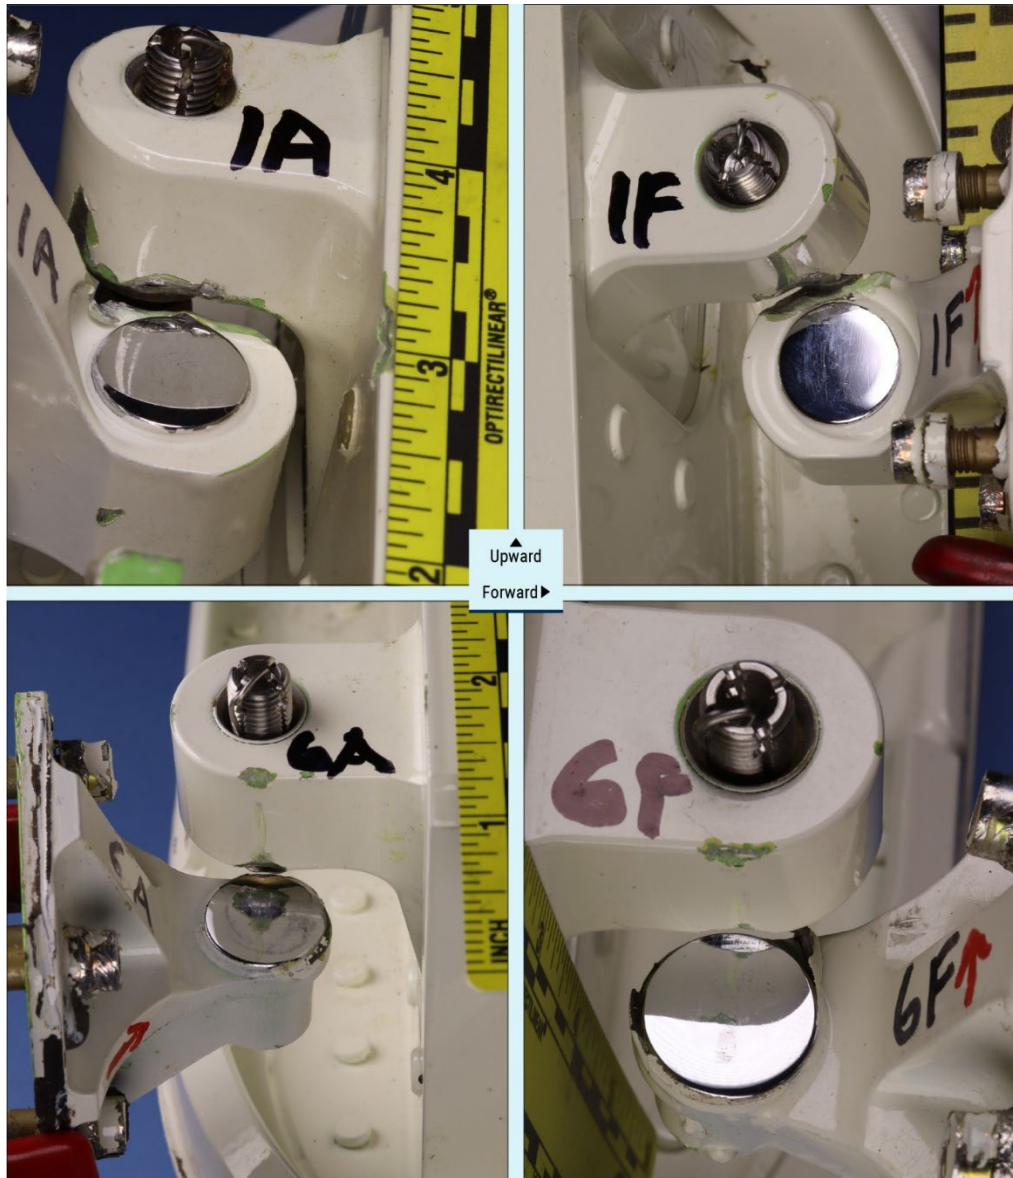
plug stop fittings. Corresponding contact damage was noted on the upper sides of the 12 frame stop fittings. The orientation and geometry of the sliding contact marks and damage on the frame stop fittings and plug stop fittings mostly exhibited features consistent with the plug displacing upward before clearing the stop fittings then displacing outboard and aft (see figure 11).

Figure 11. Views of four frame stop fittings placed next to their corresponding plug stop fittings. (Marker labels and arrows added during the examination.)

Note: Corresponding sliding contact damage is shown for each frame stop fitting (with stop pad) and plug stop fitting pair. The displayed fittings are from the left MED plug's upper aft (labeled 1A), upper forward (1F), lower aft (6A), and lower forward (6F) locations and corresponding frame locations.

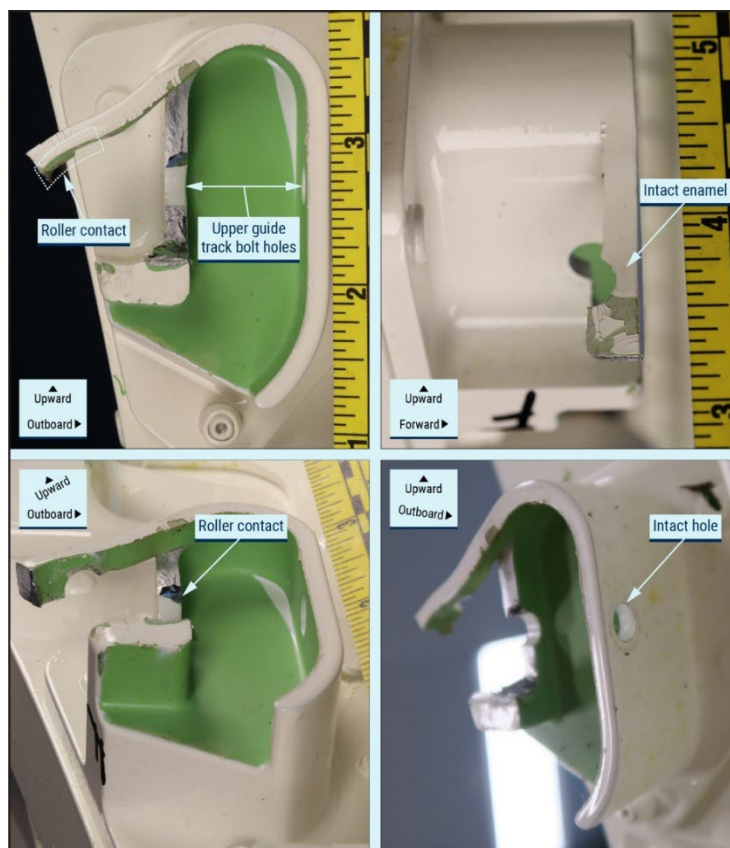
The upper guide rollers were intact. The left MED plug's forward and aft upper guide fittings each had a vertical fracture through the inboard wall of the guide track that intersected the inboard upper guide track bolt hole. The fractured wall of each guide track had arc-shaped deformation features and inward and upward deformation, consistent with contact with the respective upper guide roller. The fracture features were consistent with overstress fracture, and there was no evidence of preexisting cracks or damage.

The outboard upper guide track bolt holes in both upper guide fittings were intact and showed no evidence of contact damage. Faint circular marks consistent with prior contact with washers associated with the upper guide track bolt were visible on the forward upper guide fitting during preliminary examinations.³⁷ The inboard upper guide track bolt holes had areas of intact enamel with no evidence of contact damage around the inboard sides. Areas with missing enamel had tension cracks corresponding to the outside of the bend from the curved roller contact deformation (see figure 12).

Figure 12. Multiple views of the forward upper guide fitting on the left MED plug.

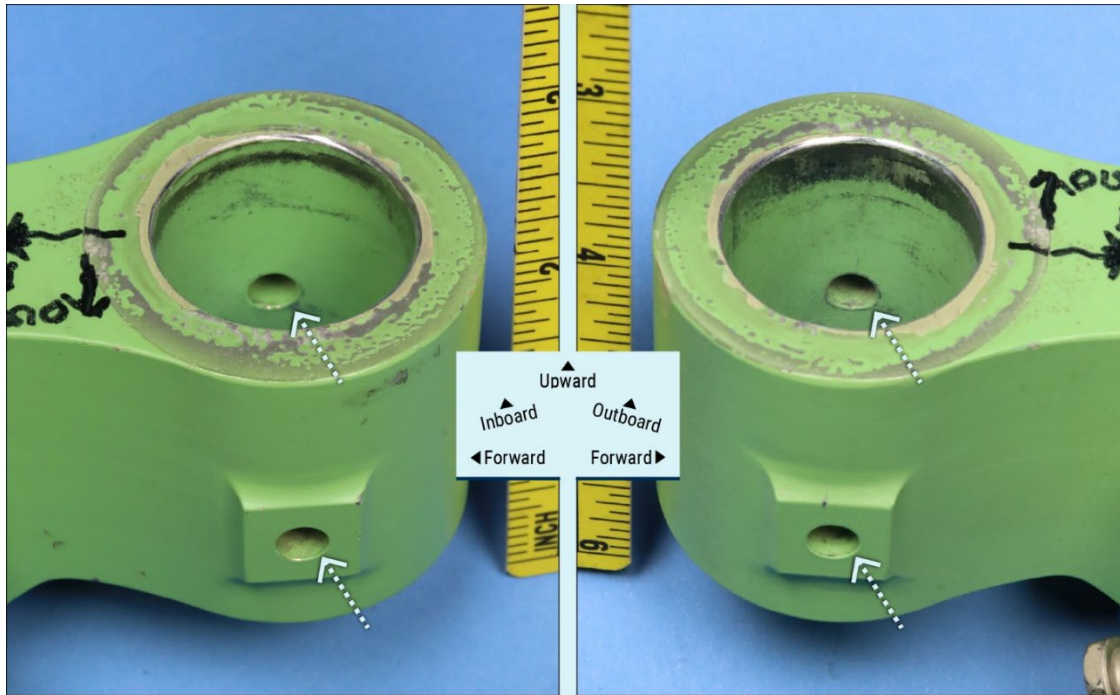
The aft lower hinge guide fitting attachment flange was fractured at the two upper attach hole locations, and the bolts remained installed in the left MED plug. The two lower attach bolts were fractured. A similar damage pattern was noted on the left MED plug at the forward lower hinge guide fitting attachment location. All features were consistent with ductile overstress fracture. The vertical movement arrestor bolt holes in the aft lower hinge guide fitting were intact and undamaged (see figure 13).

Figure 13. Photographs showing two views of the vertical movement arrestor bolt holes.

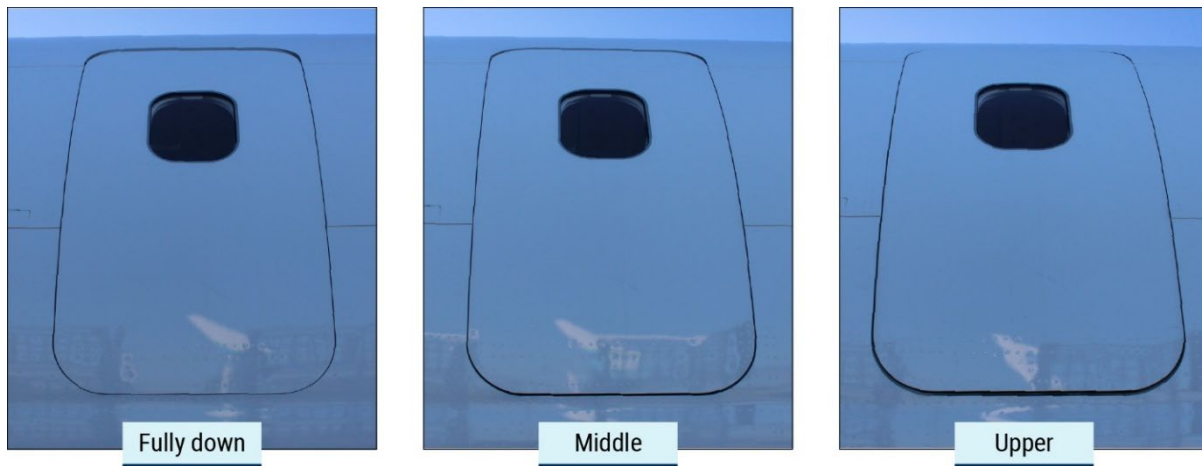
middle, and upper positions, the exterior lower gap was 0.079 inch, 0.315 inch, and 0.630 inch, respectively (see figure 14).

Figure 14. Exterior view of exemplar, unsecured right MED plug (from the accident airplane).

Note: The figure shows the visual appearance of lower gap at three plug positions in the range of stop pin-to-stop pad contact. The three positions shown are fully down, middle, and upper (at point of stop pin to stop pad instability).

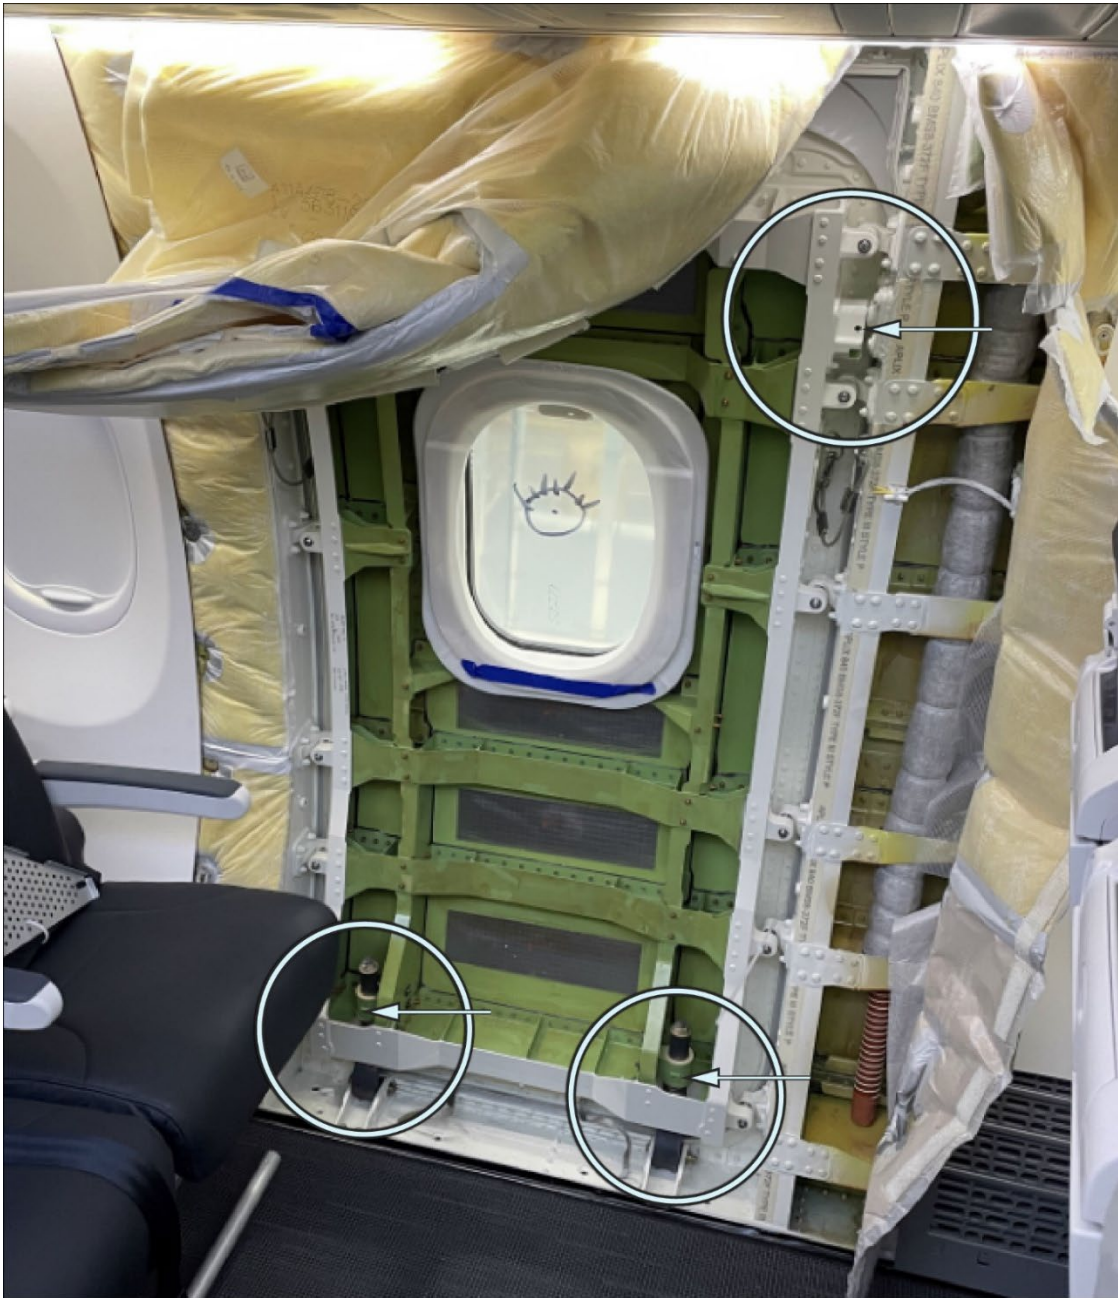
texts included a photograph sent about 1839 that showed the plug in a closed position with no attachment hardware in the three locations visible (see figure 18).

Figure 18. Photograph showing the left MED plug in the closed position with arrows indicating the locations of missing attachment hardware. Source: Boeing, cropped by NTSB.

Note: Locations circled show where both vertical movement arrestor bolts and the forward upper guide track bolt are not installed; the aft upper guide track fitting is obscured from view.
