July 3, 2025

Aviation Investigation Report: AIR-25-05

Improve Wind Detection Capabilities at Salt Lake City International Airport

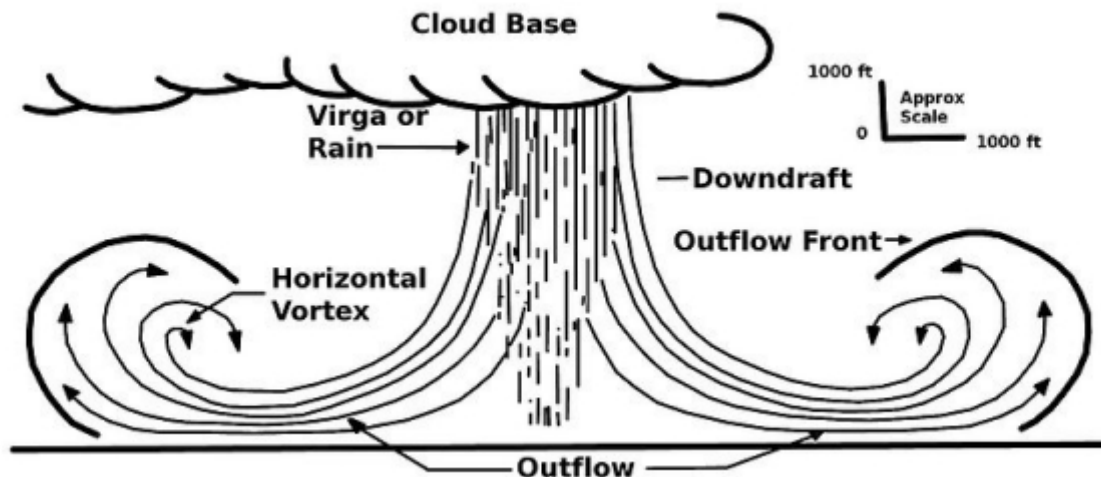
weather, potentially resulting in loss of airplane control. The figure below is a diagram of the lifecycle of a microburst originating from a convective cloud with precipitation.

Figure. Diagram of the lifecycle of a microburst. (Source: Advances in Mechanical Engineering)
