Aviation Investigation Report AIR-25-06

Address Fatigue Cracking in Hydraulic Landing Gear Actuators on Cessna 210 and 210B Airplanes

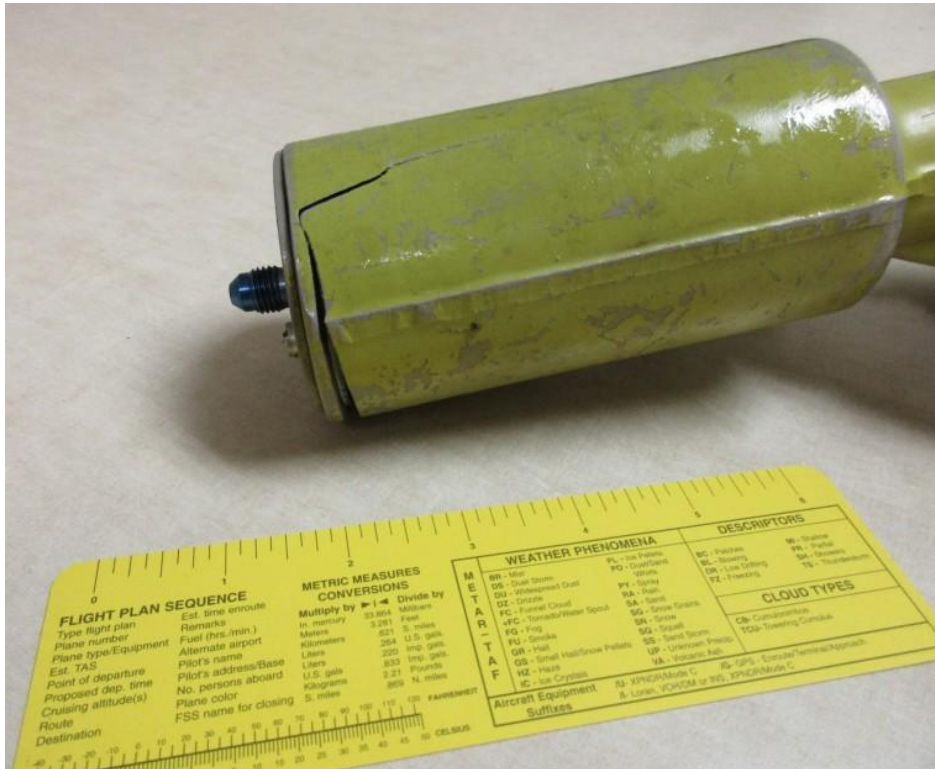
The hydraulic actuator fractures from these events were also nearly identical: fatigue cracks initiated from pitting corrosion along the retainer ring groove corners on the interior of the actuator housing and propagated outward into the housing (see figures 1 and 2). When the cracks grew large enough, the housing fractured, which resulted in a loss of hydraulic fluid, leading to the actuator failing in service.

Figure 1. Actuator with fatigue cracking (from NTSB case number ANC18LA019).

The material used to manufacture the actuator (Cessna part number 1280501-1/-2 or Electrol part number EA1614-1/-2) is an aluminum alloy tempered to maximum strength and hardness but susceptible to specific corrosion mechanisms, like pitting.² The NTSB's examination of the failed actuators found that the geometry of the housing where the retainer ring is located may impart a high stress concentration at the area of fatigue crack initiation. In three of the accidents we investigated (ANC15LA048, ANC18LA019, and WPR23LA213), pitting corrosion

observed in the retainer ring groove served as areas of increased stress concentration, acting as sites for fatigue crack initiation.³

The NTSB concludes that an inspection and overhaul of the hydraulic actuator in Cessna model 210 and 210B airplanes at a regular interval would increase opportunities to detect any defects before they progress to failure. We therefore recommend that Textron Aviation develop inspection criteria and an overhaul interval for Cessna part number 1280501-1/-2 or Electrol part number EA1614-1/-2 hydraulic actuators, develop a life-limit for when these actuators should be replaced, and issue

Develop inspection criteria and an overhaul interval for Cessna part number 1280501 1/-2 or Electrol part number EA1614-1/-2 hydraulic actuators, develop a life-limit for when these actuators should be replaced, and issue a service bulletin with this information to detect defects before they progress to fatigue failure. (A-25-37)

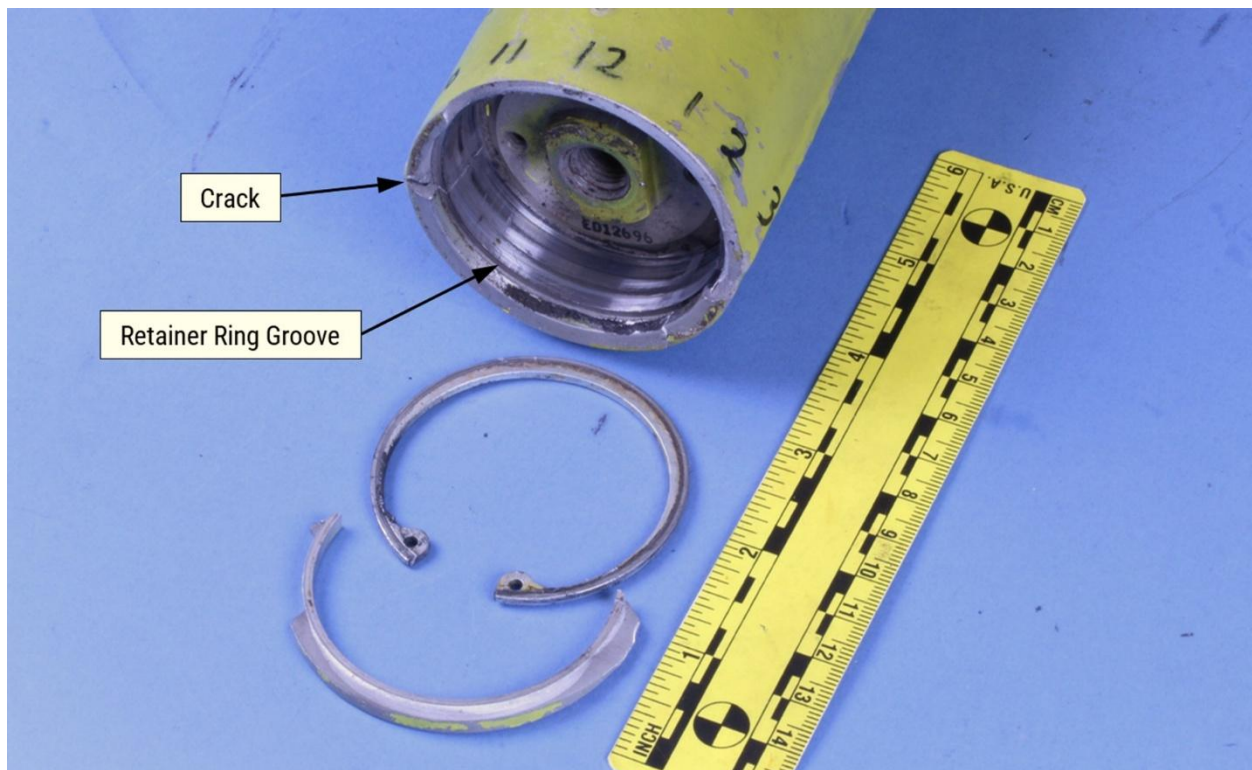
Figure 2. View into the actuator housing with the retainer ring groove and crack indicated (from NTSB case number ANC15LA048).

³ The corrosion pitting is from normal chemical reactions of latent salt elements (Na, K, Cl, Ca, S, etc.) with the aluminum alloy. The pitting was found on all the groove surfaces, not just the corners. The corners of the retainer ring groove already act as stress concentrators, but when pitting develops at these corners, the local stress increases, and the pits act as fatigue crack initiation sites, as seen in the scanning electron microscope images of the fatigue cracks, and the optical metallography cross sections of the (not fully fractured) cracks in the retainer ring groove.
