Aviation Investigation Report AIR-26-01

Establish Pilot Training and Experience Qualification Criteria and Stall Test Plan for Postmaintenance Stall Test Flights in Certain Hawker Airplane Models

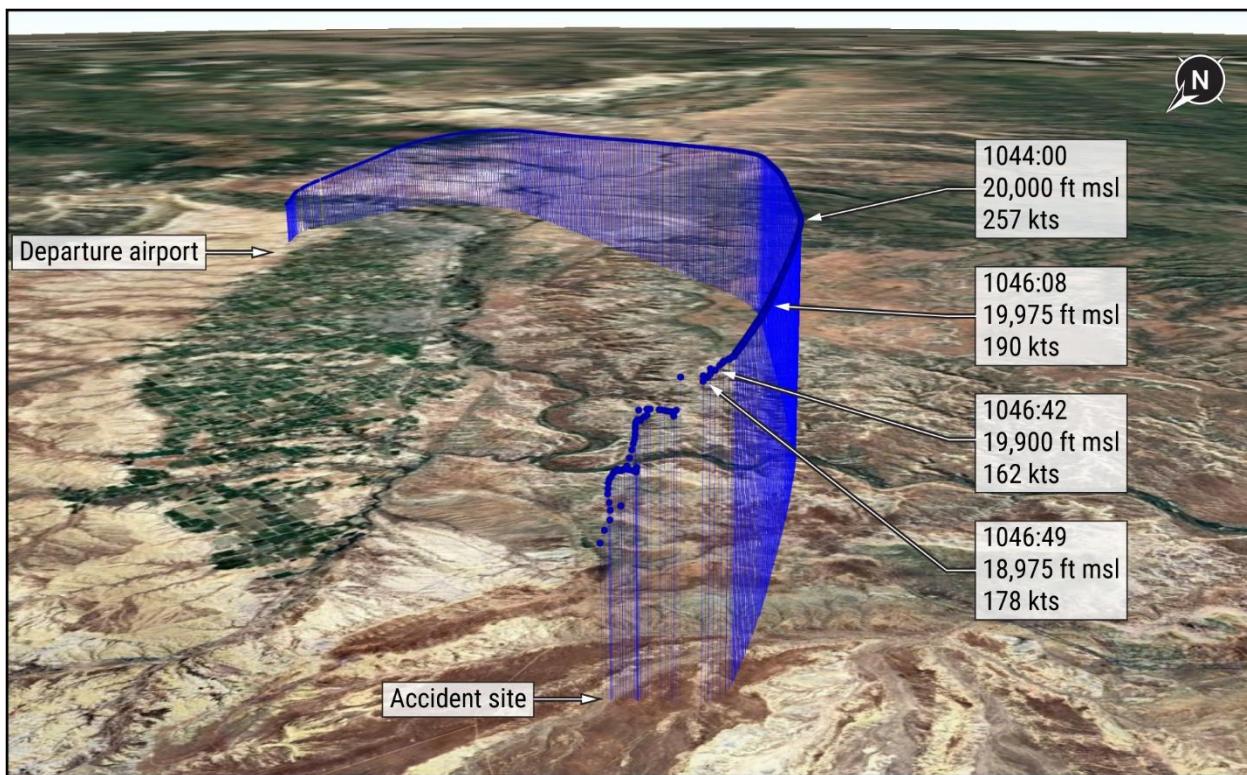
ADS-B data for the accident flight showed that the airplane departed from Grand Junction Regional Airport (GJT), Grand Junction, Colorado, about 1037 local time and climbed to near the top of the flight crew's requested block altitude of flight level (FL) FL180 to FL200 before leveling off.⁸ Areas of clouds and precipitation were in the vicinity of the departure airport. About 1047, the airplane entered a rapid, vertical descent consistent with a flat spin from which the flight crew did not recover airplane control. The airplane rolled through 360° multiple times in a corkscrew descent (see figure 1).

Figure 1. Flight track showing corkscrew descent of the February 7, 2024, Hawker 900XP accident flight near Westwater, Utah.

According to the FDR data for the accident flight, after the airplane entered the stall, it abruptly rolled to the right, and the flight crew responded with full left-wing-down aileron control input, full power, and full aft (airplane-nose-up pitch) elevator control input, which aggravated the aerodynamic stall and spin.
