Aviation Investigation Report AIR-26-02

Midair Collision over the Potomac River PSA Airlines Flight 5342, Mitsubishi Heavy Industries (MHI) RJ Aviation CL-600-2C10 (CRJ700), and US Army Priority Air Transport Flight 25, Sikorsky UH-60L

Washington, DC
January 29, 2025

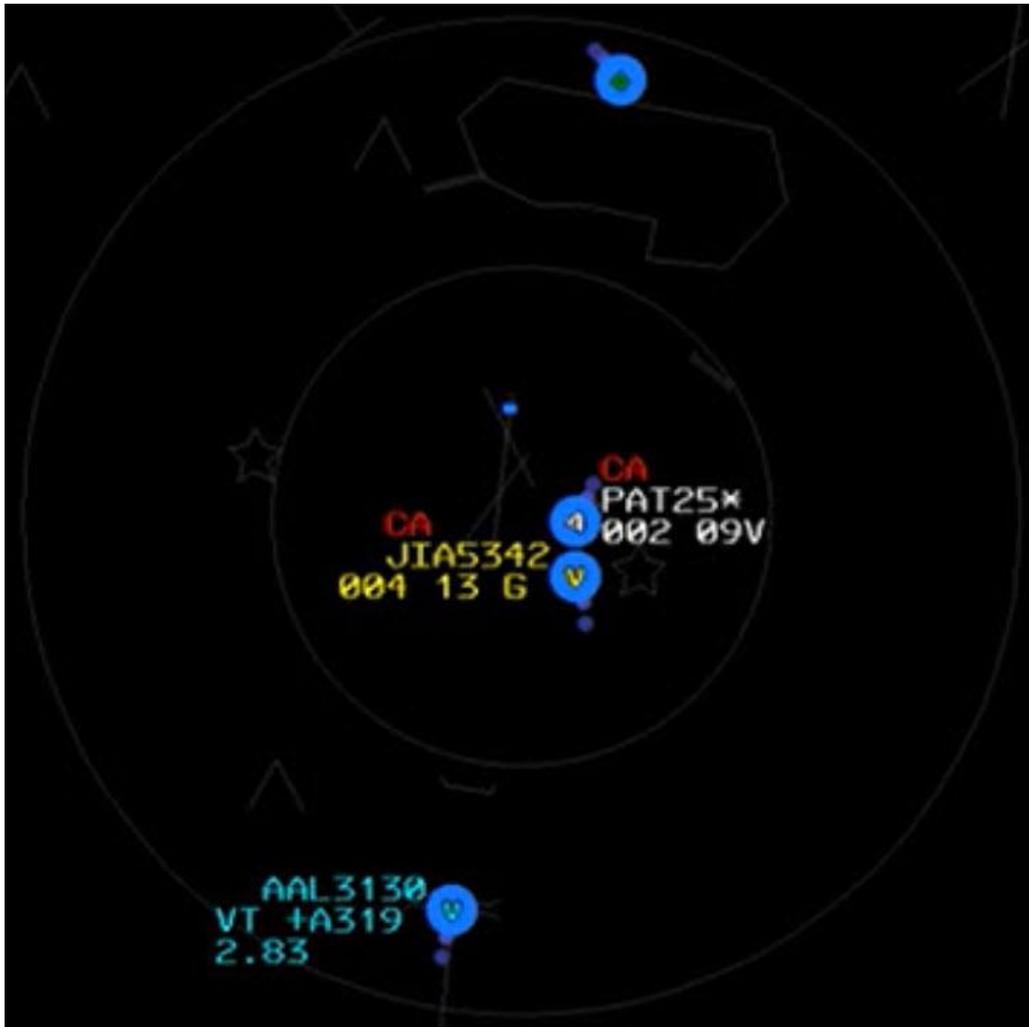
Figure 24. Photo of a CTRD screen showing the active conflict alert between PAT25 and flight 5342 (shown as JIA5342). The conflict alert activated at 2047:33 (about 26 seconds before the collision).

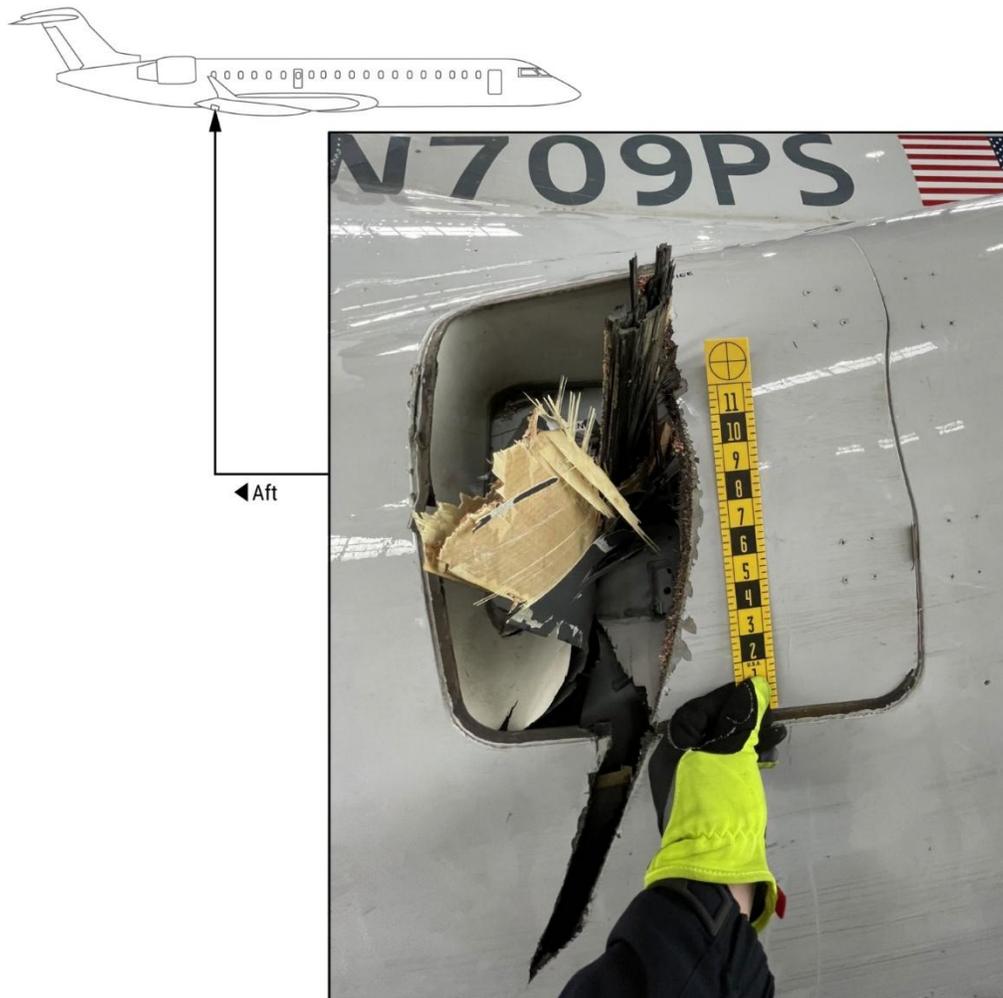
Figure 27. Aft fuselage of airplane embedded with a helicopter tail rotor blade.

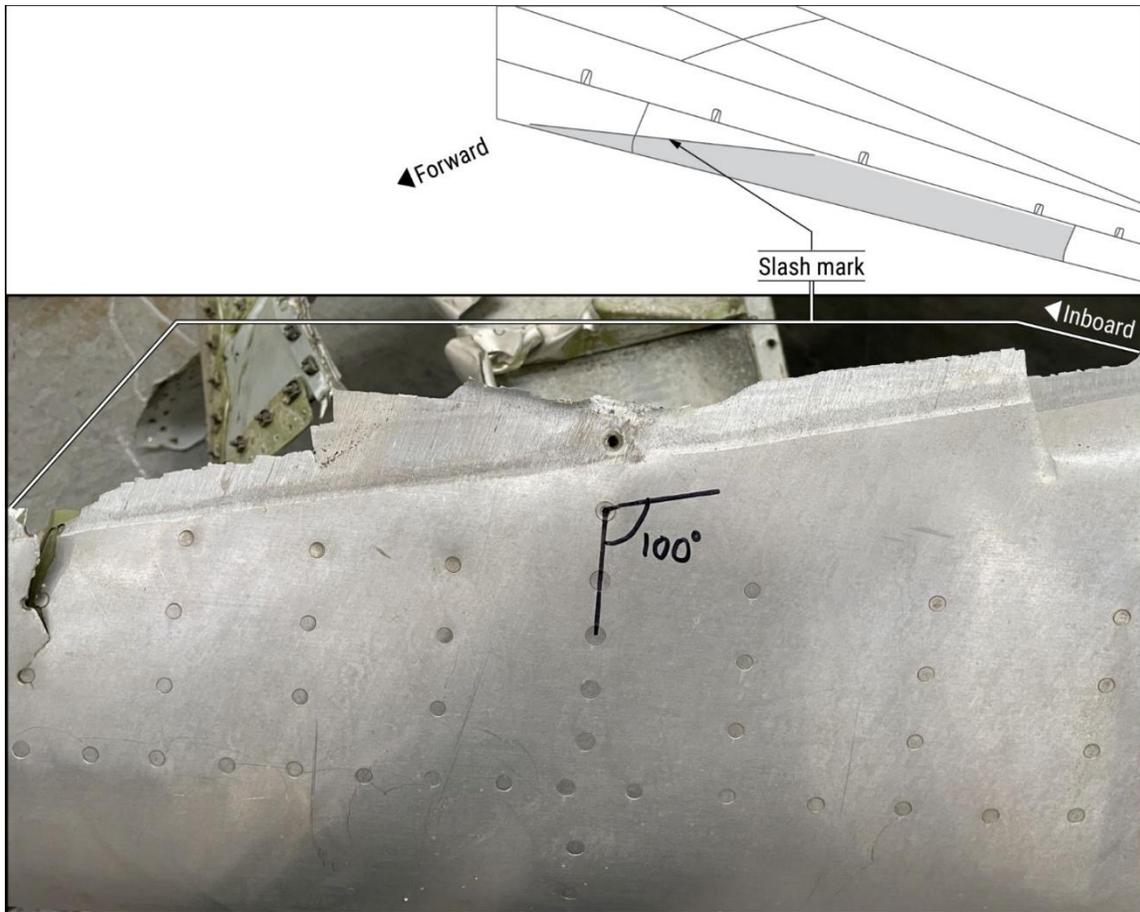
Figure 28. View of slash mark displayed on the airplane's left wing center leading edge slat.

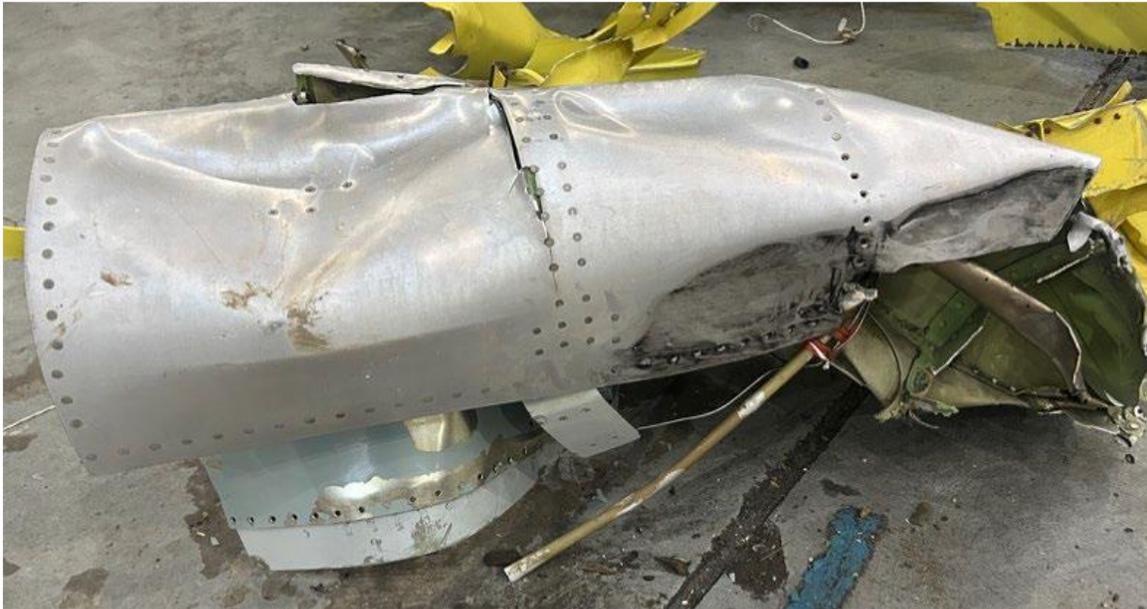
Figure 29. Wide view of impact mark on the airplane's left wing inboard leading edge slat.

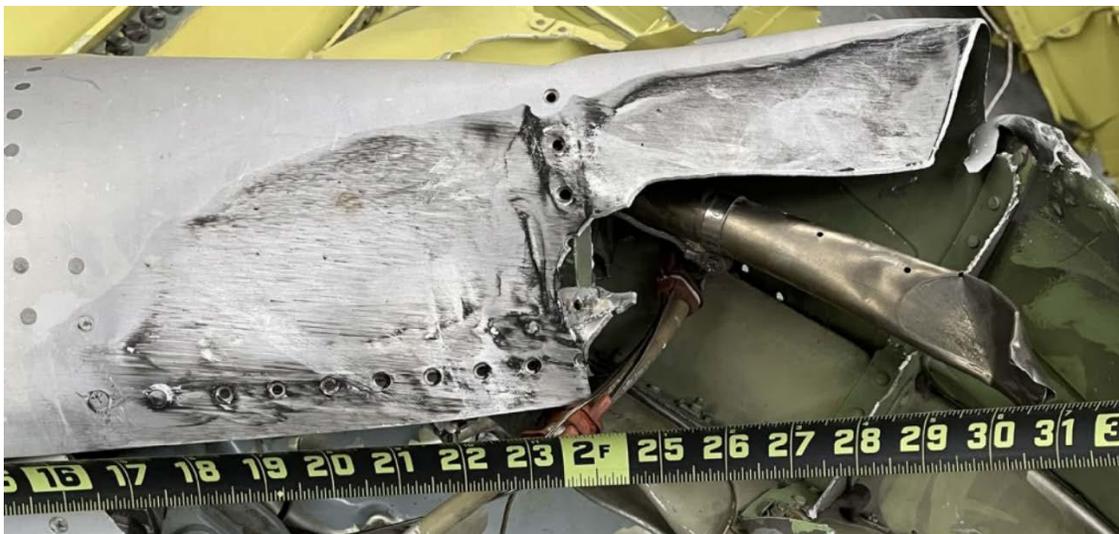
Figure 30. Close-up view of impact mark on the airplane's left wing inboard leading edge slat.

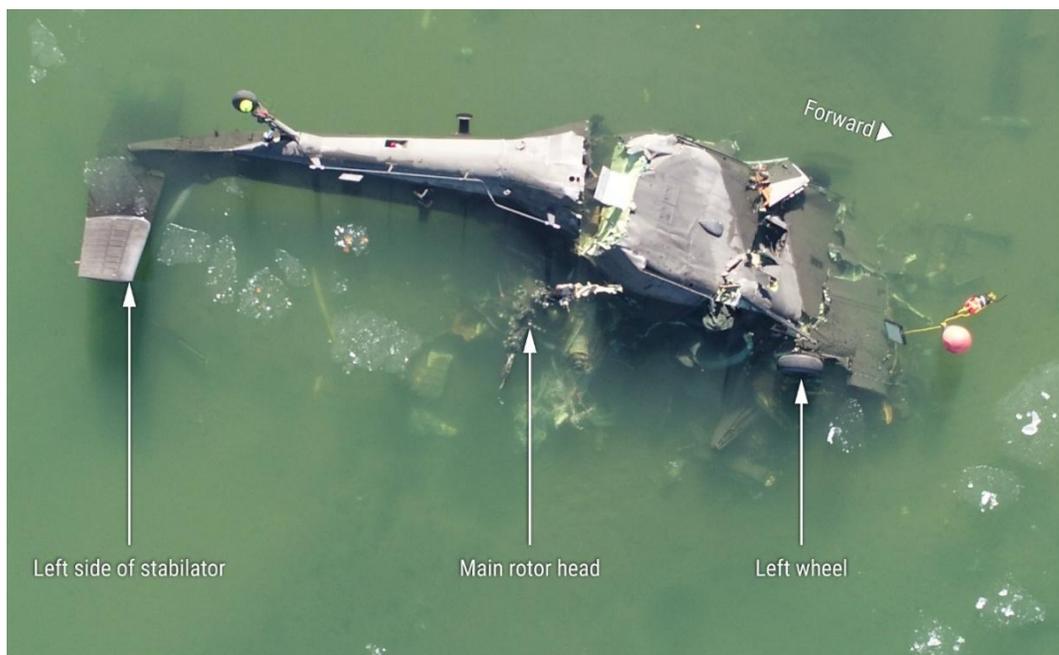
Figure 31. Helicopter main wreckage as it came to rest in the Potomac River.

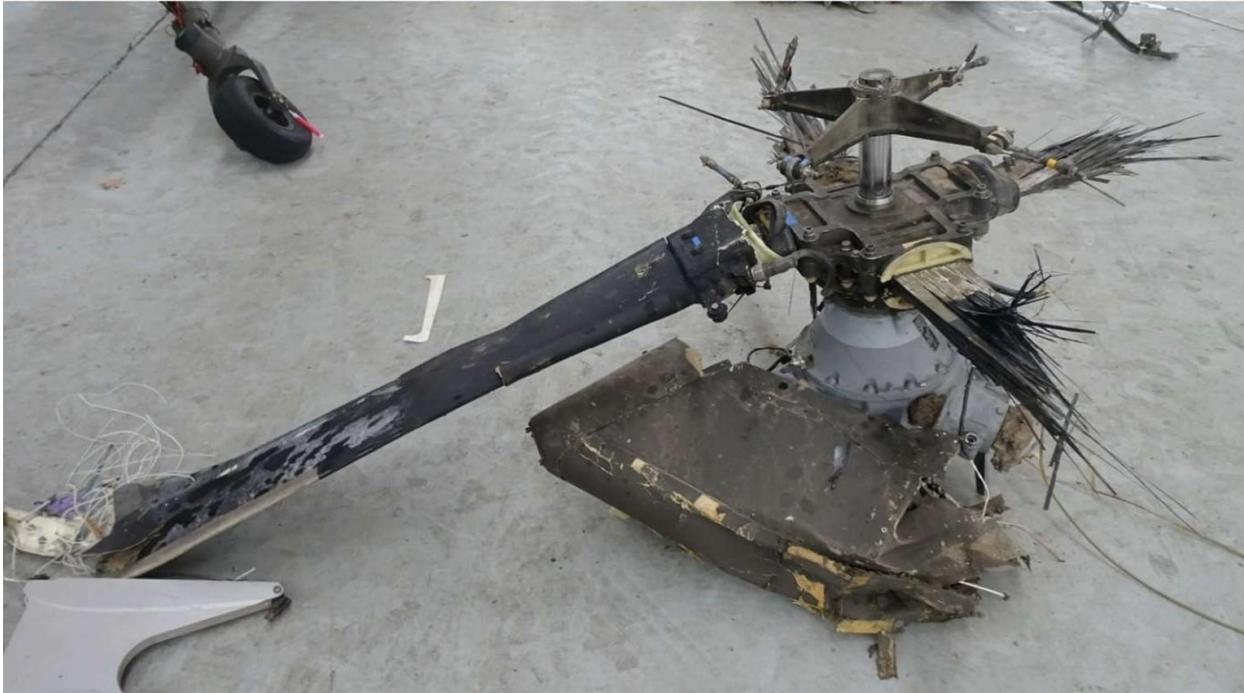
Figure 32. The helicopter's tail rotor as recovered, attached to the tail rotor gearbox.

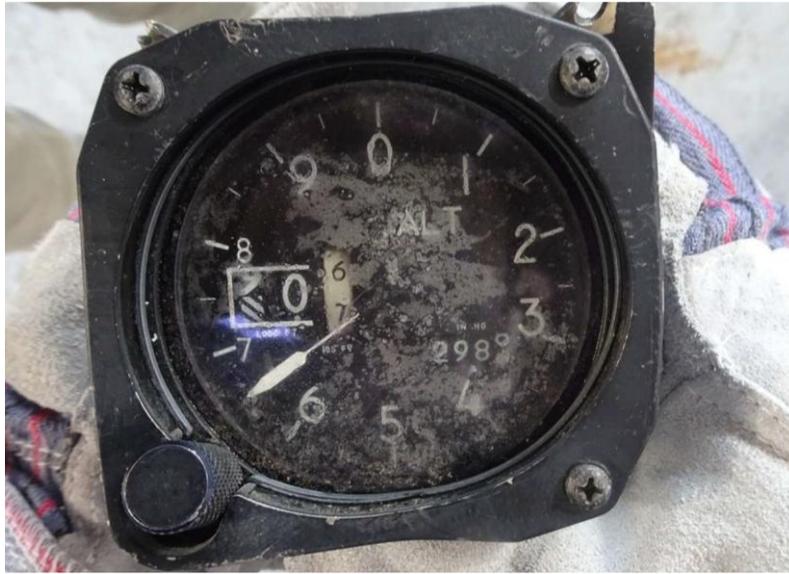
Figure 33. The left (pilot's seat) barometric altimeter.

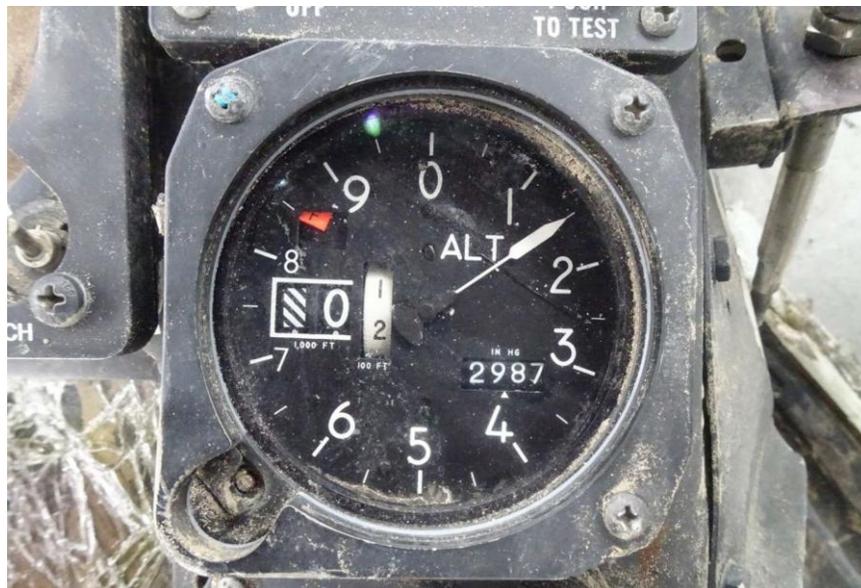
Figure 34. The right (IP's seat) barometric altimeter.

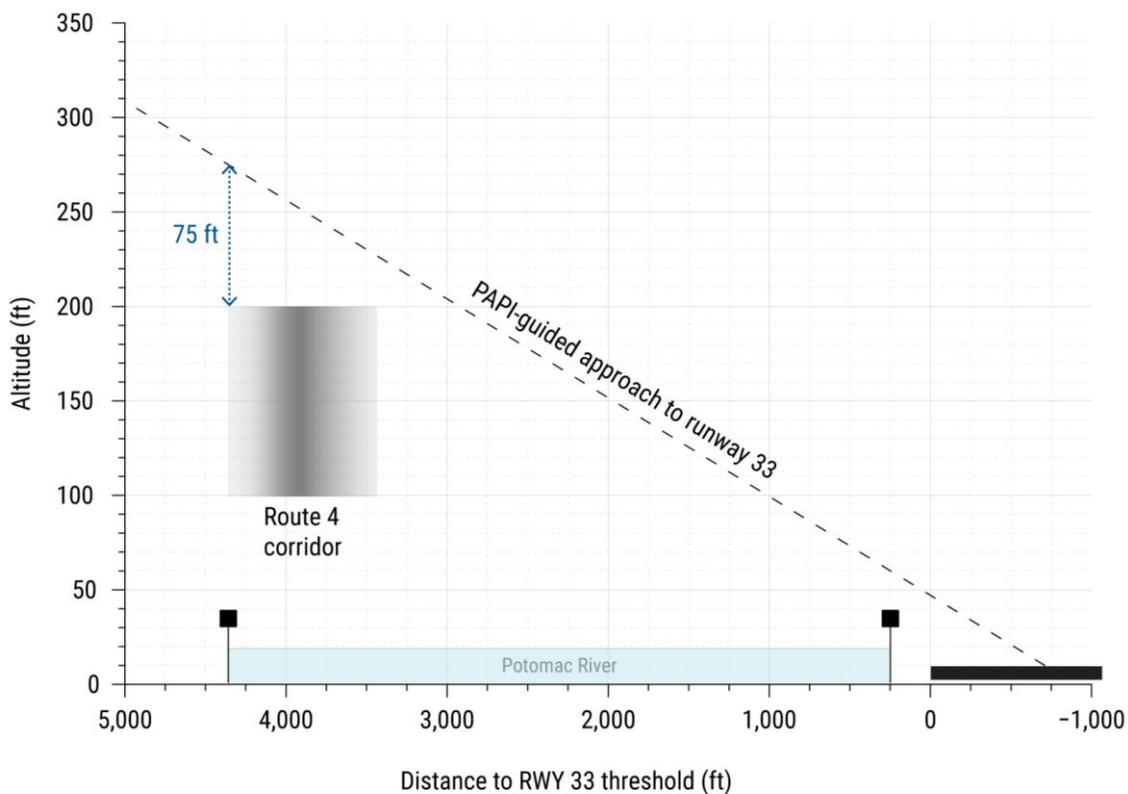
Figure 72. Cross section showing the notional separation between Route 4 and a PAPI-guided visual approach to runway 33, according to FAA charts and aerial photogrammetry analysis.
