National Transportation Safety Board

Safety Recommendation Report

Preventing Catastrophic Failure of Pratt & Whitney Canada JT15D-5 Engines Following Birdstrike or Foreign Object Ingestion

Accident Number:	ENG14IA013, ENG14IA011, and CEN09IA481
Operator/Flight Number:	Multiple
Aircraft and Registration:	Multiple
Location:	Multiple
Date:	Multiple
Adopted:	February 28, 2017

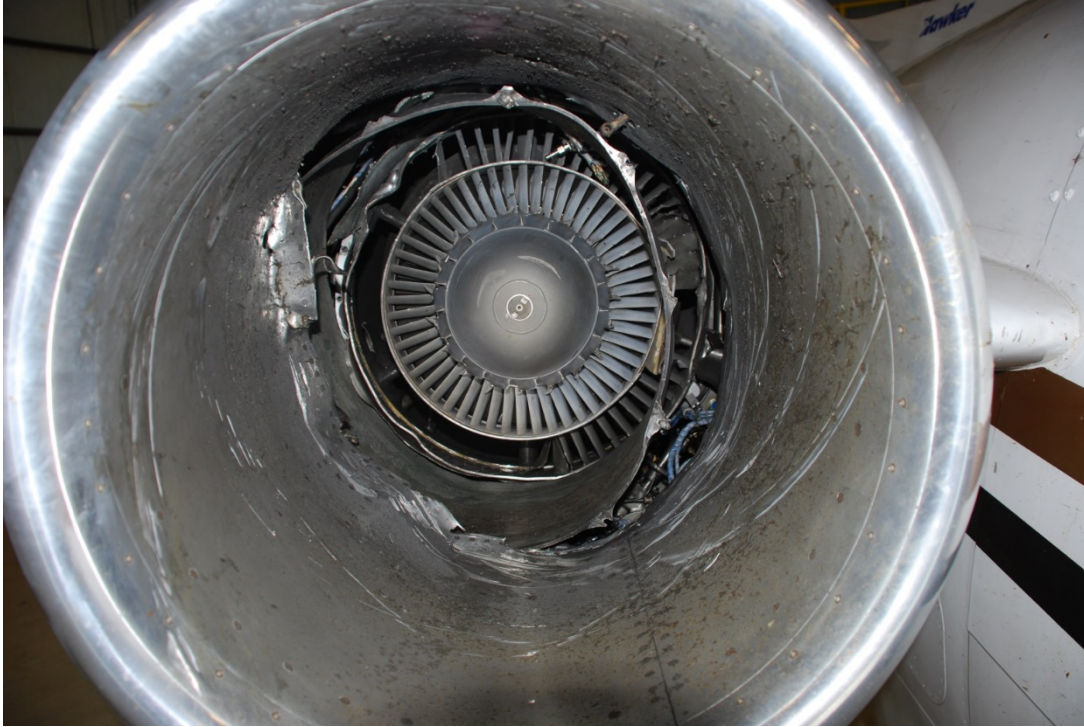
On May 13, 2014, about 1511 central daylight time, a Beechcraft Beechjet 400A, registration number N412GJ, equipped with two PWC JT15D-5 engines, experienced a fire in the No. 2 (right) engine following a birdstrike during takeoff roll at Sugar Land Regional Airport (SGR), Sugar Land, Texas. The flight crew successfully rejected the takeoff and discharged both fire bottles, which extinguished the fire. During an examination of the airplane, fuel was found leaking from the No. 2 engine cowling and from a puncture in the right wing fuel tank. The No. 2 engine fan blades were all fractured near the root. The No. 2 engine cowling had multiple penetrations and there was evidence of blade fragments impacting the inlet cowl forward of the fan (see figure 1).²

Figure 1. Photograph showing damage to the inlet cowl of the No. 2 engine on N412GJ.

Require that all JT15D-5 engines installed on Raytheon/Hawker Beechjet 400A airplanes be modified to dampen the rub-induced excitation that can occur between the engine fan and fan case during birdstrike or foreign object ingestion events. (A-17-7)

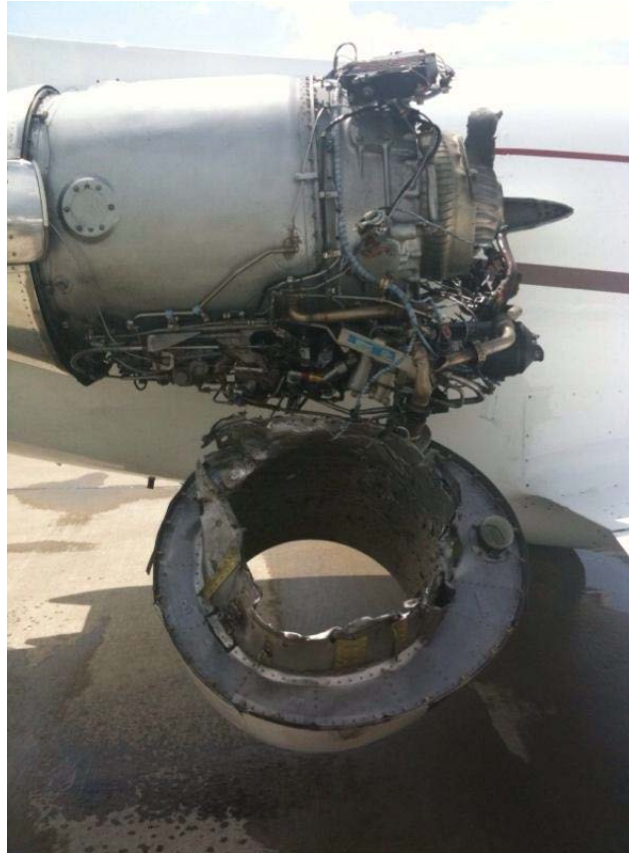
A similar event occurred at SGR in July 2009. In that incident, the No. 2 (right) PWC JT15D-5 engine on a Beechjet 400A, N679SJ, sustained damage and immediately lost all power after ingesting at least one bird during takeoff.³ The pilots successfully rejected the takeoff. Postincident examination of the airplane found all but one of the right engine fan blades fractured and that the inlet duct separated from the front of the engine (see figure 2).⁴

Figure 2. Photograph showing the inlet duct separated from the No. 2 engine on N679SJ.

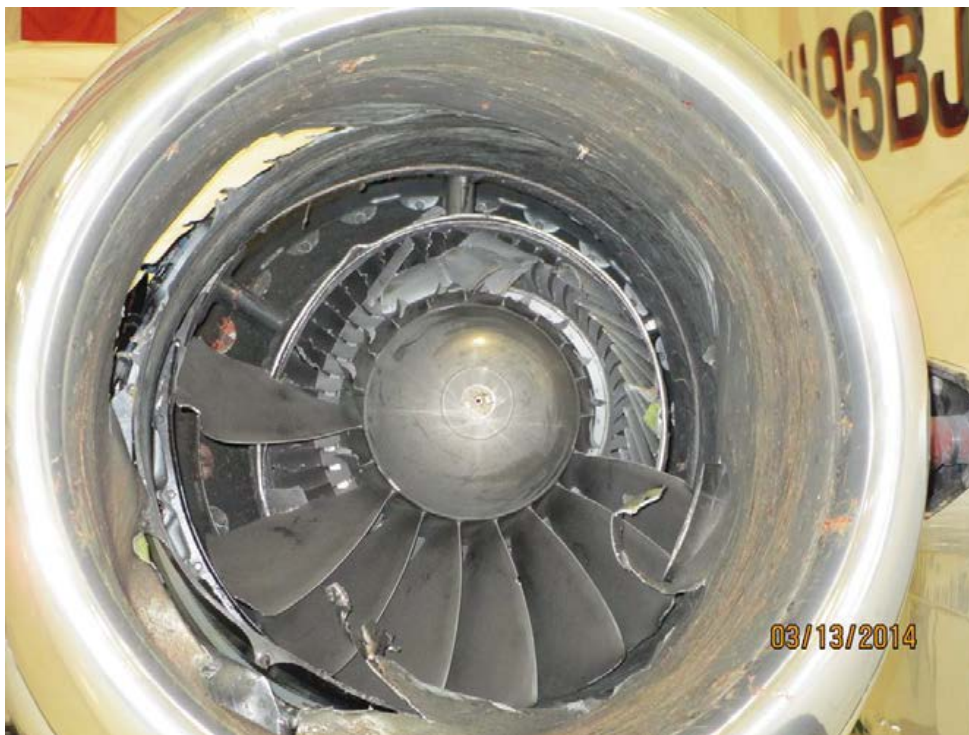
On March 13, 2014, about 1020 eastern daylight time, the No. 2 (right) PWC JT15D-5 engine of a Beechjet 400A, N193BJ, was damaged following a birdstrike shortly after takeoff from Greater Rochester International Airport, Rochester, New York.⁵ The flight crew declared an emergency and returned to the airport where they performed an uneventful landing. During an examination of the airplane, extensive damage to the No. 2 engine fan and inlet cowl was observed (see figure 3). The compressor cowl had multiple holes and the right wing had an impact mark forward of the engine fan case. Several weeks after the event, a blade fragment was found lodged in the roof of a building below the flightpath.⁶

Figure 3. Photograph showing damage to the inlet cowl of the No. 2 engine on N193BJ.
