# National Transportation Safety Board

## Safety Recommendation Report

### F&M Enterprises and Stratus Oil Filter Adapter Assembly Oil Leaks<sup>1</sup>

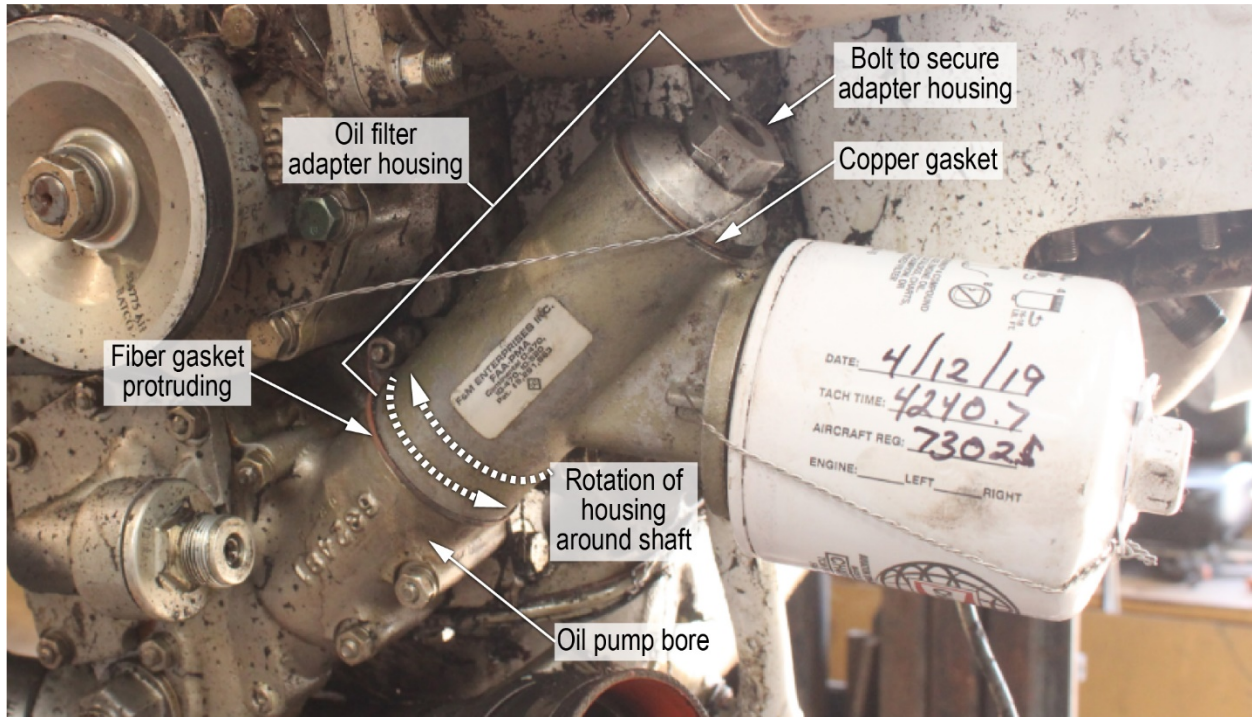
**Figure 1.** Mill Creek accident oil filter adapter attached to the engine.

Postaccident examinations of the oil filter adapters on the Ramona and Mill Creek accident airplanes revealed a crescent indentation in the fiber gasket material. Further, investigators found that the housing for both accident airplanes’ oil filter adapter rotated freely around the shaft and the fiber gasket protruded from the interface between the oil pump bore and adapter. Postaccident

examinations of the accident adapters from the Ramona and Mill Creek accidents revealed that the torque was 9 lbf-ft and less than 20 lbf-ft, respectively. However, investigators were not able to determine the root cause of these irregularities.

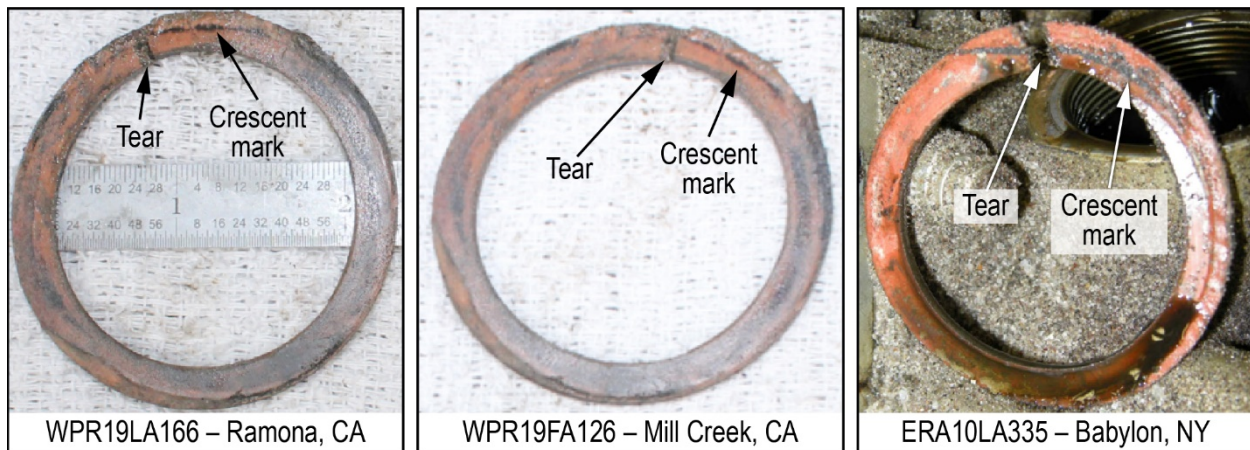
Gaskets rely on both friction and even compressive force (also called seating stress) to create a seal between mating surfaces. One of the signatures of uneven gasket compression is uneven impression marks around the gasket; if the gasket is not positioned flat during installation (for example, the housing is torqued while the gasket is canted), uneven compression could occur or the gasket material could be torn.

A review of NTSB accidents and incidents showed that the two oil filter adapter leaks and gasket ruptures cited above were not isolated events.<sup>6</sup> Figure 2 shows the torn fiber gaskets and crescent marks from the two accidents described above and from a June 25, 2010, accident that occurred following an oil leak, a total loss of engine power, and a forced landing near Babylon, New York.<sup>7</sup> In addition, at least 10 other accidents or incidents occurred in which the airplane was equipped with an F&M or Stratus oil filter adapter and had a loss of engine power following an oil leak; 5 of those included evidence of torn fiber gaskets and crescent marks and 4 of those had loose adapters. Some of the issues identified in those accidents and incidents included misalignment of the gasket and adapter, use of a copper gasket instead of a fiber gasket, undertorqued oil filter adapters, missed or undocumented adapter retorques, and gaskets that had not been recently replaced.

**Figure 2.** Torn gaskets with crescent marks from three different accidents.

In response to the findings of the ongoing investigations and other reports of oil leaks, on October 25, 2019, Stratus issued a mandatory service bulletin (SB), SB-001, to the owners of affected aircraft. Stratus' SB instructs mechanics to inspect the adapter for leaks, gasket damage or protrusion, and movement of the assembly; reinstall the oil filter adapter, if necessary; tighten the cylinder torque to 65 lbf-ft; and install safety wire. The SB instructs owners to inspect oil adapters before the next flight, every time the oil is changed, each 100-hour or annual inspection, and whenever the adapter is removed and installed. The SB also instructs mechanics to make an index mark on the adapter housing and the oil pump bore and calls for a wooden block to be placed behind the adapter to ensure that the adapter housing does not rotate while increasing the torque. The FAA has not issued an airworthiness directive (AD) mandating compliance with Stratus SB-001.

Issue an Airworthiness Directive to address the unsafe conditions of F&M Enterprises Inc. or Stratus Tool Technologies (Stratus) oil filter adapters that have led to oil starvation and loss of engine power by requiring owners of airplanes equipped with the adapters to repetitively inspect and, if necessary, reinstall the adapters in compliance with Stratus' service bulletin SB-001. (A-20-39)
