PRELIMINARY REPORT

HAZARDOUS MATERIALS

DCA16SH002

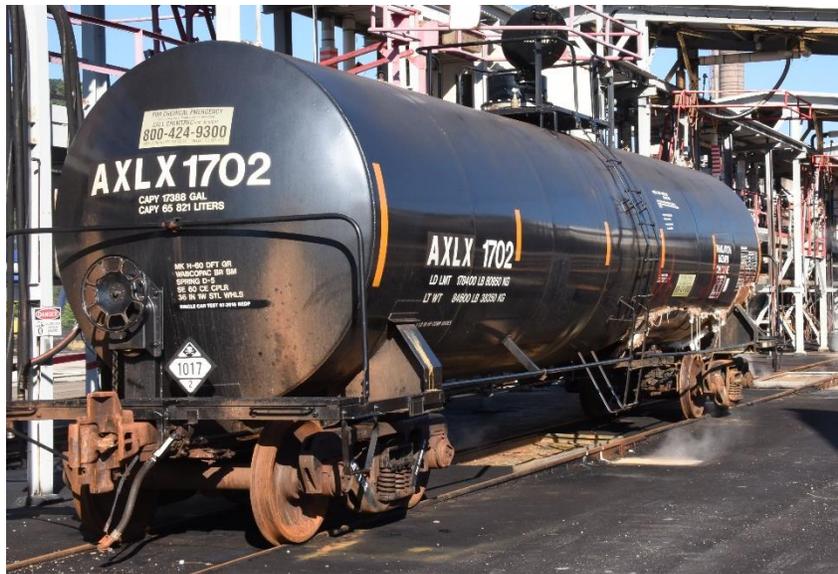
- The tank car, built by ACF Industries in 1981, had water capacity of 17,380 gallons, and its original shell thickness was 0.7751 inch. It was equipped with an ACF 200 stub sill underframe. (See figure 1.)

Figure 1. Tank car AXLX 1702 after chlorine release.

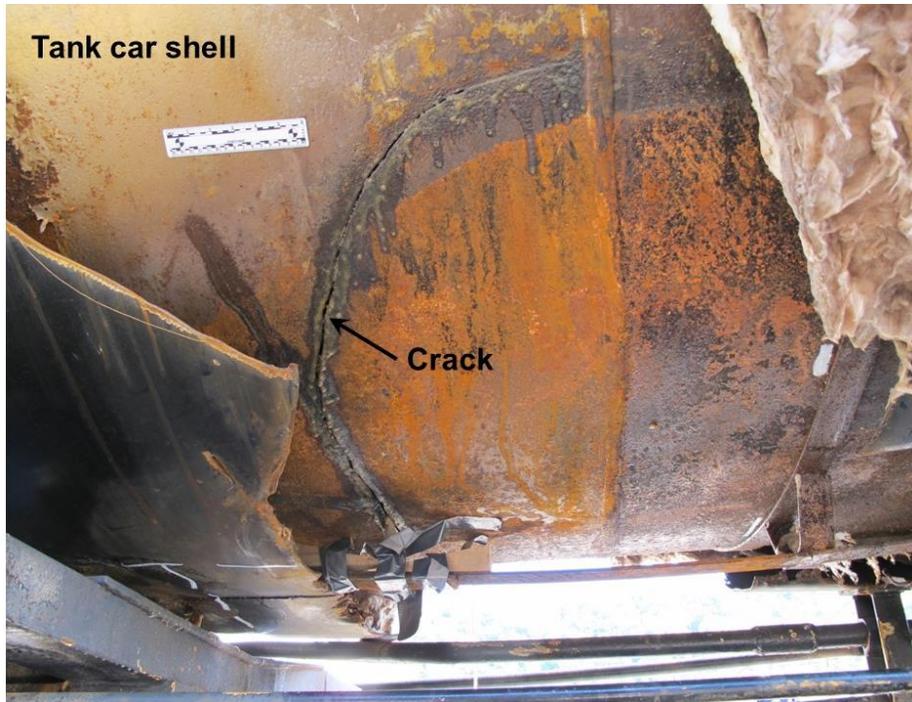
- A circumferentially-oriented crack about 46 inches long propagated inboard of the A-end stub sill reinforcement pad on the bottom of the tank car. (See figure 2.)

Figure 2. Cracked tank shell with portions of tank jacket and insulation removed.

- Preexisting cracks were found at the toe of two fillet weld repairs made in 2010 to the stub sill reinforcement pad. The added welds extended beyond the inboard end of the reinforcement pad.
- One of the preexisting cracks from the 2010 weld repairs was the origin of the tank shell crack.
- At one end, the crack arrested near a region of the tank shell that exhibited internal surface thermal scaling and tested softer than surrounding steel.
- Investigators found buckling in the tank shell between the end of the stub sill reinforcing pad and the adjacent girth weld, as well as several areas of repair to the tank shell that measured below the minimum allowed thickness of 0.7438 inch.
