National Transportation Safety Board

Highway Accident Brief

Accident Number: HWY15MH004
Accident Type: Bus roadway departure and collision with moving train
Location: Interstate 20, Ector County, near Penwell, Texas
Date and Time: January 14, 2015, 7:50 a.m.
Vehicles: 2015 Blue Bird Vision bus, modified for prison transport
Union Pacific train ZLCMN2, consisting of 4 locomotives and 58 loaded railroad intermodal flatcars
Fatalities: 10
Injuries: 5

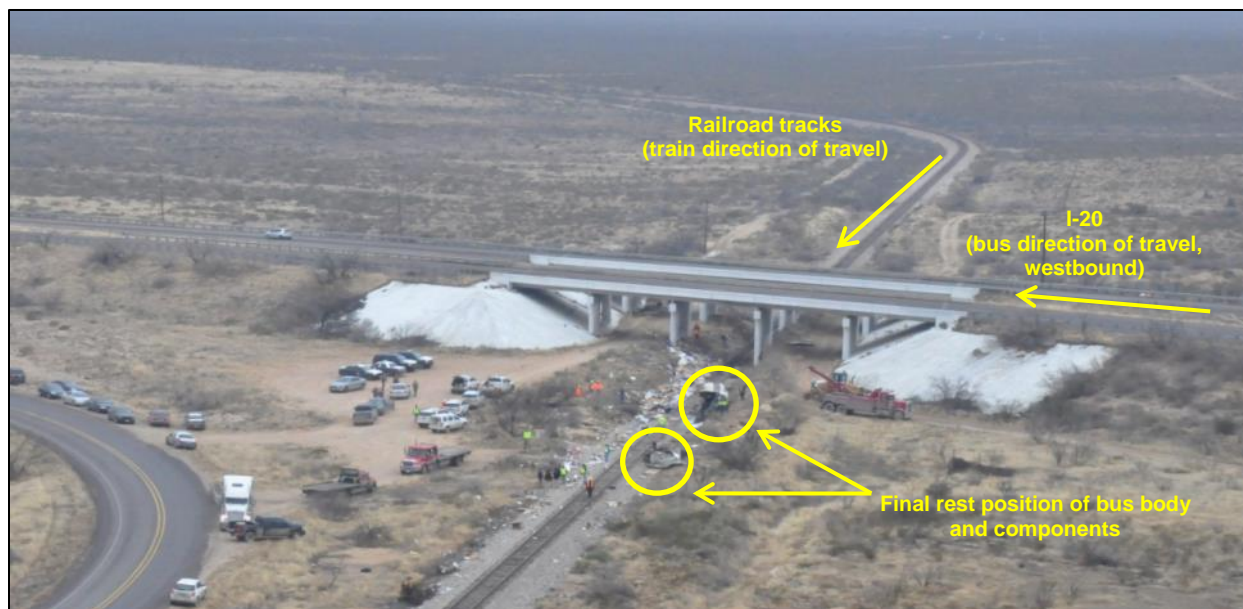
The bus departed the left edge of the westbound roadway, overrode the previously damaged guardrail, entered the median, and became airborne between the westbound and eastbound parallel bridges. At the same time, a Union Pacific (UP) freight train was traveling southbound under the highway overpass. The bus fell about 20 feet onto an earthen area at the base of a concrete slope, on the east side of the railroad tracks, and continued forward, striking

an intermodal flatcar. The train redirected the bus southward, and the left side of the bus collided with pillars supporting the eastbound bridge. The bus body and separated components came to rest along the east side of the tracks, about 220 feet south of the impact area (figure 2). Although the train stopped, it did not derail. (See “Railroad Tracks and Freight Train” for additional discussion.)

Figure 2. Aerial view of highway overpass with parallel bridges, railroad tracks, and final rest positions of bus body and components. (Source: TxDPS)

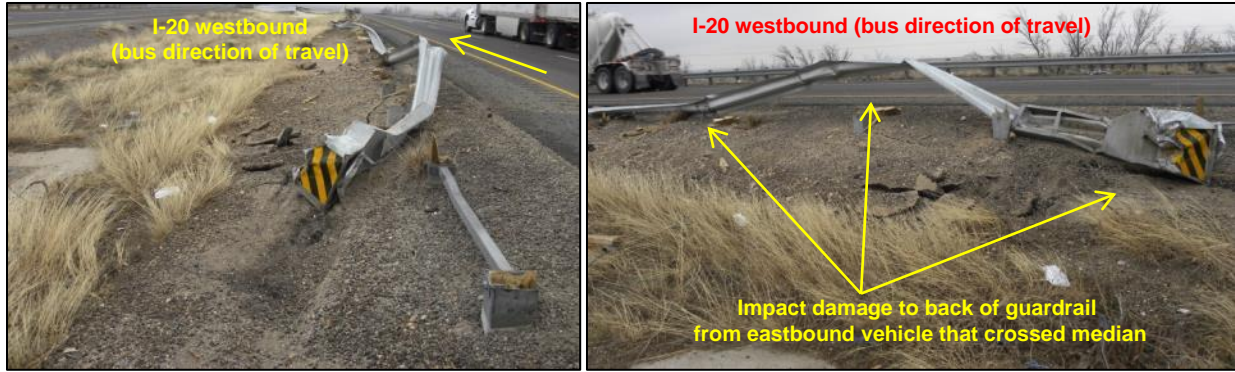
The guardrail had been struck at least three times in the 28 hours preceding the crash of the prison bus. On Tuesday, January 13, about 3:50 a.m., a vehicle traveling eastbound lost control, traveled across the median, and struck the back side of the guardrail. TxDPS notified the Texas Department of Transportation (TxDOT) of the damage. About noon on that day, TxDOT staff assessed and photographed the damage and moved the guardrail from the roadway (figure 3).

Figure 3. Condition of guardrail along I-20 westbound on January 13, 2015, after it was struck by eastbound vehicle and moved off roadway. (Source: TxDOT)

TxDOT also placed traffic cones on the shoulder and posted a sign, about 750 feet in advance of the end treatment, warning of the damaged guardrail. The department’s inspection and repair policy requires guardrail replacement as soon as practical after it is determined that a guardrail is no longer functional. This policy is consistent with the federal W-beam guardrail repair guidelines.¹⁰ A work order to repair the guardrail was sent to the contractor on January 20, 2015; the work was completed on February 9, 2015.

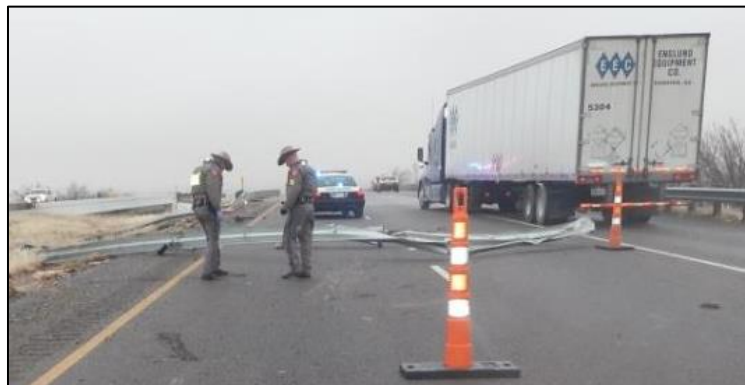
Following the bus crash, a section of the guardrail, including the end treatment, was displaced into the highway across both westbound lanes (figure 4). An inspection of the guardrail following its removal from the roadway revealed that about 207 feet had been damaged.

Figure 4. Orientation of guardrail across I-20 westbound lanes postcrash. (Source: TxDPs)

The NTSB concludes that, by the time of the bus crash, the structural integrity of the guardrail had been compromised such that it could not provide its safety function. Although an intact TL-3 guardrail might not have the capability of fully redirecting the type of vehicle involved in this crash, it might have provided some resistance and kept the bus from traveling between the parallel bridges.

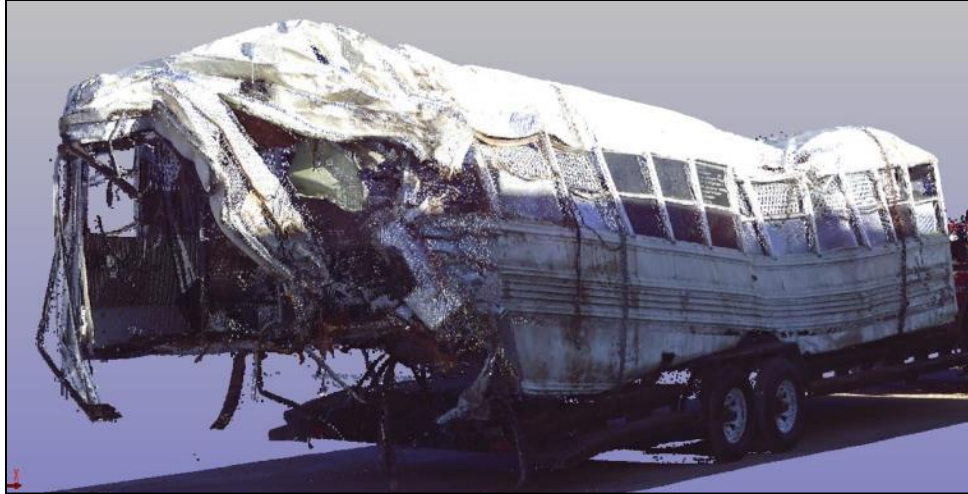
Figure 6. 3D scan showing damage to front, roof, and left side of bus body, which is resting on a tow vehicle.

The engine, suspension components, drive shaft section, and exhaust system components were scattered throughout the postcrash debris. The main portion of the bus body sustained multiple side and roof impacts and was deformed in all directions. According to the respective manufacturers, no crash-related vehicle data can be recovered from the transmission or antilock brake system control modules. No brake pad or drum crack defects were observed. The engine control module was not located postcrash.

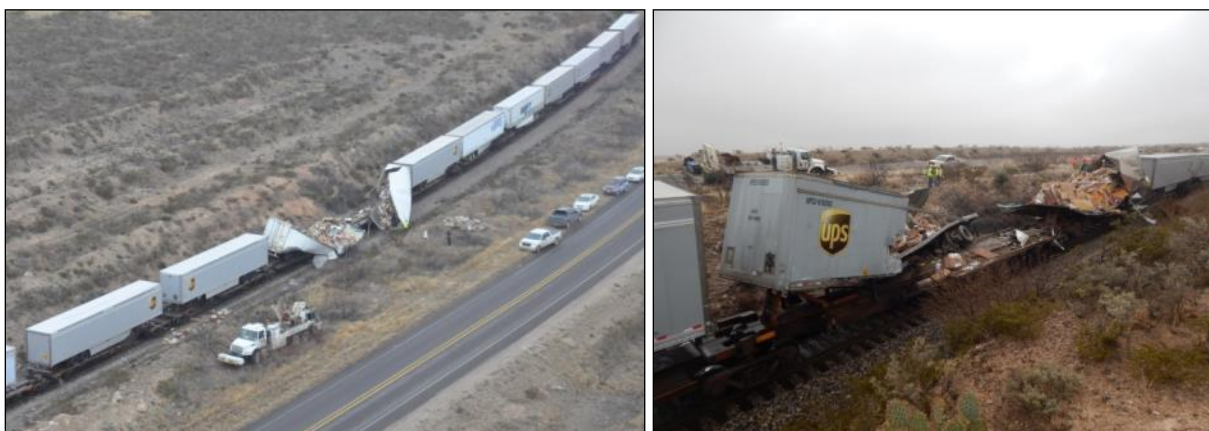
The bus collided with the 54th railcar, an articulated intermodal spine flatcar designed to carry highway semitrailers. According to the locomotive event data recorder, the train was traveling 46 mph at the time of the collision. The maximum authorized train speed in this area is 50 mph. None of the railcars derailed as a result of the impact, though two highway semitrailers were torn open—allowing cargo to be exposed and damaged (figure 7).

Figure 7. At left, two damaged semitrailers on intermodal flatcar. At right, closer view of damaged semitrailers. (Source: TxDPS)
